Christchurch City Council BE 0893 EQ2 Cuthberts Green Softball Complex Pages Road, Wainoni

COMBINED QUALITATIVE AND QUANTITATIVE
REPORT

FINAL

- 4
- 05 February 2013

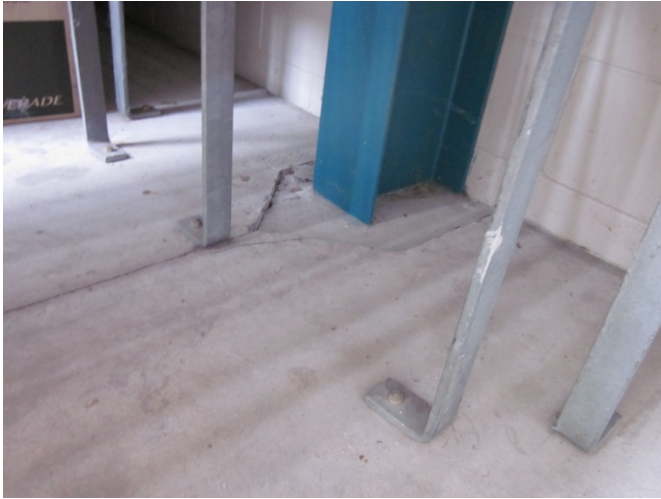
The ground bearing concrete slab between the Grandstand and the Softball complex has sever cracking where the two structures have moved separately.

■ **Figure 6 – Complex – Differential movement of column base and ground floor slab.**

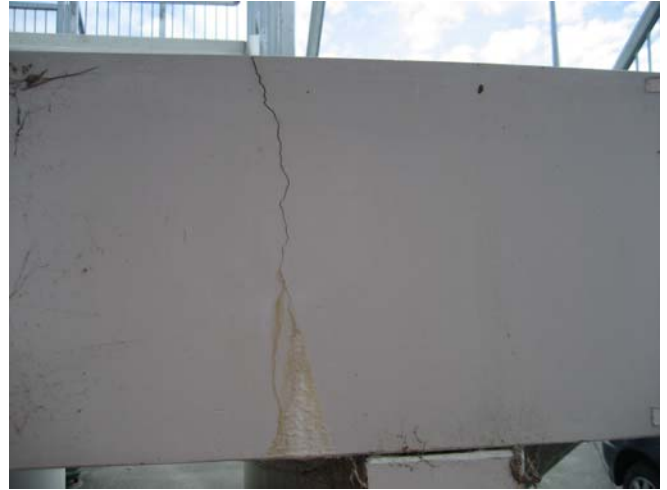
Damage noted during an inspection of the building includes hairline cracks to the underside of the bleacher units, 0.6 mm wide cracking to cantilever part of the stairs and ‘puckering’ of the

■ **Figure 7 – Grandstand – Cracking of stair landing.**

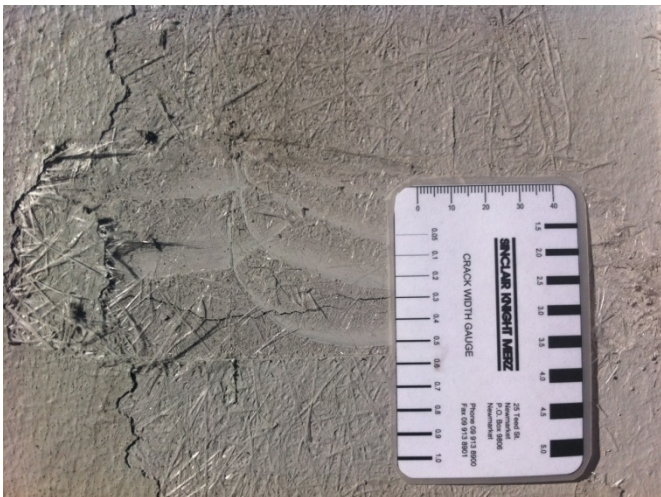
fibreglass topping of the viewing platform which appears to be at the joins of the precast floor units. One section of the 'puckering' was lifted and the concrete beneath inspected revealing 0.3mm cracks. The separation joint with the Softball Complex has been damaged and rainwater is now leaking into the walkway beneath. Some of the waterproofing seals on the structure has visible cracking and in some cases spalled plasterwork beneath.

■ **Figure 8 – Grandstand – cracking under fibreglass topping.**

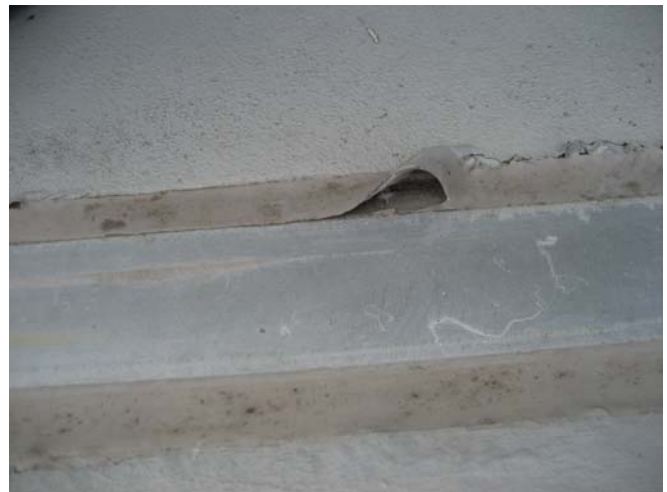
■ **Figure 9 – Grandstand – Damage to separation joint at Softball Complex.**

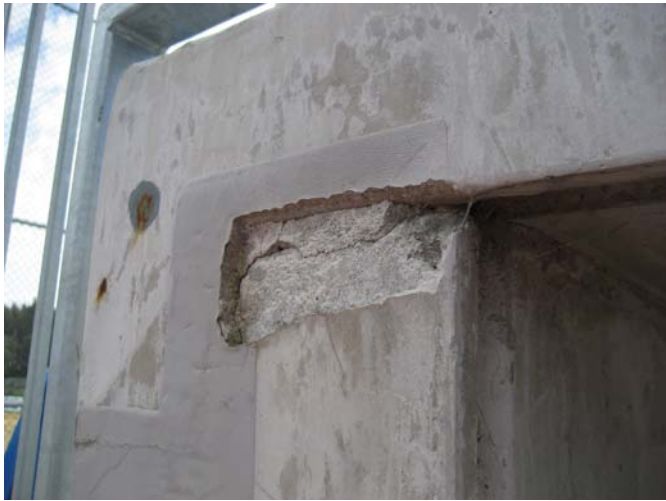
■ **Figure 10 – Grandstand – Section of plastering has broken out damaging the waterproofing.**

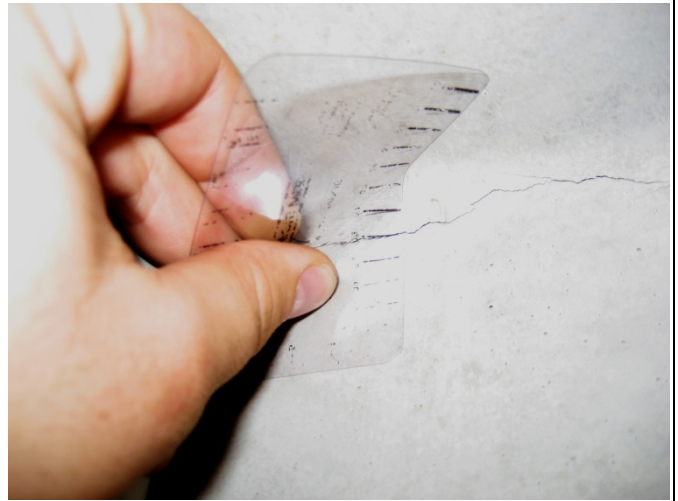
■ **Figure 11 – Grandstand – Typical concrete wall cracking.**

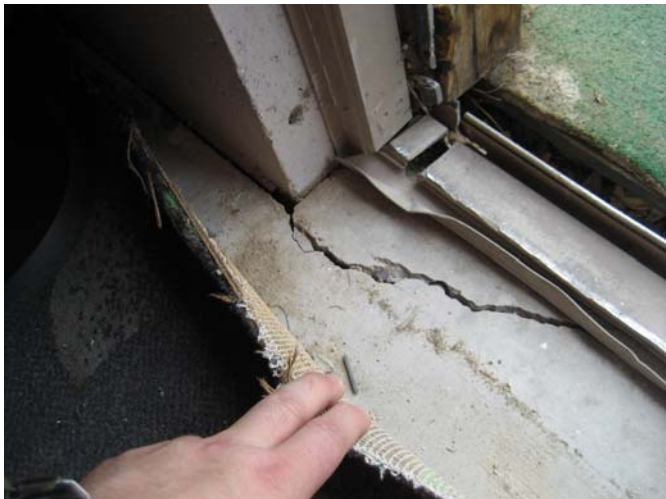
Damage to the Groundsmans Shed consisted of hairline cracking to some of the blockwalls as well as substantial cracking to ground floor slab.

■ **Figure 12 – Groundsmans Shed – Floor slab damage at door threshold.**

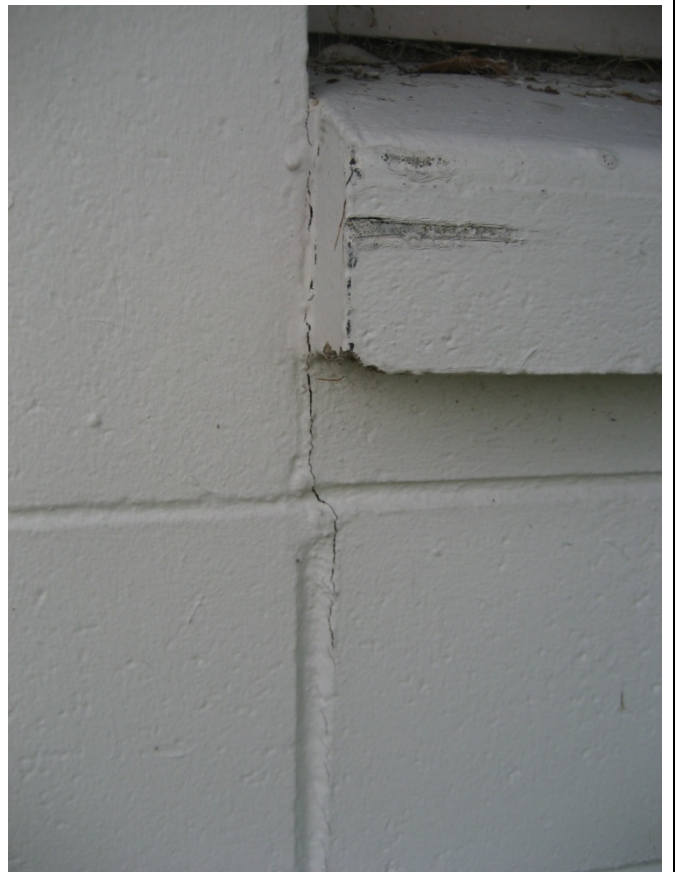
■ **Figure 13 – Groundsmans Shed – Typical Blockwork cracking.**

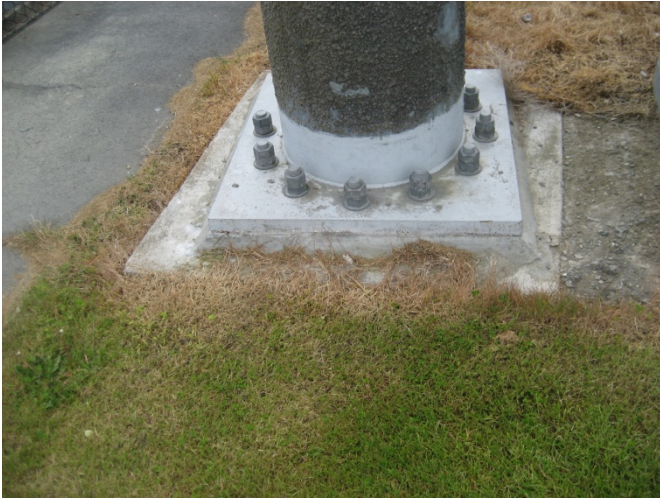
The verticality survey of the light towers which is attached at Appendix 3 – Survey Results has shown that the 5 of the 6 light towers were not vertical and exceeded the recommended column plumb tolerance. The recommended column plumb tolerance is 25mm for any point up to 60m in height and lights 1, 2, 3, 5 and 6 exceed this tolerance in one or both measured orthogonal directions and hence these light towers will need to be re-plumbed. The towers should be levelled by lifting them off the foundations, providing the necessary level of shims and then replacing the towers, tensioning the bolts using the methods contained in NZS3404 and the baseplates drypacked.

■ **Figure 14 – Light Towers – Typical Base detail, some require relevening.**

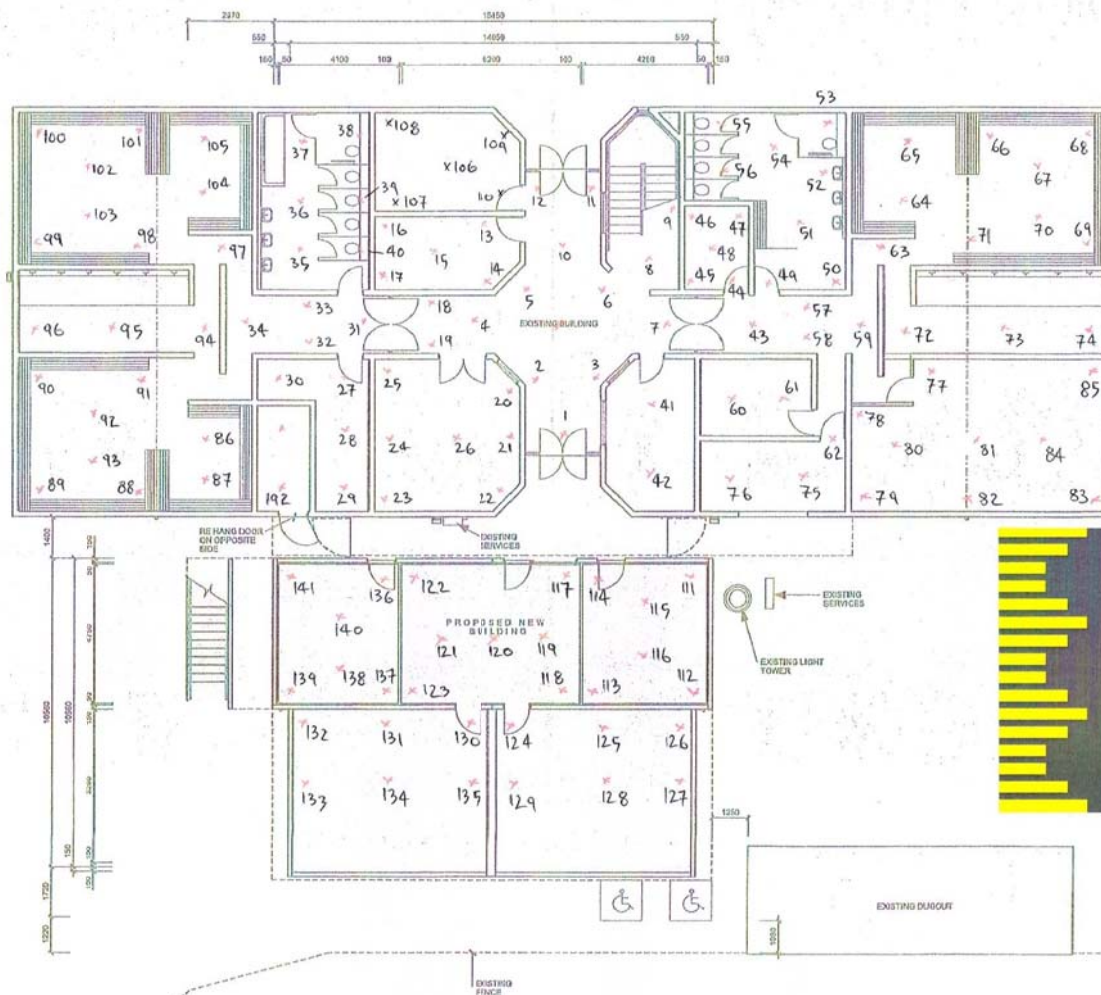
The floor slab survey contained in Appendix 3 – Survey Results indicated significant settlement with around 100mm maximum variation in level at ground floor level. While this is not a residential property the guidance document titled “Guidance on house repairs and reconstruction following the Canterbury Earthquake” recommends that a house with Type C foundations (slab on grade) should have foundations completely rebuilt if the maximum variation in level exceeds 100mm; as noted above the maximum variation in level is approximately 100mm. The above levels would lead to the conclusion that the slab is significantly out of level and should be substantially

replaced. We note that the slab is a floating slab on grade and the surrounding structures are not reliant on the slab for stability and so this repair could be undertaken relatively simply.
