**Denton Park Pavilion**  
**PRK 0770 BLDG 005 EQ2**  
Detailed Engineering Evaluation  
Quantitative Report  
Version FINAL

Denton Park, 446 Main South Road  
Hornby, Christchurch

Christchurch City Council

**Date**  
**3/10/2013**

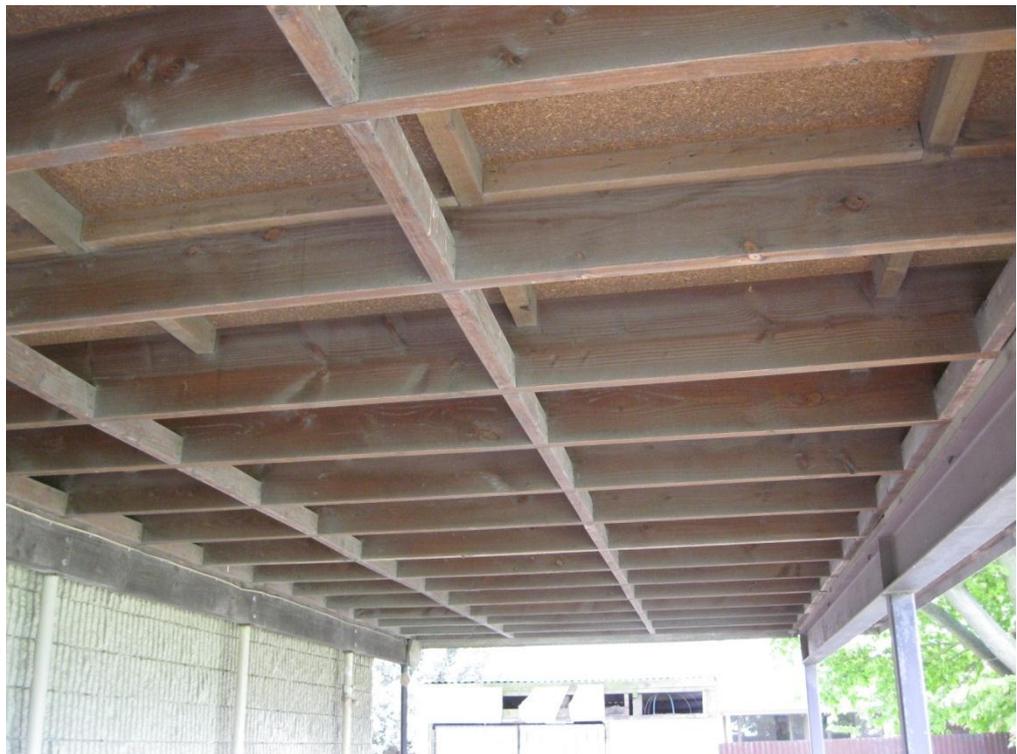
**Photograph 4 Underside of the first floor framing supported by steel framing to the north and concrete masonry walls to the south.**

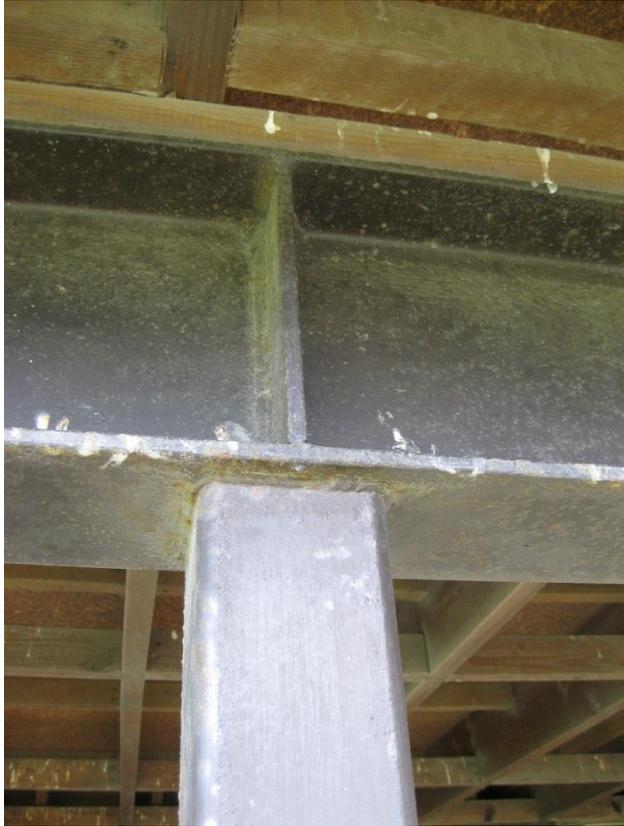
**Photograph 5 Steel framing with web stiffener above SHS column.**

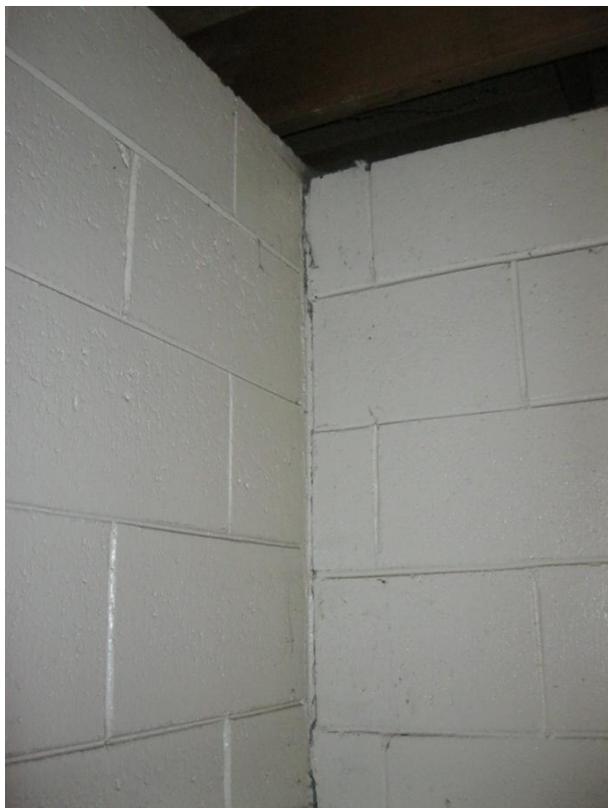
Minor cracking was noted to the plasterboard wall linings of the clubrooms above and below windows. Cracking was also noted along construction joints of an internal masonry partition wall within the ground floor changing rooms. These cracks are believed to have occurred because the partition wall is not an original wall and has not been adequately tied into the original masonry walls. No damage was noted to the stairs and these are not considered to be a critical structural weakness within the building. The strength of the building has not been affected by the damage.

**Photograph 6 Cracking between original concrete masonry wall (left) and later concrete masonry internal wall (right).**

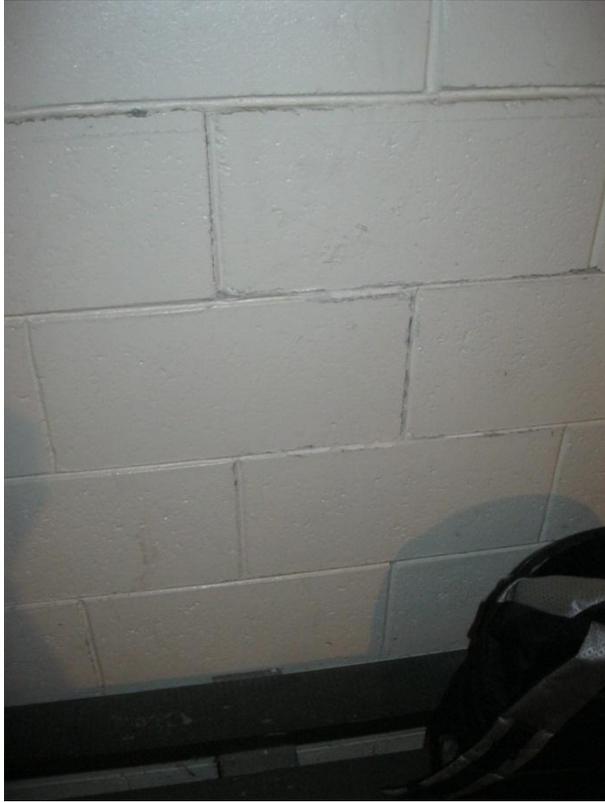
The recent seismic activity in Christchurch has caused minor damage to the ground floor portion of the building, with cracking in concrete masonry walls the only damage noted along with minor cracking to plasterboard linings of the first floor structure.

**Photograph 7 Cracking along mortar line of concrete masonry walls.**

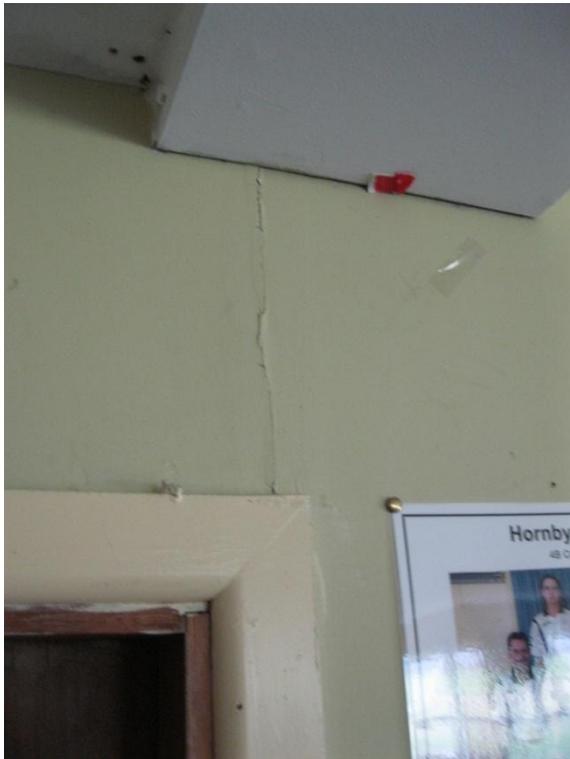
**Photograph 8 Example of typical plasterboard cracking above windows and doors of clubrooms**
