Denton Park Shed

PRK 0770 BLDG 012 EQ2

Detailed Engineering Evaluation

Quantitative Assessment Report

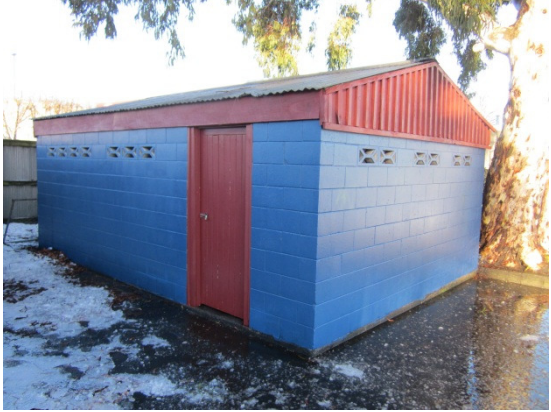
| Denton Park Shed | | |
|---|---|--|
| 1. | North-eastern view of building | |

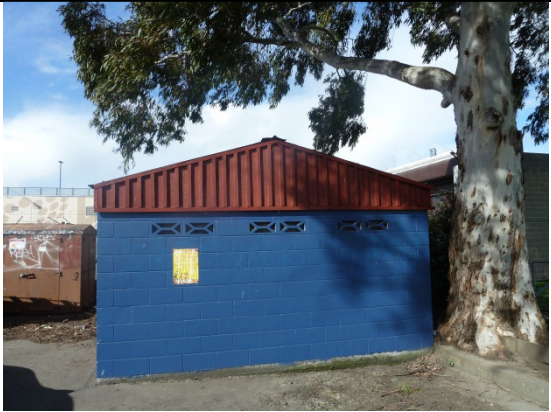
| Denton Park Shed | | |
|---|---|--|
| 2. | Northern view of building | |

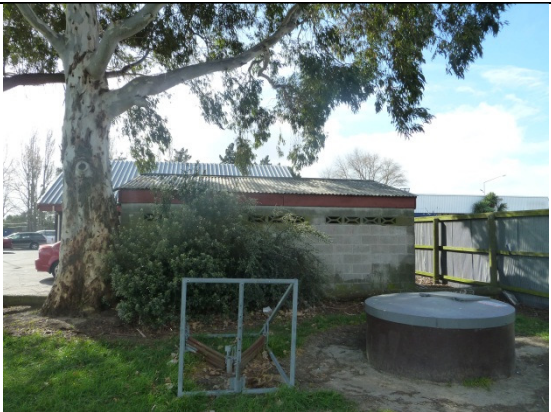
| Denton Park Shed | | |
|---|---|--|
| 3. | Western view of building | |

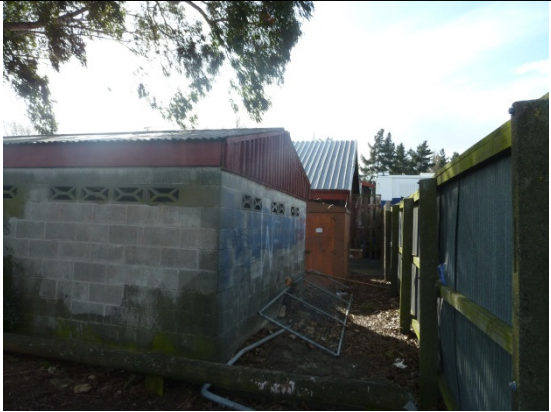
| 4. | South-western view of building | |

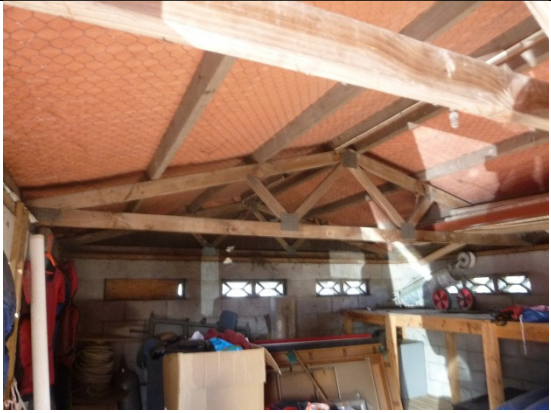
| 5. | Timber top plate continuous all sides on block walls | |

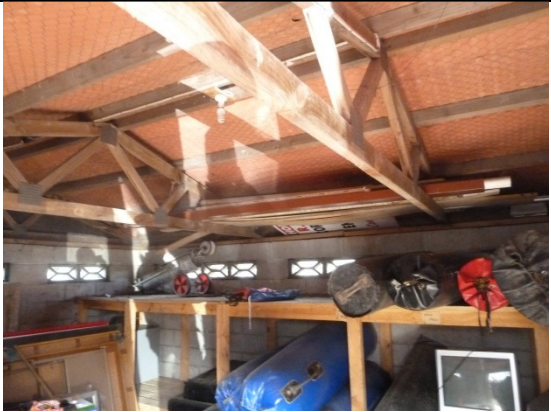
| 6. | Timber purlins with timber trussed roof | |

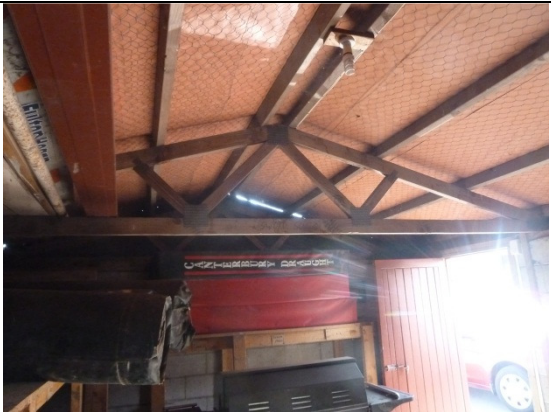
| 7. | Looking back to door from inside. Timber top plate continuous over door (no block work lintel/bond beam present) | |
