Dog Shelter Detailed Engineering Evaluation BU 0890-001 EQ2 Quantitative Report

Prepared for Christchurch City Council (Client)

By Beca Carter Hollings & Ferner Ltd (Beca)

11 June 2013

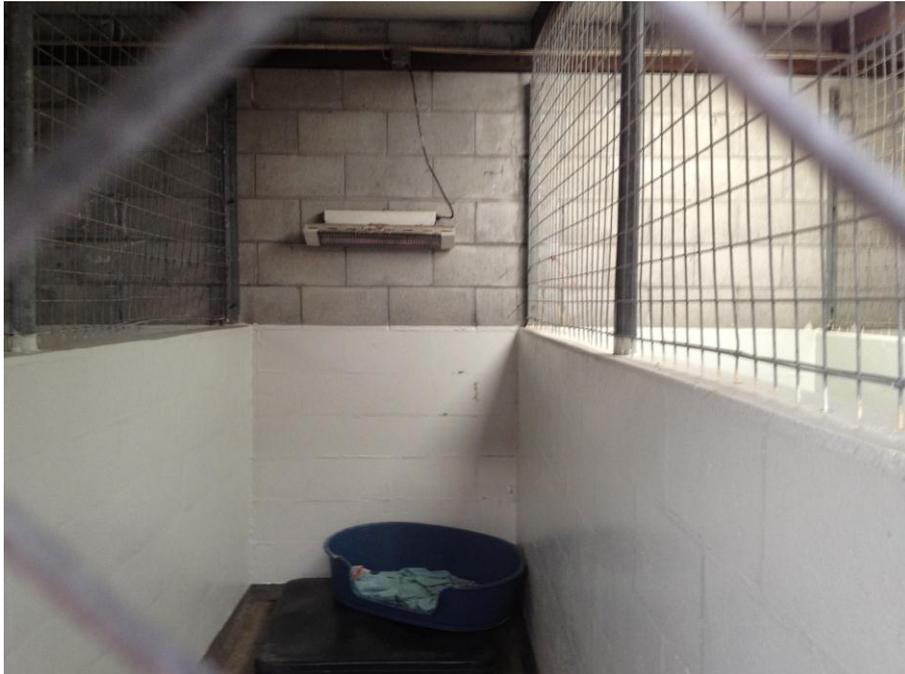
Photo 3: Interior view of typical dog shelter space with transverse half height concrete masonry partitions

Damage Description: Vertical cracking at interface of partition wall and perimeter wall.

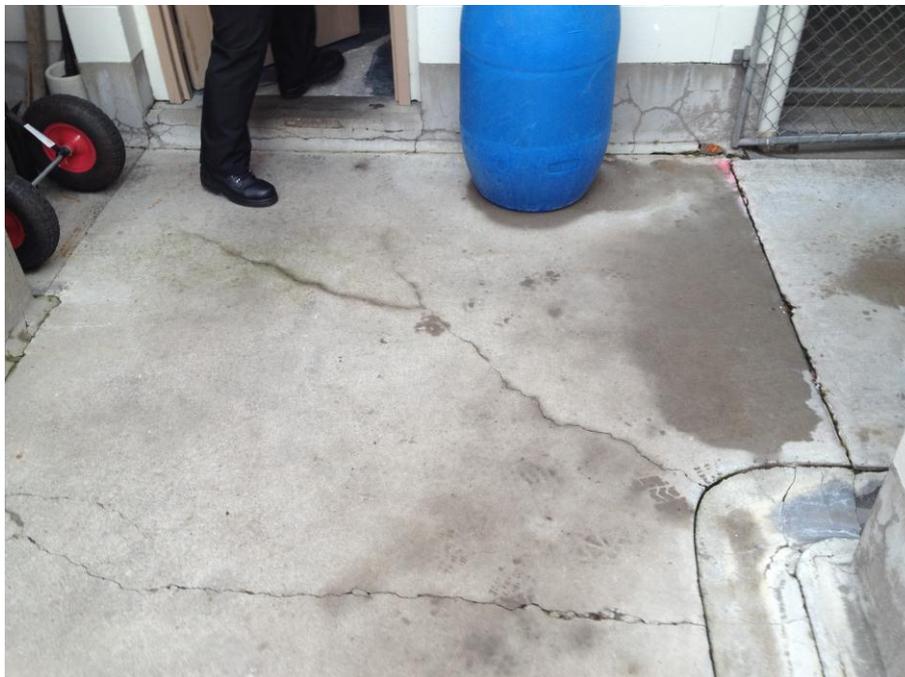
Photo 4: Interior corridor at entrance to dog pens on eastern side of building.

Damage Description: Cracking to concrete slab on grade and separation of construction joints potentially due to lateral spreading.

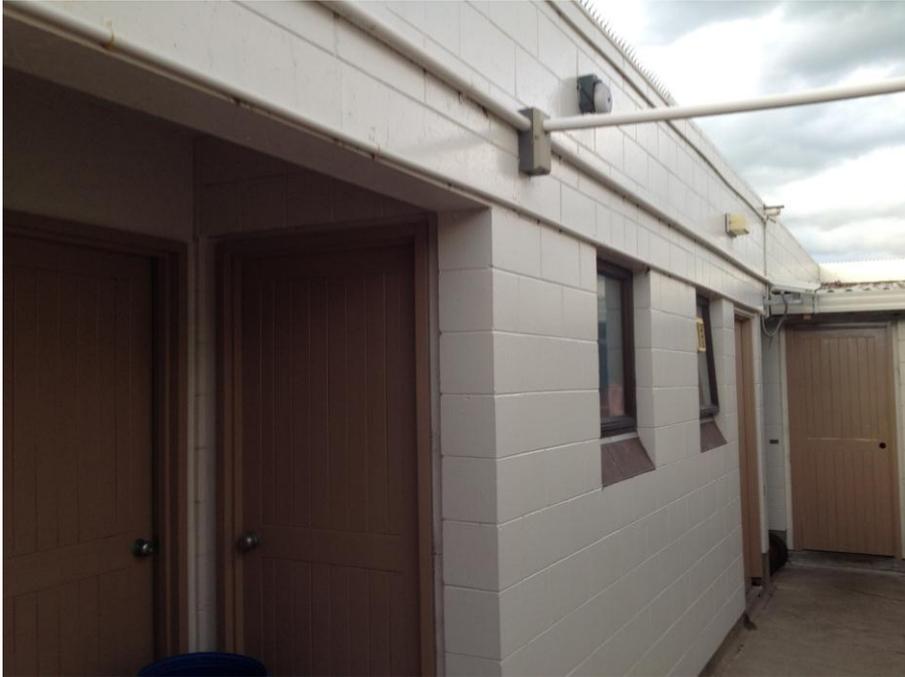
Photo 5: Interior view of headers and lintels in the main corridor.

Damage Description: Hairline cracking to masonry headers and lintels above doorways.

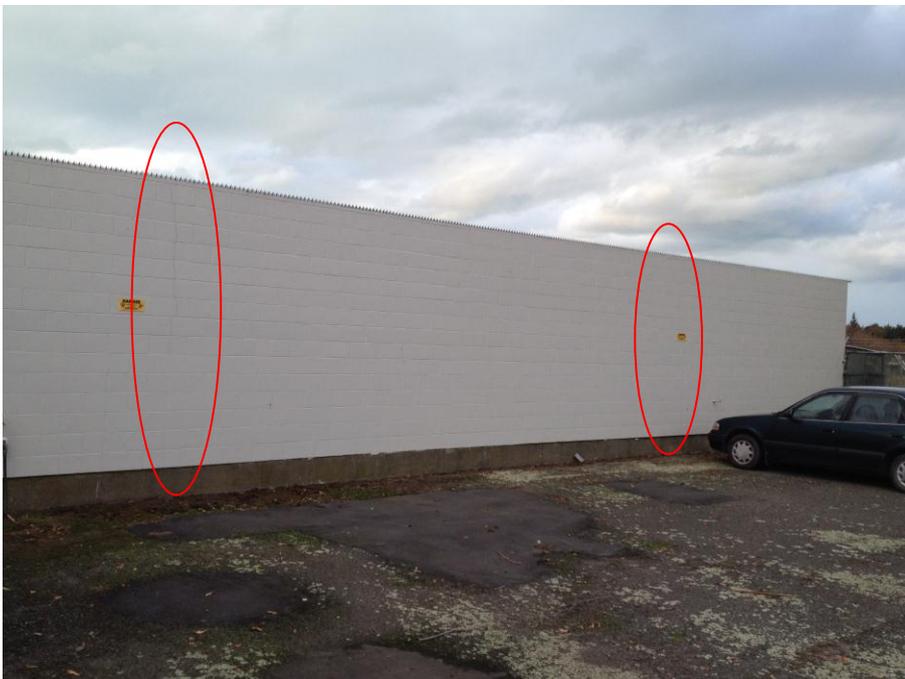
Photo 6: Exterior view of south-west perimeter wall at Dog Shelter building.

Cracking to the concrete masonry walls at mid-span and at the joints is likely to have occurred due to the differential settlement of approximately 70mm around the south-east corner of the building.

Damage Description: Full height vertical cracking at wall quarter points i.e halfway between the interior perpendicular return wall. Cracks are 0.8mm at mid-height of wall, increasing to 1.0mm at base.

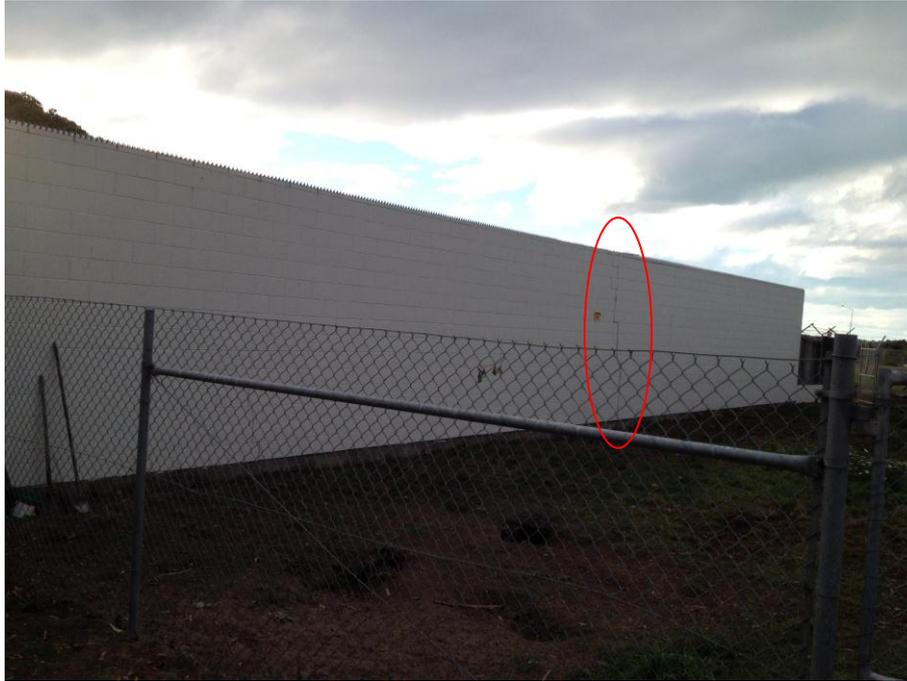
Photo 7: Exterior view of east perimeter wall at Dog Shelter building.

Damage Description: Large vertical crack at intersection with interior return wall. Crack typically 1.8mm wide at mid-height, increasing to 3.5mm or more at base.

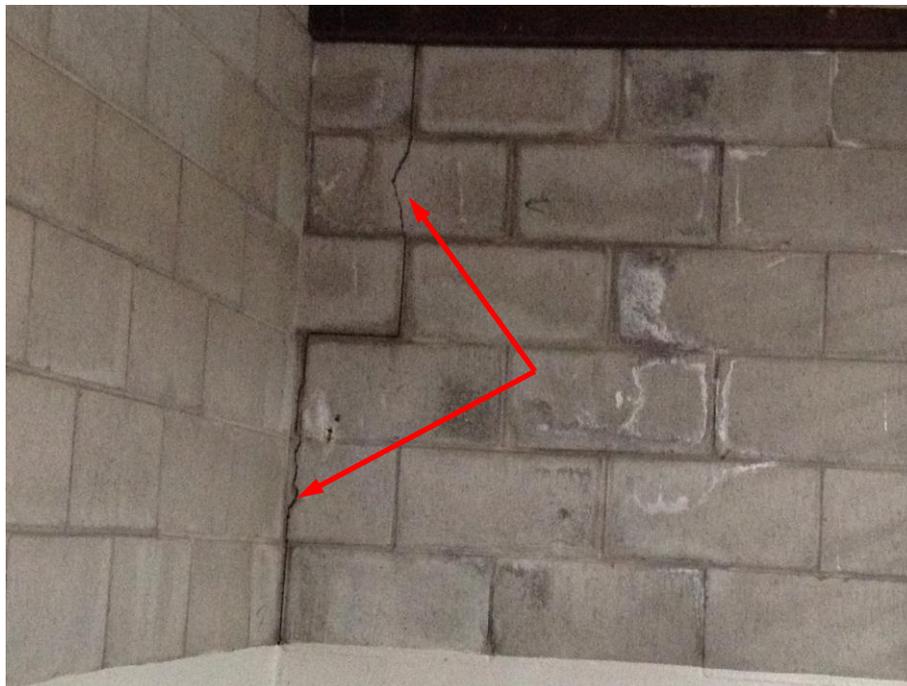
Photo 8: Vertical cracking to concrete masonry wall in the order of 3.5mm at corner where intersecting walls occur

Damage Description: Crack possibly due to flexural forces, created by out-of-plane face loads.

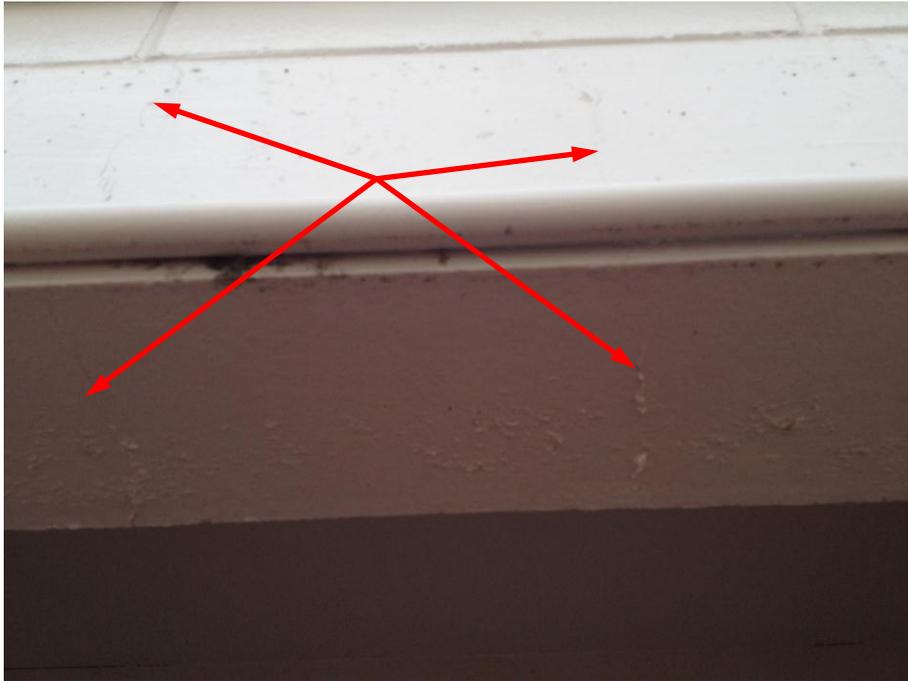
Photo 9: Hairline cracking at concrete masonry lintel.

Damage Description: Vertical cracking at concrete masonry header along midspan of header.

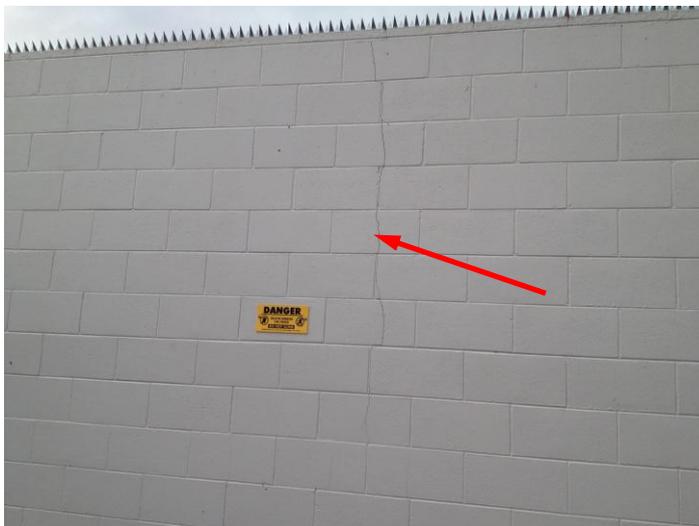
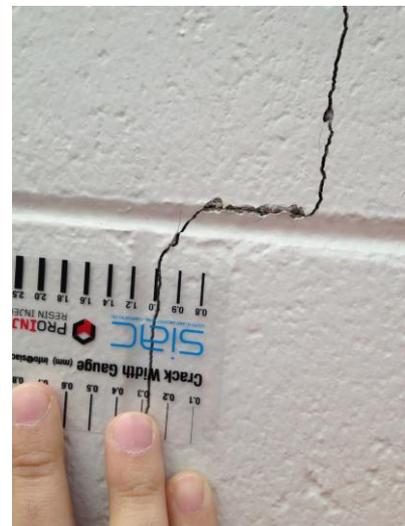
Photo 10A and 10B: Vertical cracking to concrete masonry in the order of 1.0mm at midspan of wall length.

Damage Description: Crack possibly due to flexural forces, instigated by out-of-plane face loads.

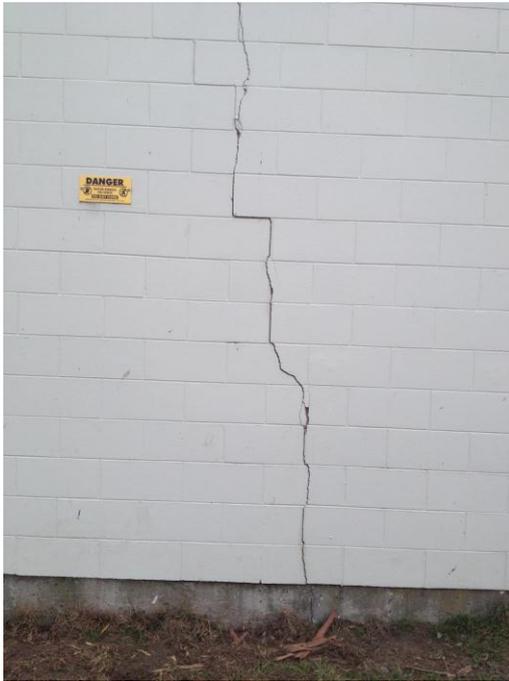
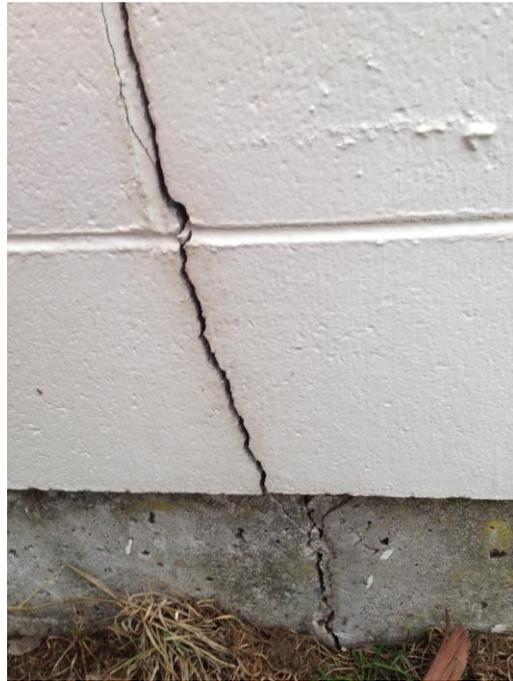
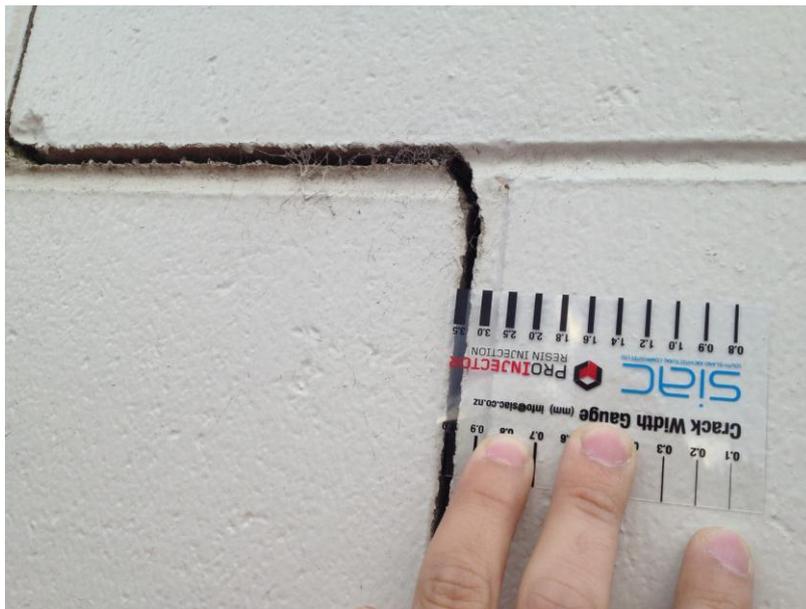
Photo 11A, 11B & 11C: Vertical cracking to concrete masonry wall on the order of 4.0mm at midspan of wall length

Damage Description: Crack possibly due to flexural forces caused by out-of-plane face loads.

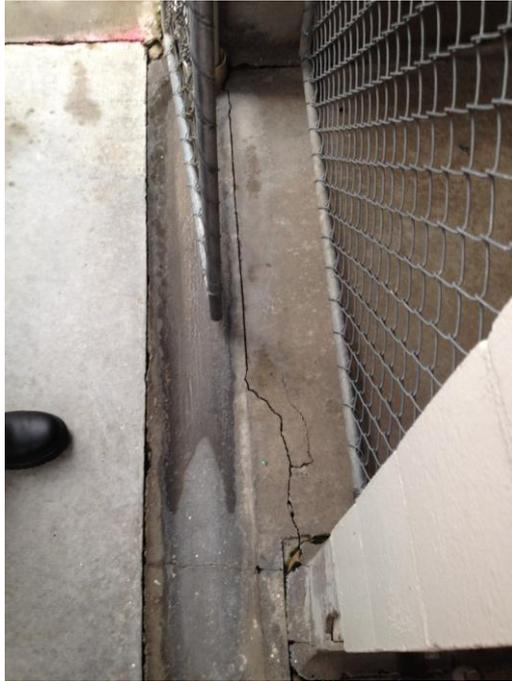
Photo 12: Cracks and separation of floor slab on the order of 1.0mm – 4.0mm at construction joints and at walls.

Damage Description: Minor cracking and separation possibly due to settlement and lateral spreading.

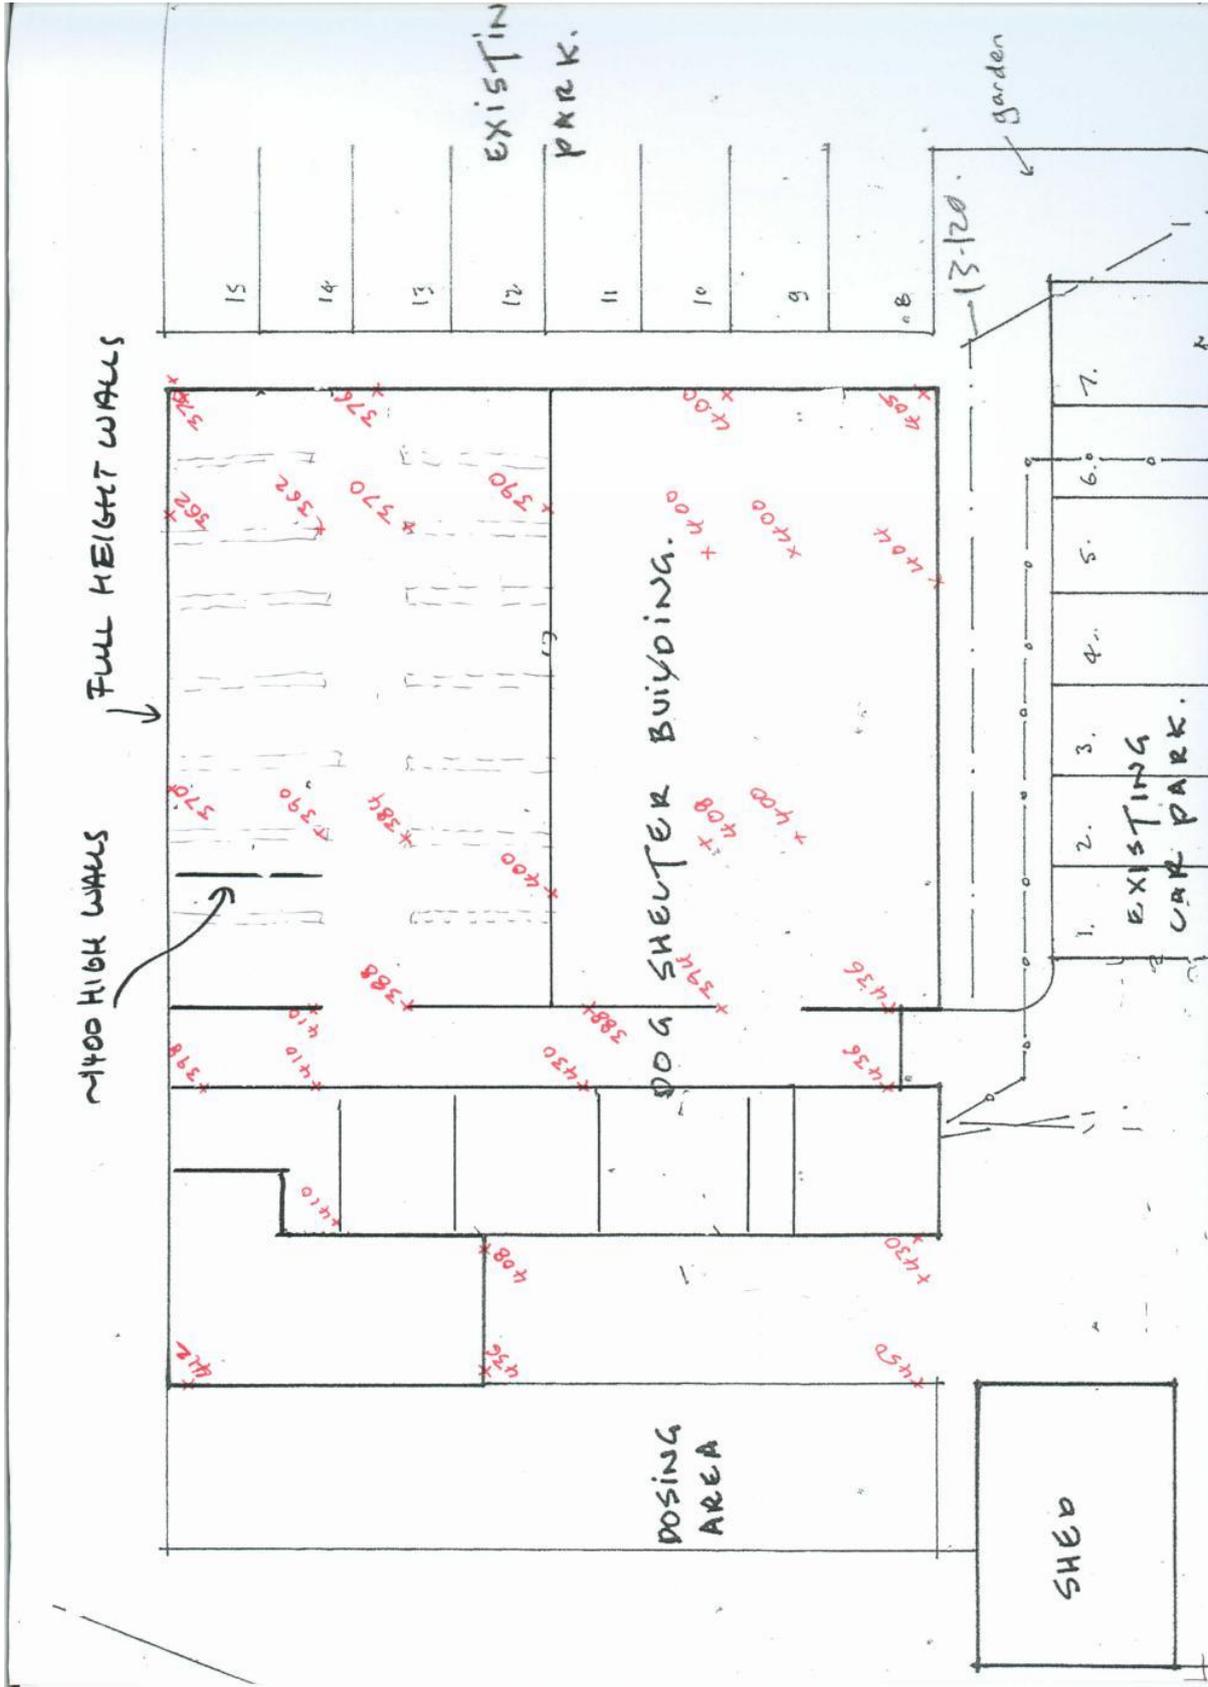
Figure 5: Levels survey plan with levels marked in red

A level survey was carried out by City Care which indicated differential settlement across the floor in the order of 70mm. Refer to Appendix B. This is believed to be due to earthquake induced liquefaction. A full verticality survey and levels survey is recommended as part of a full damage assessment, which would better identify any intentional drainage channels as well as site differential settlement.

- A full damage assessment is carried out for insurance purposes.
- Foundations are exposed to confirm suitability of the key assumptions made in Table 4.1, and also to inspect any post-earthquake damage. This may be part of the damage assessment procedure.
- Full level and verticality survey carried out.
