## **Duvauchelle Works Yard Store**

**PRO 3612 B003**

Detailed Engineering Evaluation

Pawsons Valley Road, Duvauchelle

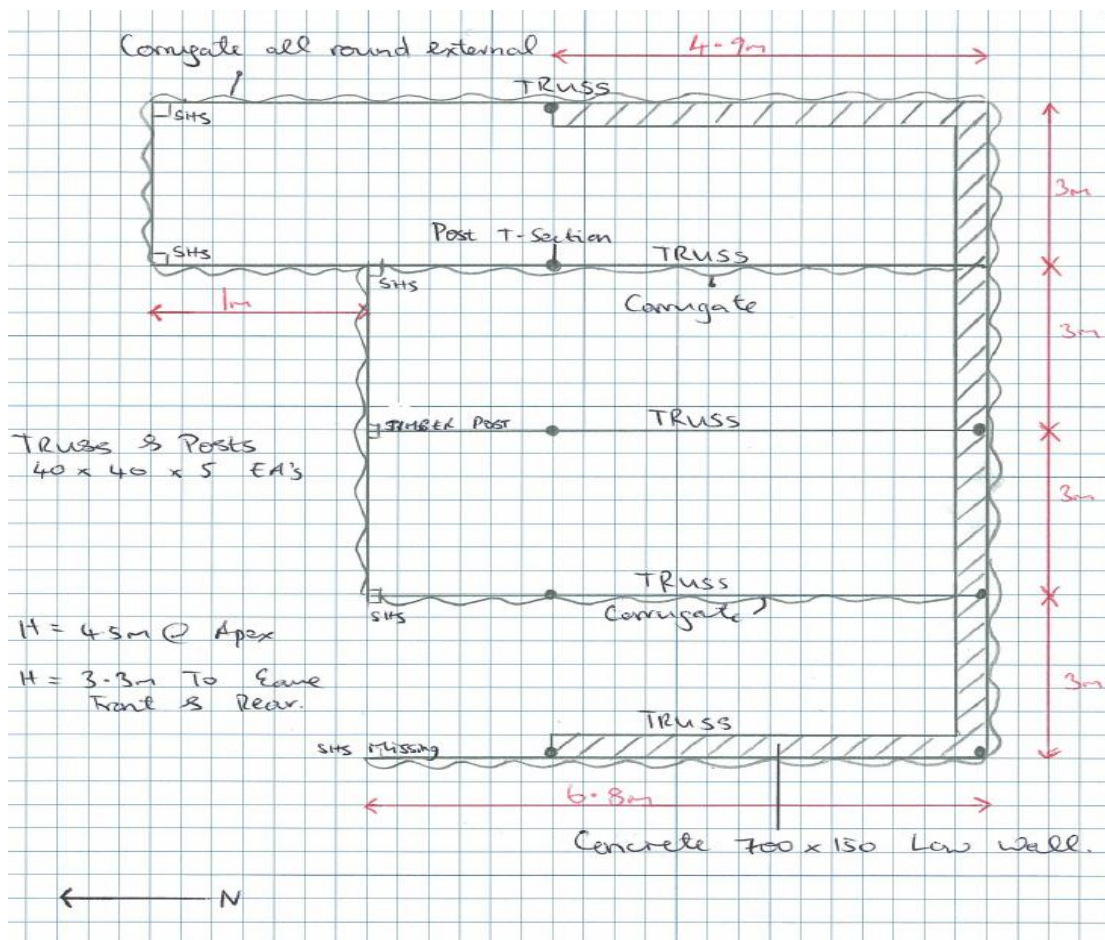
Figure 2 Plan Sketch Showing Key Structural Elements

The roof is braced only using sheet corrugate cladding contributing to plan irregularity. No diagonal strap bracing was present in the roof.

There is seismic bracing in only three of the four sides of this structure, causing torsional effects. The front of the building is open-sided, lacking bracing, so consequently bracing this side must be achieved via roof bracing to transfer the seismic load to the rear wall. Currently this is achieved by corrugate sheet panel action. However; due to the lightweight nature of the building it is unlikely that it will prematurely collapse as a result of plan irregularity during a seismic event. As such, plan irregularity is considered to be “insignificant”.

The structure is entirely braced in both longitudinal and transverse directions by brace panel action provided by sheet steel corrugate cladding fixed to the exterior (and some interior) steel frames. This system transfers all seismic and wind bracing demand to foundations from eaves level. There is no longitudinal bracing in the front of the building due to this northern side having only doors and no walls, which is likely to cause structural torsion. To brace the seismic load in this front side of the building, the load is transferred to the rear braced frame via the roof cladding in steel corrugate panel action. The brace-panel cladding system of seismic resistance in this building is not the most effective means of bracing the structure and the installation of diagonal steel strap bracing in walls and roof would be of great benefit.

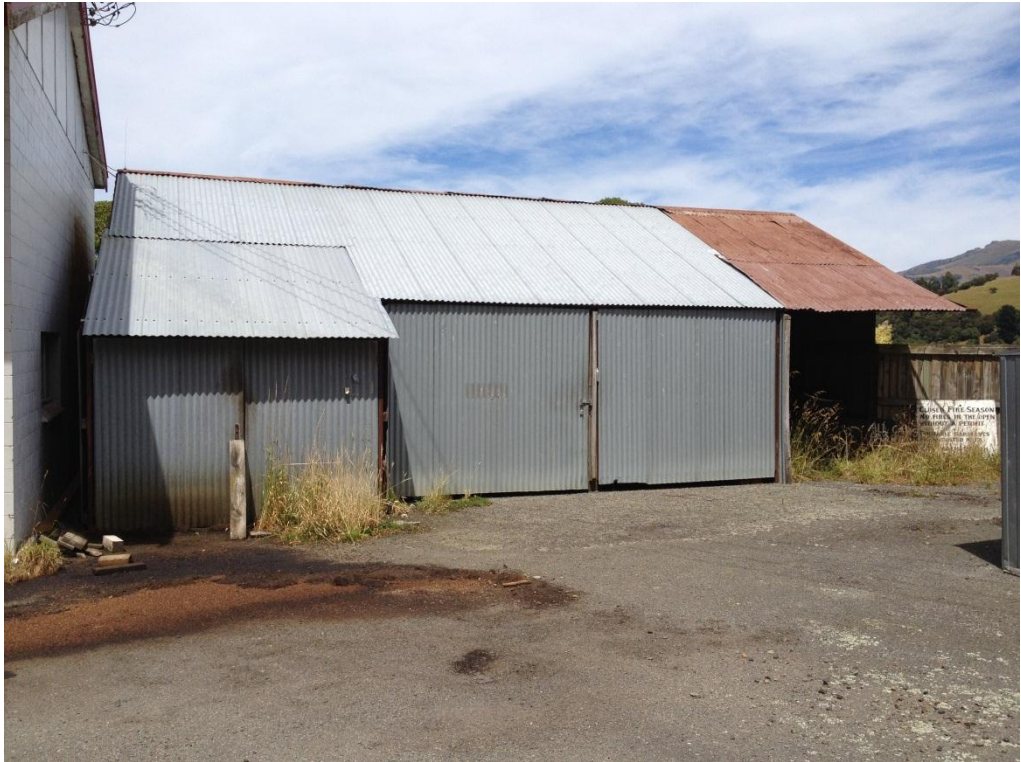
**Photograph 1: North (front) Elevation**

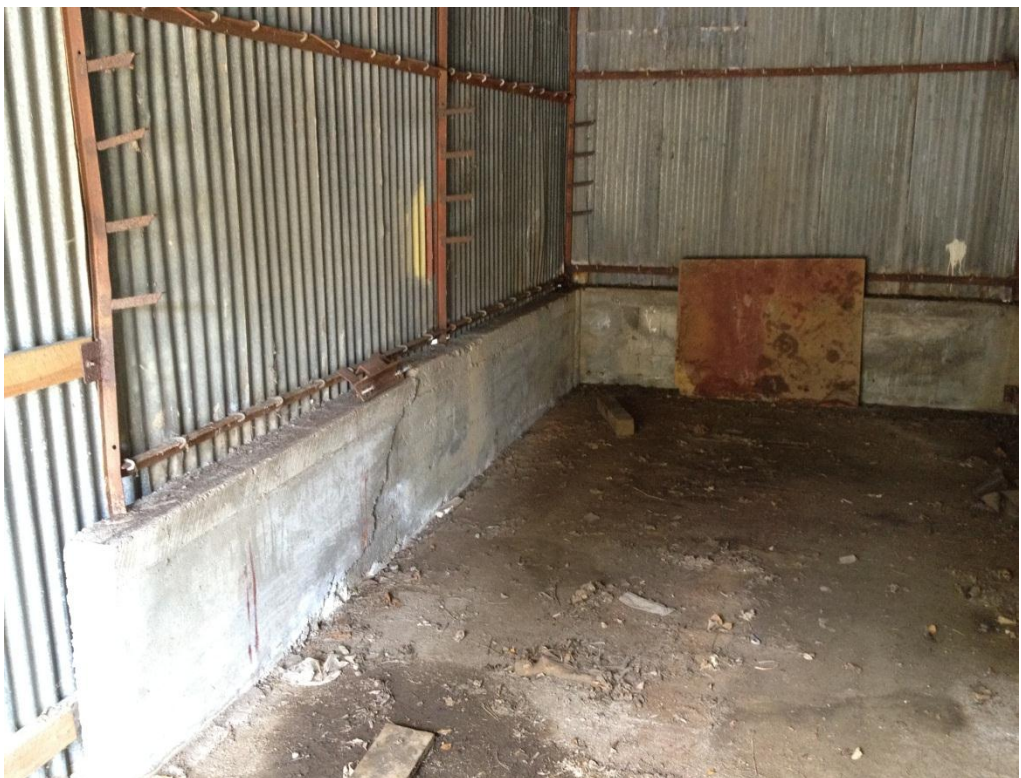
No cracking to the perimeter strip footing was noted. Existing shrinkage cracks to the concrete floor slab and perimeter wall were observed, these may have opened up slightly during the recent seismic activity.

**Photograph 2: Concrete perimeter surround with existing concrete crack**

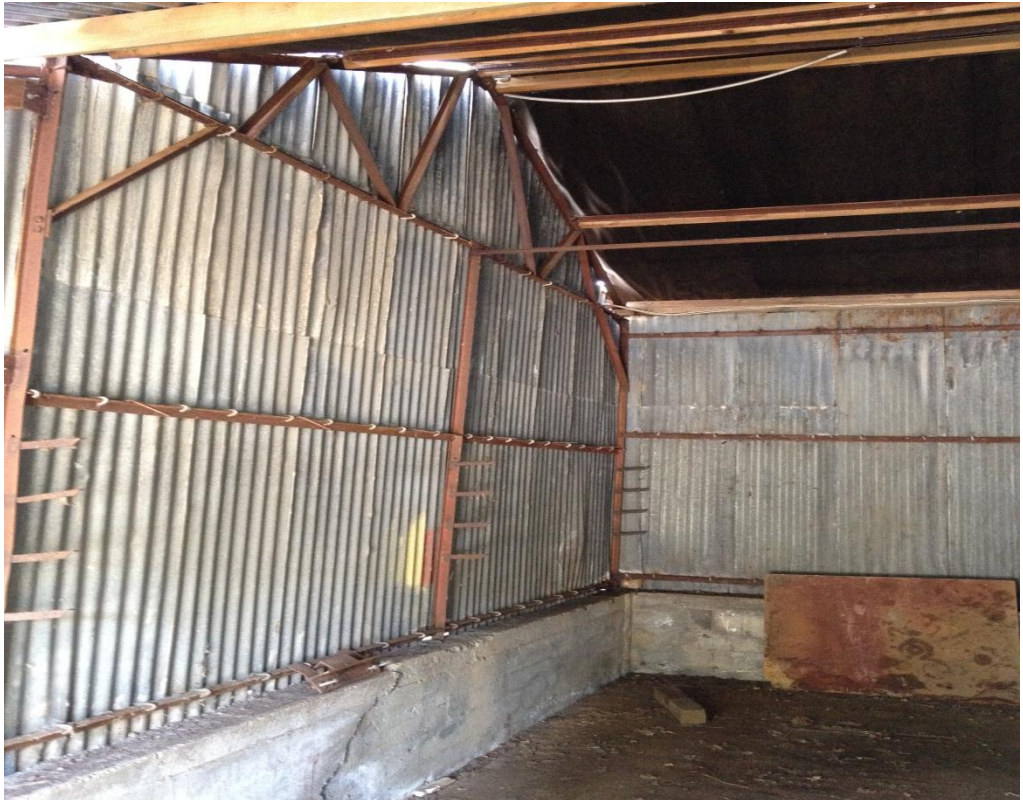
No damage was noted to the steel framed system including the lightweight steel roof cladding.

**Photograph 3: Steel framed structure with lightweight metal cladding connected into concrete perimeter**

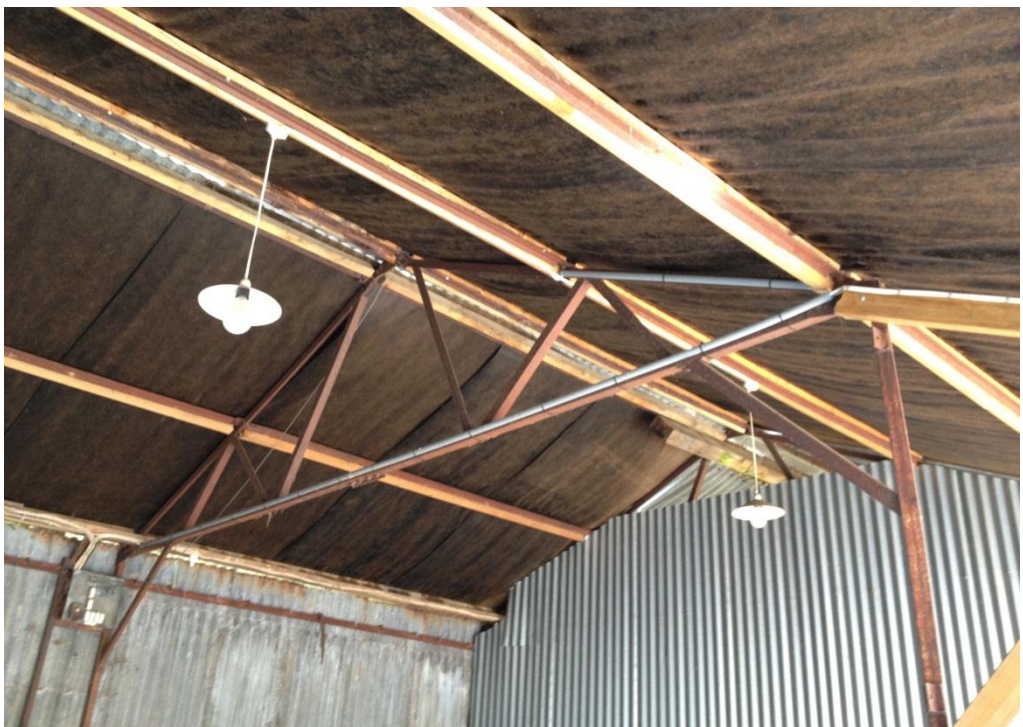
The general structure appears to have been repaired with timber 4x2's added to the structure to give it additional support.

**Photograph 4: Equal angel truss connected into T-section posts. Timber supports added to strengthen the structure previously**

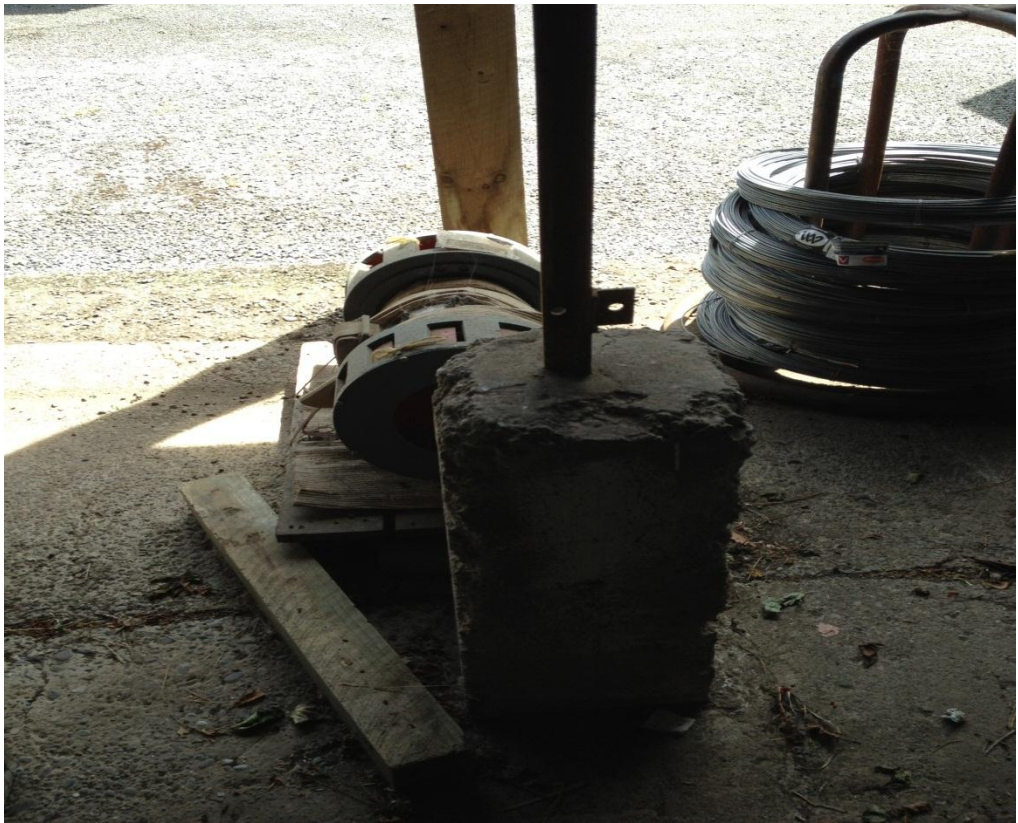
**Photograph 5: T-sections posts set into concrete**

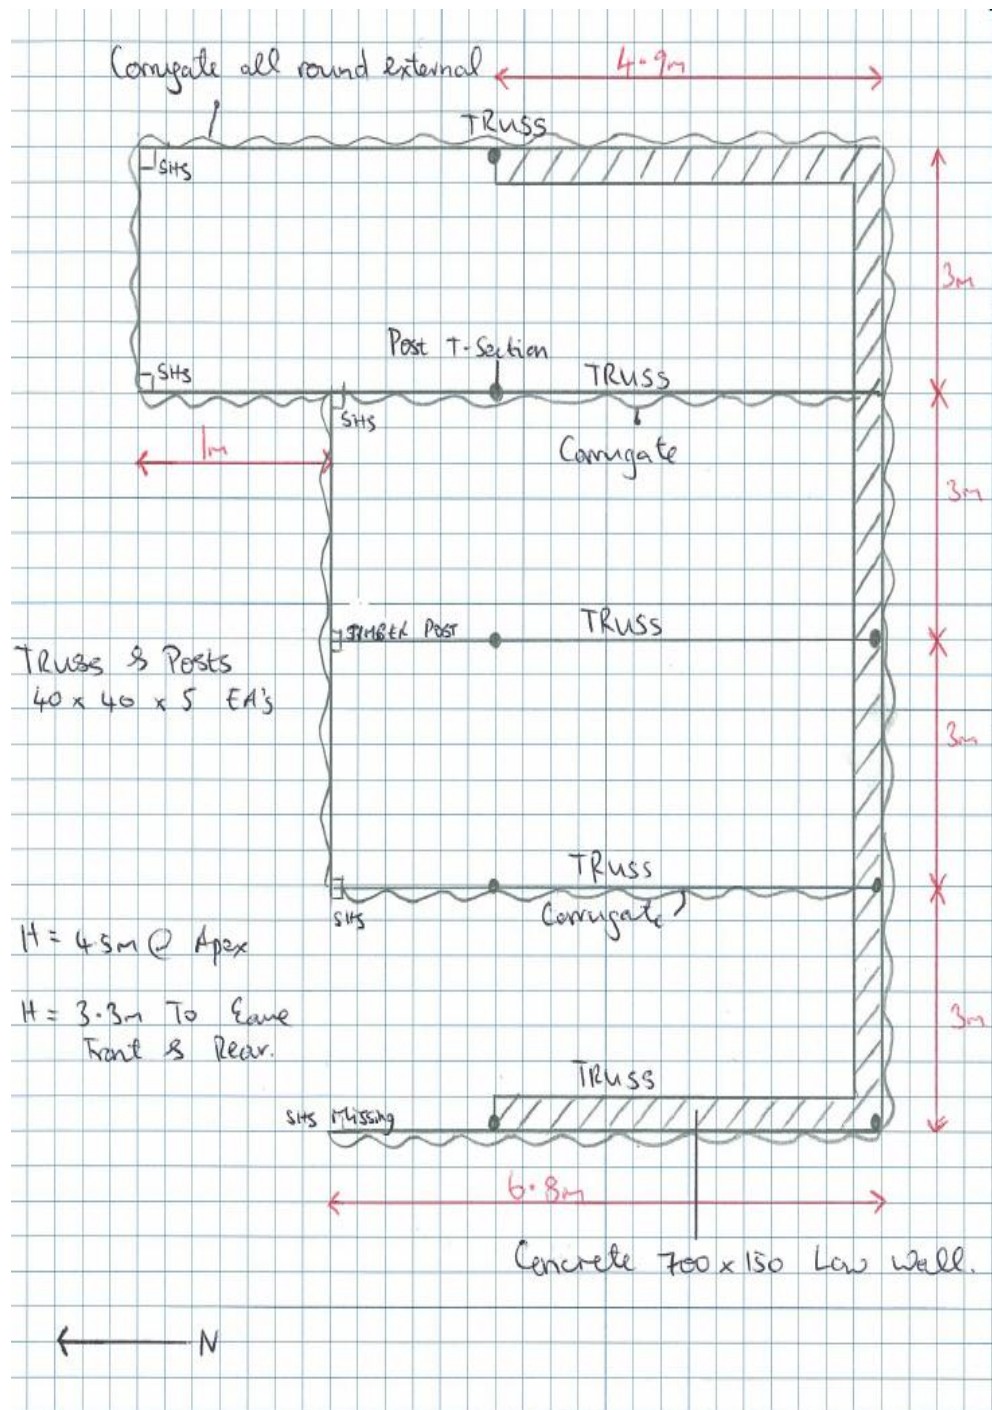
No drawings have been made available for this building. Shown below is a sketch of the building showing key structural elements.
