Edmonds Phone Booth Poplars Reserve
PRK 1927 BLDG 002 EQ2
Detailed Engineering Evaluation
Qualitative Report
Version FINAL

Christchurch City Council

Date
12th December 2013

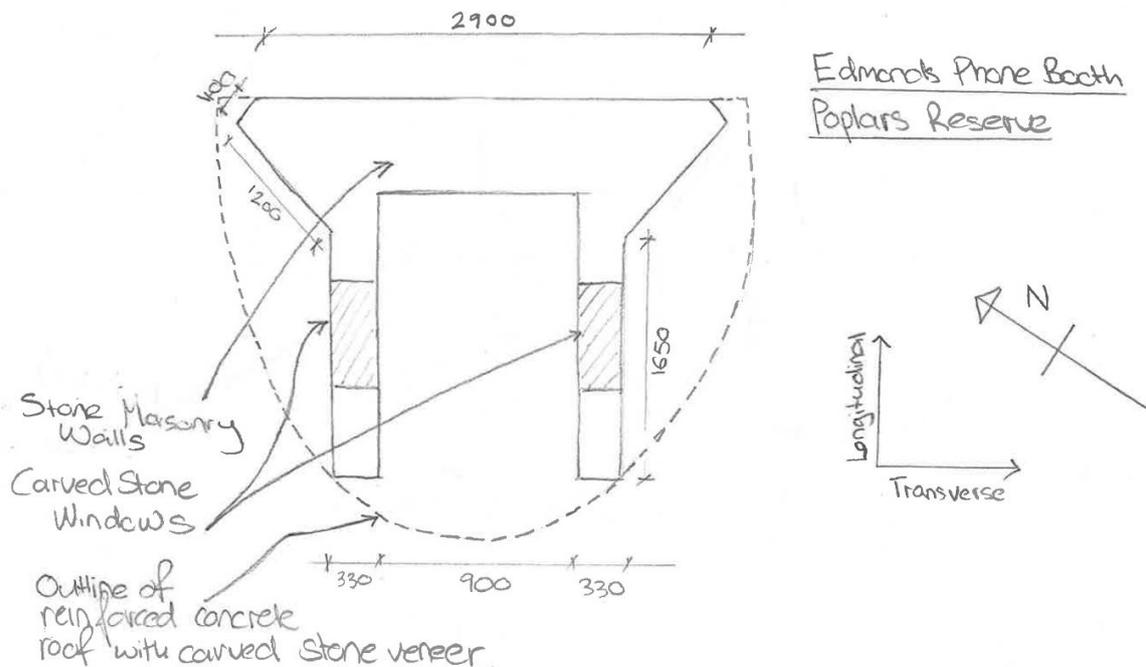
Figure 2 Plan Sketch Showing Key Structural Elements

The small building consists of a relatively thick (approximately 650mm) reinforced concrete roof slab with a carved stone veneer supported by unreinforced stone masonry walls in both the longitudinal and transverse directions of the building. The stone masonry walls are shown in Photograph 5. The window frames are constructed from carved stone. The walls are likely to be supported on concrete strip footings. The floor consists of a concrete slab-on-grade.

Lateral loads are resisted primarily by panel action of the stone masonry walls in both the transverse and longitudinal directions of the building. Given the thickness of the roof slab and the corresponding large seismic mass at roof level, lateral seismic loads are likely to be significant. The walls may be subject to additional forces as a result of torsion, due to the stiffness eccentricity caused by the larger wall on the north-eastern side of the building.

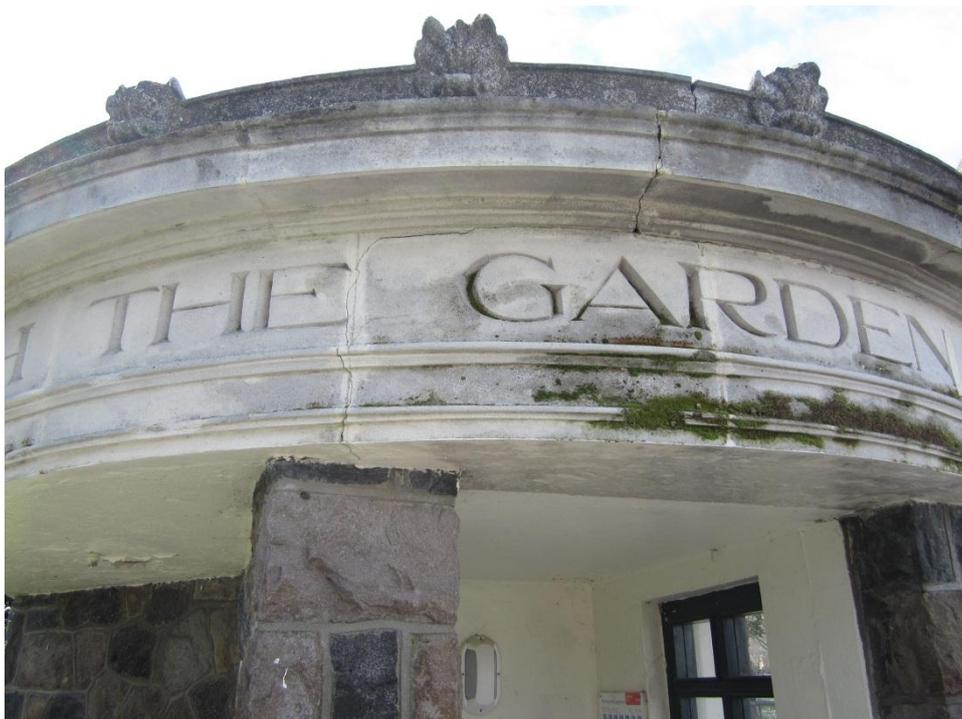
Some cracking in the reinforced concrete roof was observed. The cracking has occurred along joints in the carved stone veneer in sections of the roof that overhang the supporting stone masonry walls.

Some cracking in the reinforced concrete roof was observed. The cracking (shown in Photograph 2) has occurred along joints in the carved stone veneer in the sections of the roof that overhang the supporting stone masonry walls.

Photograph 2 Cracking in carved stone veneer on reinforced concrete roof

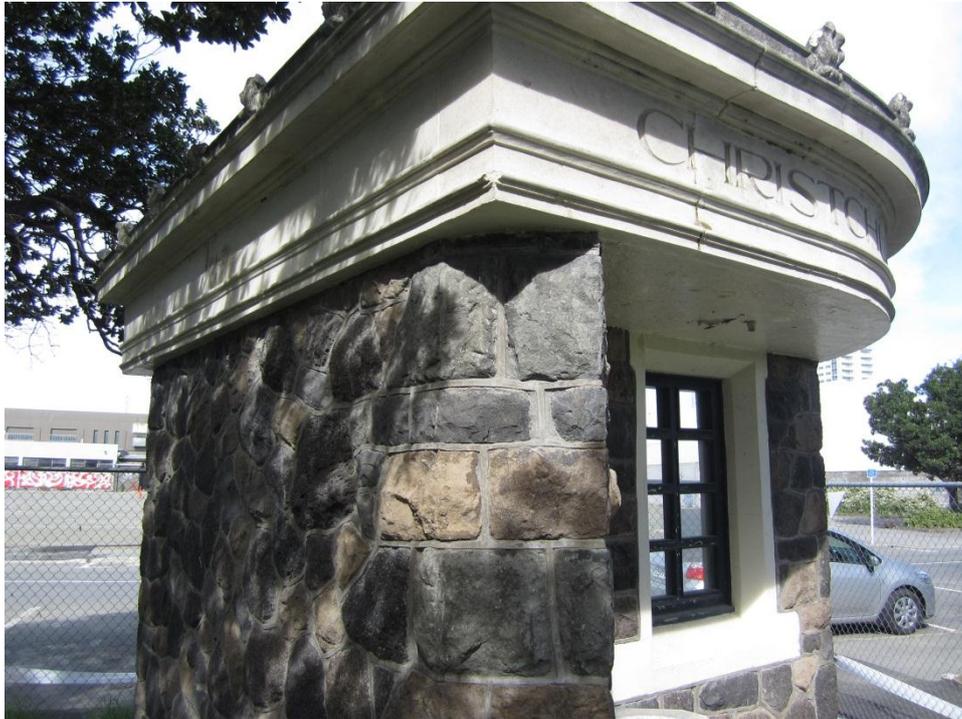
A structural ductility factor of 1.0 has been assumed based on the unreinforced stone masonry wall system observed. It is unlikely that the walls are reinforced given the appearance and the age of the building. As a result, the walls are expected to have very limited ductility.

Photograph 5 **Stone masonry walls**
