**Elizabeth Park Main Pump Shed
PRK 1832 BLDG 001
Detailed Engineering Evaluation
Qualitative Report
Version FINAL**

Christchurch City Council

Date
17th May 2013

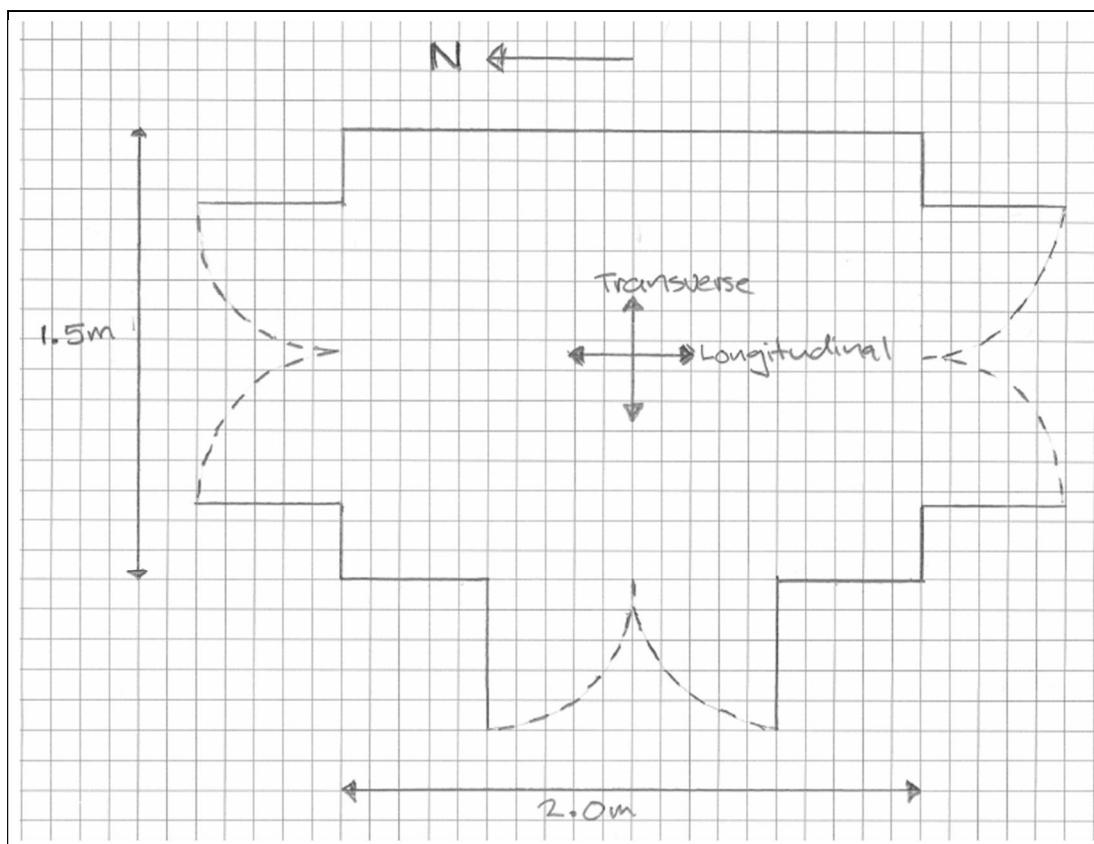
Figure 2 Plan Sketch

The structure has a hipped roof formed from welded steel plates. This likely has a welded connection to four steel plate walls which form the structures rectangular shape; however, as interior access was restricted this connection cannot be confirmed. The walls are connected to each other along their vertical edge by fully welded 50 mm equal angles. There are openings on three of the four walls. The walls are supported by a concrete slab on grade which founds the structure.

The structure stands 1.95m tall and covers an area of approximately $3m^2$. Although there is a concrete water tank approximately half a meter to the east of the Pump Shed, the structure is otherwise isolated. There are no waterways near the slightly sloped section.

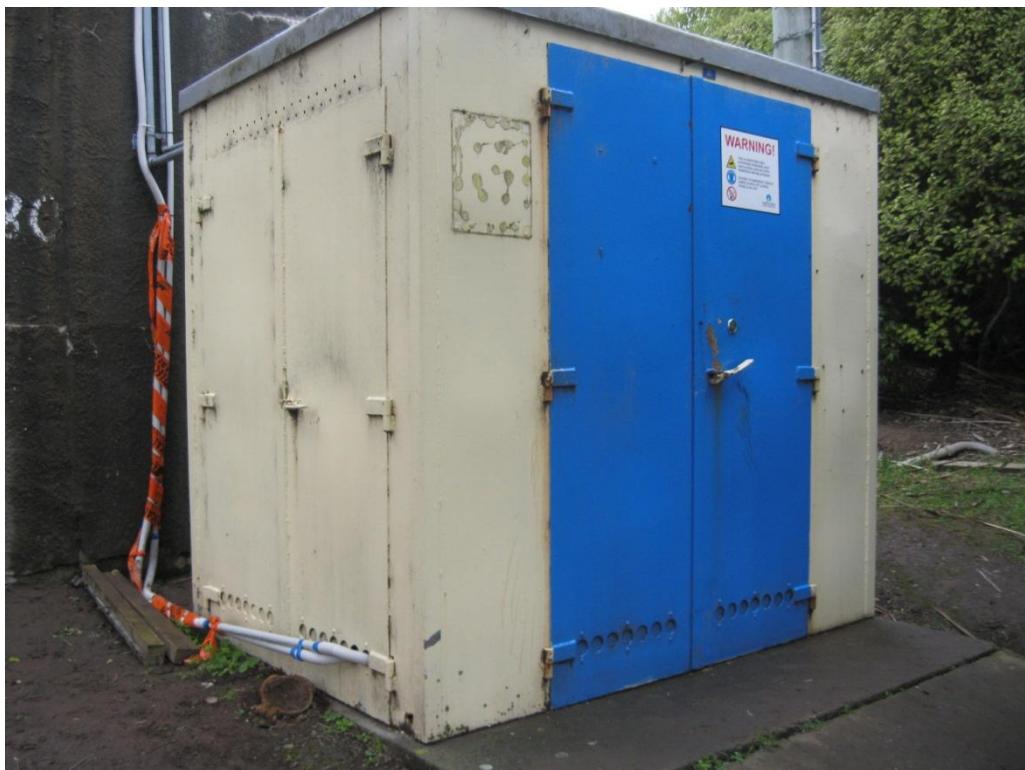
Photograph 1 View of pump shed from the northwest.

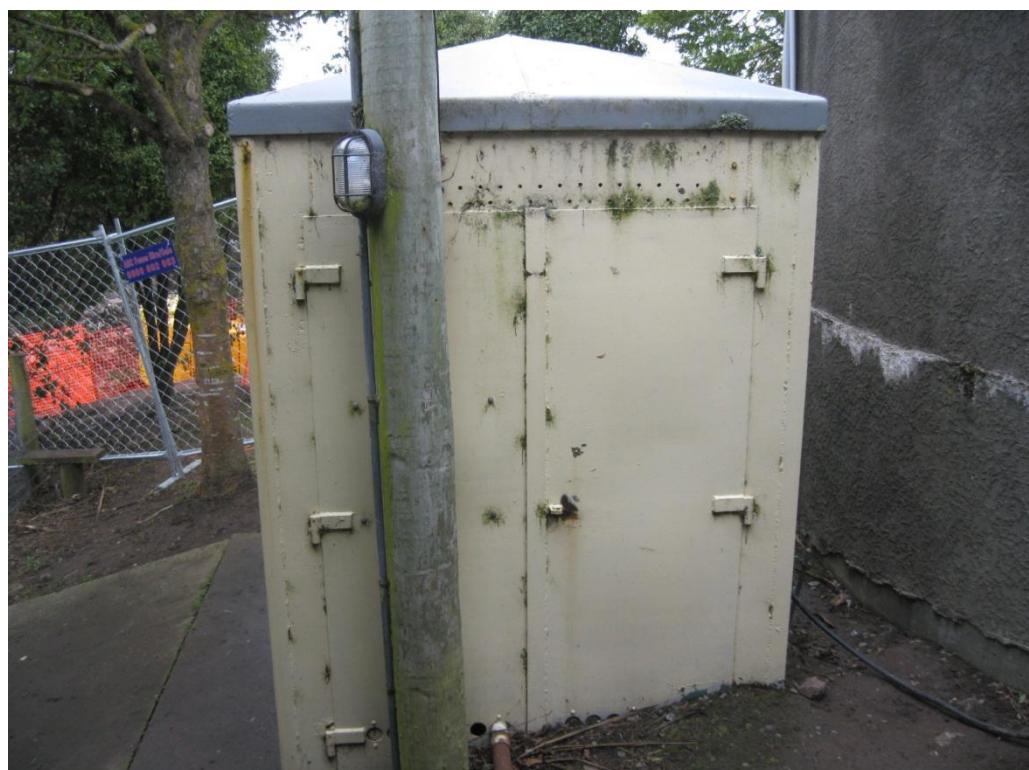
Photograph 2 South Elevation.

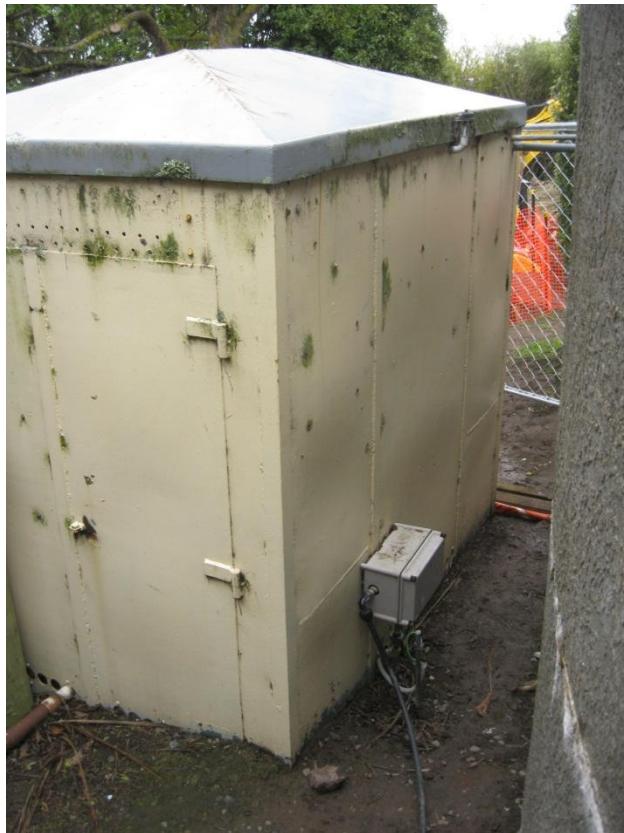
Photograph 3 View of pump shed from the southeast.

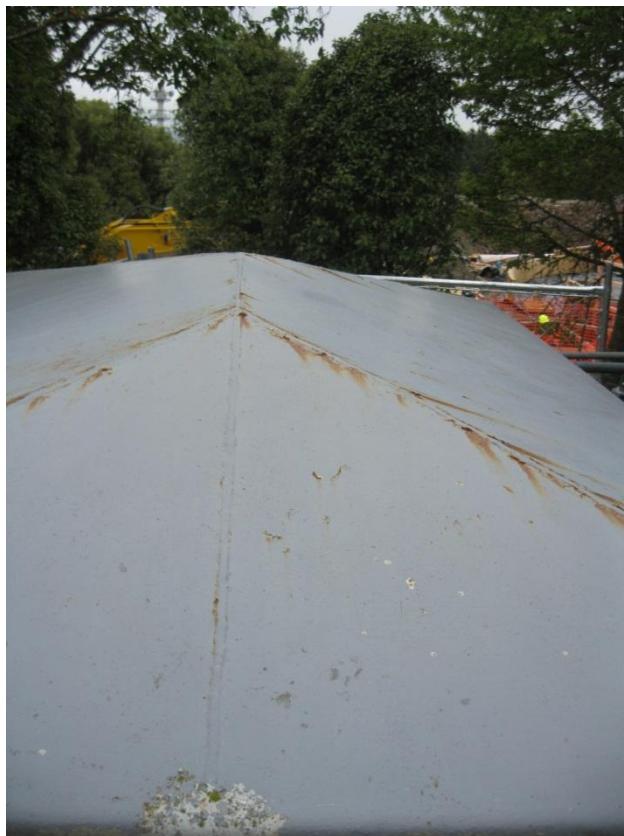
The steel plate will form a nominal roof diaphragm.

Photograph 4 Hipped steel-plate roof

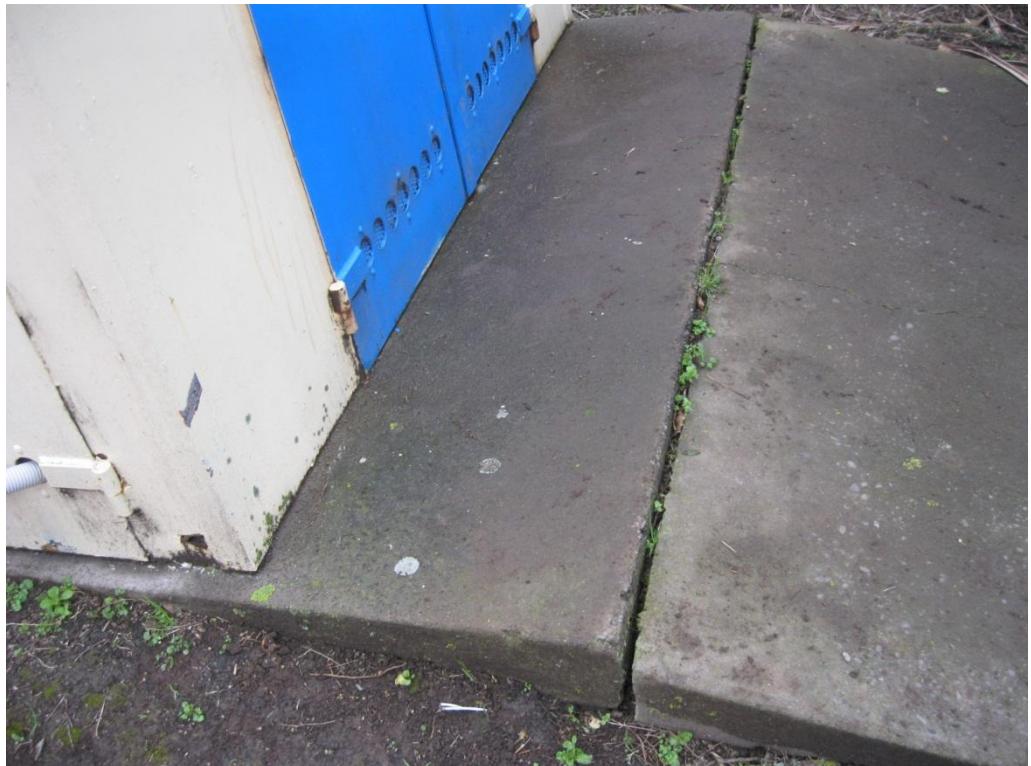
Photograph 5 Concrete slab on grade
