Elm Grove Block B
BU 0782 -002 EQ2
Detailed Engineering Evaluation
Quantitative Report
Version FINAL

16-20 Elm Grove
Linwood
Christchurch

Christchurch City Council

Date
7 December 2012

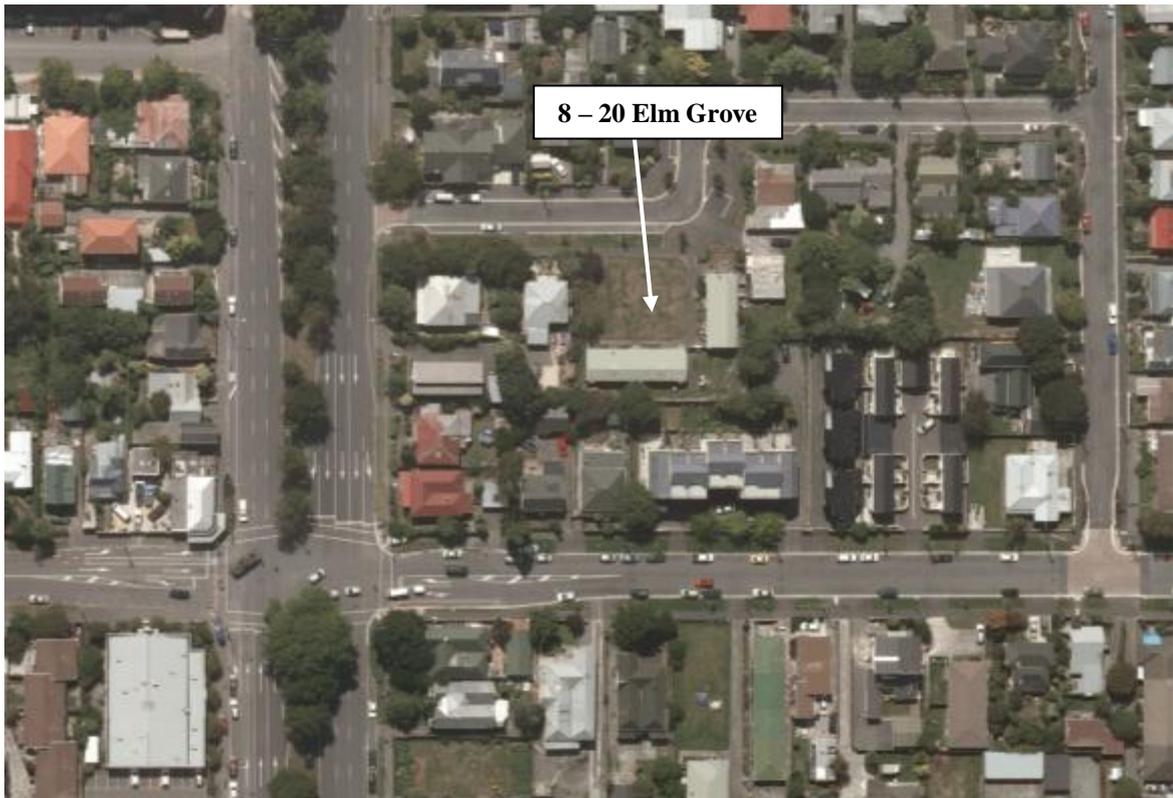
Figure 3 Post February 2011 Earthquake Aerial Photography

Aerial photography⁵ taken following the significant earthquakes of the Canterbury earthquake sequence show no signs of liquefaction outside the building footprint or adjacent to the site, aerial photography taken 22 February 2011 earthquake is shown in Figure 3.

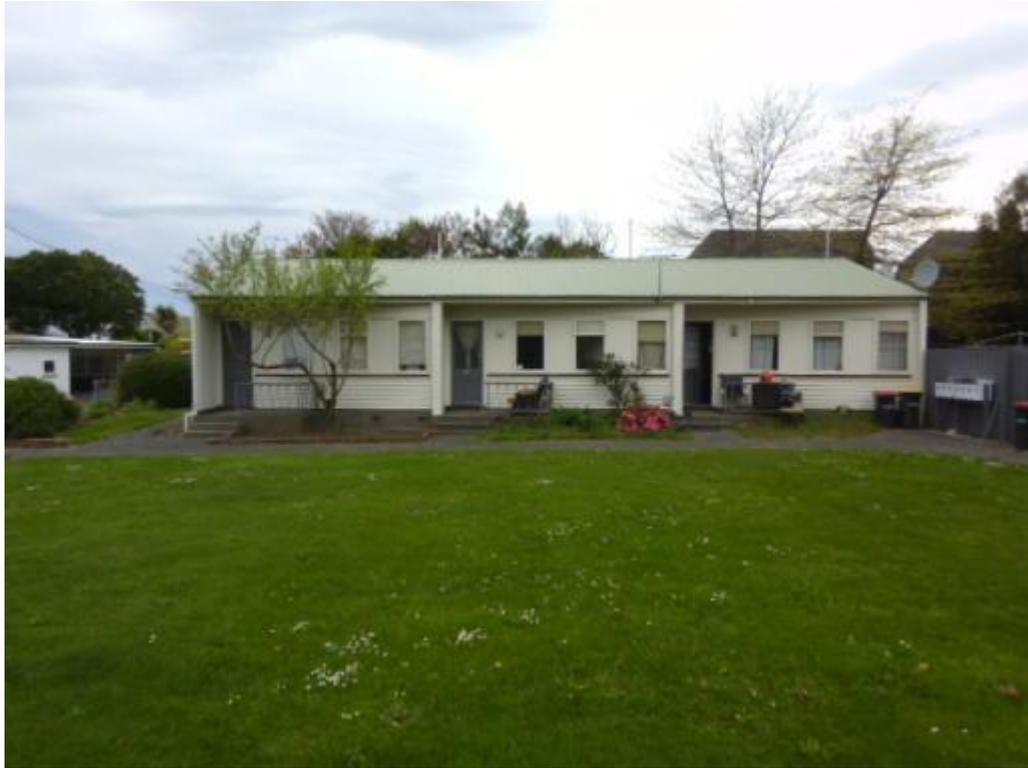
Photograph 1 Front elevation.

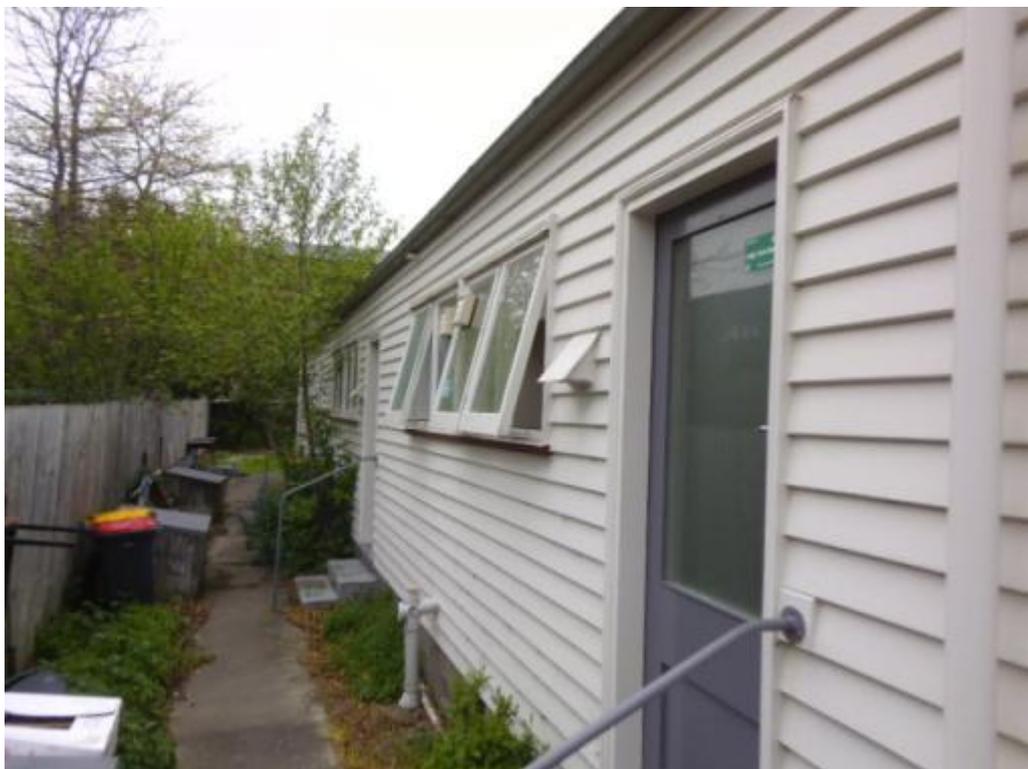
Photograph 2 Rear elevation.

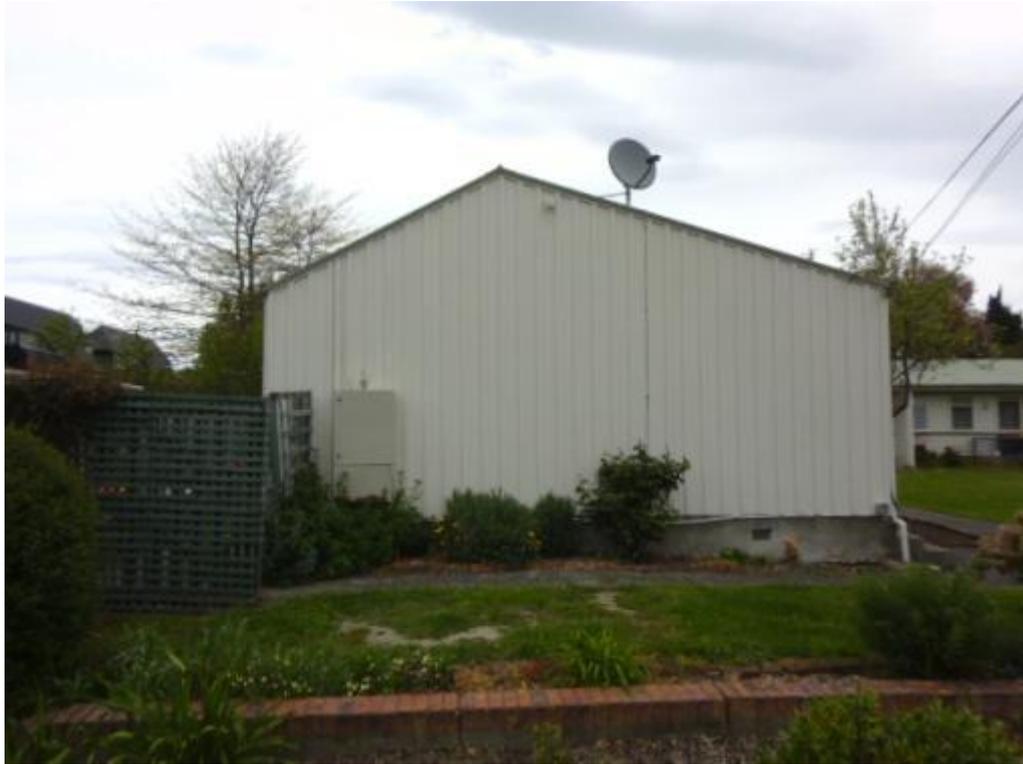
Photograph 3 Side walls with lightweight cladding.

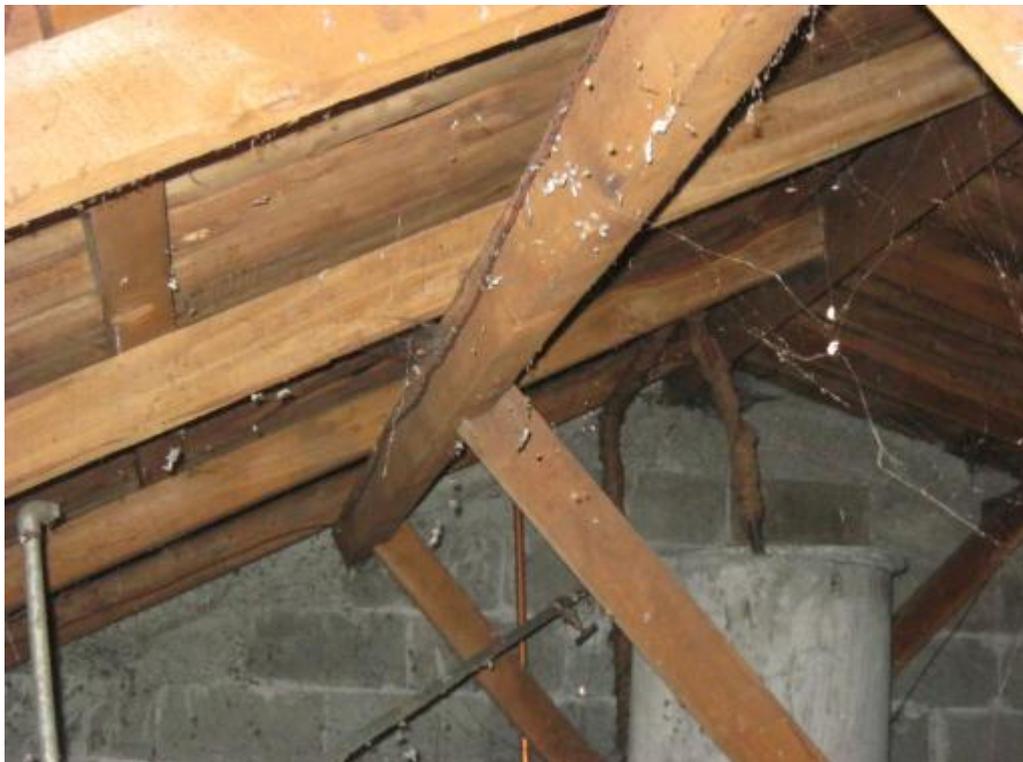
No damage was evident to the roof structure.

Photograph 4 Roof structure.

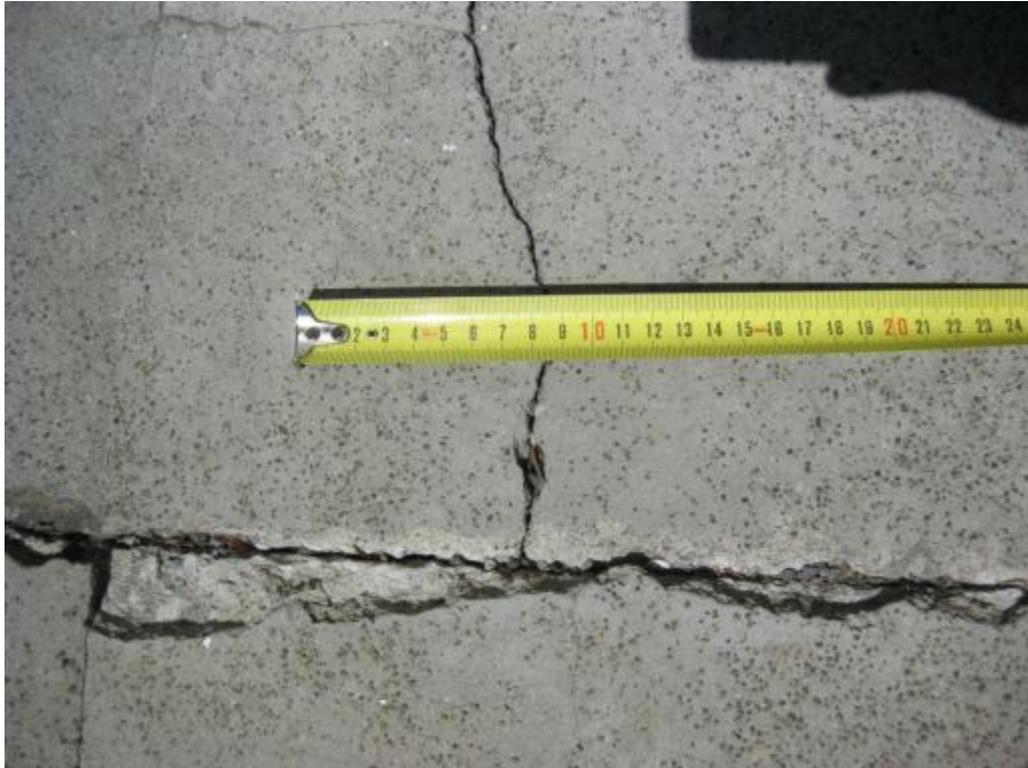
Minor damage to surrounding buildings was observed during our inspection of the site. This was mainly in the form of cracking to plasterboard linings, and cracking to external paved areas.

Photograph 5 Cracking to external paving.

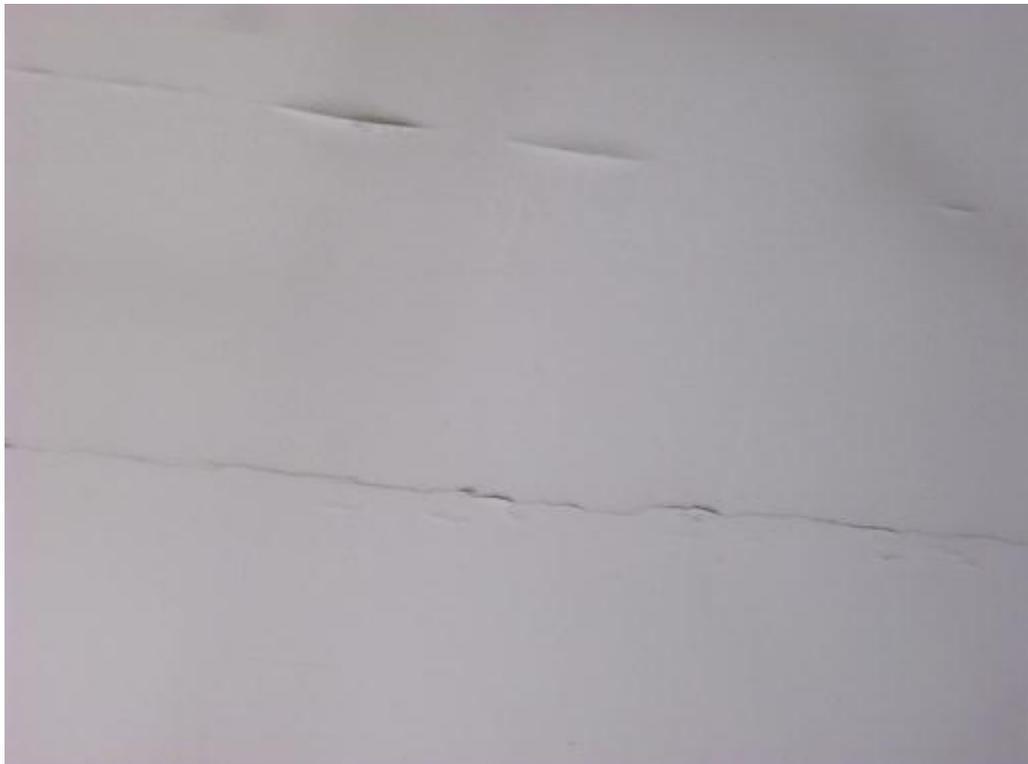
Minor cracking was noted to plasterboard linings in several locations throughout the building however this is not deemed to affect the load carrying capacity of the structural systems.

Photograph 6 Cracking to plasterboard linings.

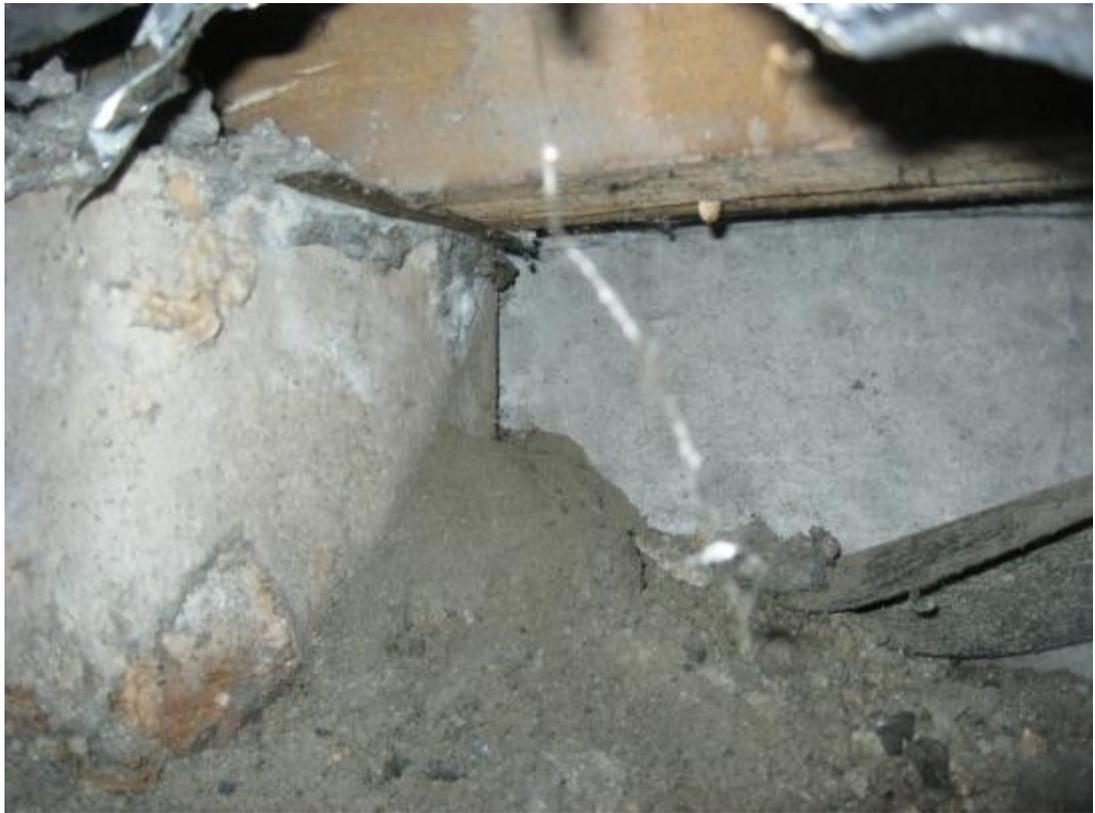
Photograph 7 Timber bearer supported by concrete pile.
