Englefield Reserve Toilet
Qualitative Engineering Evaluation

Reference: 229172
Prepared for:
Christchurch City Council

Functional Location ID: PRK 0362 BLDG 001

Date: 4 July 2013

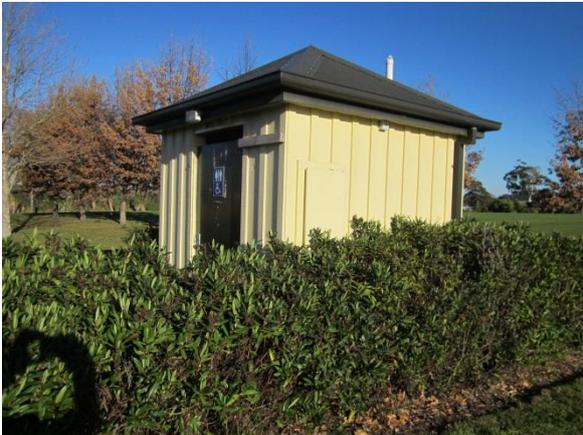
| <p>Building northern elevation.</p> | |

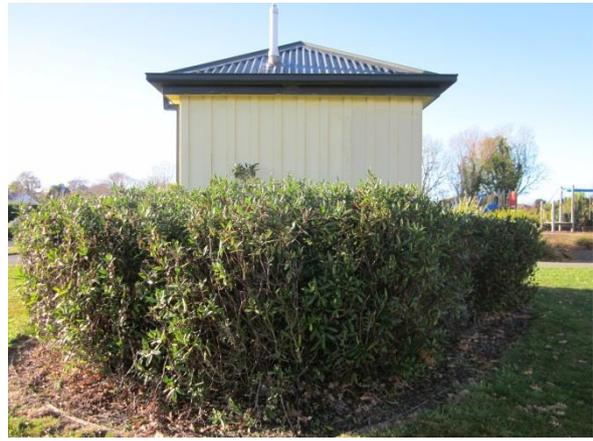
Building western elevation.

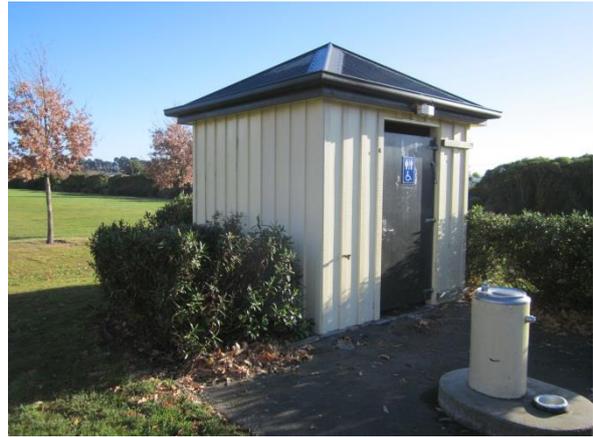
Building eastern elevation.

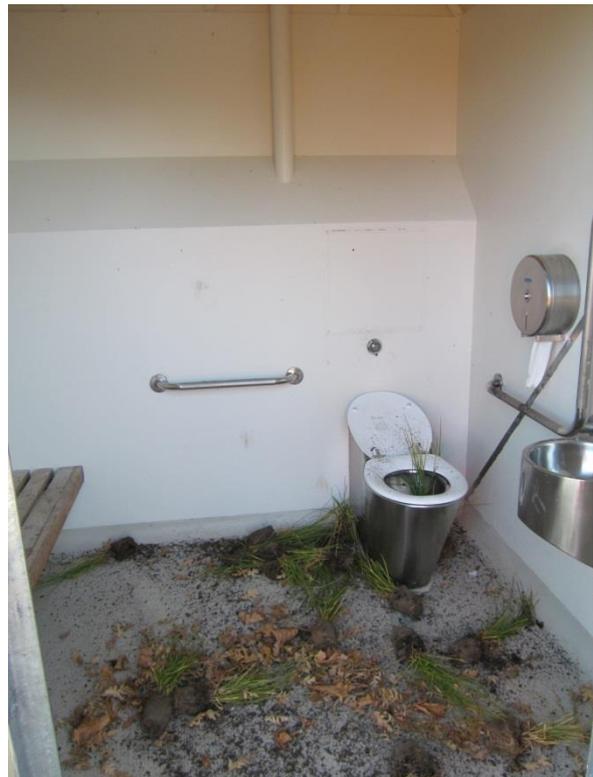
Building internal view.

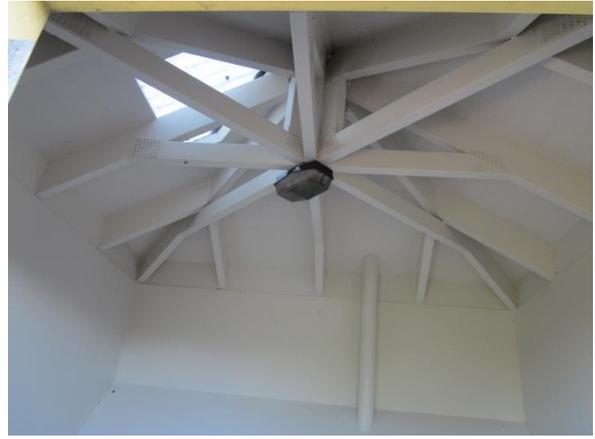
Internal view of roof.
