**CHRISTCHURCH CITY COUNCIL
BU 0450-003 EQ2
Fendalton Library - Caged Fuel Tank
4 Jeffreys Road, Fendalton**

**QUALITATIVE ASSESSMENT REPORT
FINAL**

- Rev B
- 21 September 2012

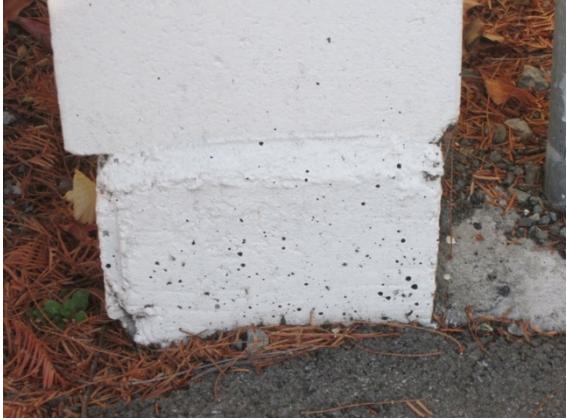
Photo 5: Concrete strip footing directly under masonry walls.	Photo 6: South masonry wall and steel hollow section column on east side.

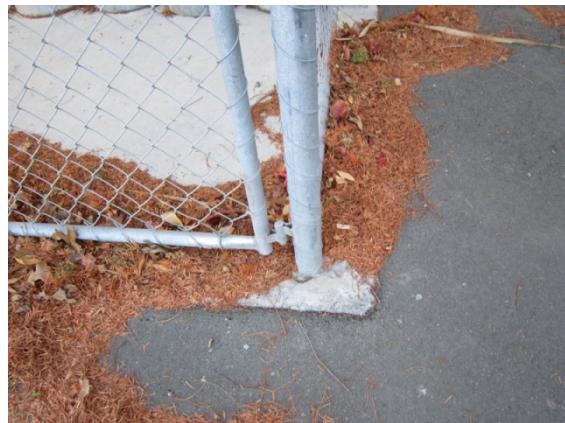
Photo 13: Steel hollow section column ground connection on north east corner.

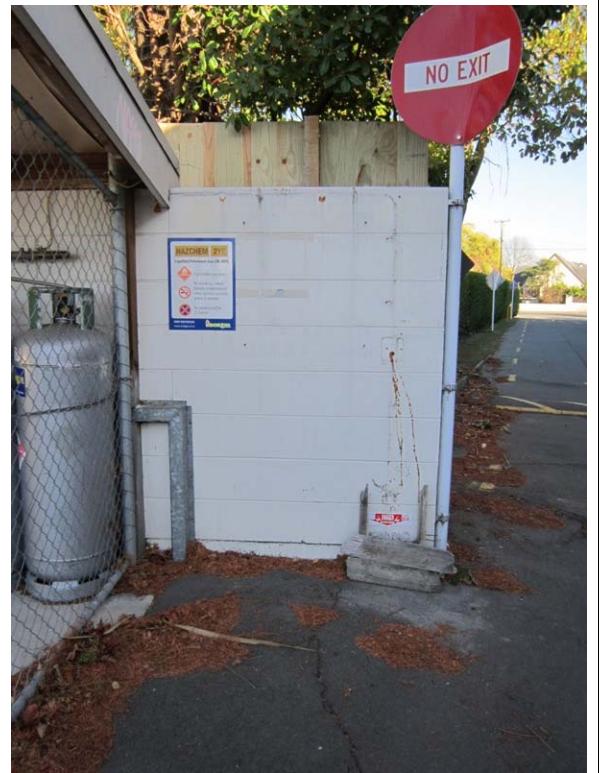
Photo 14: Masonry wall extension past roof on west side.

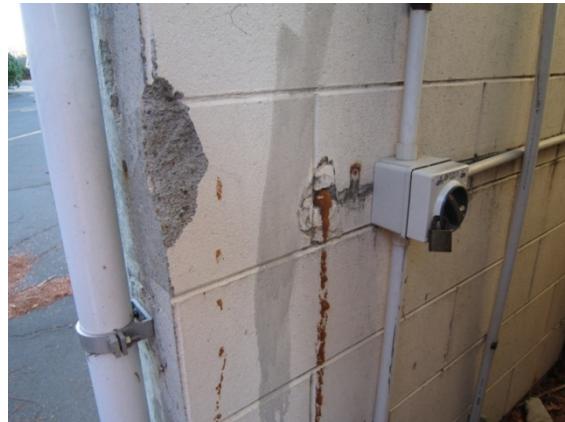
- 1) No earthquake-related damage was observed during our site inspection.
- 2) Impact damage was noted on the west masonry wall. This is not believed to be earthquake-related damage.

Photo 15: Existing impact damage to west wall extension and traces of ceiling foam in an existing cavity.

Only damage thought to be the cause of the earthquakes have been considered for reinstatement.

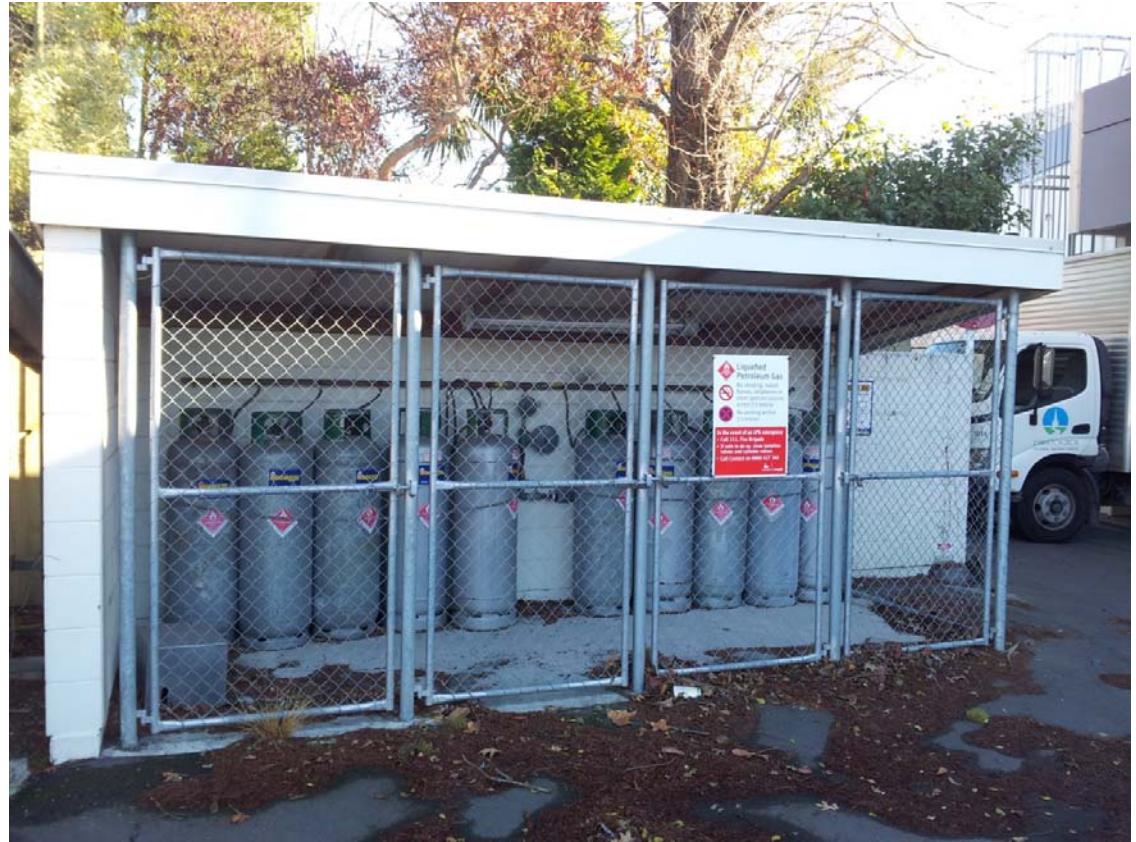
The fuel storage was noted to be a masonry block construction on the southern and western sides, with steel hollow section columns propping the timber-framed roof on the northern and eastern sides. The foundation solution appeared to be a concrete slab on grade footing. There was minor damage to masonry blocks at one location (on the western side); otherwise no significant structural damage was noted from the external site inspection.

▪ **Figure 7 Overview of the fuel storage (eastern elevation)**

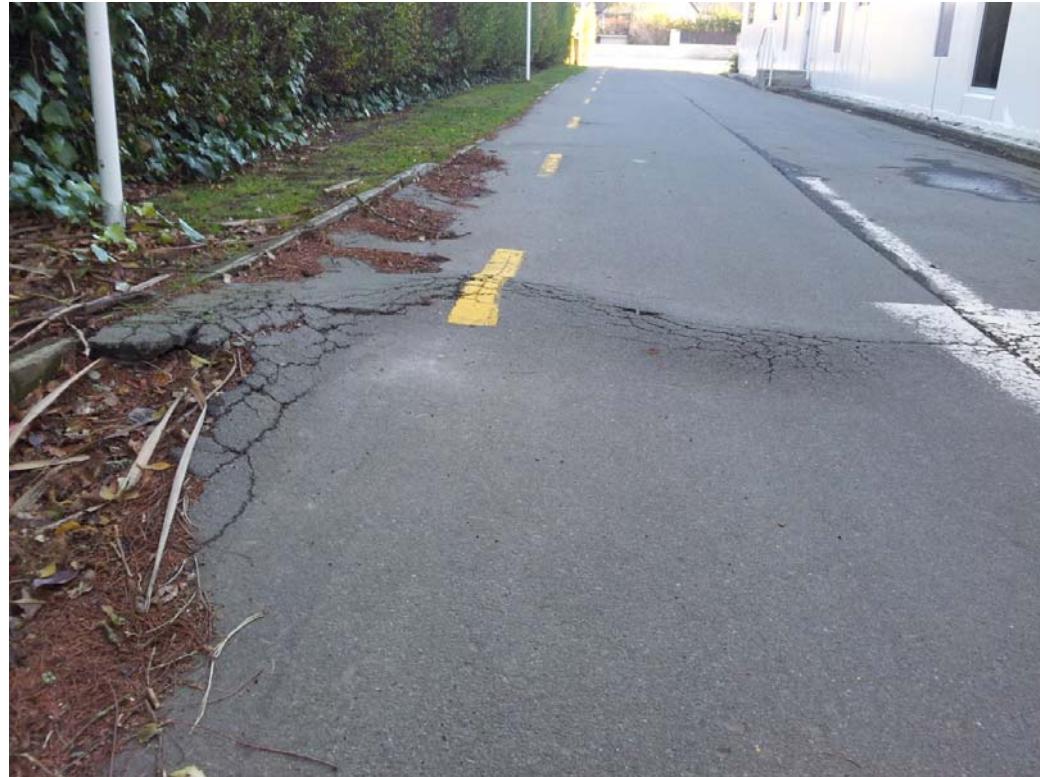
There was no evidence of surface expression of liquefaction. Some cracking of the asphalt surface and undulating ground was noted on the driveway; however, this is not believed to be as a consequence of the earthquake event. No visual evidence of settlement or apparent land damage was observed within the site.

▪ **Figure 8 Observed undulating ground on the driveway**

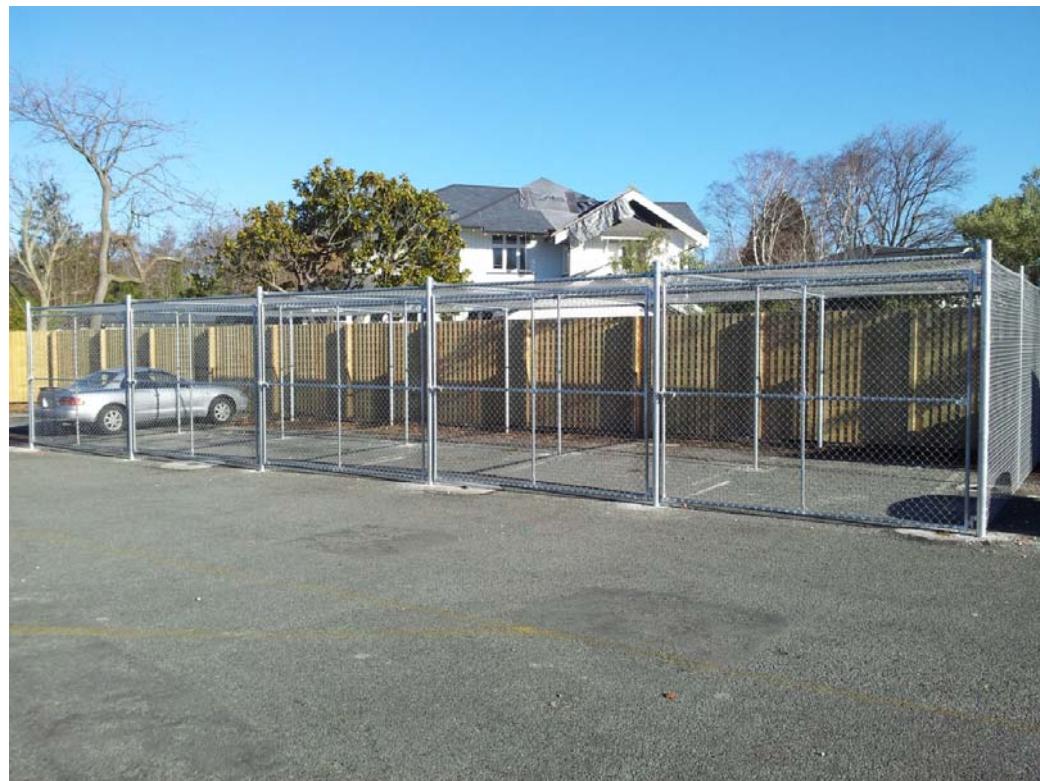
During the external site inspection, it was noted that the original car garage had burned down and been replaced with steel cages.

▪ **Figure 9 Car garage replaced with steel cages**
