**Dwelling Ferry Road**  
**BU 2672-001 EQ2**  
Detailed Engineering Evaluation  
Qualitative Report  
Version FINAL

347 Ferry Road, Waltham, Christchurch

Christchurch City Council

**Date**  
30<sup>th</sup> October 2012

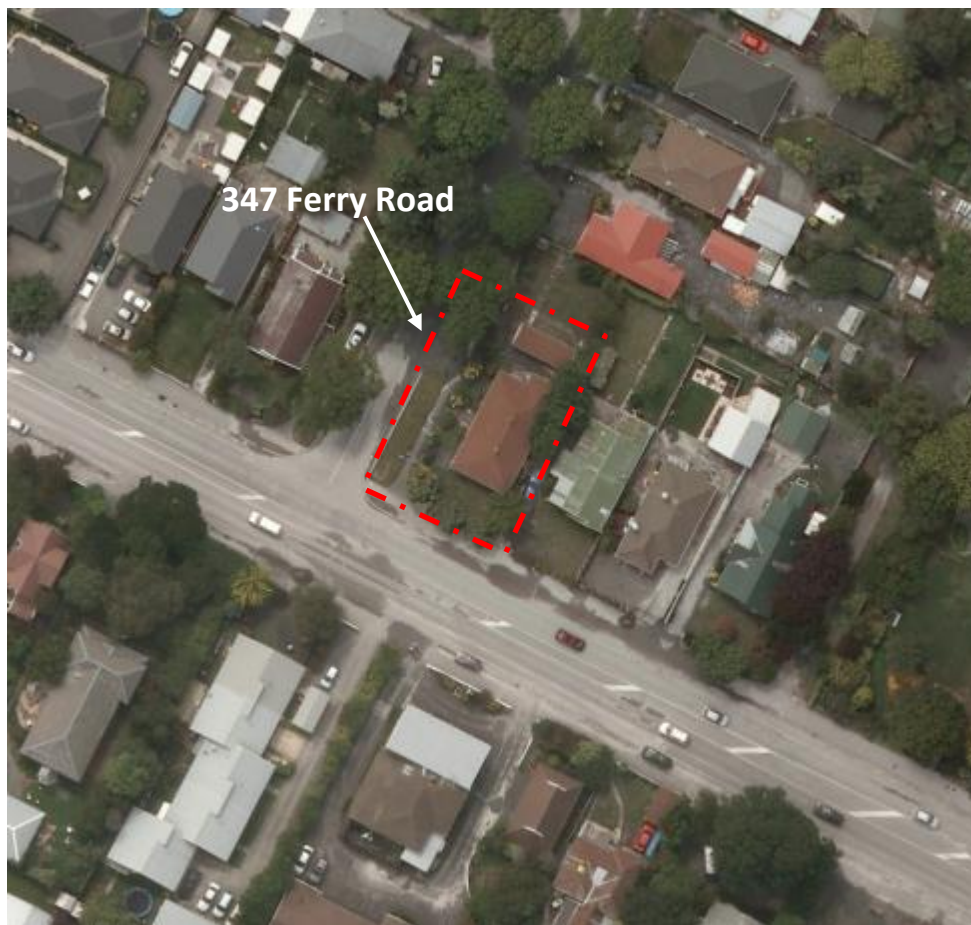
**Figure 3 Post February 2011 Earthquake Aerial Photography**<sup>4</sup>

Aerial photography taken following the 22 February 2011 earthquake shows no signs of liquefaction outside the building footprint but is evident on neighbouring properties, as shown in Figure 3.

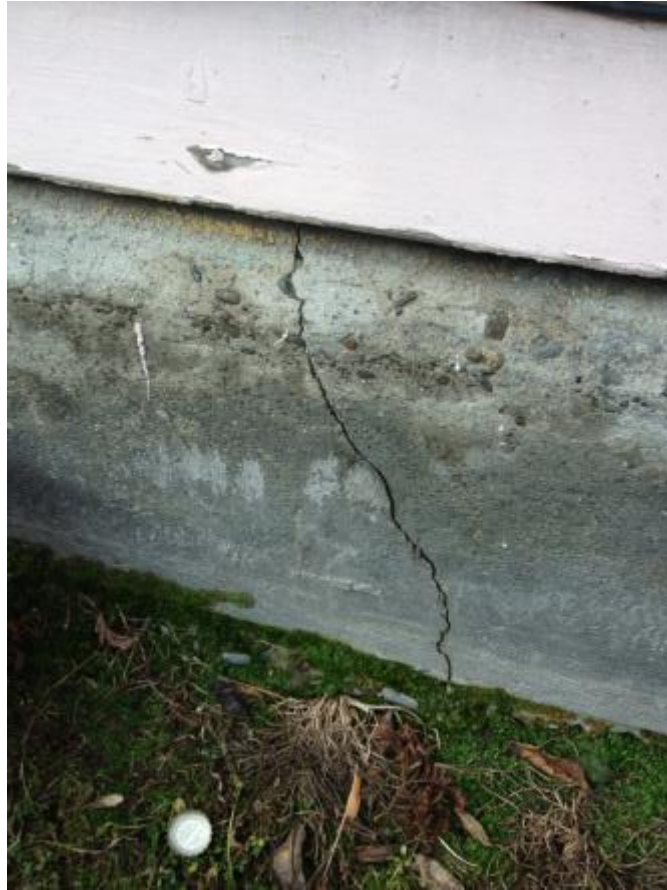
Cracking was noted to the internal plasterboard linings in several locations throughout the building and on the perimeter strip footing (see photographs 5 to 13).

**Photograph 5 Vertical cracking in foundation.**

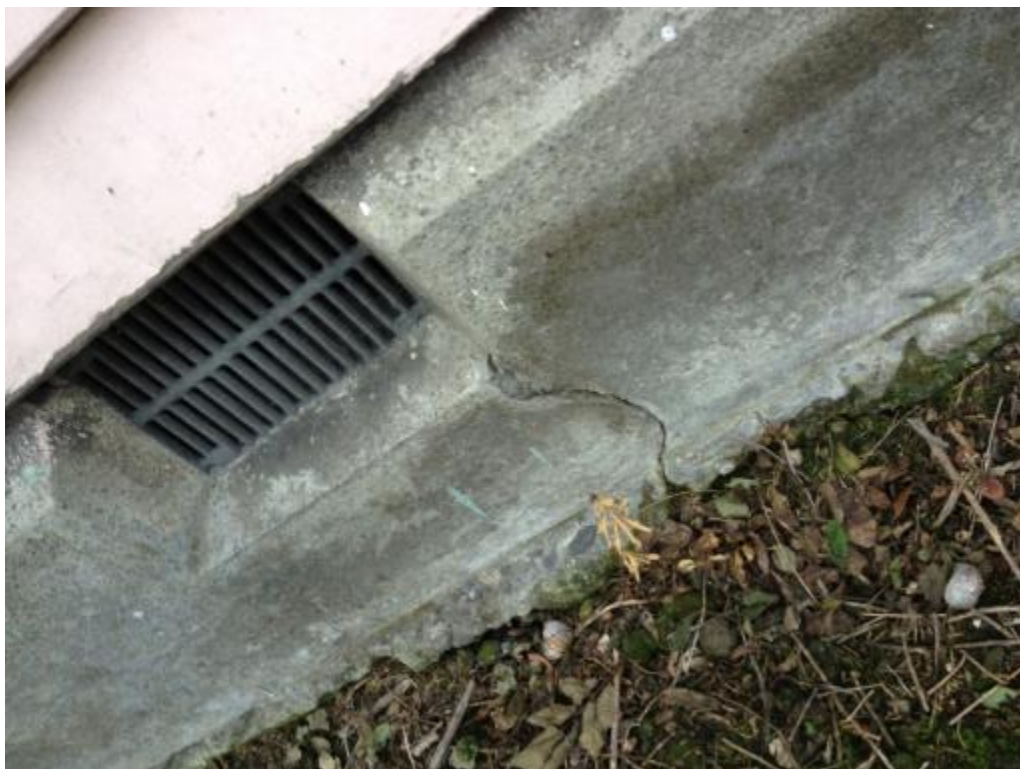
**Photograph 6 Vertical cracking in foundation.**

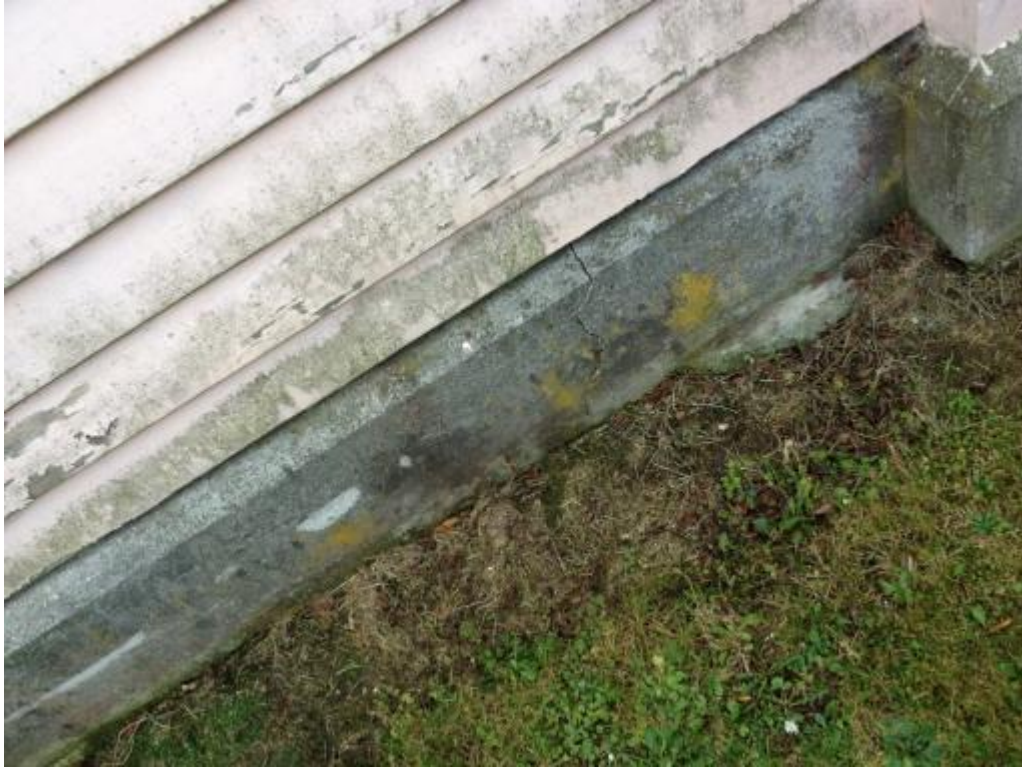
**Photograph 7 Cracking in foundation**

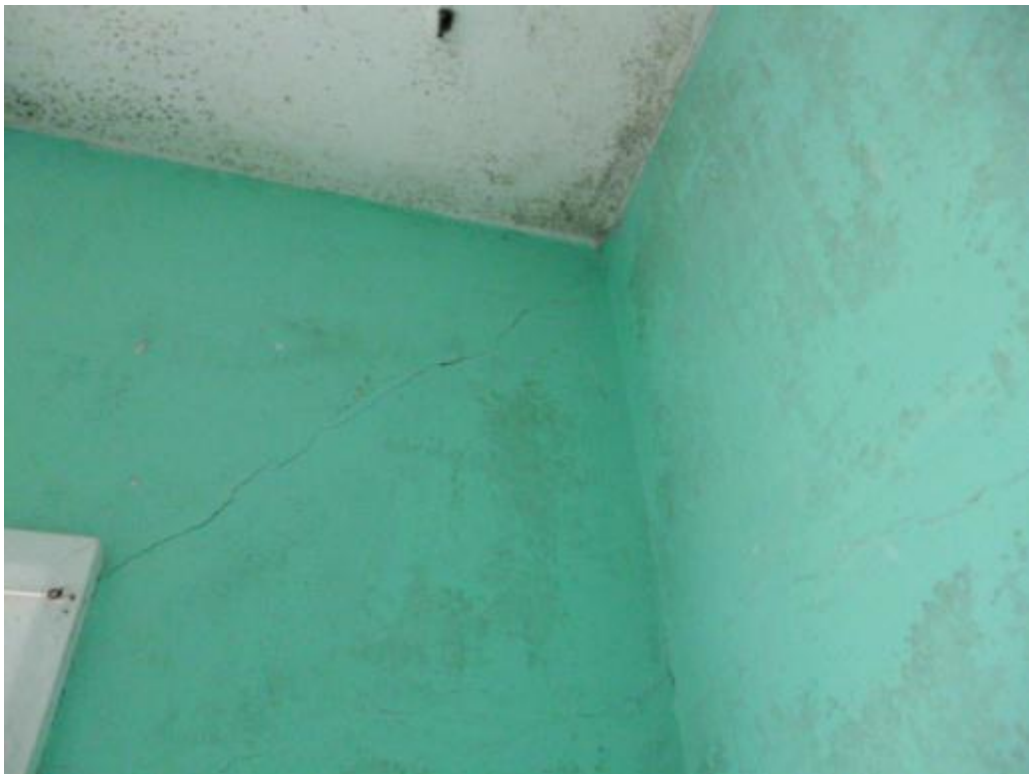
**Photograph 8 Cracking in plaster board**

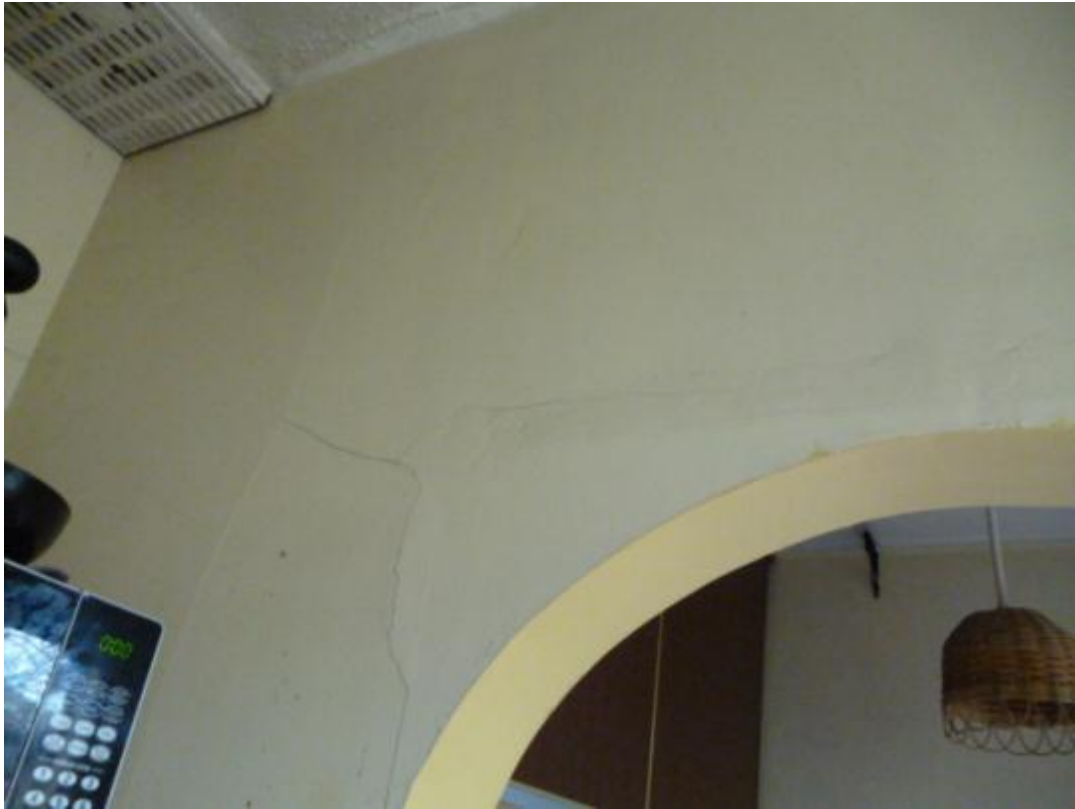
**Photograph 11 Cracking in plasterboard.**

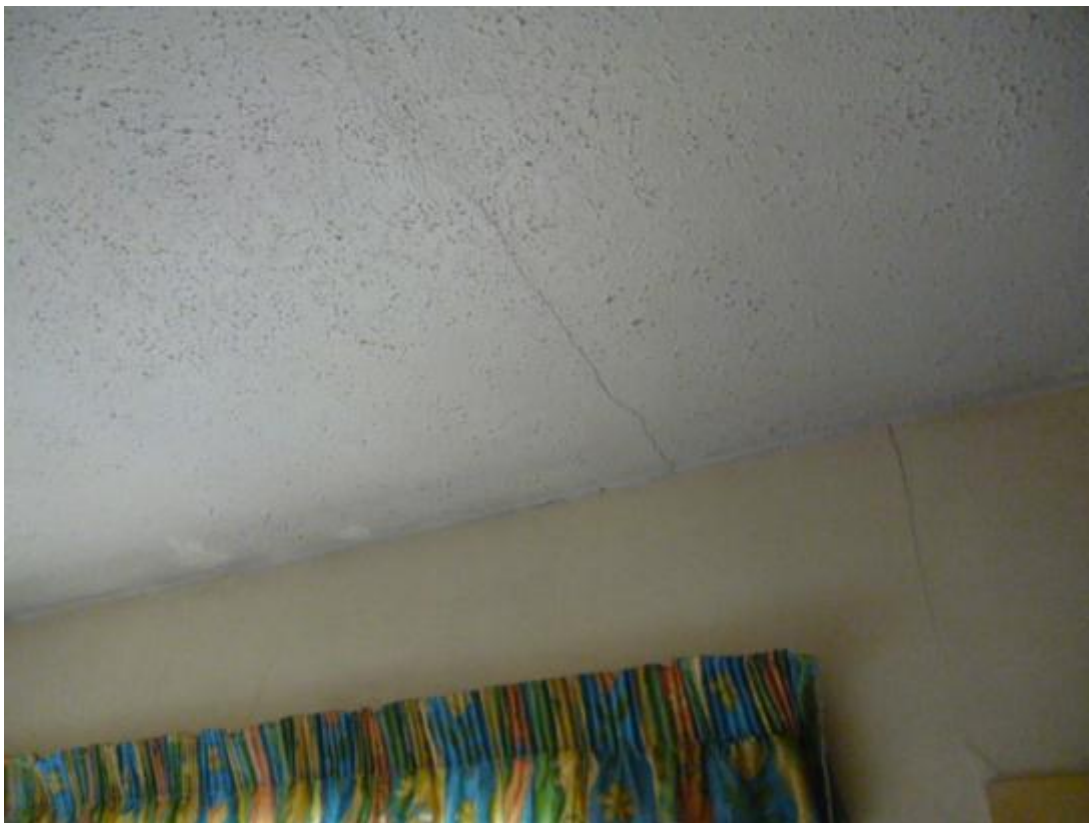
**Photograph 12 Cracking in ceiling**
