**Ferrymead Reserve Toilet**  
**PRK 1750 BLDG 002**  
Detailed Engineering Evaluation  
Qualitative Report  
Version Final

Christchurch City Council

**Date**  
23<sup>rd</sup> May 2013

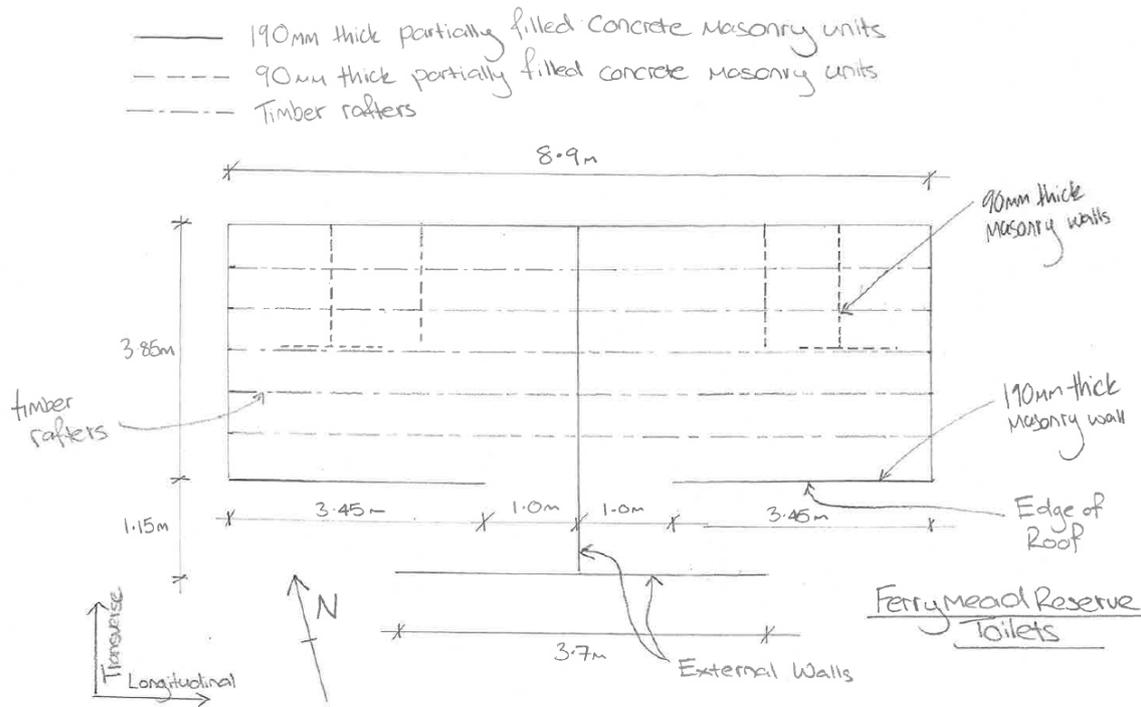
**Figure 2 Plan Sketch Showing Key Structural Elements**

The main 190 mm thick concrete masonry walls and the 90 mm thick partial height internal concrete masonry walls are effectively unrestrained along the top edge. Out-of-plane loading on these walls is likely to be resisted by a combination of the walls spanning horizontally between return walls and vertical cantilever action.

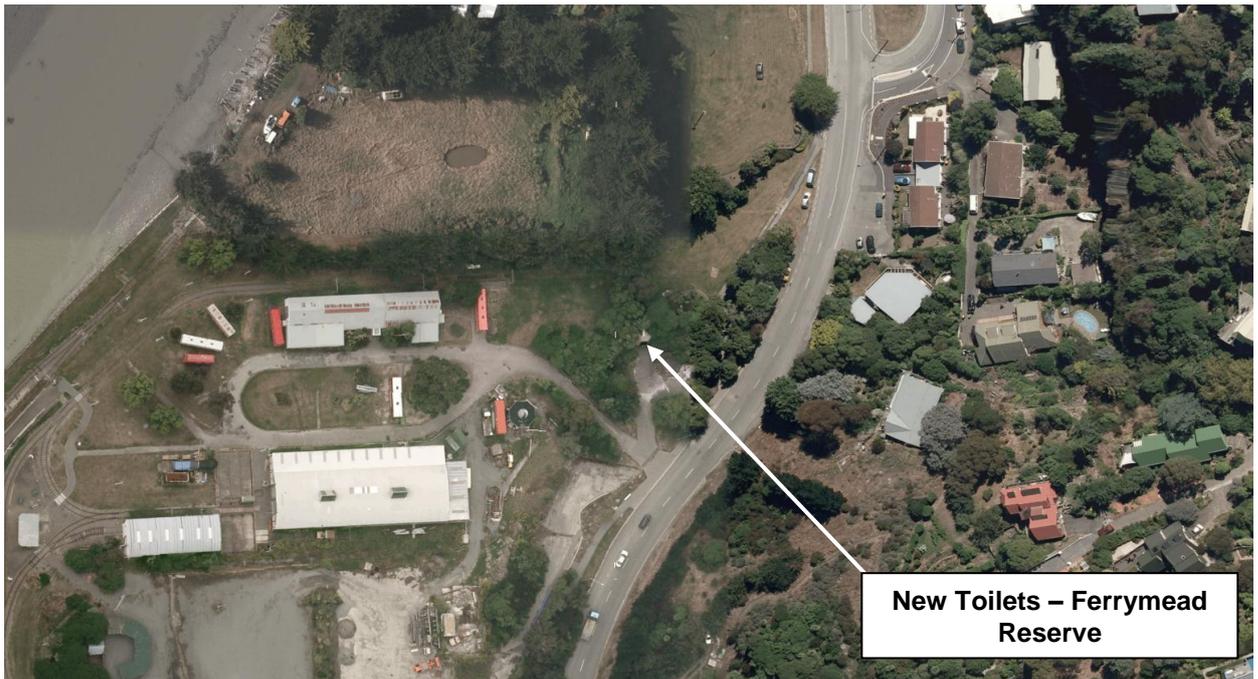
**Figure 3 Post February 2011 Earthquake Aerial Photography**

Aerial photography<sup>2</sup> taken following the 22 February 2011 earthquake shows no signs of liquefaction outside the building footprint or directly adjacent to the site, however significant liquefaction is observed 120m to the southwest of the site, as shown in Figure 3.

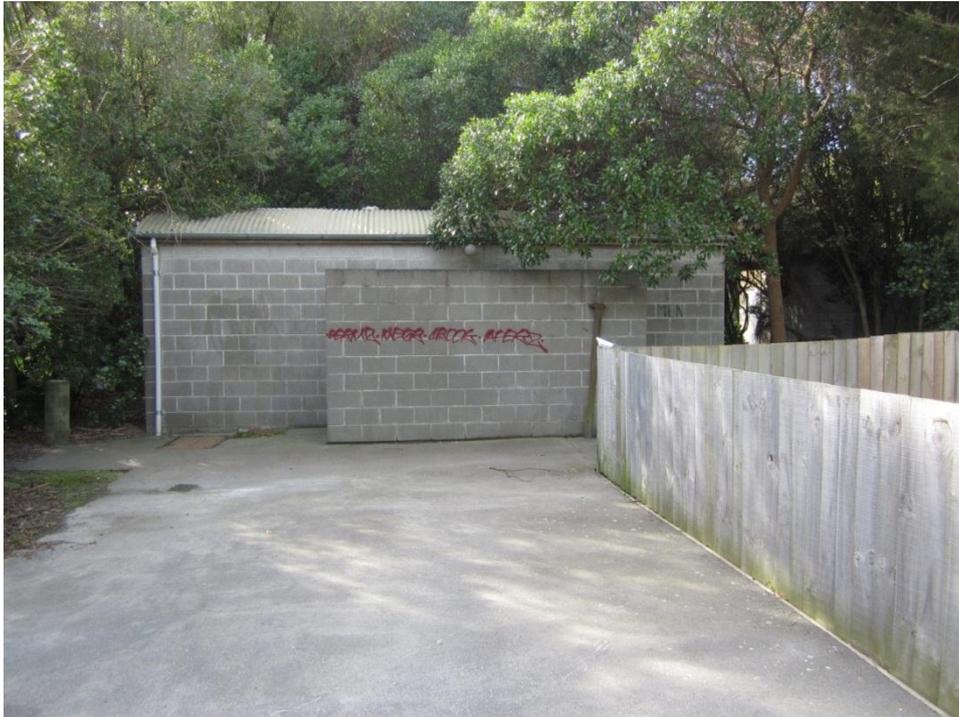
**Photograph 1** View of toilet entrance from the south

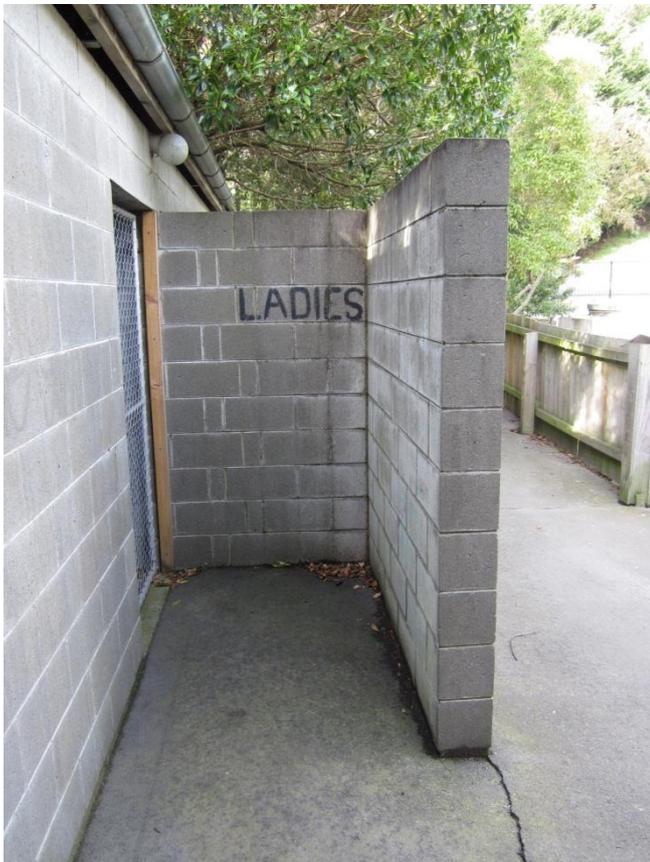
There is some minor cracking in the asphalt pavement outside the entrance wing of the toilets (see Photograph 2).

**Photograph 2** Entrance wing

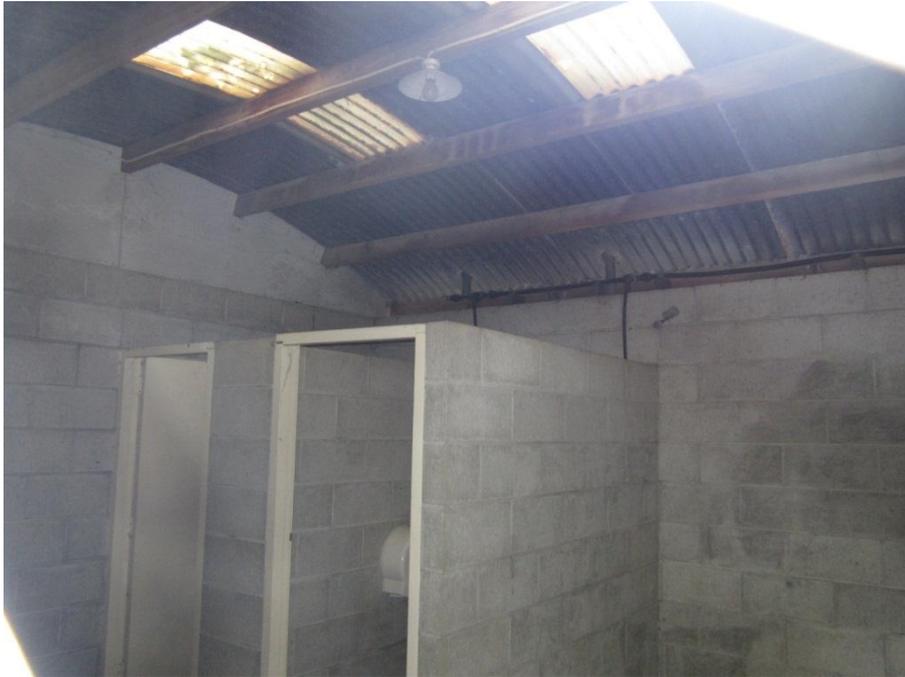
The top edges of the 190 mm main concrete masonry walls are effectively unrestrained due to the absence of a diaphragm or bracing in the roof structure. The internal 90 mm thick concrete masonry walls (see Photograph 3) and the 190 mm thick concrete masonry entrance wing walls (see Photograph 2) are unrestrained along the top edge and are susceptible to collapse from out-of-plane seismic actions.

**Photograph 3** 90mm thick internal walls

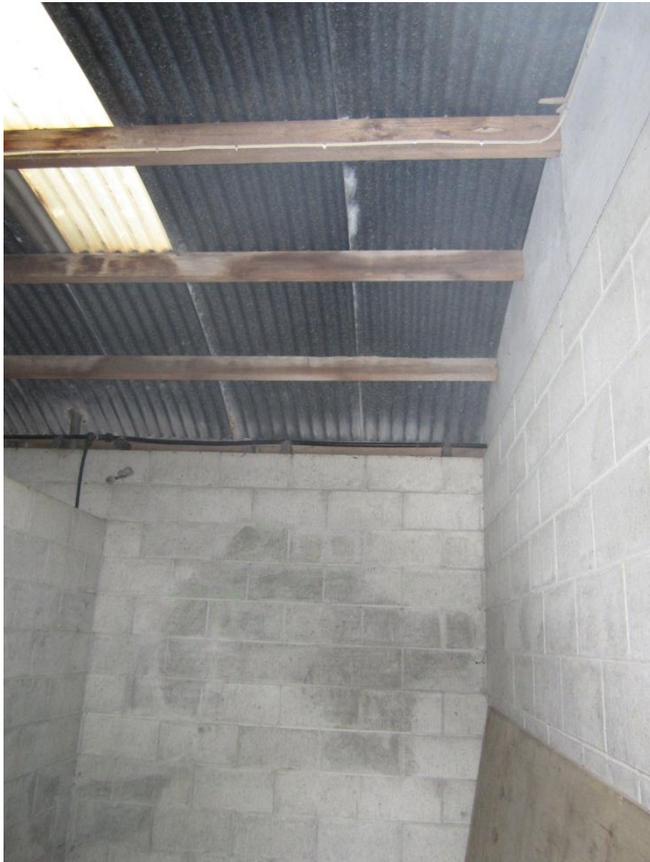
The corrugated sheet metal roof is unlikely to have sufficient strength and stiffness to distribute the lateral in-plane seismic forces to the walls in the plane of loading through diaphragm action. The lack of a diaphragm to transfer in-plane forces through the roof to the supporting walls is considered a Critical Structural Weakness. The absence of a roof diaphragm has been assessed as a 'significant' plan irregularity Critical Structural Weakness in accordance with NZSEE guidelines.

**Photograph 4** Timber roof rafters

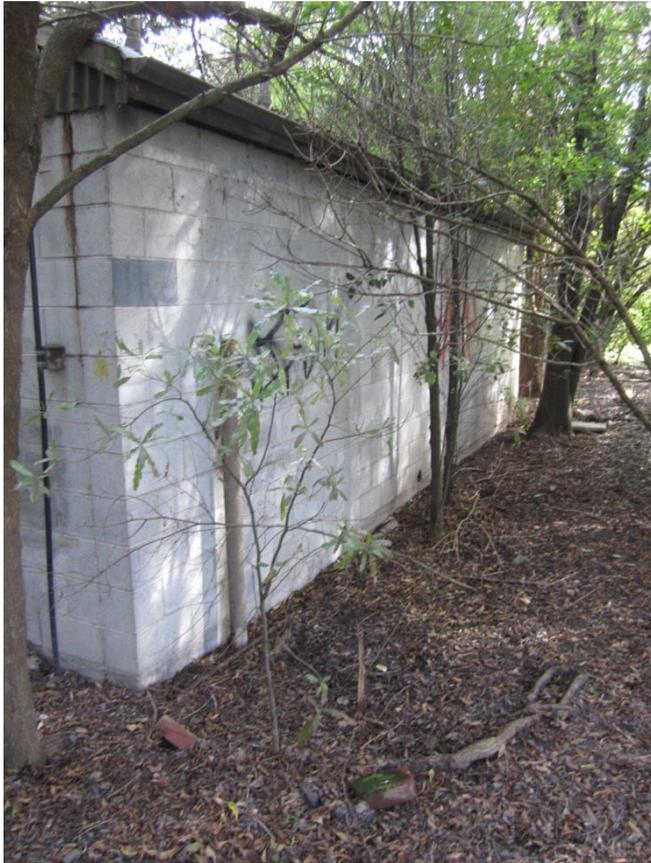
**Photograph 5** Rear masonry wall

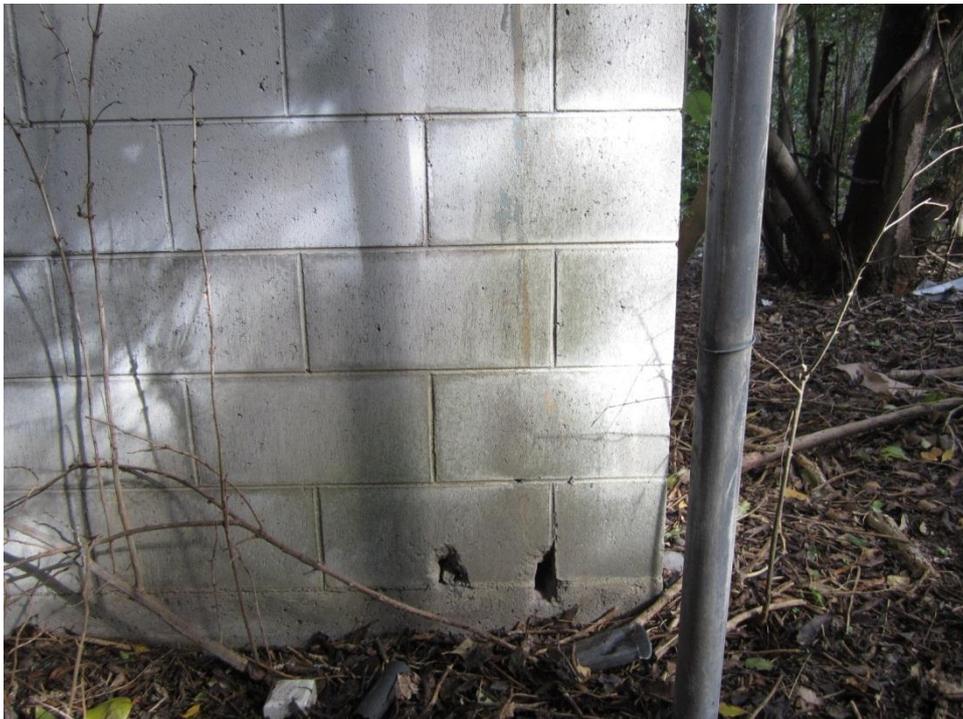
**Photograph 6** Drainage holes in external wall
