Forfar Courts Housing Complex PRO 0629

**Detailed Engineering Evaluation
Quantitative Assessment Report**

**95 Forfar Street, St Albans,
Christchurch**

Date: January 2014
Reference: 6-QC341.00
Status: Final

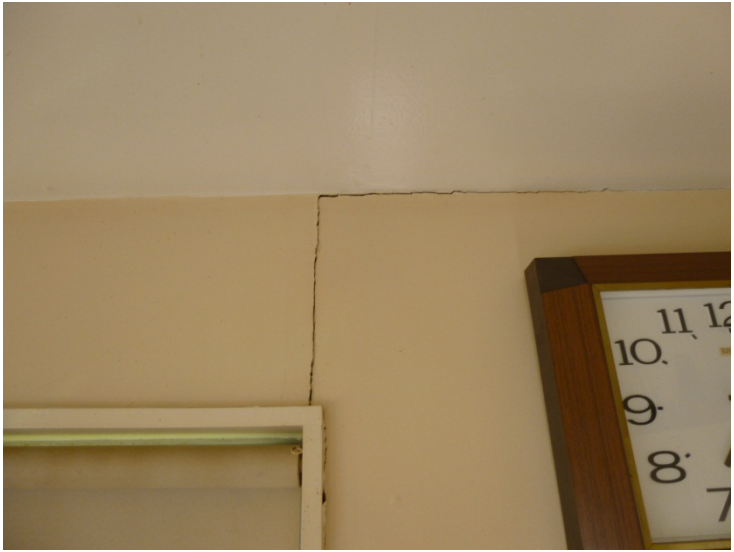
Minimal cracking of plasterboard ceiling diaphragms and wall linings was observed in the units. This form of damage is common throughout the units.

9.	Typical cracking of wall lining

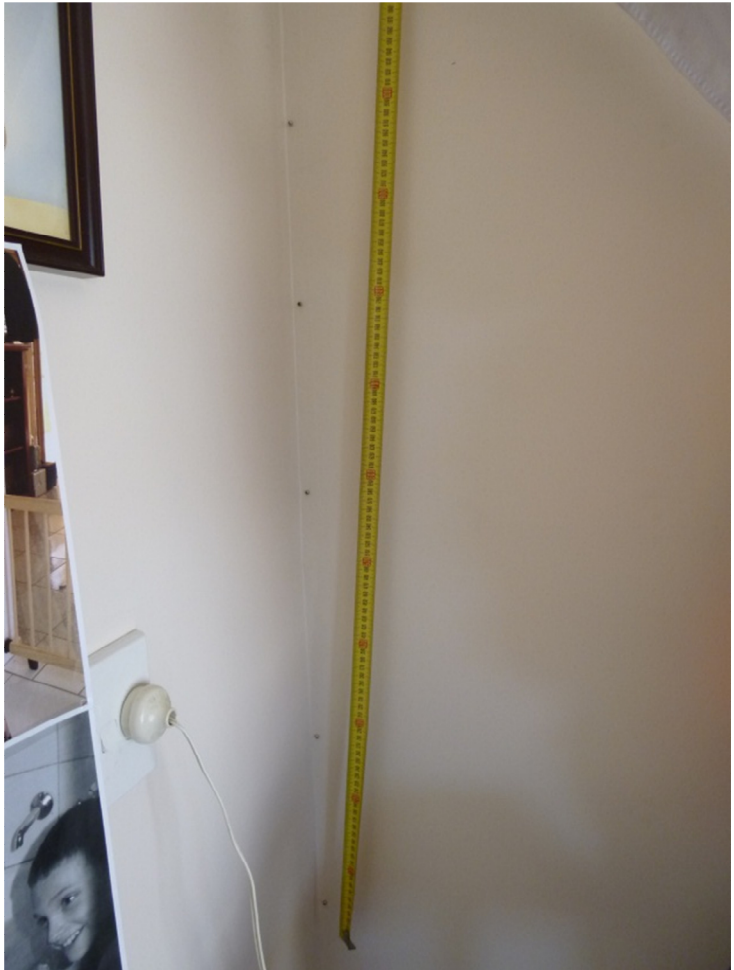
The internal lining nail spacings were measured on site to vary between 200-300mm in the residential units and 150-300mm in the Residents Lounge.

10.	Typical wall lining nail spacings

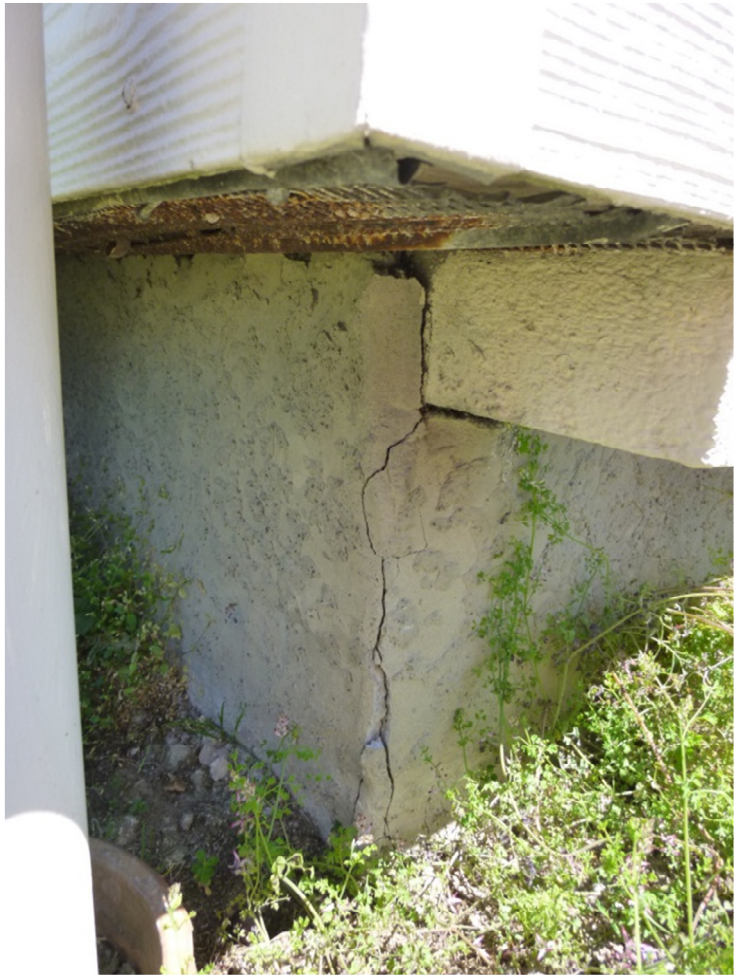
Foundation damage was limited to minimal cracking in the rendered perimeter sub-floor cladding on some of the residential unit blocks.

11.	Typical cracking of concrete perimeter footings at corners

- The rendered perimeter sub-floor cladding be repaired on blocks where severe cracking occurs.

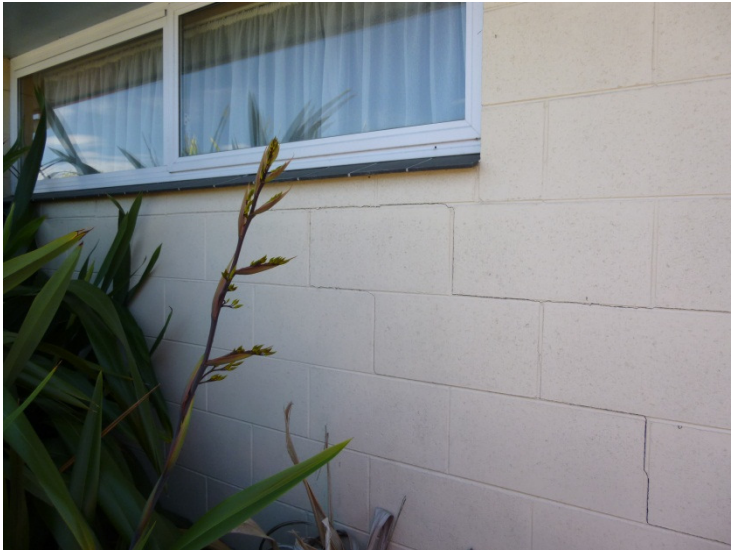
Minimal stepped cracking in the concrete block veneer exterior cladding mortar joints was observed on the residents lounge.

18.	Stepped cracking of block veneer

- The veneer and cracks be repaired on the Residents Lounge so that the load path no longer travels through the veneer ties. This will ensure continued damage does not occur.
- A site specific geotechnical site investigation be carried out to determine the liquefaction potential of the site and the shallow bearing capacities of the soils if this information is required for future construction on the site.
- Cosmetic repairs be undertaken as required.

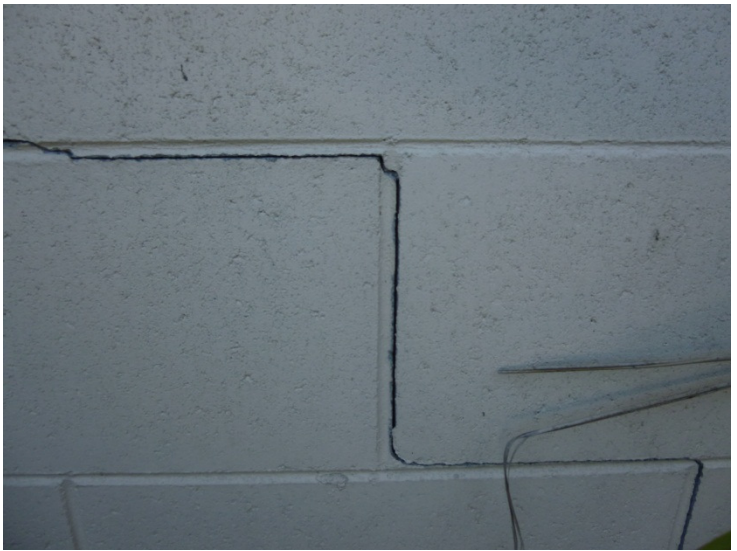
19.	Stepped cracking of block veneer

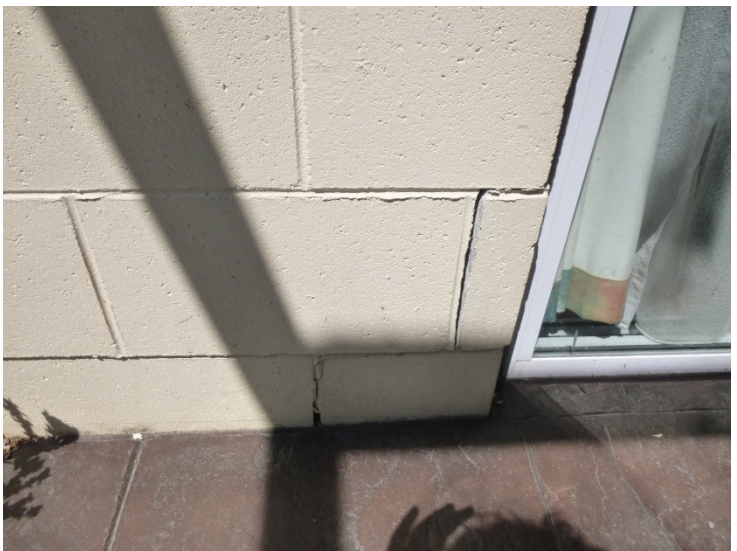
20.	A loose block was observed

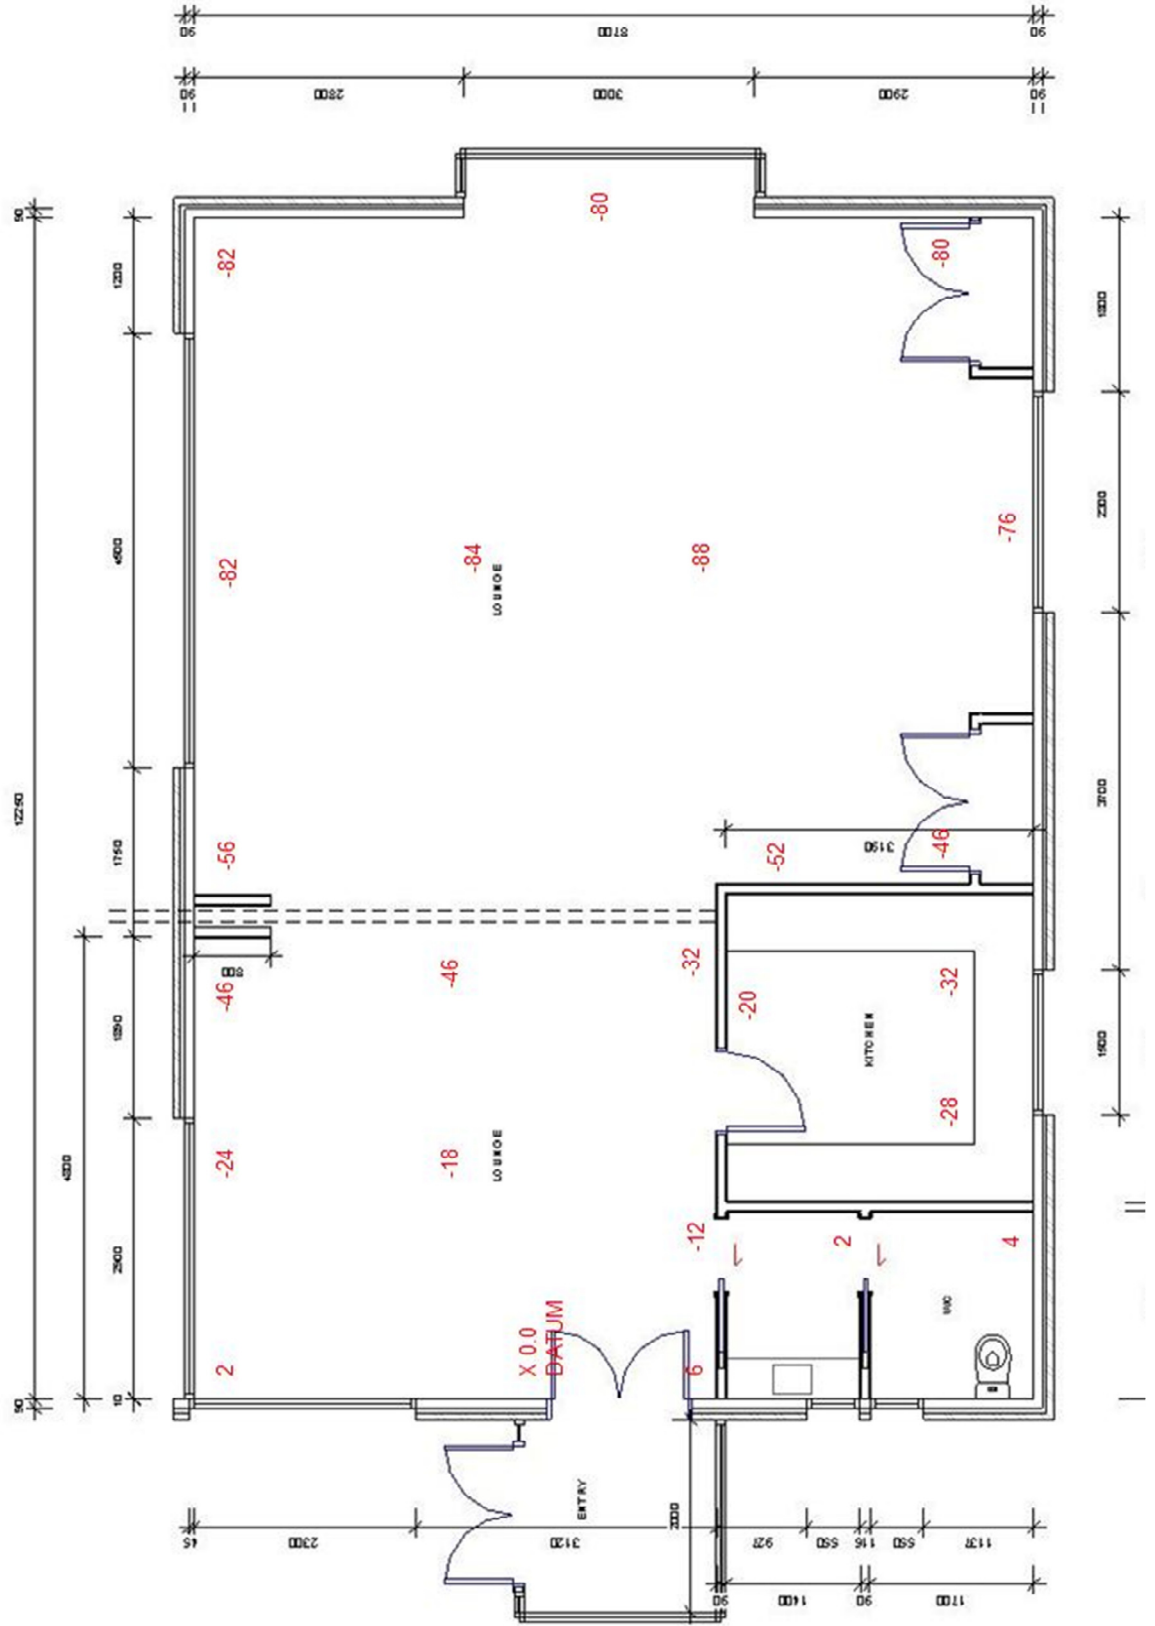
FORFAR COURTS: RESIDENTS LOUNGE

All accessible floor slopes were assessed in a full level survey. None of the residential floor slopes were greater than the 5mm/m limitation set out in the MBIE guidelines [6], as shown below. The floor slope in the Residents Lounge was greater than this limitation.
