**Garden of Tane**  
**PRK 3742 BLDG 001 EQ2**

**Detailed Engineering Evaluation**

**Quantitative Assessment Report**

**Onuku Road, Akaroa, Canterbury**

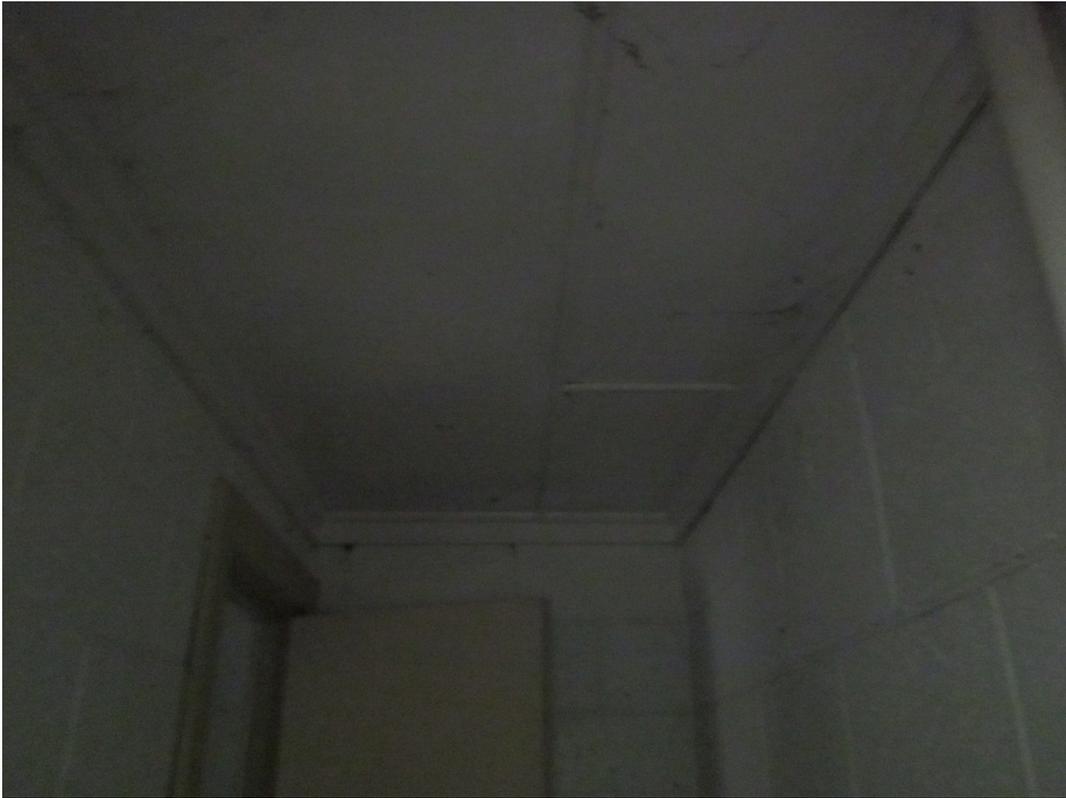
**Photo 5: Internal view through window opening**
