**Gayhurst Road
Housing Complex
PRO 0712**

**Detailed Engineering Evaluation
Quantitative Assessment Report**

154 Gayhurst Road, Dallington,

Date: February 2014
Reference: 6-QC343.00
Status: Final

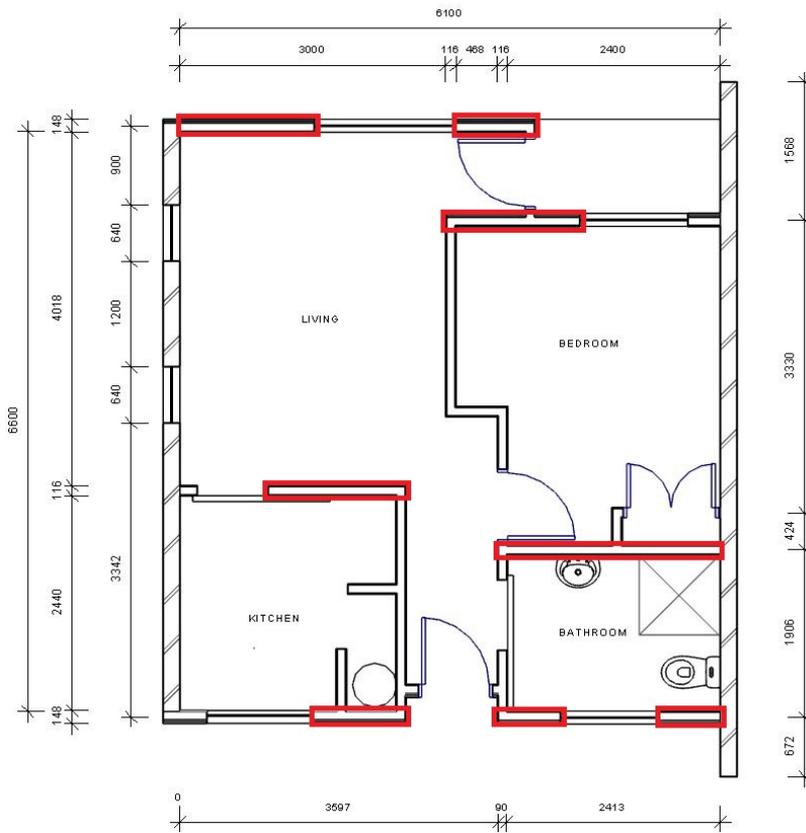
Figure 6: Walls used for bracing in the longitudinal direction.

- Block A has a capacity of 43% NBS, as limited by the in-plane capacity of the bracing walls. It is deemed to be a 'moderate risk' in a design seismic event according to NZSEE guidelines. The level of risk is 5-10 times that of a 100% NBS building (Figure 1) and is not considered to be Earthquake Prone.
- Based on the geotechnical appraisal, differential settlement as a result of liquefaction could result in further damage, similar in nature to that which has occurred in the recent earthquake sequence. However, based on the nature of construction, this is unlikely to result in the collapse of concrete ground beams beneath the masonry walls.

- A strengthening scheme be developed to increase the seismic capacity of Block A to at least 67% NBS.
- Veneer at height (gable ends) have the veneer ties checked, loose bricks are to be fixed.
- Cosmetic repairs be undertaken as required.

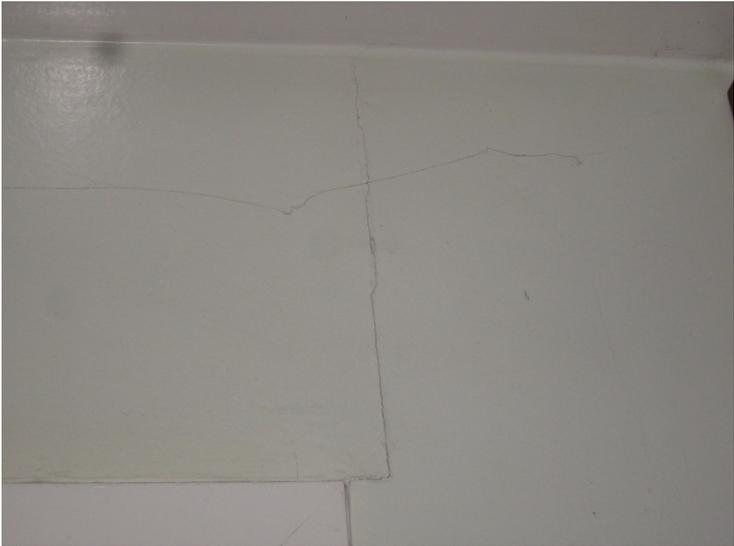
Cracking of interior wall linings, especially surrounding the corners of doors and windows (photo 10) and where wall linings meet the fire wall (photo 11).

10.	Cracking to interior wall linings from windows and doors

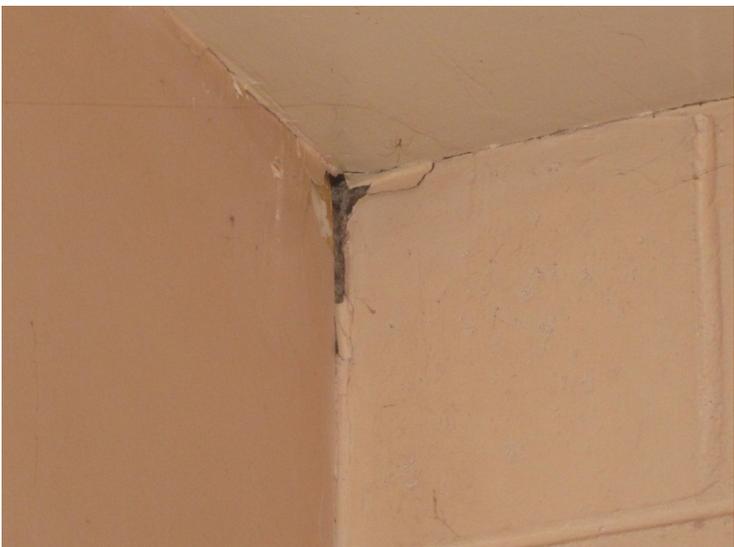
11.	Cracking to interior wall linings where they are separating from firewall

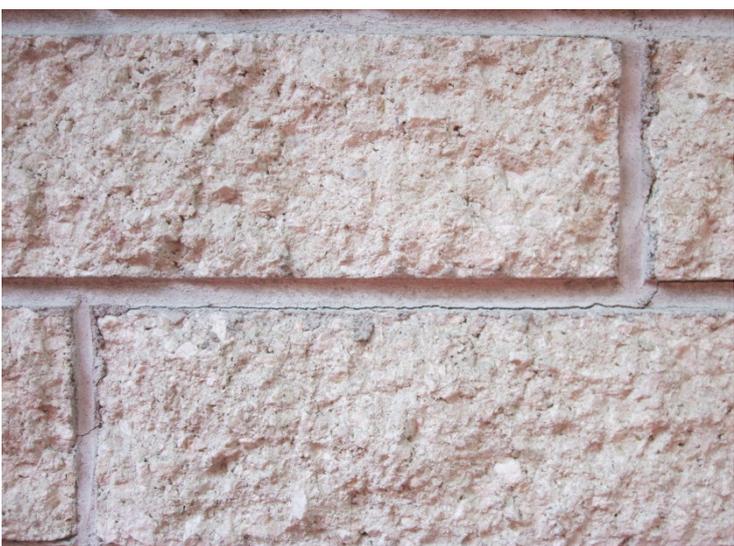
Damage was also observed to the external stone veneers including stepped cracking (photo 12) and several loose bricks at the top of the gable ends of the building (photo 13). It was also observed that there was a minor crack in the path outside Unit 4 (photo 14).

12.	Stepped cracking to exterior veneers

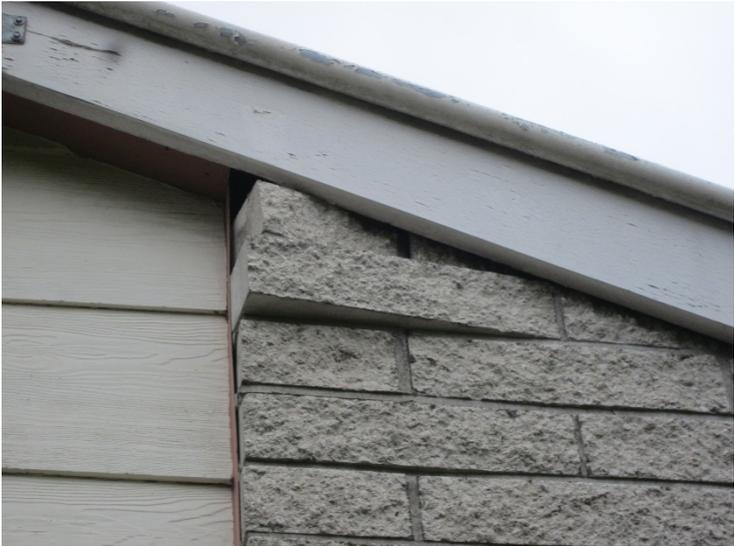
<p>13.</p>	<p>Loose veneer bricks at the tops of gable ends</p>

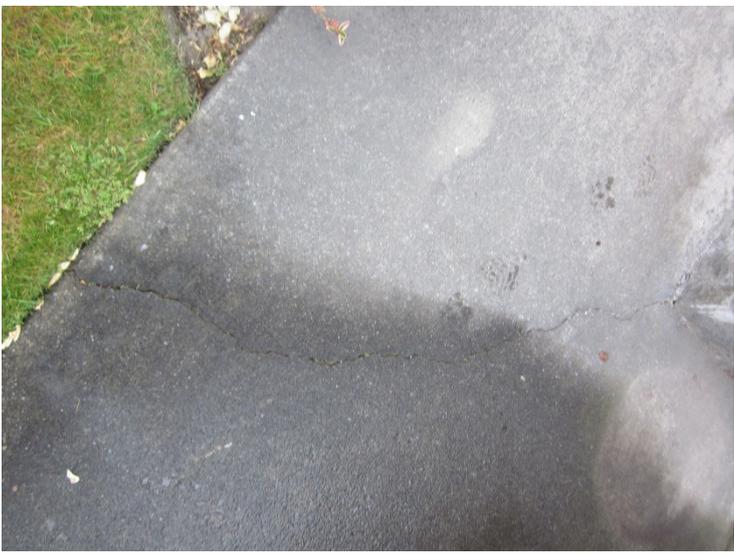
<p>14.</p>	<p>Crack in path outside Unit 4</p>
