Christchurch City Council
BU 3569-005 EQ2
Governors Bay Pottery Shed
Main Road, Governors Bay

QUANTITATIVE ASSESSMENT REPORT

FINAL

- Rev B
- 04 March 2013

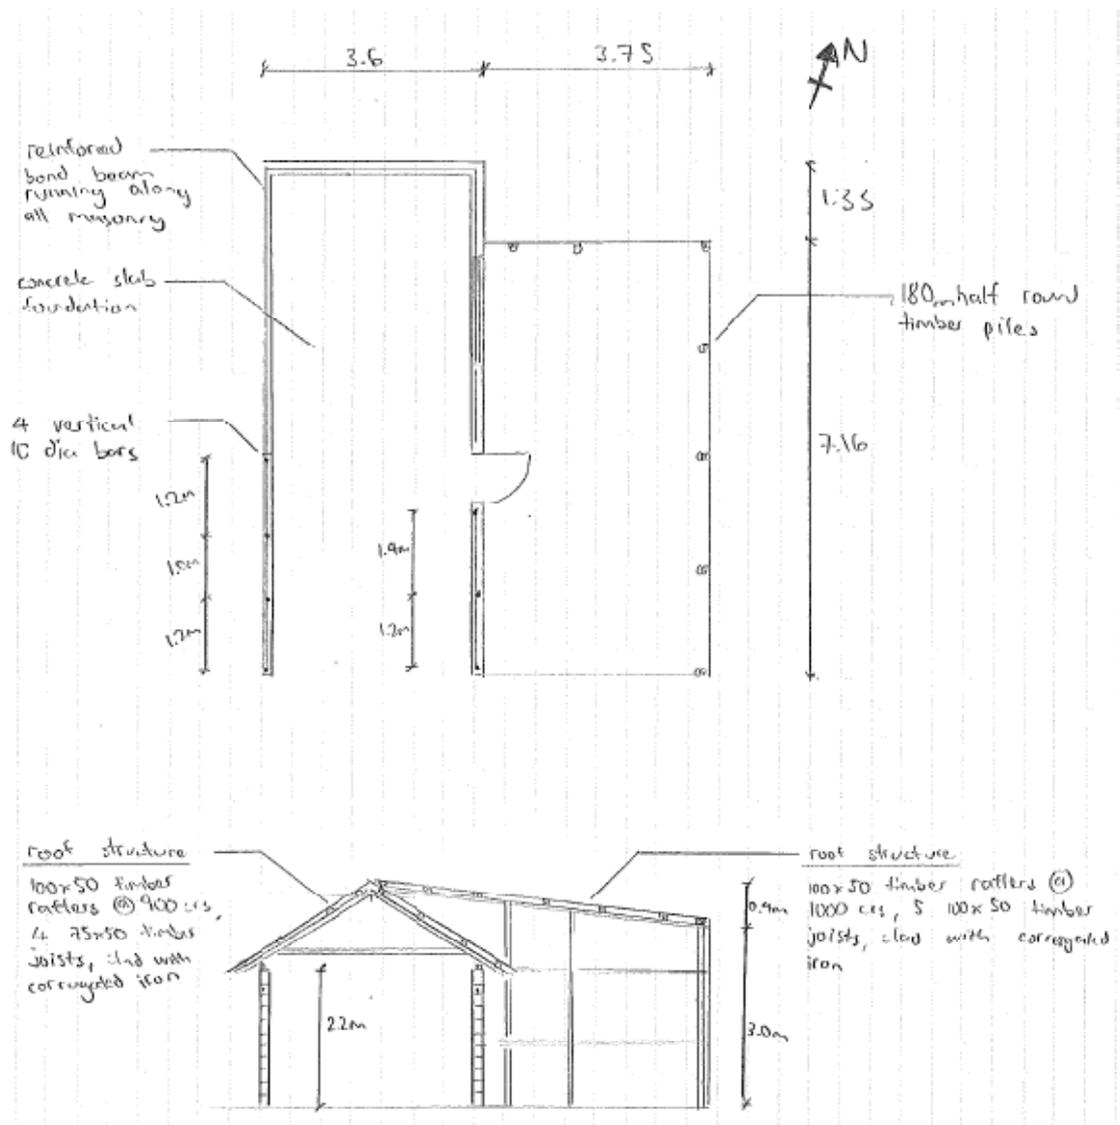
■ **Figure 3: Sketch of building**

The Governors Bay pottery shed is a single storey building located on Main Road, Governors Bay. The structure is made up of two parts, the main structure and the addition. The main structure is constructed from unfilled masonry walls with a concrete slab on grade foundation. The walls are mostly unreinforced except for a portion of the east and west walls, see Figure 3.

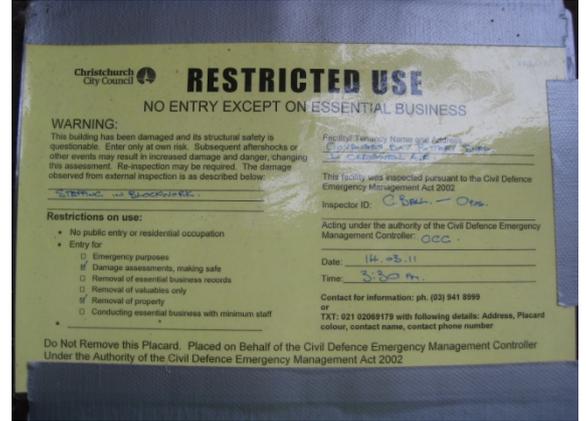
Photo 6: Yellow Placard posted on front opening

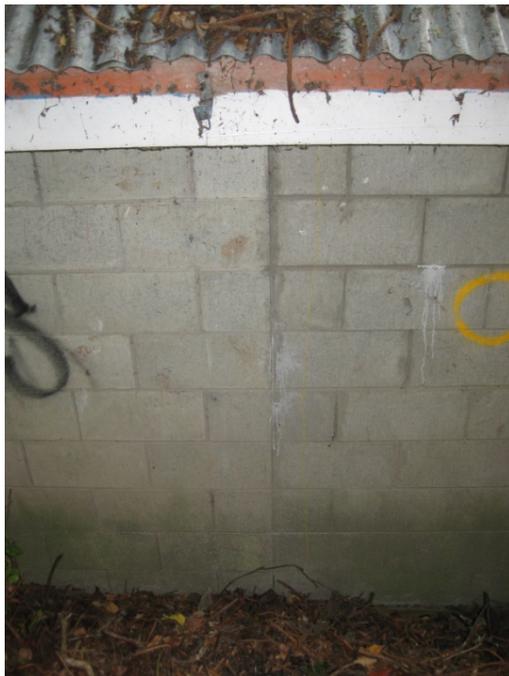
- 1mm vertical crack in west wall running through masonry grout (photo 7 & 8)
- 0.3mm step cracks and displaced blocks in west wall (photo 9 - 12)
- 0.7mm crack through masonry in north wall (photo 14)
- 0.5mm vertical crack at masonry block joint (photo 15)

Photo 7: West wall, with junction between unreinforced wall and reinforced wall

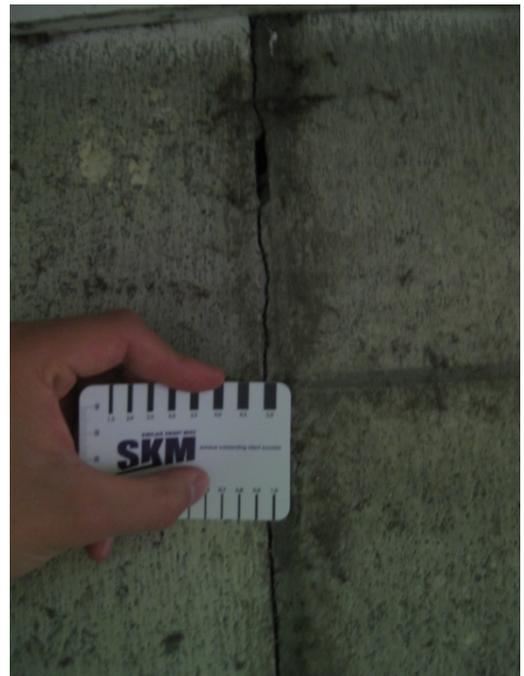
Photo 8: Close up from photo 7 showing 1mm crack between junction

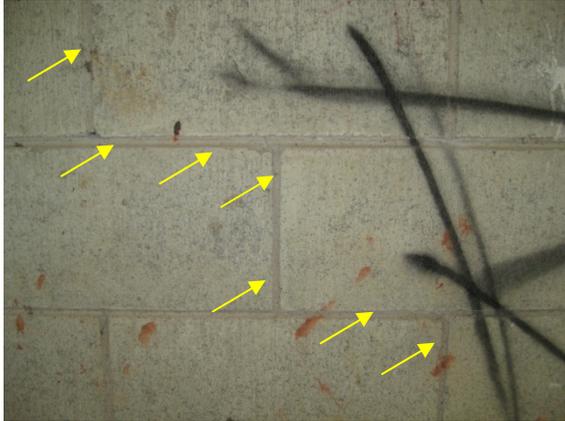
Photo 9: Step cracking running diagonally on west wall

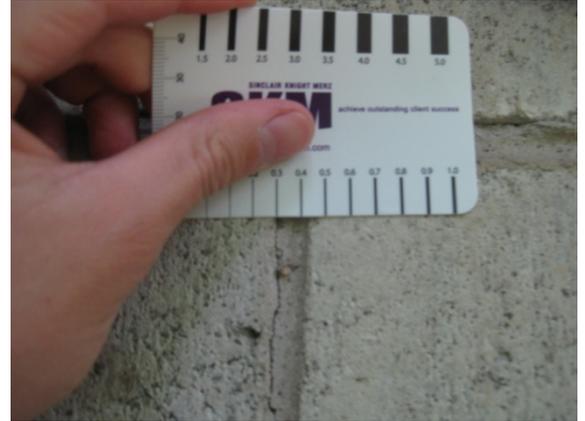
Photo 10: Close up view from photo 9 showing 0.3mm crack

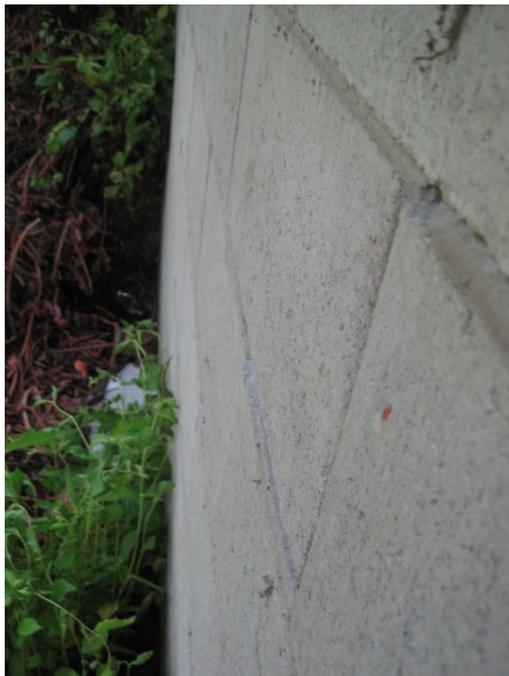
Photo 11: View of west wall showing displaced blocks

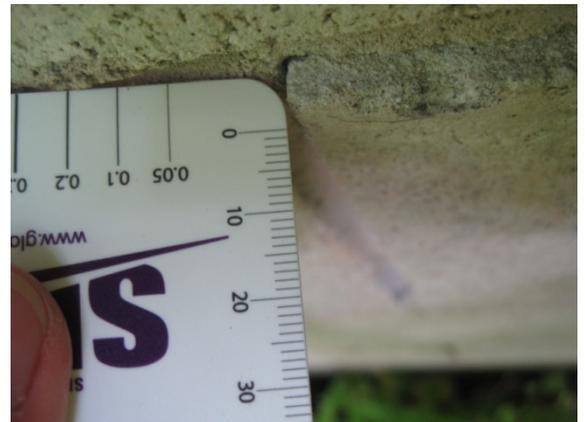
Photo 12: Close up view from photo 11 showing 3mm displacement

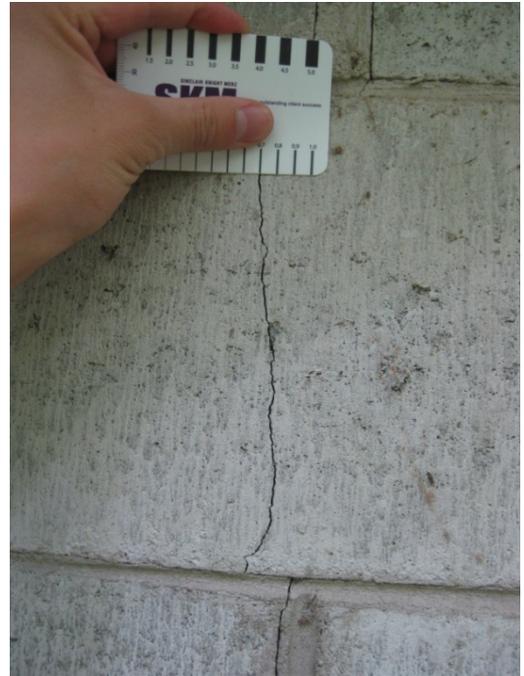
Photo 14: Close up of north wall showing 0.7mm vertical crack

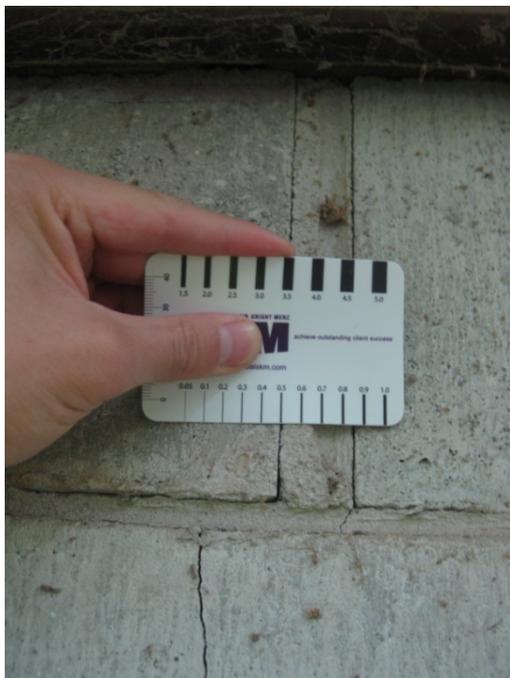
Photo 15: 0.5mm vertical crack at masonry block joint

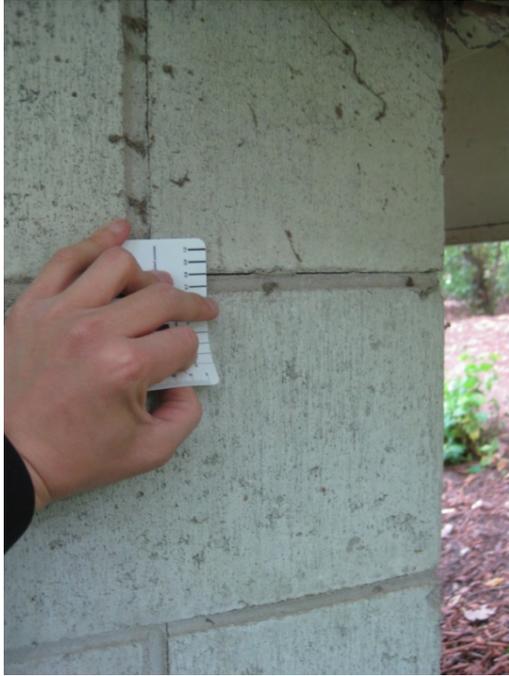
- 0.8mm and 0.6mm cracks around northwest corner of building (photo 17 & 18)
- 0.4mm crack around northeast corner of building (photo 19 & 20) can also be seen inside the building (photo 29 & 30)

Photo 17: Close up view from photo 16 showing 0.8mm crack at top block course

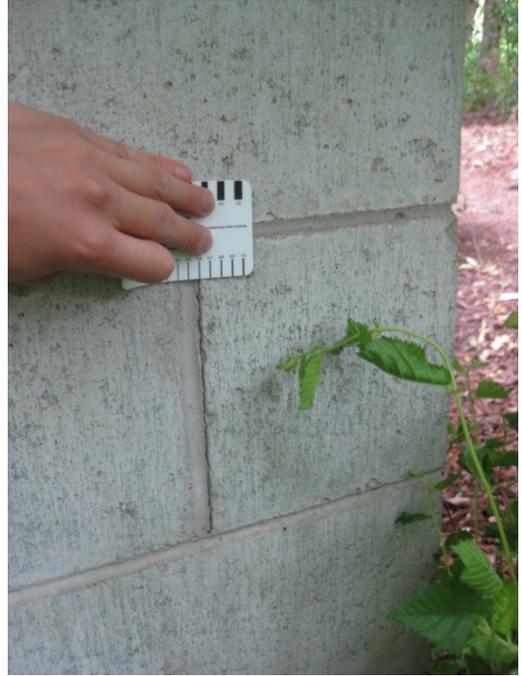
Photo 18: Close up view from photo 16 showing 0.6mm crack.

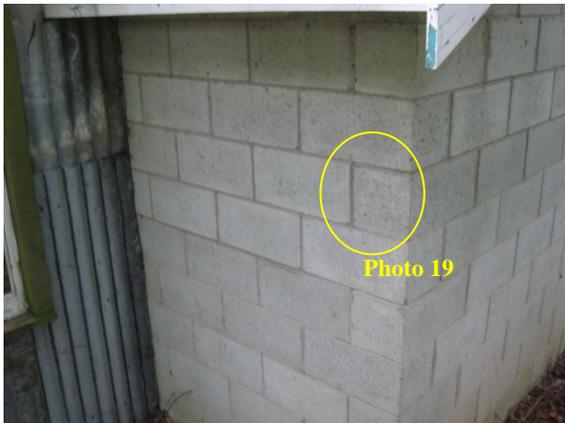
Photo 19: Northeast corner of masonry structure

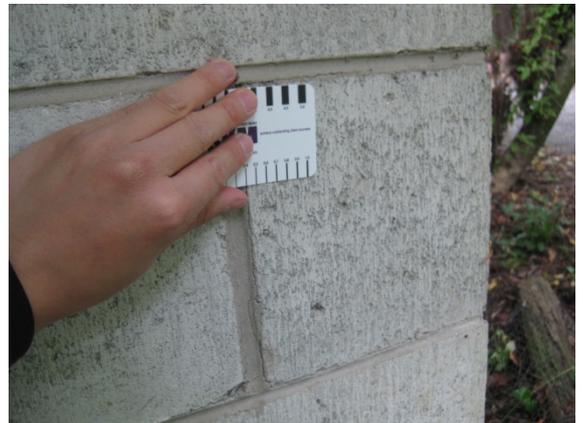
Photo 20: Close up view of photo 19 showing 0.4mm crack

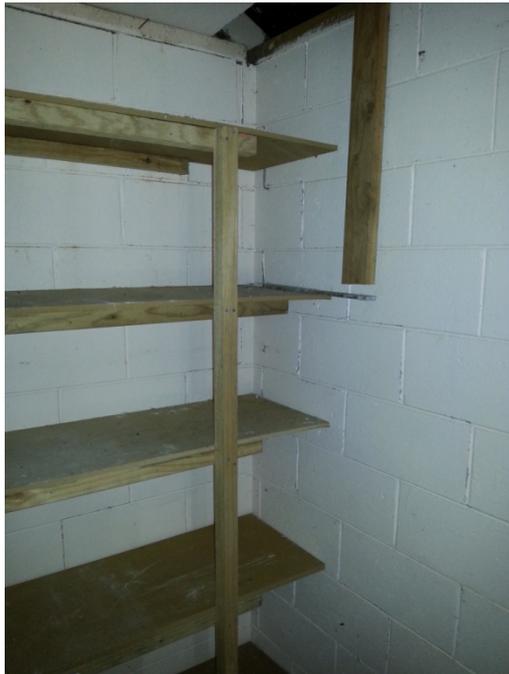
Photo 29: Northeast corner, with step cracks

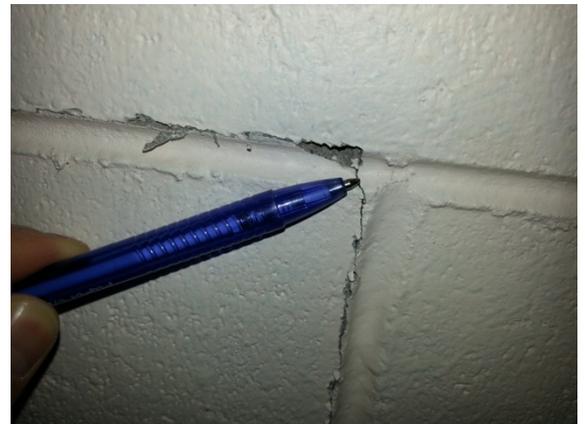
Photo 30: close up view from photo 29 showing 0.4mm step cracks
