CHRISTCHURCH CITY COUNCIL
PRK_0348_BLDG_006 EQ2
The Groynes – Dwelling No.2
182 Johns Road

QUANTITATIVE ASSESSMENT REPORT

- Rev B
- 26 February 2014

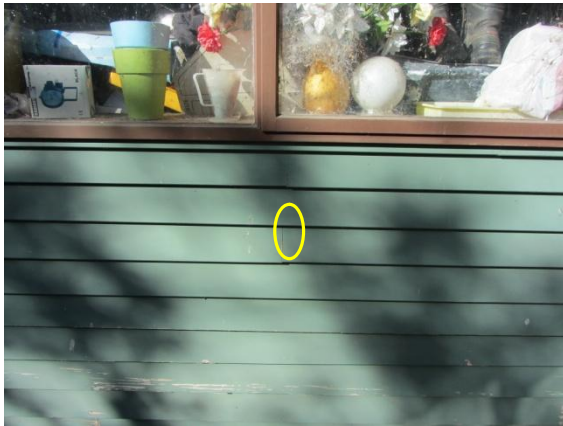
- 1) No visual evidence of settlement was noted at this site. Therefore a level survey is not required at this stage of assessment.
- 2) Vertical joints in the weatherboard cladding have opened up (PHOTO 3 & 4).
- 3) Wall joint between the garage and the house in the north-west corner has opened up (PHOTO 5 & 7).
- 4) Hairline cracking along the wall joint in the corners along the north elevation (PHOTO 6 & 8).

Photo 3: Cracking along Weatherboard Joints

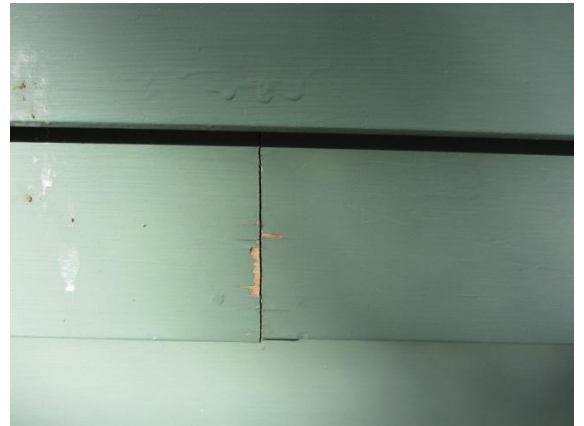
Photo 4: Close Up of Photo 3

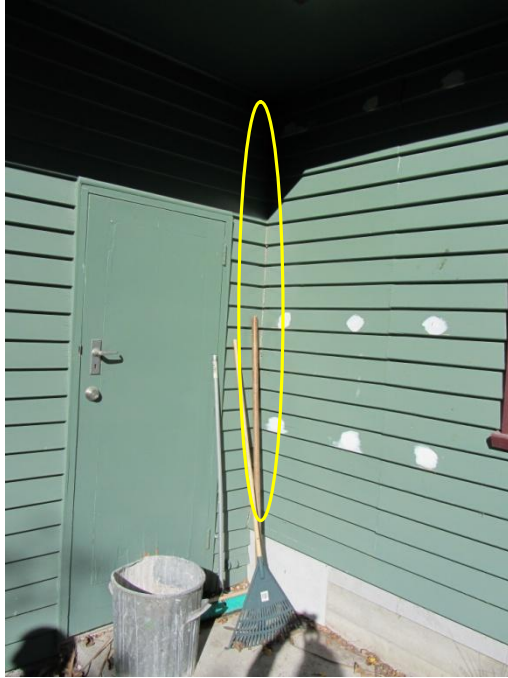
Photo 5: Hairline Cracking along Cladding Joints

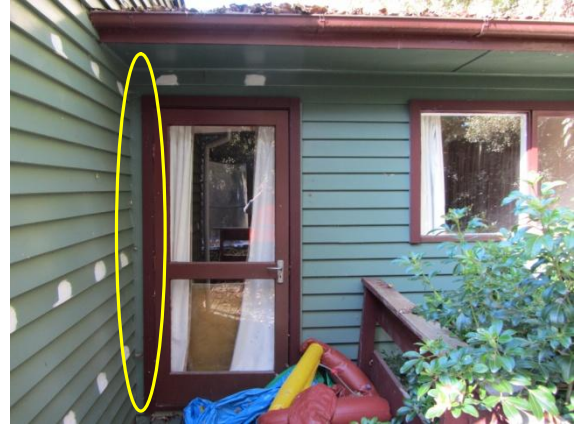
Photo 6: Hairline Cracking along Cladding Joints

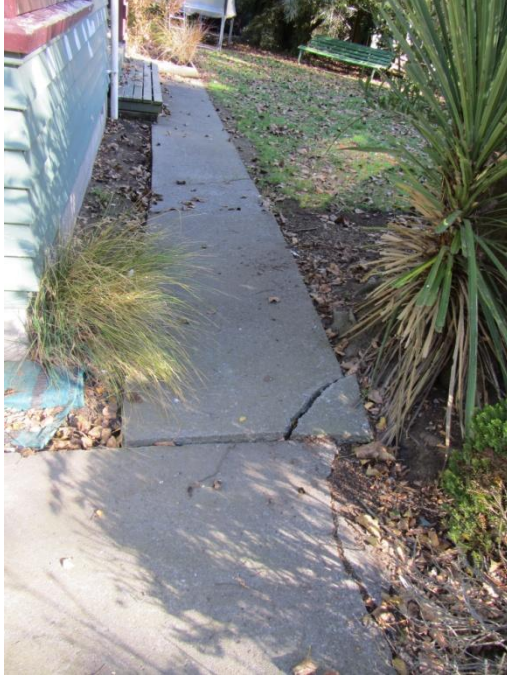
- 5) Cracking and damage to concrete path near the north-east corner of the main house. This damage appears to be a result of the tree roots growing under the path and as a result has not been considered as earthquake damage (PHOTO 9 & 10).
- 6) Northern timber deck has pulled away from the main house structure (PHOTO 11 & 12).
- 7) Southern timber deck appears to have fallen off the centre row of piles. This has resulted in the deck caving in at the middle and becoming very springy (PHOTO 13 & 14).

Photo 9: Damage to Pathway on North Side of Dwelling

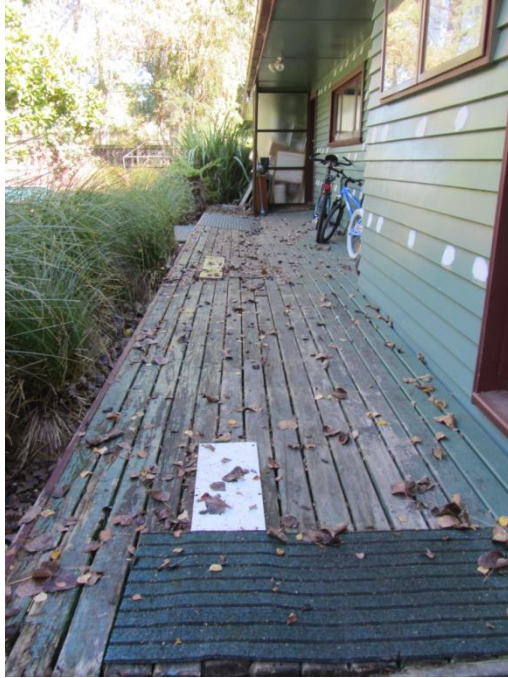
Photo 13: Damage to Southern Deck

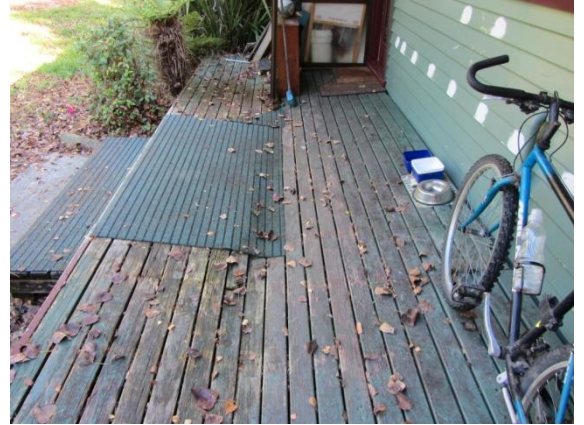
Photo 14: Close Up of Photo 13

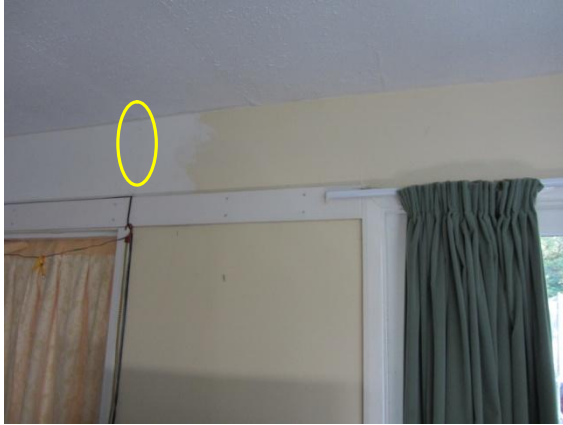
- 1) Hairline cracking present along wall lining joints, located above the west wall opening, the west wall French doors and the east wall window (PHOTO 17, 18, 19, 20 & 21).
- 2) Hairline crack present along the ceiling lining joint above the west wall window (PHOTO 22).

Photo 17: Hairline Cracking to Wall Lining Joints above the French Door and Opening on the West Wall

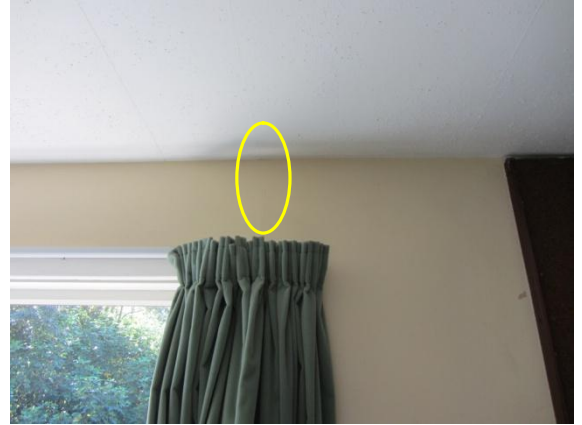
Photo 20: Hairline Cracking above East Wall Window

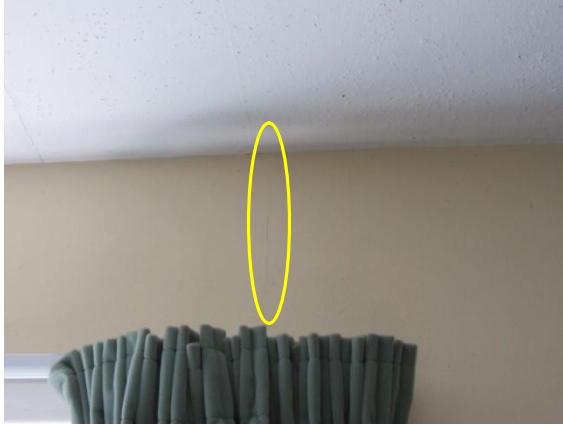
Photo 21: Close Up of Photo 20

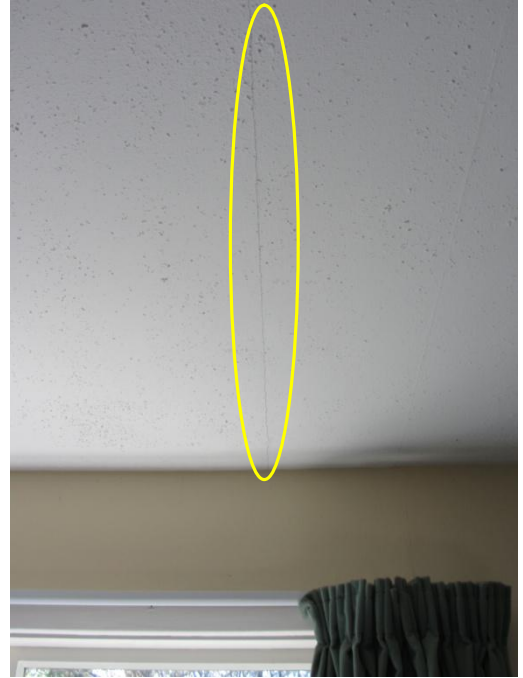
Photo 22: Hairline Cracking along Ceiling Lining Joint above East Window

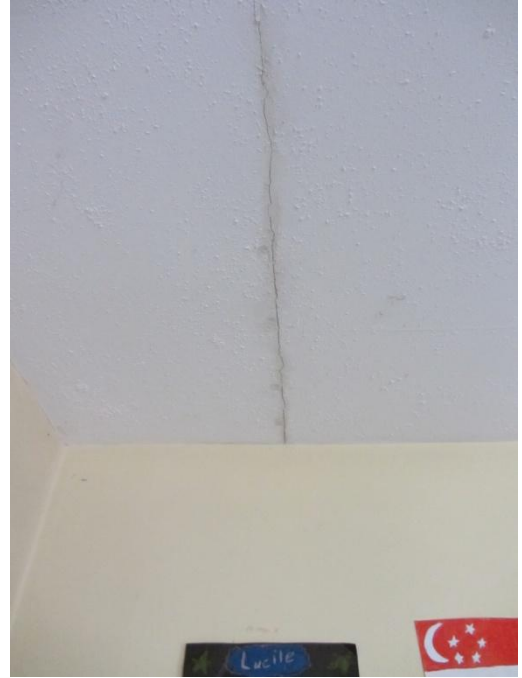
- 1) Hairline cracking present along the ceiling lining joint near the south-east corner (PHOTO 24).
- 2) Hairline cracking along the wall and ceiling lining joint, present on the east and west walls (PHOTO 25, 26 & 27).
- 3) Cracking present along the wall lining joint in the north-east corner (PHOTO 27).
- 4) Hairline cracking present along the wall lining joint above the French doors (PHOTO 28).
- 5) Hairline cracking along wall lining joint on east wall near south corner (PHOTO 29 & 30).

Photo 24: Hairline Cracking along Ceiling Lining

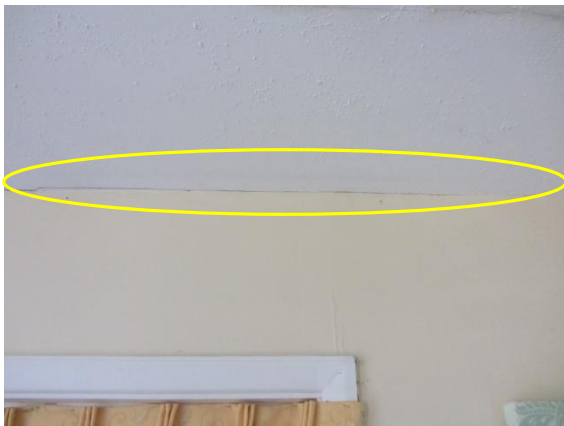
Photo 25: Hairline Cracking along Wall and Ceiling Lining Joint

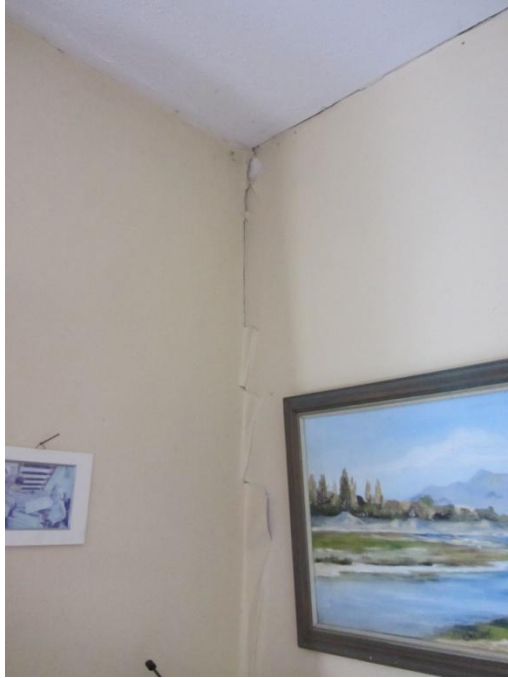
Photo 27: Cracking along Wall Lining in North-East Corner

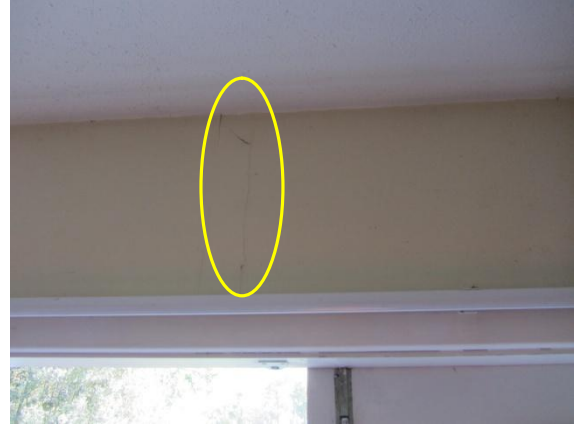
Photo 28: Hairline Cracking along Wall Lining Joint above French Doors

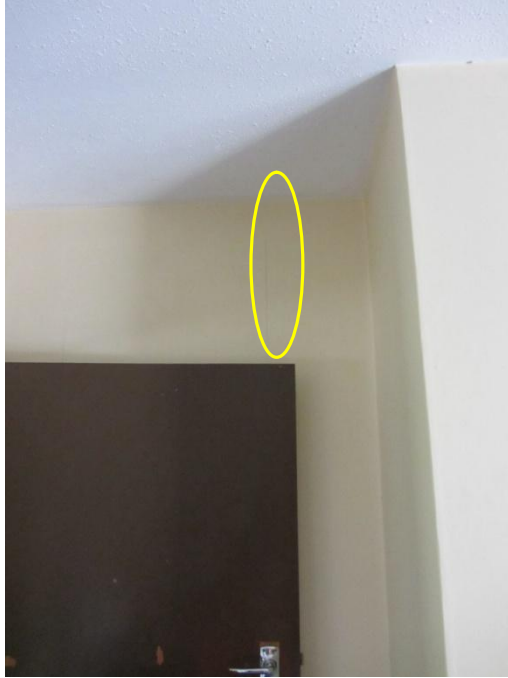
Photo 29: Hairline Cracking along Wall Lining Joint on East Wall near South Corner

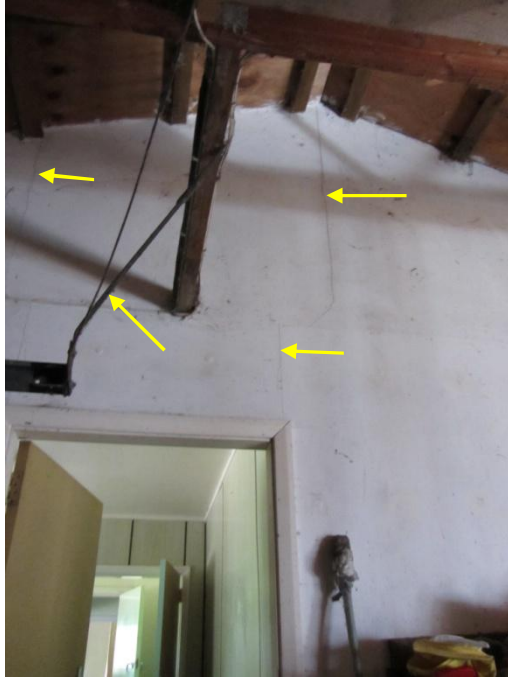
- 1) Hairline cracking present along the wall lining joint above the door on the west wall (PHOTO 31 & 32).

Photo 31: Cracking along Wall Lining Joints in Garage on East Wall

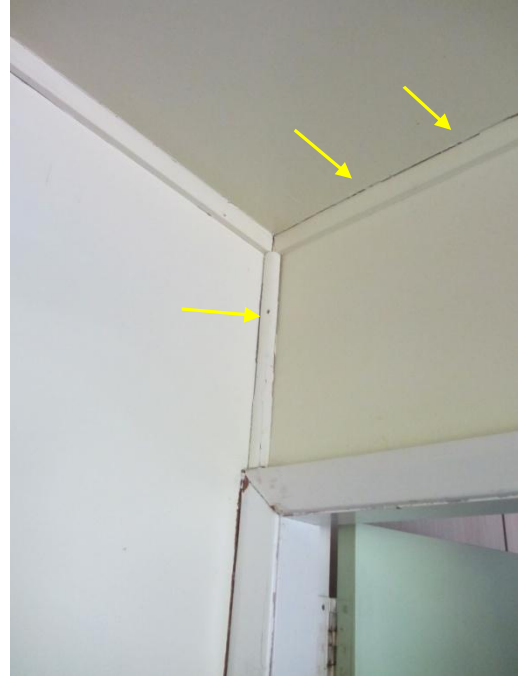
- 1) Hairline cracking present along wall lining joint above the window.
- 2) Hairline cracking present along the ceiling lining and scotia joint (PHOTO 34 & 35).
- 3) Hairline cracking along the wall lining and the timber trim present in the north-east and south-east corners (PHOTO 34).

Photo 34: Cracking along lining and scotia joints and lining and timber trim joints

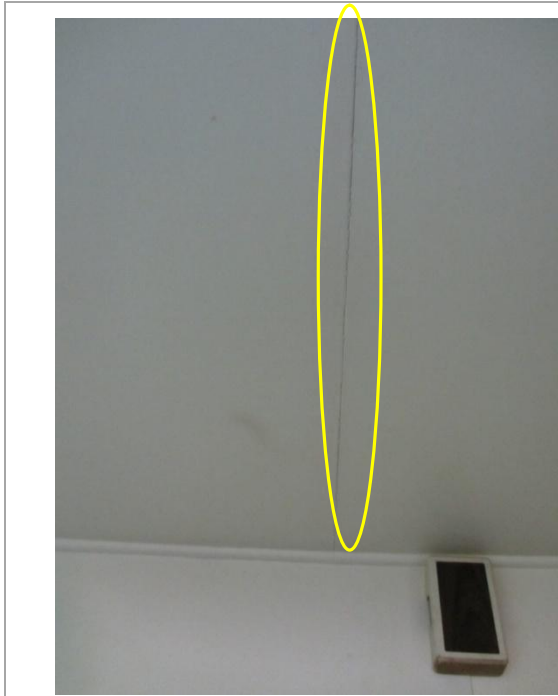
- 1) Hairline cracking present along the ceiling lining joints (PHOTO 37).
- 2) Hairline cracking present along the wall lining joints on the south wall, east corner (PHOTO 38).

Photo 37: Hairline Cracking along Ceiling Lining Joint

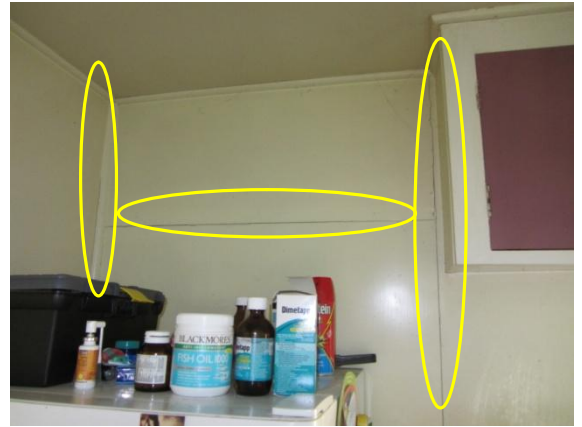
Photo 38: Hairline Cracking to Wall Lining Joints on the South Wall, East Corner

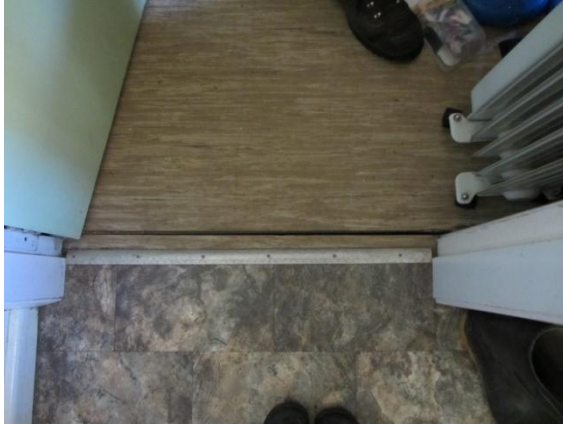
Photo 39: Separation between the Kitchen and Laundry Floor

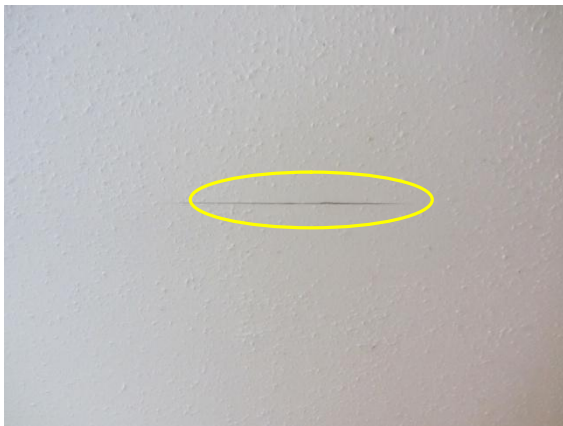
- 1) Hairline cracking present to ceiling lining (PHOTO 41 & 42).
- 2) Hairline cracking present along wall lining joints above the lounge, bedrooms, toilet, bathroom and front doors (PHOTO 43).
- 3) Hairline cracking present along the ceiling and wall lining joint on the west wall.

Photo 41: Cracking to Ceiling Lining

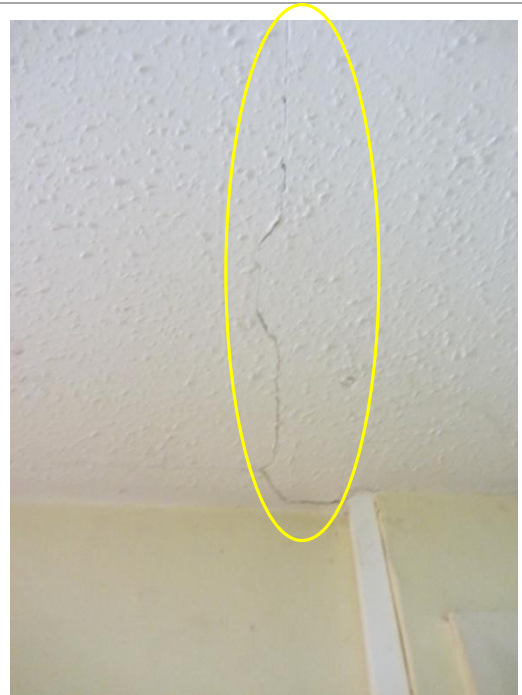
Photo 42: Cracking to Ceiling Lining

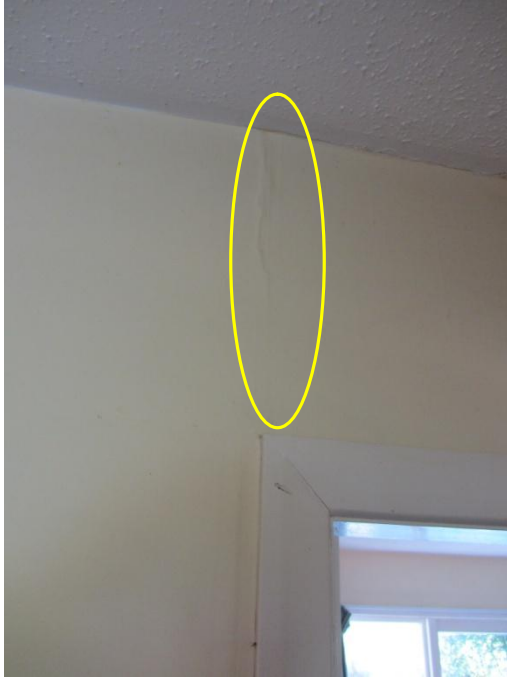
Photo 43: Hairline Cracking to Wall Lining Joint above Doorway (Typical)

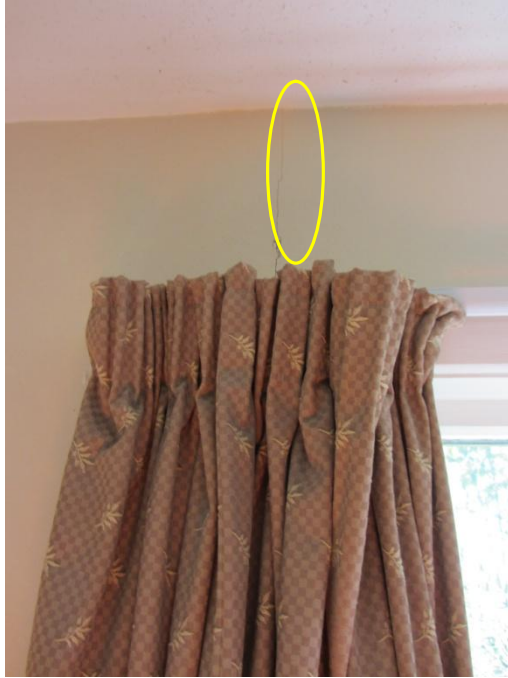
- 1) Hairline cracking present along wall lining joint above the window (PHOTO 45).
- 2) Hairline cracking present along ceiling lining joints (PHOTO 46).
- 3) Hairline cracking present along the wall and ceiling lining joint (PHOTO 47).

Photo 45: Hairline Cracking along Wall Lining Joint above Window

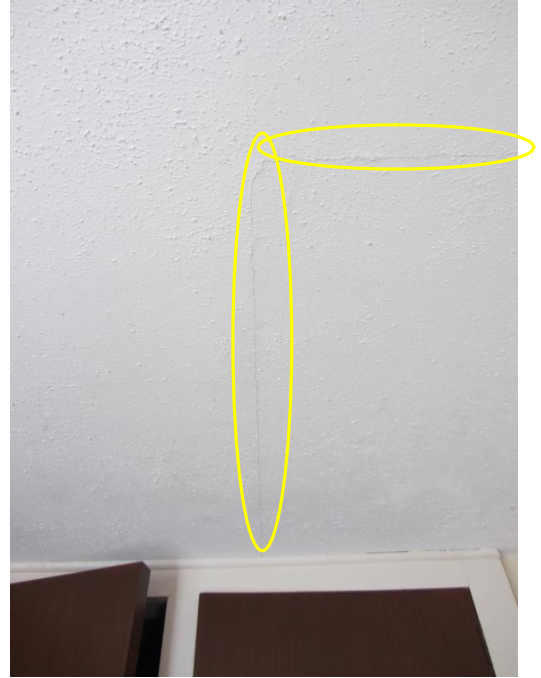
Photo 46: Hairline Cracking along Ceiling Lining Joints

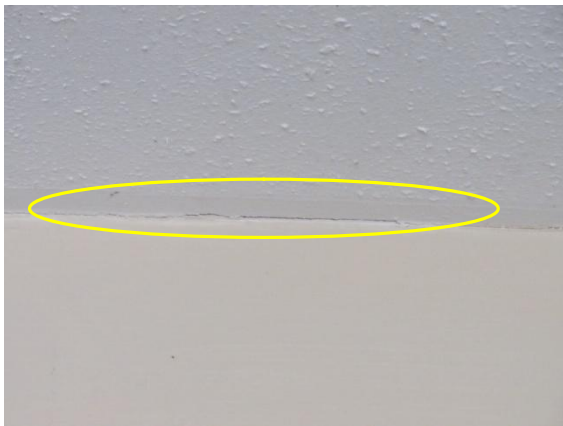
Photo 47: Hairline Cracking along Wall and Ceiling Lining Joint

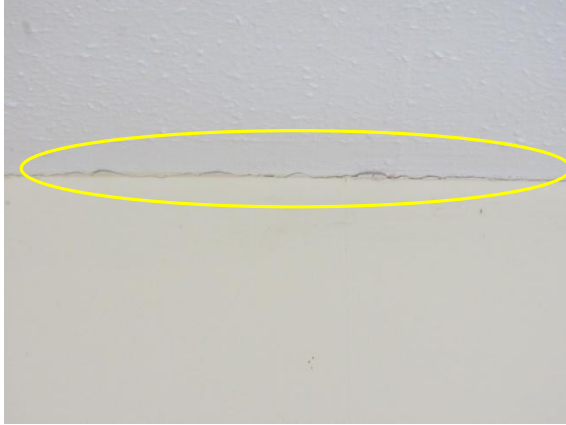
- 1) Hairline cracking present along the wall and ceiling lining joint (PHOTO 49).
- 2) Hairline cracking present along the wall lining joint above the window (PHOTO 50).

Photo 49: Hairline Cracking along Wall and Ceiling Lining Joint

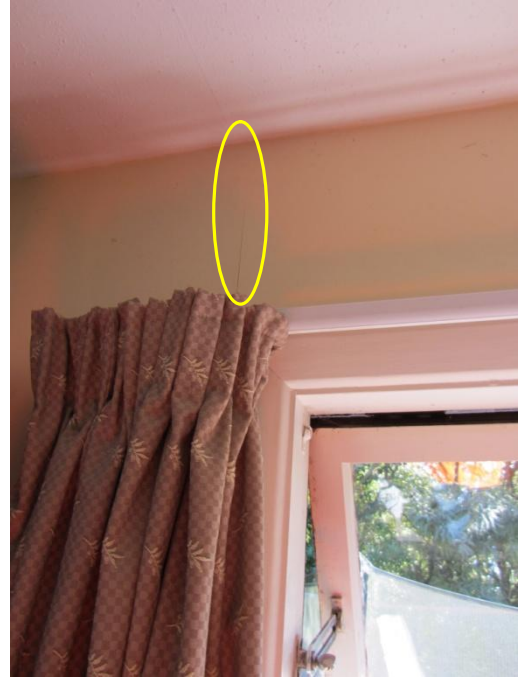
Photo 50: Hairline Cracking along Wall Lining Lining Joint above Window

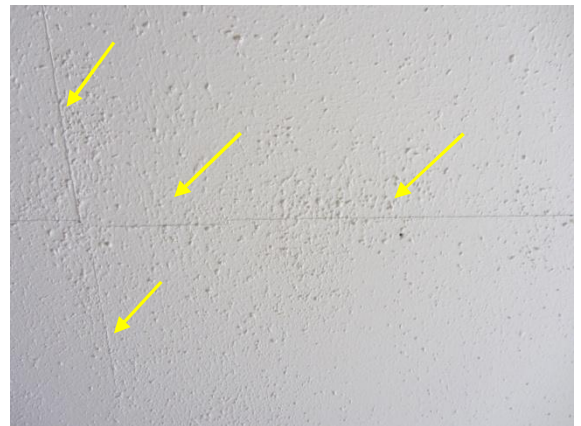
- 1) Hairline cracking present along the ceiling lining joints (PHOTO 52).
- 2) Hairline cracking present along the wall lining joints above all windows (PHOTO 54).
- 3) Cracking present along the wall lining joint in the south-west corner (PHOTO 53 & 55).
- 4) Cracking present along the wall lining joint under the north-west window (PHOTO 56 & 57).
- 5) Cracking present along the wardrobe architrave and wall lining joint (PHOTO 58 & 59).
- 6) Hairline cracking present along the wall lining joint under south wall windows (PHOTO 60 & 61).

Photo 52: Hairline Cracking along Ceiling Lining Joints

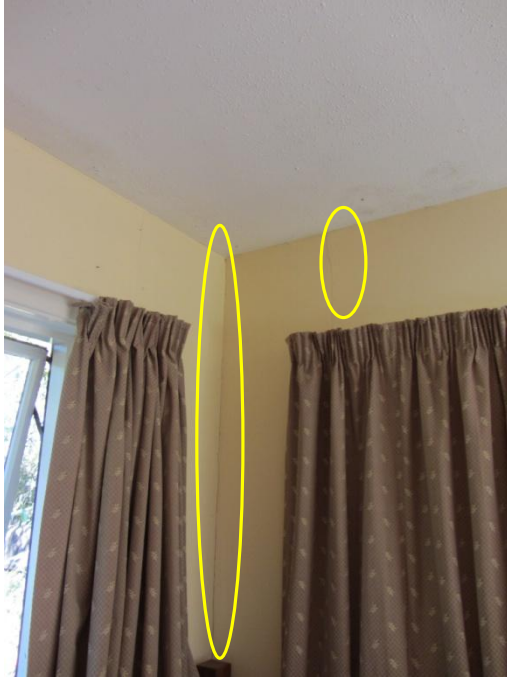
Photo 53: Cracking along Wall Lining Joint in South-West Corner and above Window

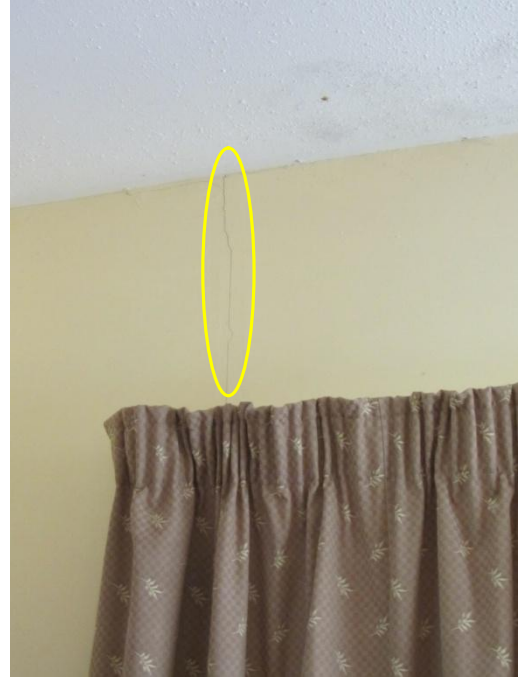
Photo 54: Hairline Cracking along Wall Lining Joint above Window (Typical)

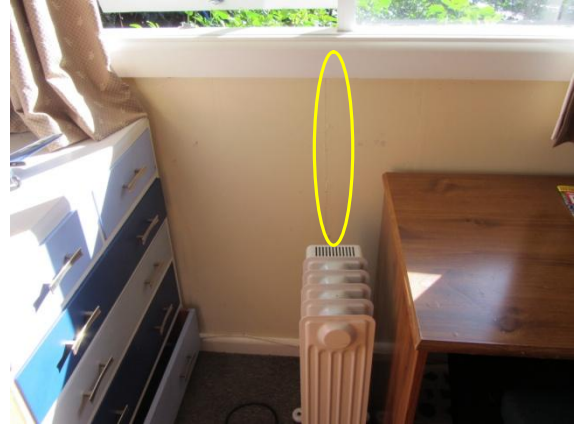
Photo 56: Hairline Cracking along Wall Lining Joint under North-West Window

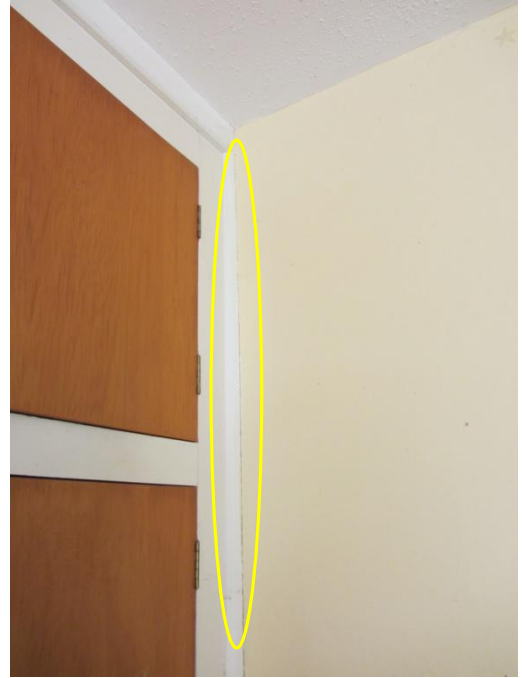
Photo 58: Cracking along Wardrobe Architrave and Wall Lining Joint

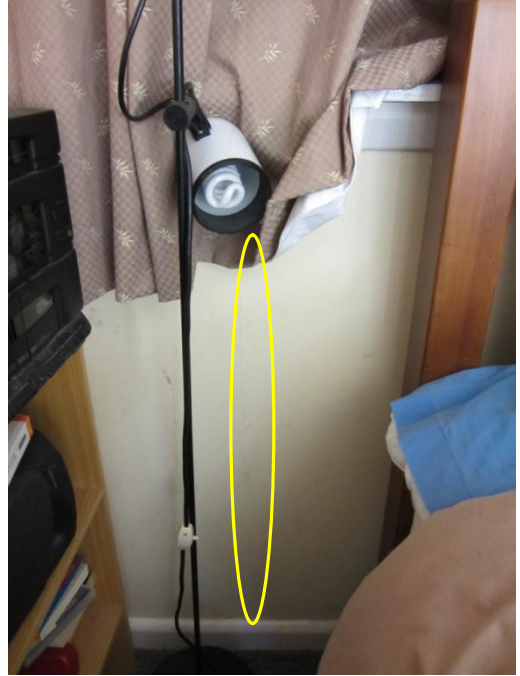
Photo 60: Hairline Cracking along Wall Lining Joint under South Wall Window

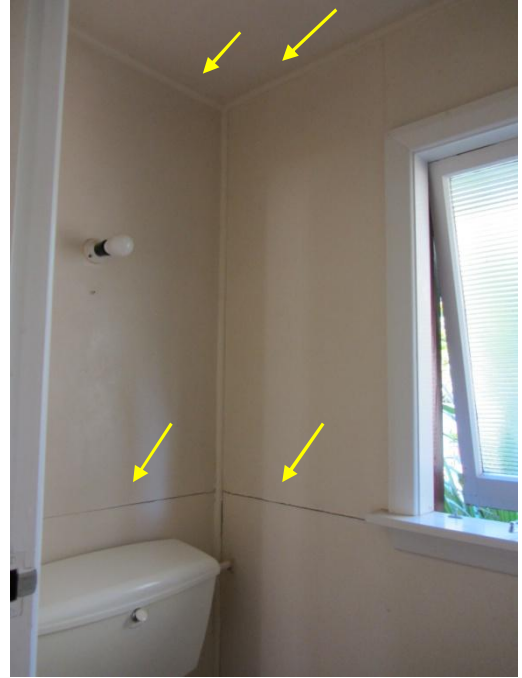
- 1) Cracking present along wall lining joints (PHOTO 62 & 63).
- 2) Hairline cracking present along the ceiling lining and scotia joint (PHOTO 62 & 64).
- 3) Hairline cracking present along wall lining and timber trim joint in the corners (PHOTO 64).
- 4) Cracking present along the skirting board and wall lining joint (PHOTO 65 & 66).

Photo 62: Cracking along Wall Lining Joints in Toilet

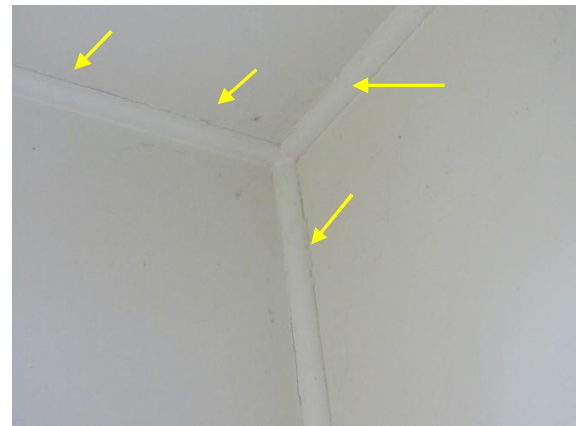
Photo 64: Hairline Cracking along Ceiling Lining and Scotia Joint and along Wall Lining and Timber Trim Joint

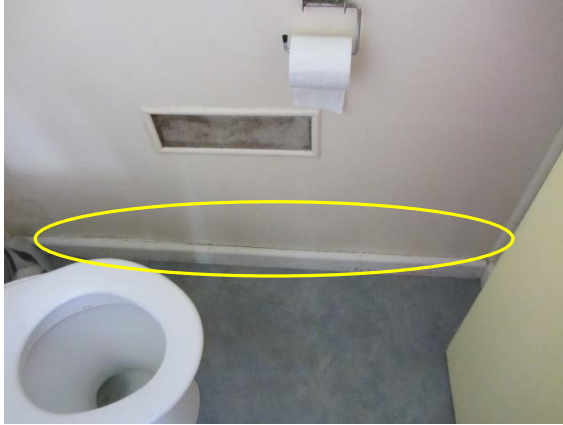
Photo 65: Cracking along Wall Lining and Scotia Joint

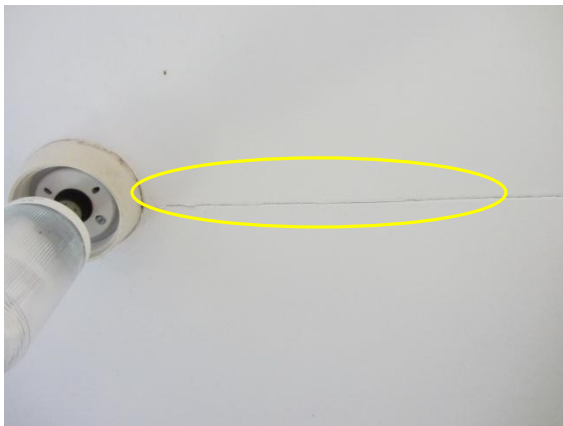
- 1) Hairline cracking present along ceiling lining joints (PHOTO 67 & 68).

Photo 67: Hairline Cracking along Ceiling Lining Joints in Bathroom

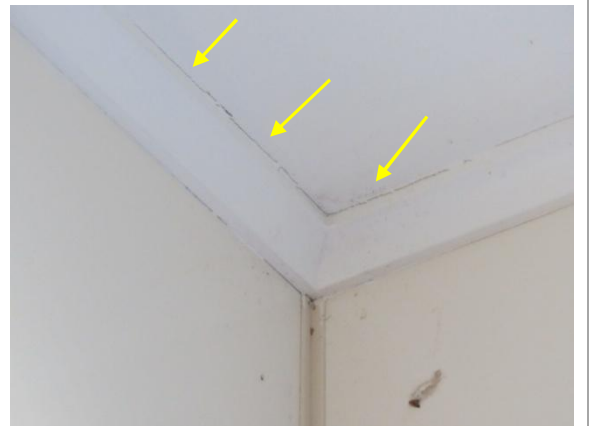
Photo 68: Hairline Cracking along Ceiling Lining and Scotia Joint
