Christchurch City Council

PRK_0348_BLDG_020

Toilets No 1 Ground East

QUALITATIVE ASSESSMENT REPORT FINAL

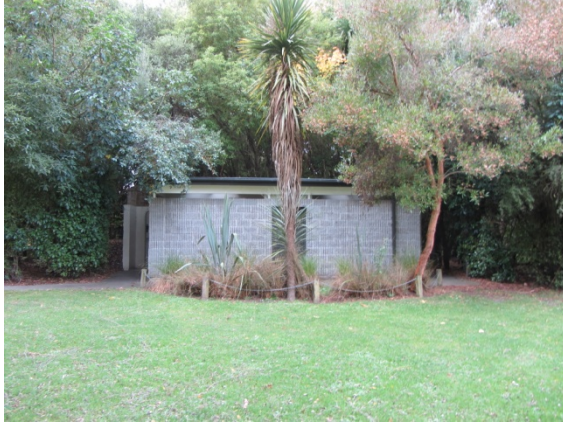
Photo 1: North Elevation. Men's toilet on the left and Women's toilet on the right.

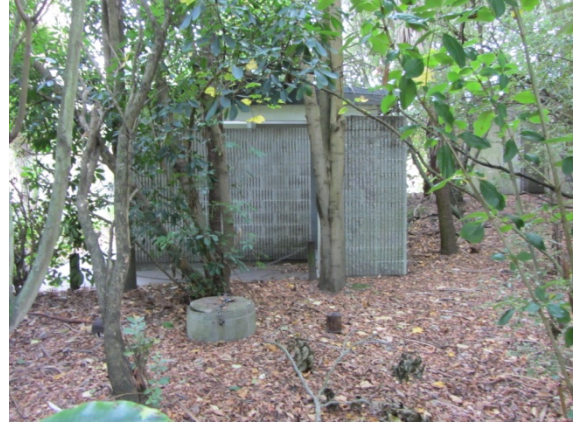
Photo 2: West Elevation. Women's toilet entrance

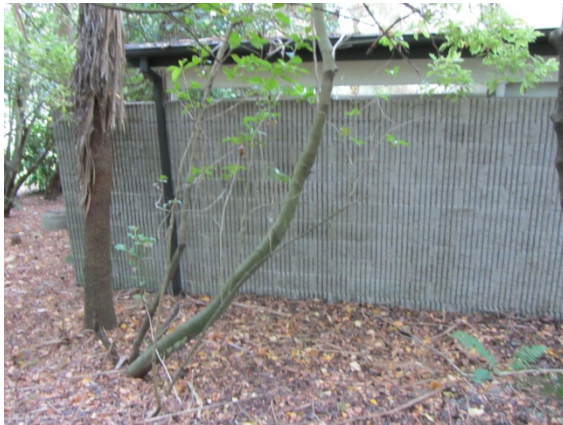
Photo 3: South Elevation

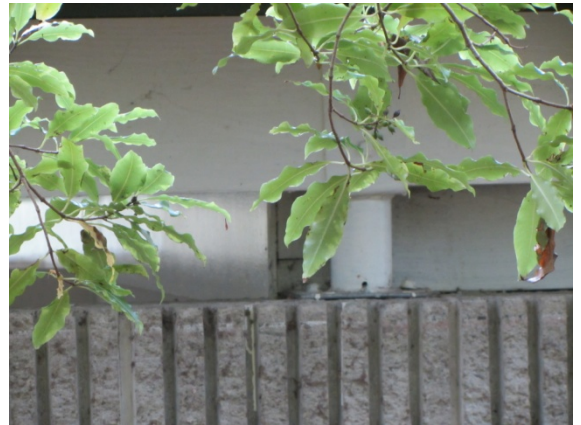
Photo 4: 100mm proud steel tube connecting the timber frame roof to the masonry walls

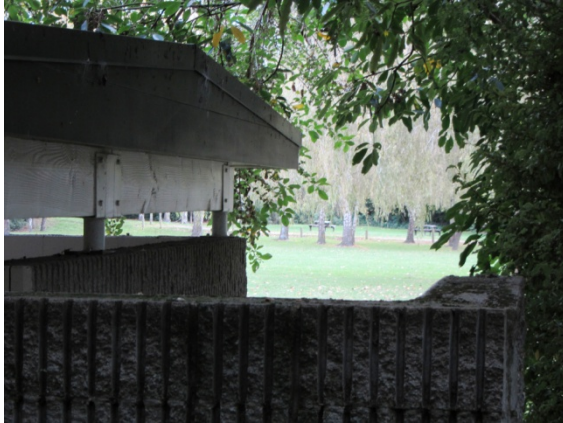
Photo 5: View from the men's toilet entrance

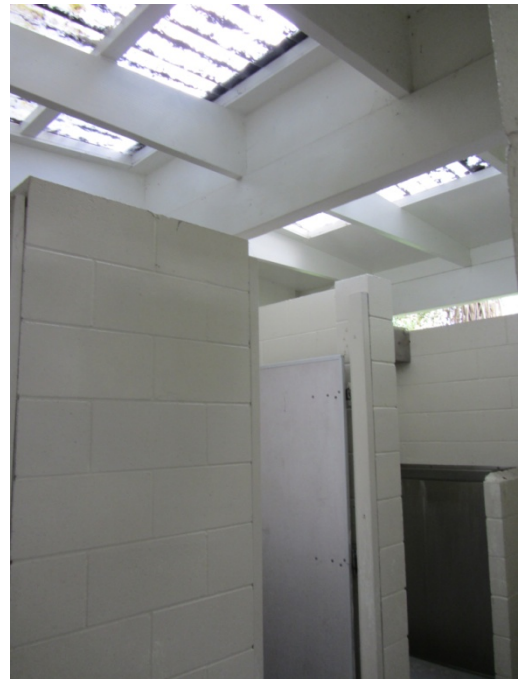
Photo 6: View of timber roof inside the men's toilet

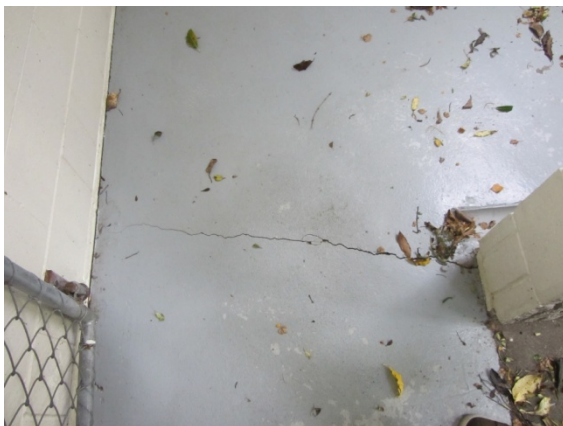
- 1) 1.5mm cracks in the slab at the men toilets entrance
- 2) Pavement leading up to the men toilets has cracked, settled and shifted away from the structure. Settlement was found to be 30mm in some areas, and has introduced a small trip hazard
- 3) 1mm crack in the slab at the women toilet entrance

Photo 7: Entrance to the men's toilet showing 1.5mm crack

Recommendations			
	Level of repair/strengthening required	minor non-structural	Describe: Grouting of crack Describe: Describe:
	Building Consent required:	no	
	Interim occupancy recommendations	full occupancy	
Along	Assessed %NBS before:	91%	%NBS from IEP below If IEP not used, please detail assessment methodology:
	Assessed %NBS after:	91%	
Across	Assessed %NBS before:	91%	%NBS from IEP below Qualitative Assessment carried out, this includes the NZSEE IEP - refer to SKM report
	Assessed %NBS after:	91%

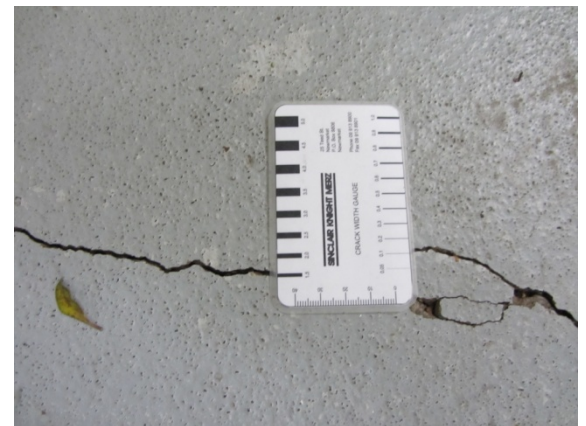
Photo 8: Close up view of 1.5mm crack from photo 7

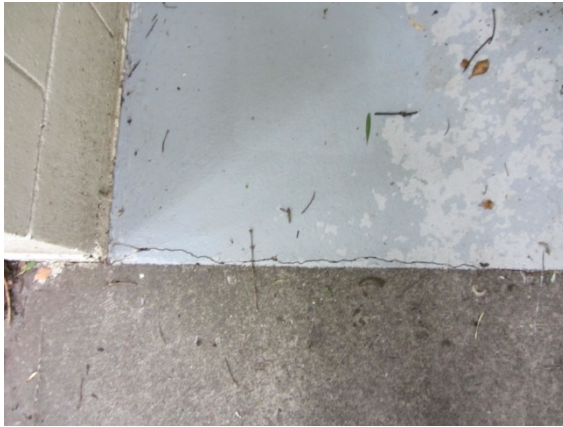
Photo 9: 1.5mm crack at the entrance to men's toilet

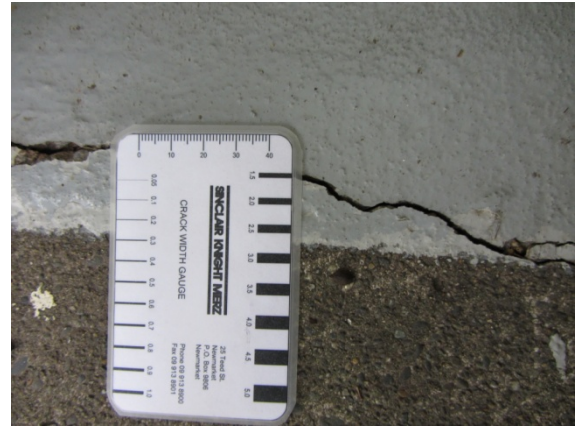
Photo 10: close up of 1.5mm crack in photo 9

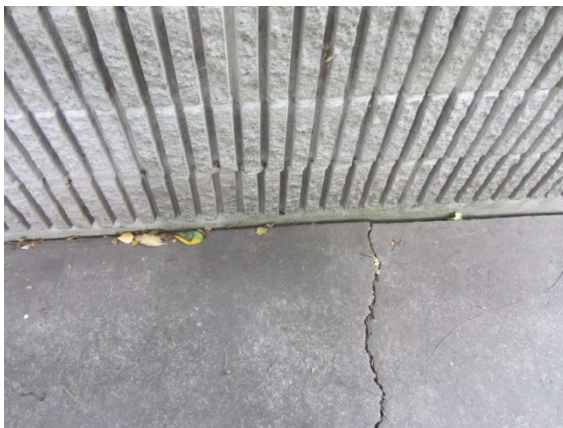
Photo 11: Pavement leading up to men's toilet showing crack.

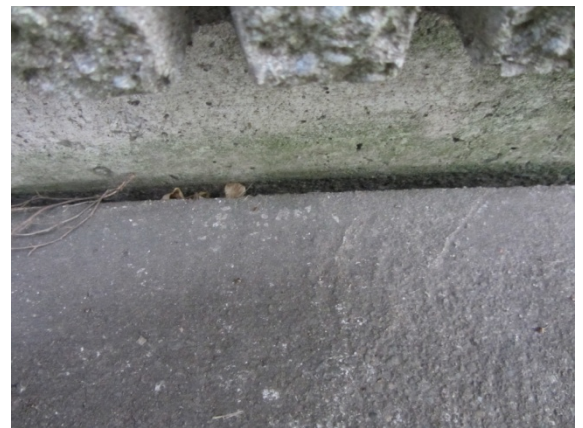
Photo 12: Close up of edge of pavement showing separation away from the structure

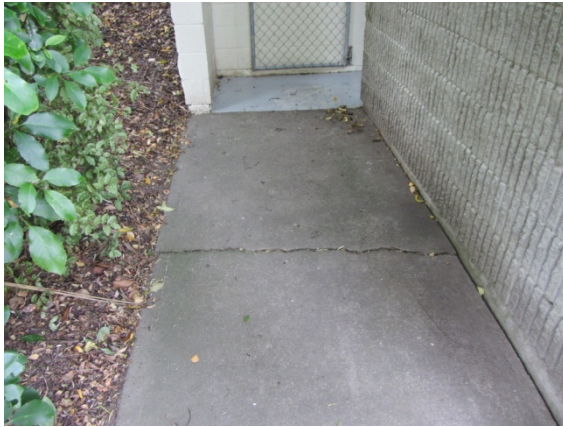
Photo 13: Same crack as found in photo 1, showing its full length

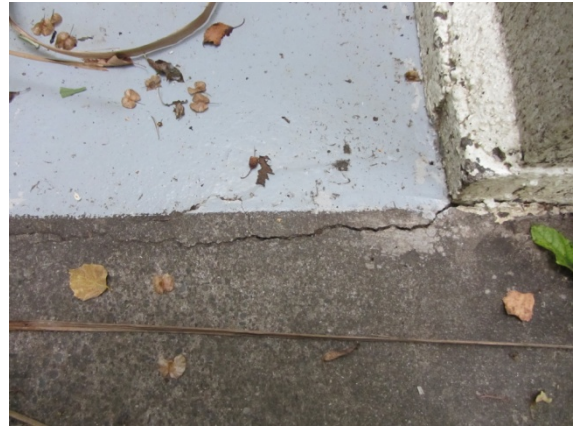
Photo 14: 1mm crack at the entrance to the womens toilet

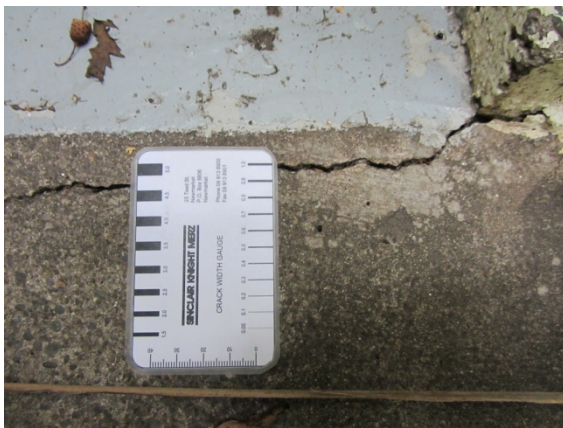
Photo 14: Close up of crack found in photo 14

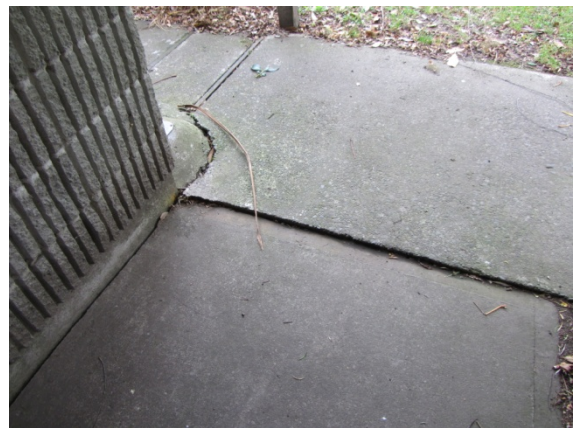
Photo 15: Mens toilet pavement showing the settlement, and the small trip hazard

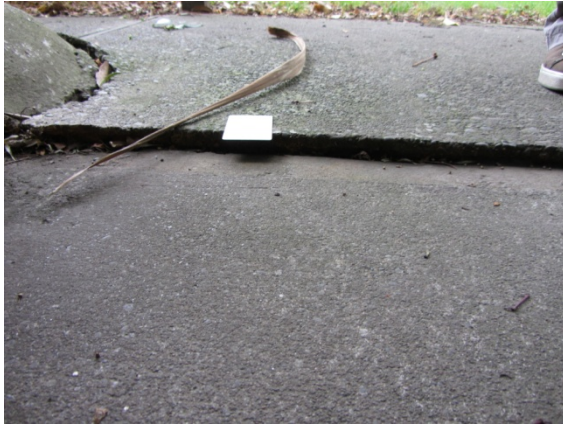
Photo 16: Close up of settled pavement from photo 16

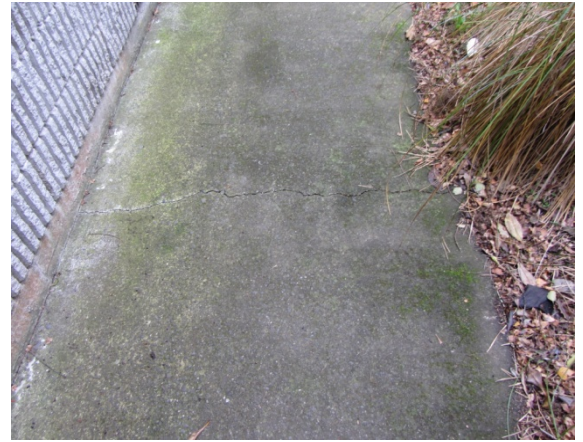
Photo 17: crack in the front of the toilet block (North Side)

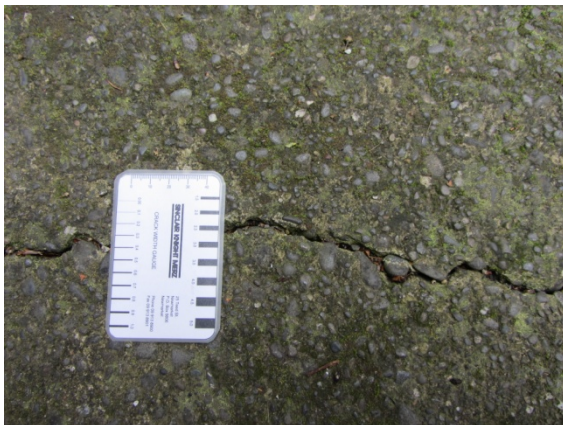
Photo 18: Close up of crack found in photo 18

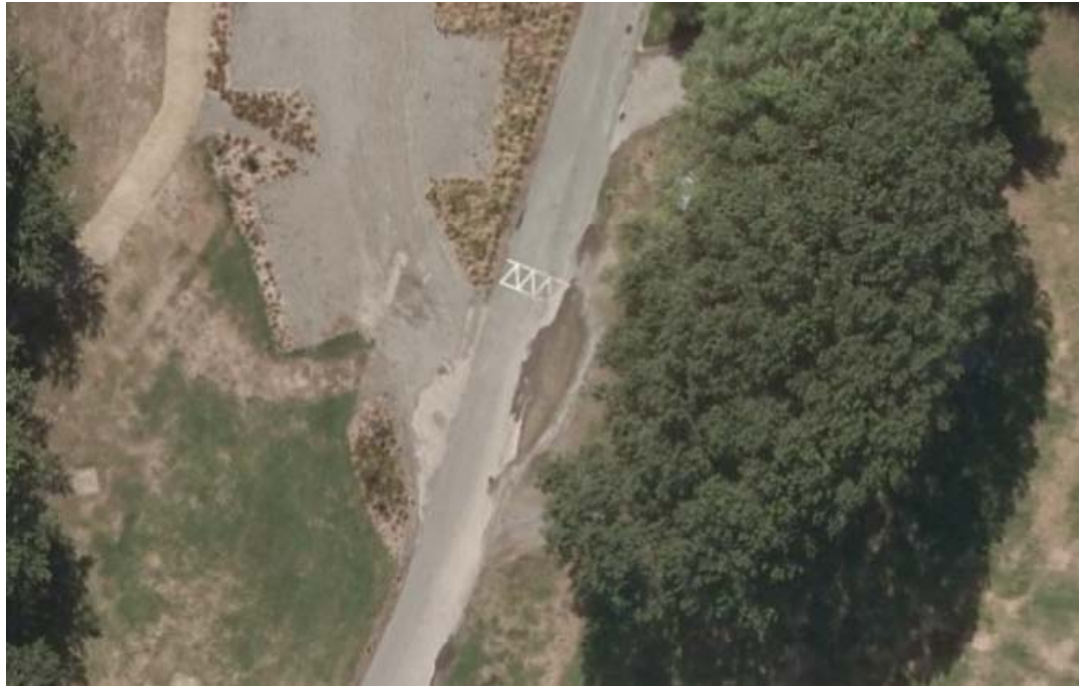
- **Figure 4 Aerial photograph showing liquefied material ejected near road way**
(<http://viewers.geospatial.govt.nz/>)

The aerial photographs appears to show some evidence of liquefaction occurring on site due to the 22 February earthquake, with localised sand boils and liquefied material ejected near the road way visible in figure 4.
