Christchurch City Council
PRK_0348_BLDG_007 EQ2
The Groynes - Office
182 Johns Road

QUALITATIVE ASSESSMENT REPORT

- Rev C
- 23 May 2013

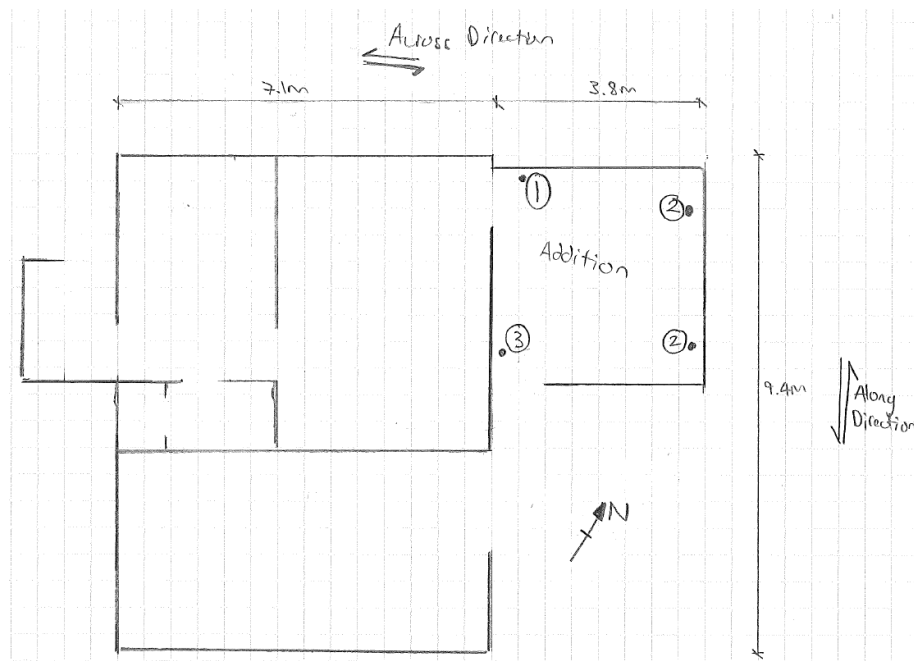
■ Figure 3: Plan view of office showing locations of damage

- 1) Vertical crack at Gib joining below window corner (PHOTO 15)
- 2) Vertical hairline cracks present above the top window corners. (PHOTO 16 and 17)
- 3) Vertical hairline crack radiating out from the bottom corner of the window. (PHOTO 19)
- 4) Hairline cracking present along ceiling lining and scotia joint around the interior perimeter of the building addition. (PHOTO 18)
- 5) Cracks in exterior cladding joints (typical) (PHOTO 8)
- 6) No visual evidence of settlement was noted at this site. Therefore a level survey is not required at this stage of assessment.

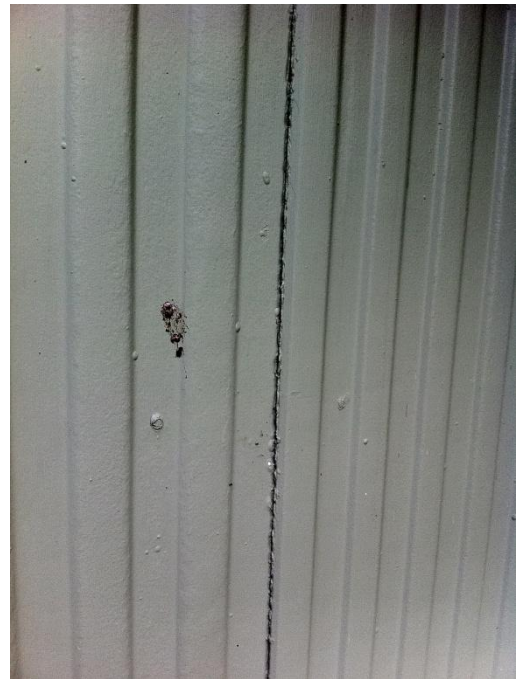
Photo 8: Crack in timber exterior cladding joint

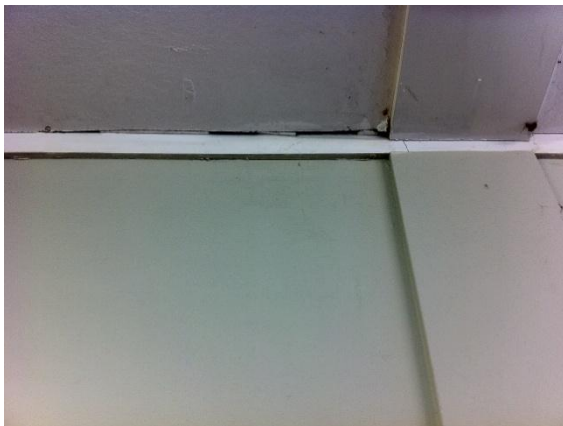
Photo 11: Crack in ceiling edge, appears to be pre earthquake

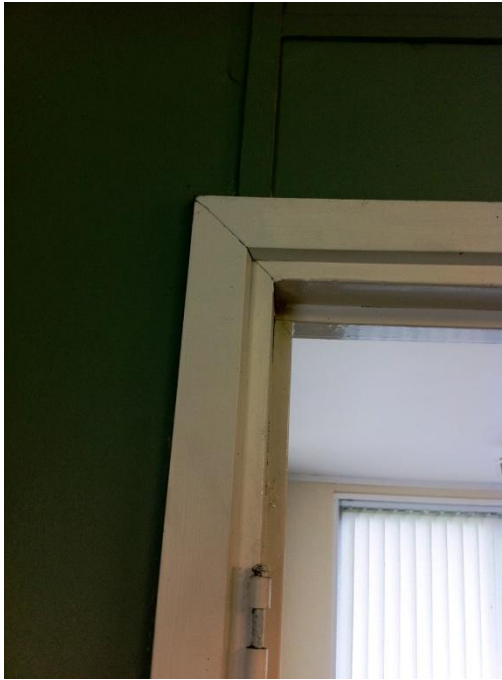
Photo 13: Typical crack at door frame corners

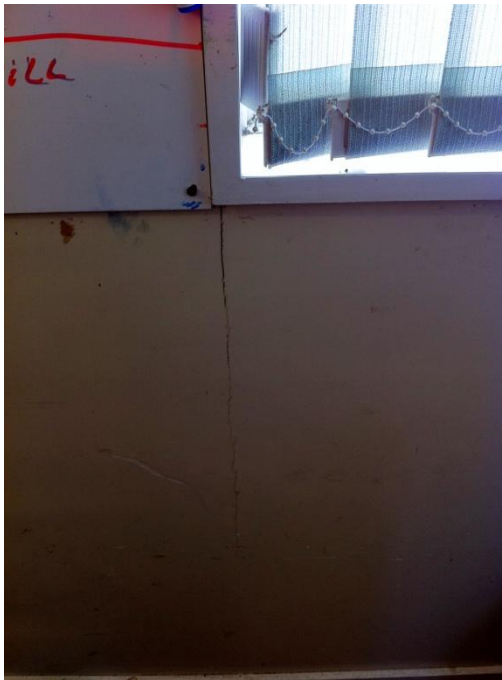
Photo 15: Vertical crack at gib joint below window corner

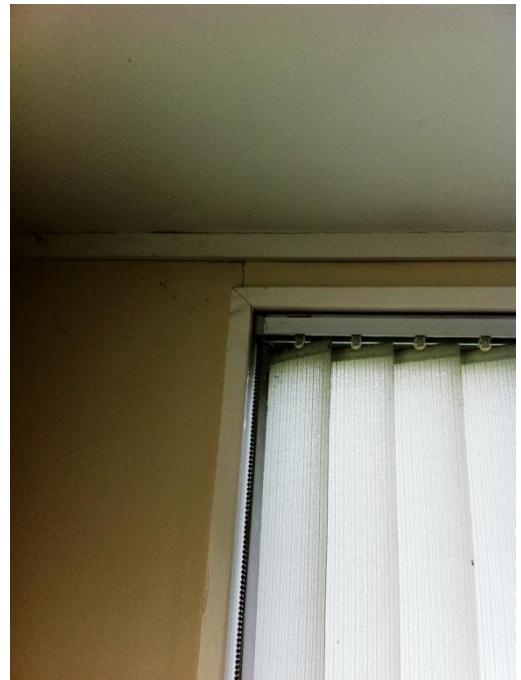
Photo 16: Small vertical cracks at upper window corners 1

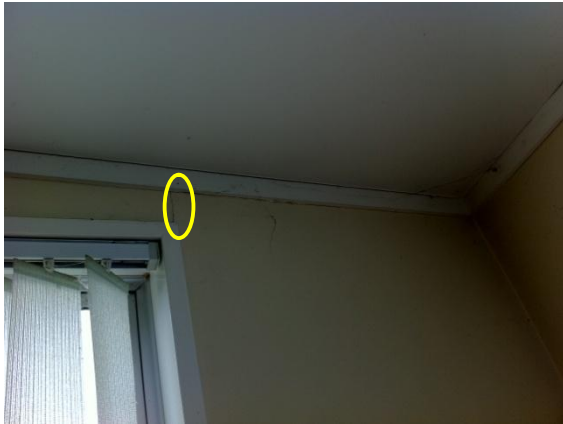
Photo 17: Small vertical cracks at upper window corners 2

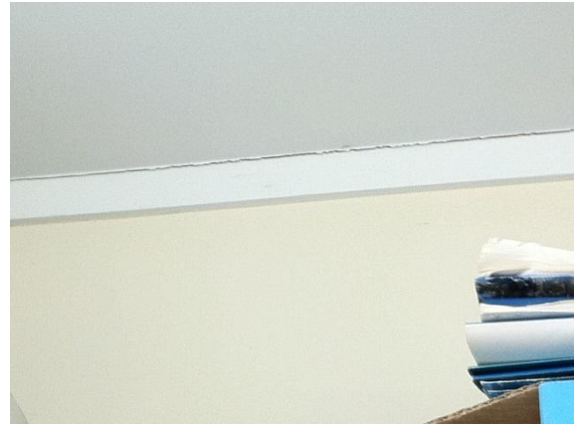
Photo 18: Cracking along ceiling lining & scotia

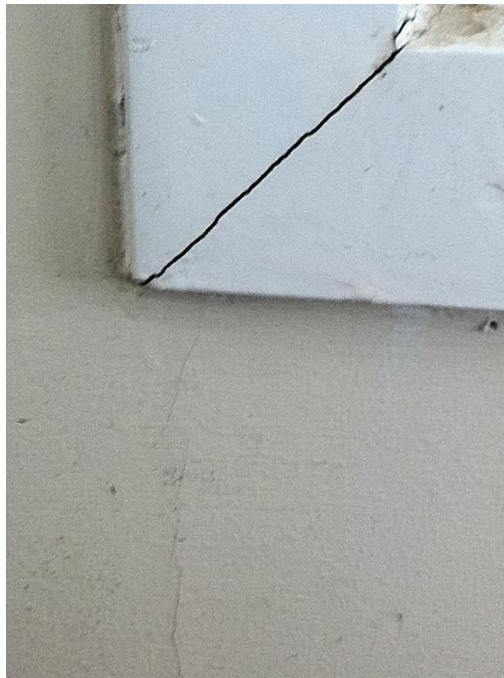
Photo 19: thin vertical crack at bottom window corner

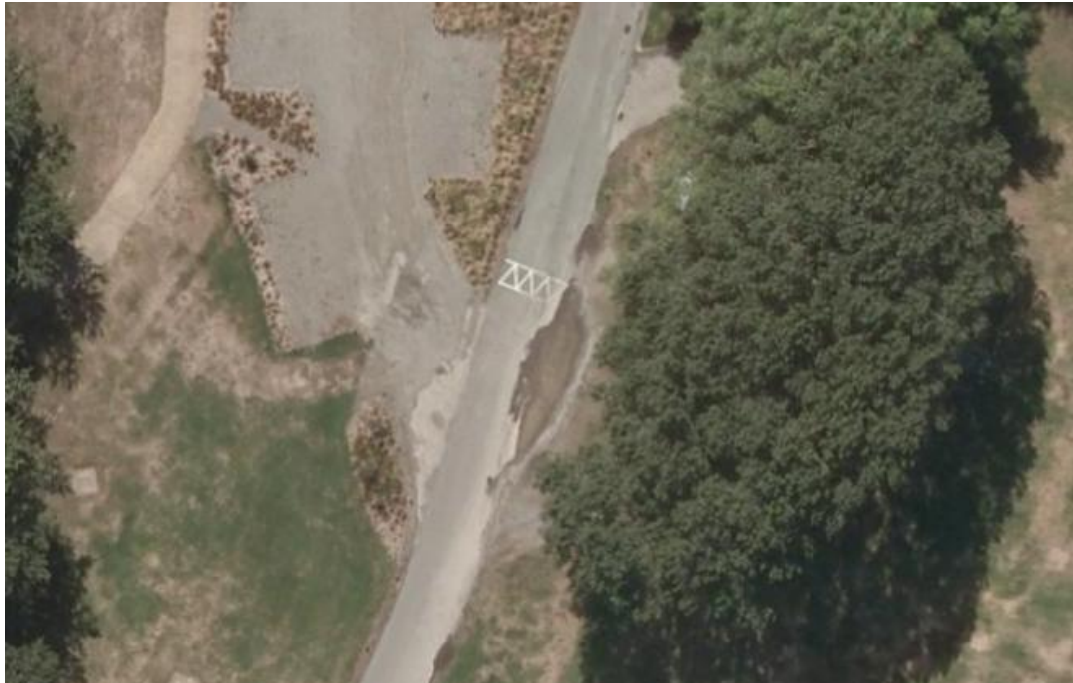
- **Figure 4 Aerial photograph showing liquefied material ejected near road way**
(<http://viewers.geospatial.govt.nz/>)

The aerial photograph appears to show some evidence of liquefaction occurring on site due to the 22 February earthquake, with localised sand boils and liquefied material ejected near the road way visible in figure 4.
