**Guise Lane
Housing Complex
PRO 1519**

**Detailed Engineering Evaluation
Quantitative Assessment Report**

6 Guise Lane, Hoon Hay,

Date: March 2014
Reference: 6-QC349.00
Status: Final

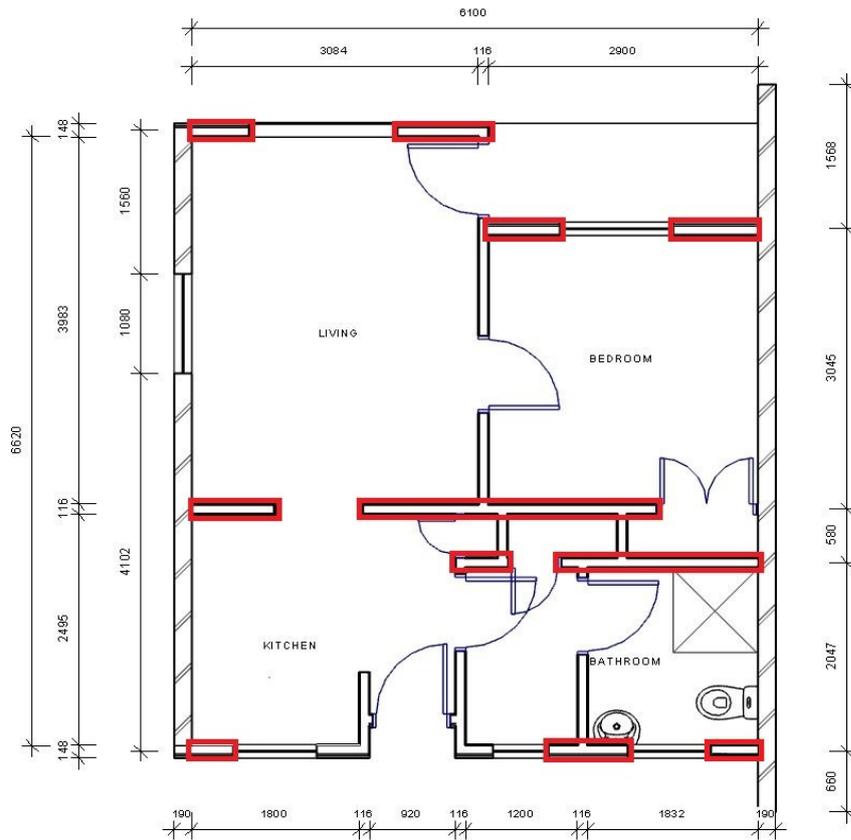
Figure 6: Walls used for bracing in the longitudinal direction.

The residential units (Blocks A – G) have capacities of 52% NBS as limited by the in-plane shear capacity of the timber-framed shear walls in the longitudinal direction. They are deemed to be a ‘moderate risk’ in a design seismic event according to NZSEE guidelines.

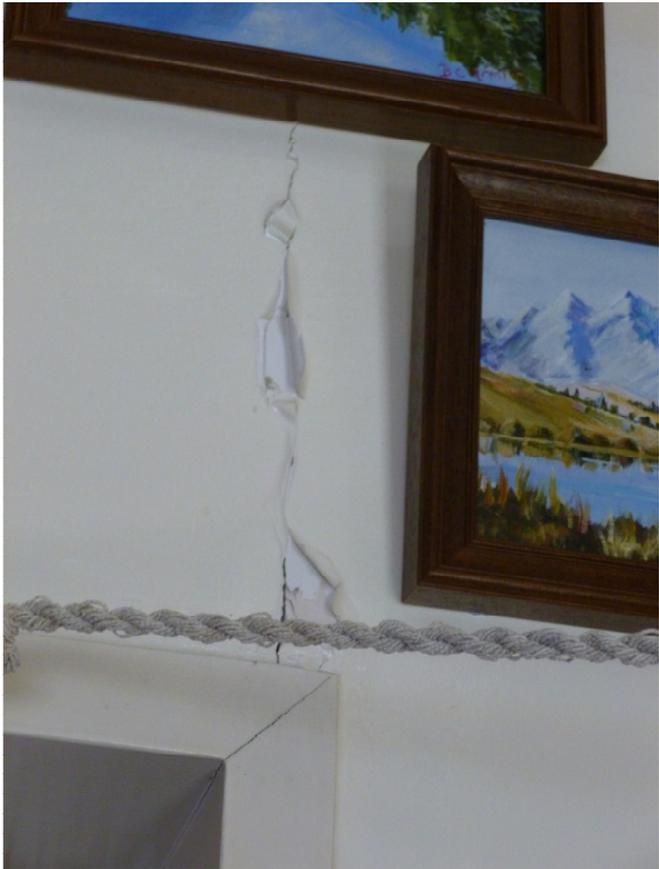
Minor cracking was observed to the plasterboard wall linings and ceiling diaphragm in most units (photos 12-15).

<p>12.</p>	<p>Typical cracking above doorways</p>

- Structural systems be developed to increase the seismic capacity of all blocks to at least 67%NBS.
- Cosmetic repairs be undertaken as required.
- Veneer at height (gable ends) have their veneer ties checked.

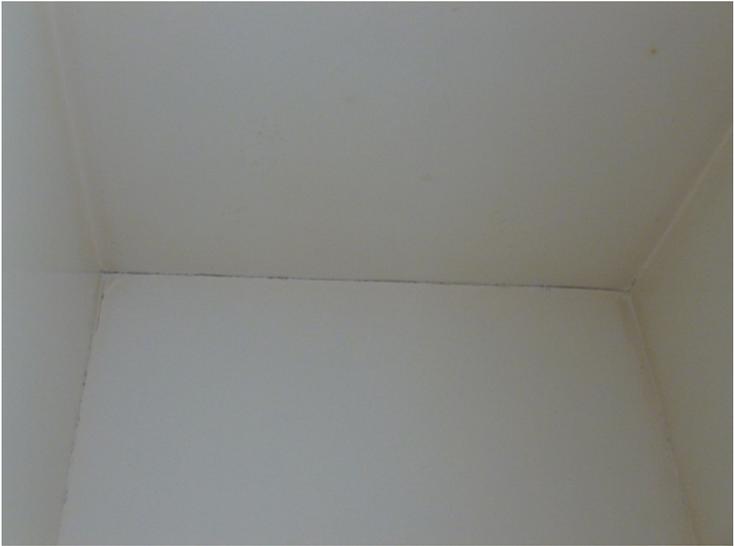
14.	Typical cracking at the roofline

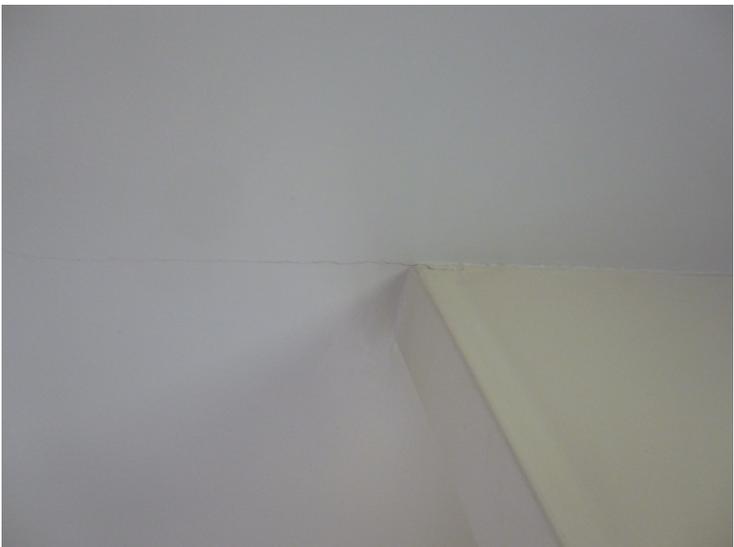
15.	Typical cracking of the ceiling diaphragm

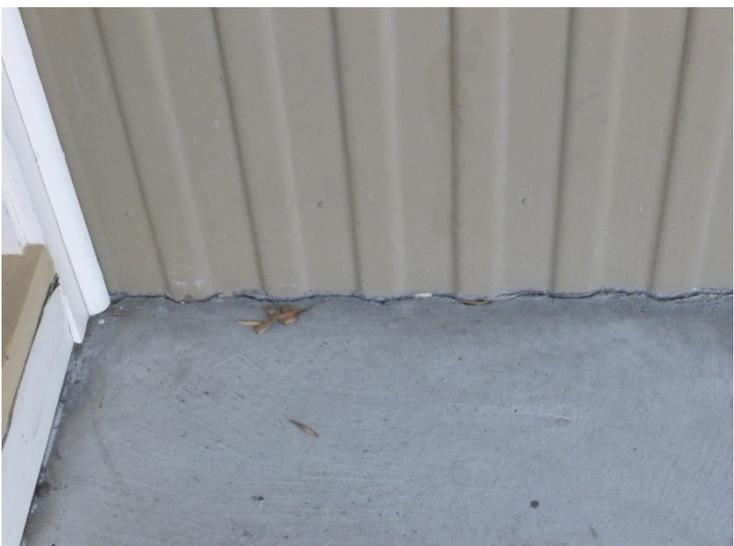
16.	Typical splitting of the concrete patio and veneer

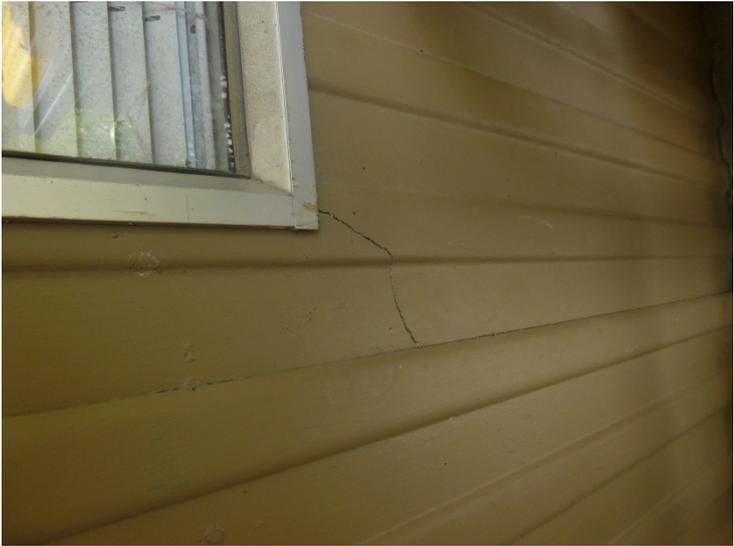
Minor cracking was observed in both the Hardie board and Summerhill stone veneer (photos 17 and 19). A loose brick in the veneer was also observed at the corner of Blocks C and E. Slight splitting was observed between the veneer and the concrete block firewall (photo 21). Cracking to the concrete path surrounding the units was observed.

<p>17.</p>	<p>Cracking of wooden veneer</p>

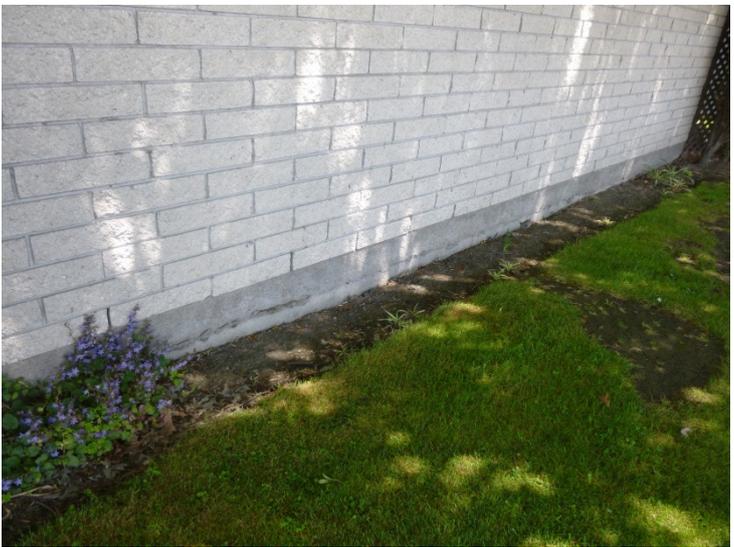
<p>18.</p>	<p>Ground settlement at road end of block A</p>

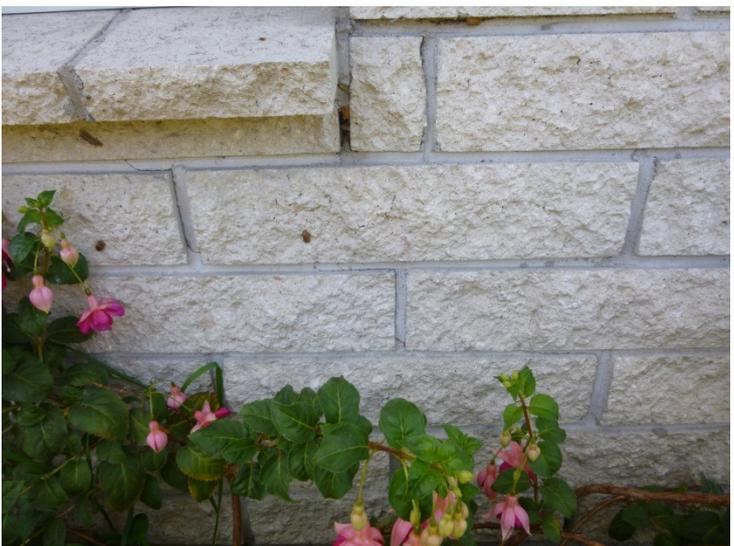
<p>19.</p>	<p>Cracking in summerhill stone veneer</p>

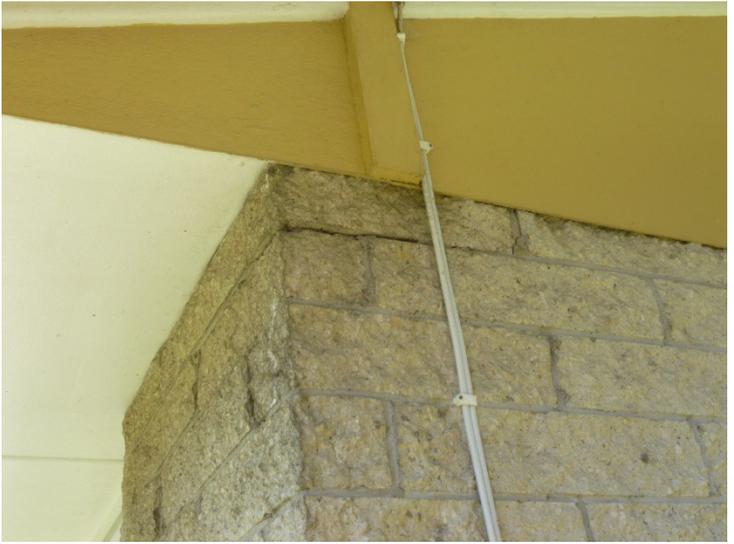
20.	Loose brick insitu

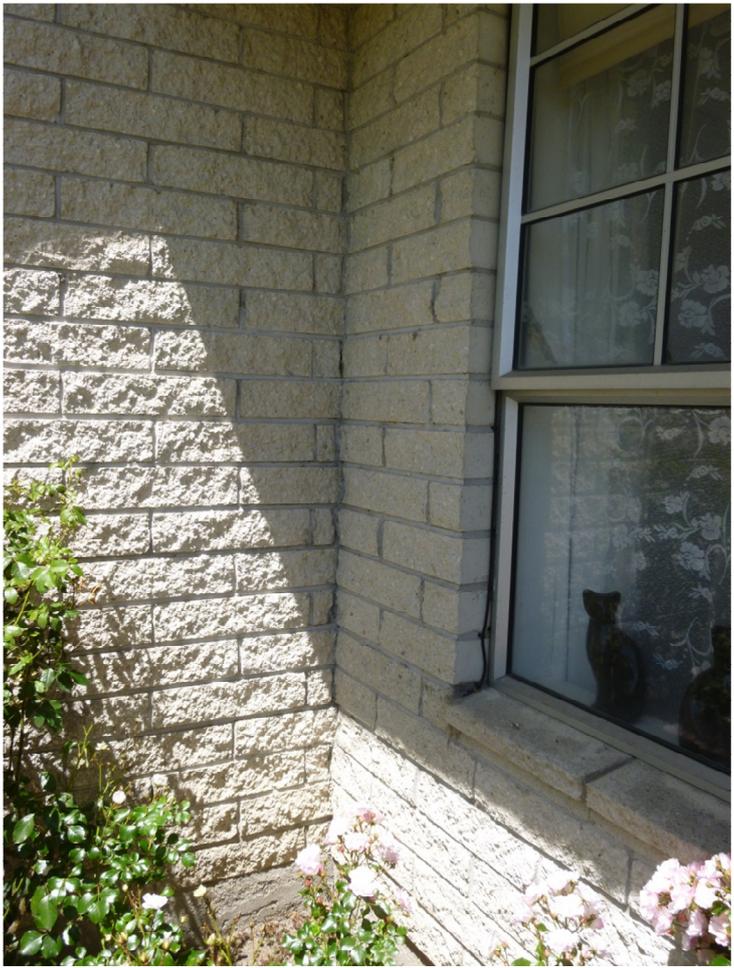
21.	Slight splitting between veneer and firewall

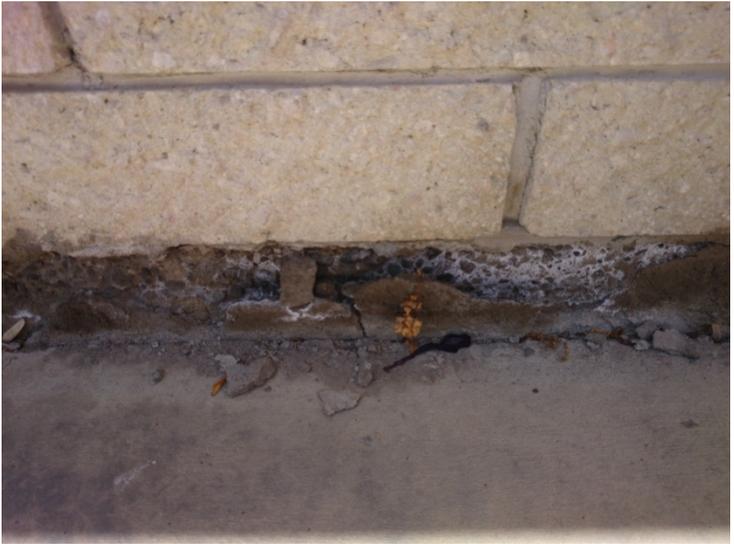
Spalling of the foundation's outer render was observed (photo 22).

<p>22.</p>	<p>Spalling of render on concrete pad</p>

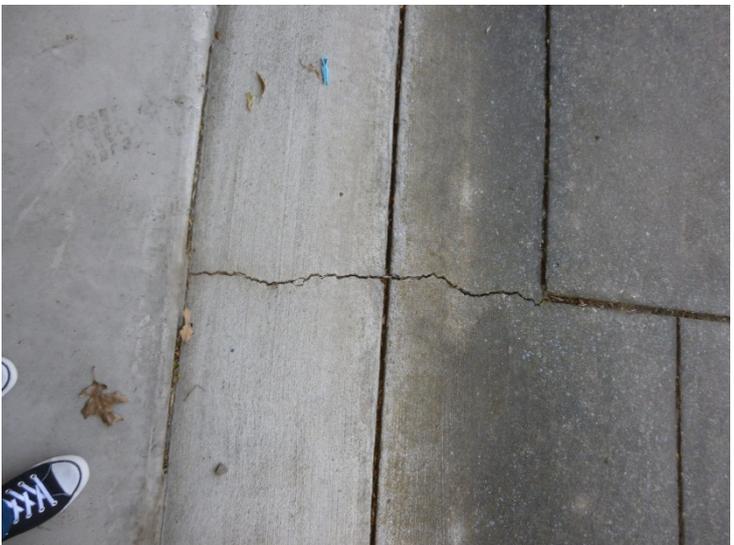
A close-up photograph of the base of a wall where it meets a concrete pad. The wall is made of light-colored, textured masonry blocks. There is significant damage to the render at the base, with large areas missing, exposing the underlying concrete and aggregate. Debris, including small pieces of concrete and some dried leaves, is scattered on the concrete pad surface.
<p>23.</p>	<p>Cracking in concrete pathways</p>
