CHRISTCHURCH CITY COUNCIL  
BU 0812-001 EQ2  
Guthrey Courts – Block A  
72a Olliviers Road, Phillipstown

QUANTITATIVE ASSESSMENT REPORT  
FINAL

- Rev E
- 03 May 2013

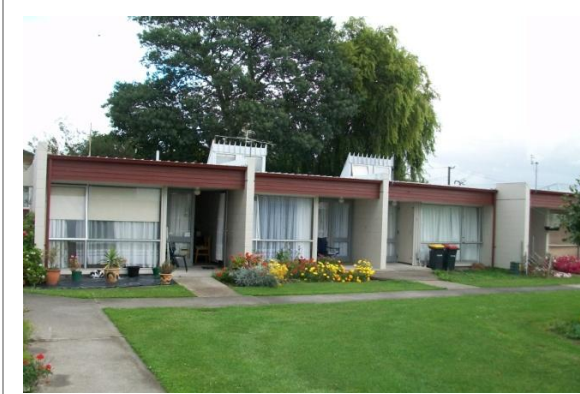
Photo 1: View of the front of units in block A

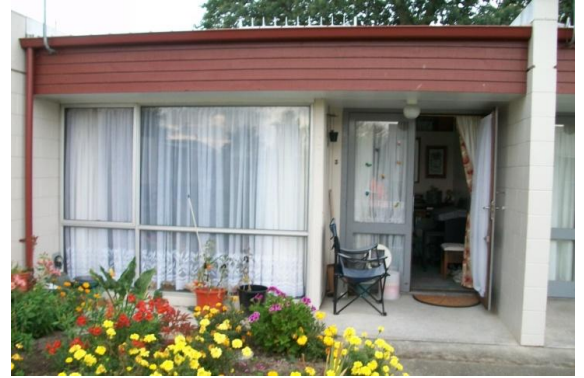
Photo 2: Typical unit front

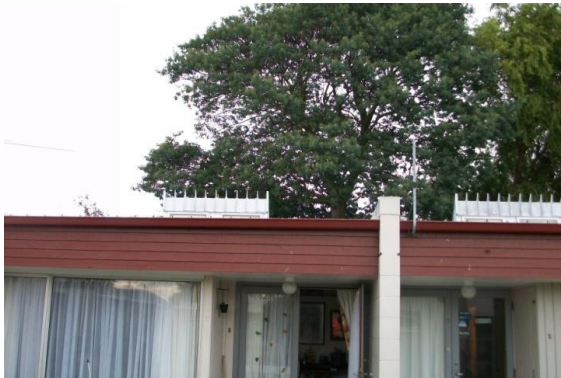
Photo 3: Units are separated by masonry walls which extend above the height of the timber roofs

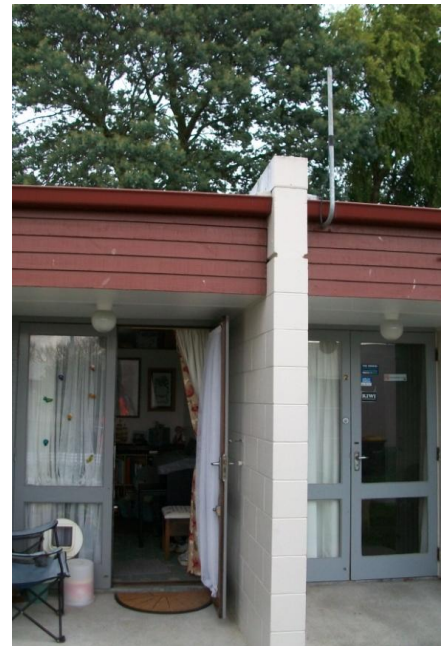
Photo 4: Close up of a wall between units

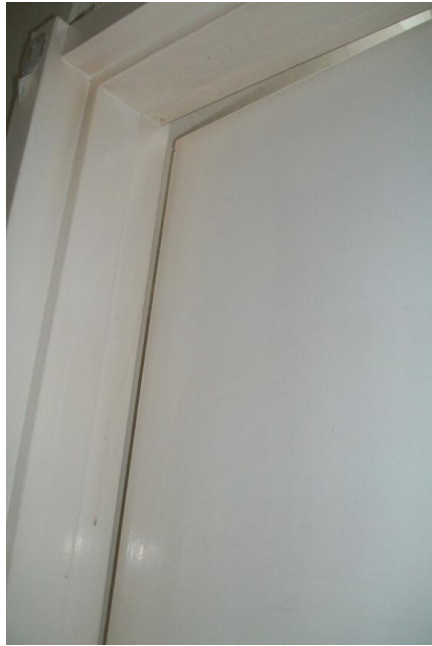
Photo 5: Door Frame skew has caused the door pictured to jam.

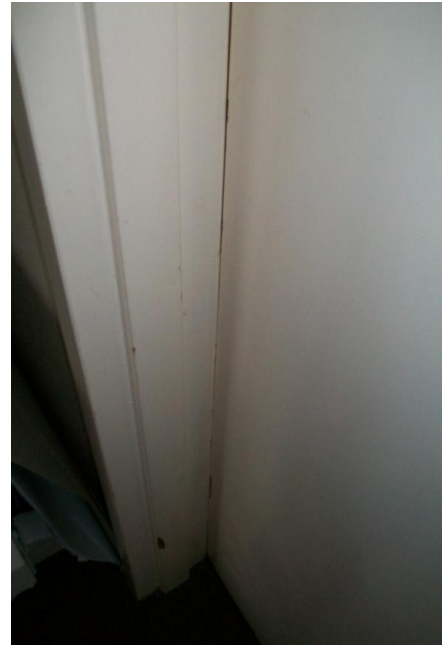
Photo 6: Door jamming over the bottom third of the door

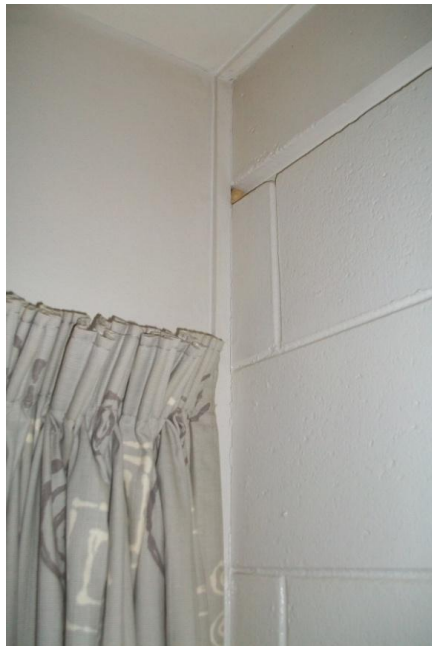
Photo 7: Top of the concrete masonry walls and transition to concrete bond beam

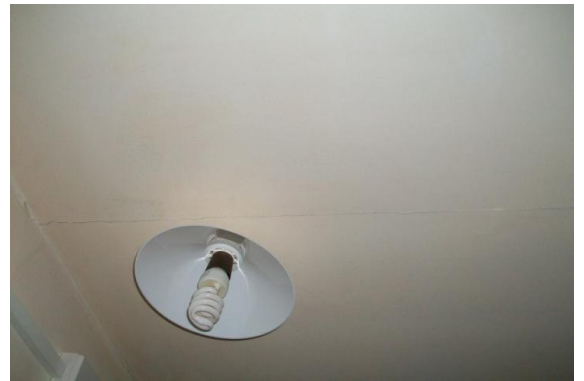
Photo 8: Separation through the roof linings along the plasterboard joint line.

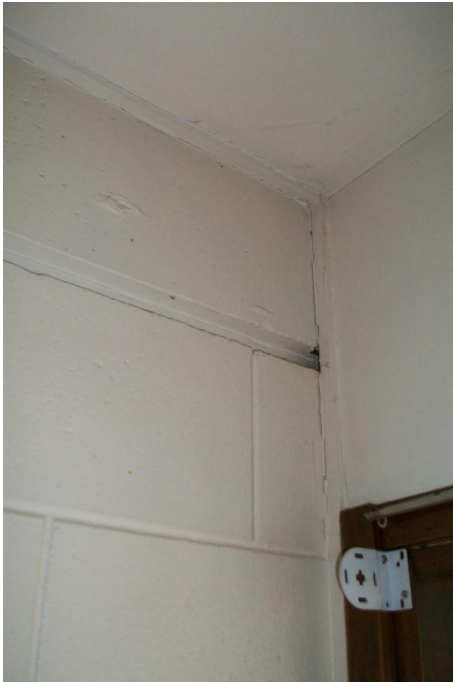
Photo 9: Wall junction separation

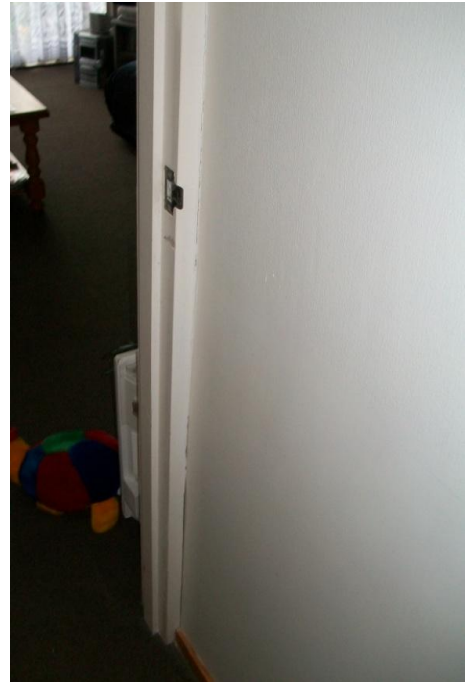
Photo 10: Separation of the door frame from the plasterboard lining

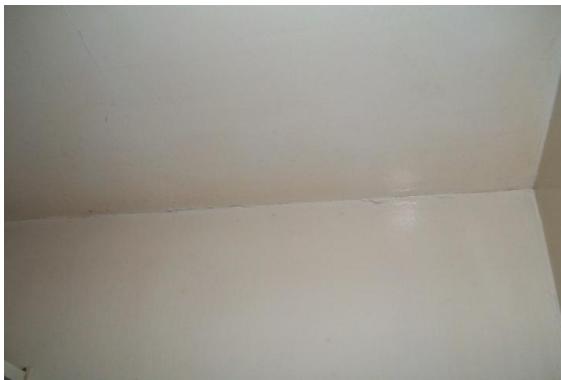
Photo 11: Wall ceiling junction separation

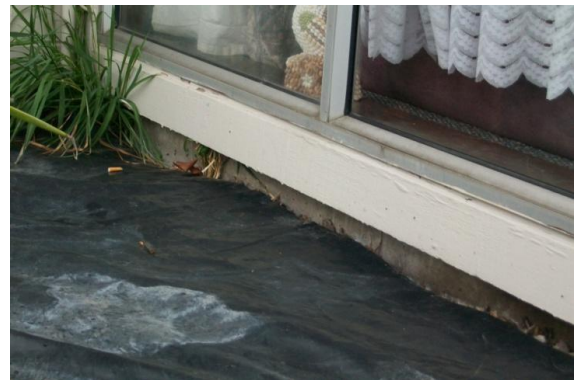
Photo 12: Separation between the the window framing and the timber cladding

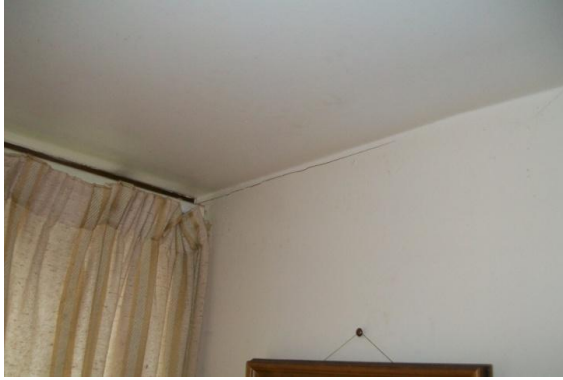
Photo 13: Separation along the wall and ceiling junction

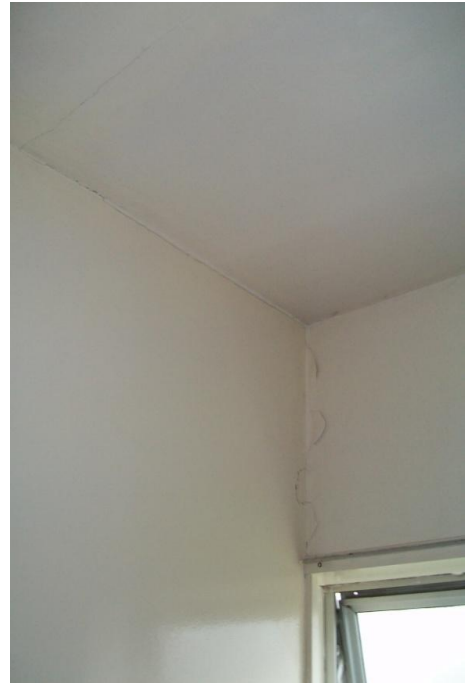
Photo 14: Separation of the plastboard linings along the wall and ceiling junction and along the plasterboard ceiling lining join
