CHRISTCHURCH CITY COUNCIL
BU 0812-003 EQ2
Guthrey Courts – Block C
72a Olliviers Road, Phillipstown

QUANTITATIVE ASSESSMENT REPORT
FINAL

- Rev E
- 03 May 2013

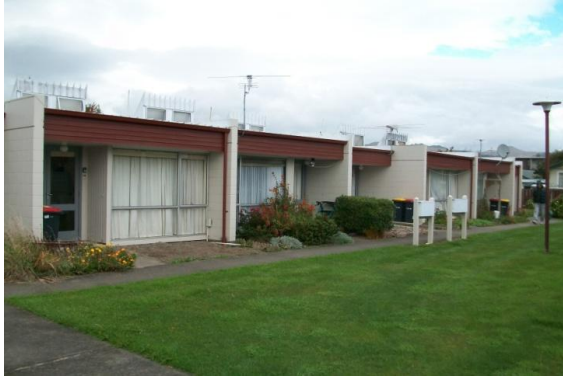
Photo 1: View along the front of the units in block C

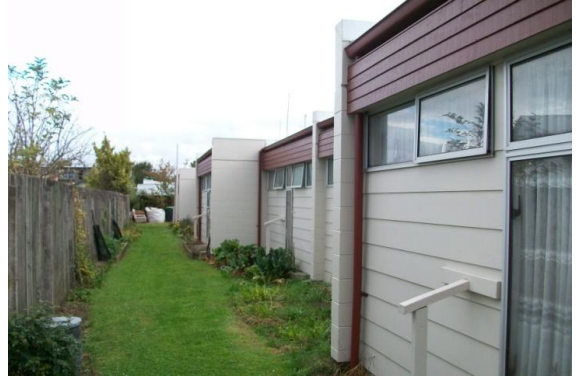
Photo 2: View along the back of block C

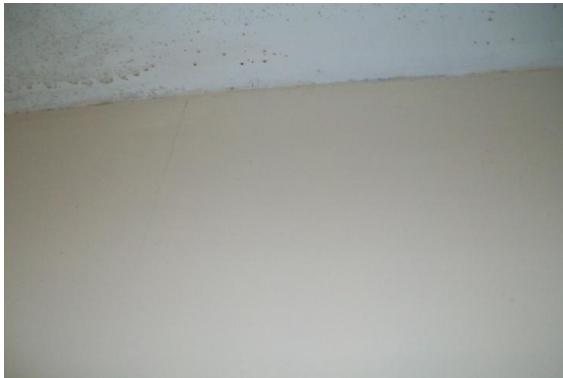
Photo 3: Vertical separation along the plasterboard

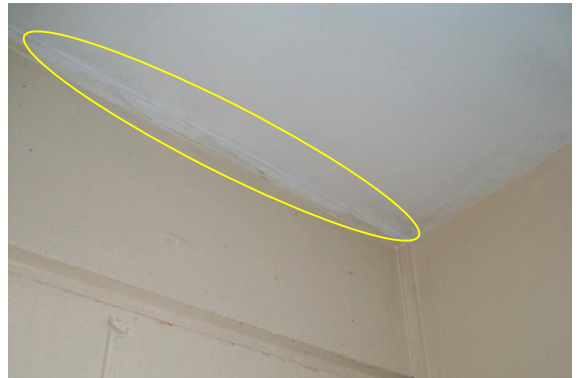
Photo 4: Separation along the roof and wall junctions

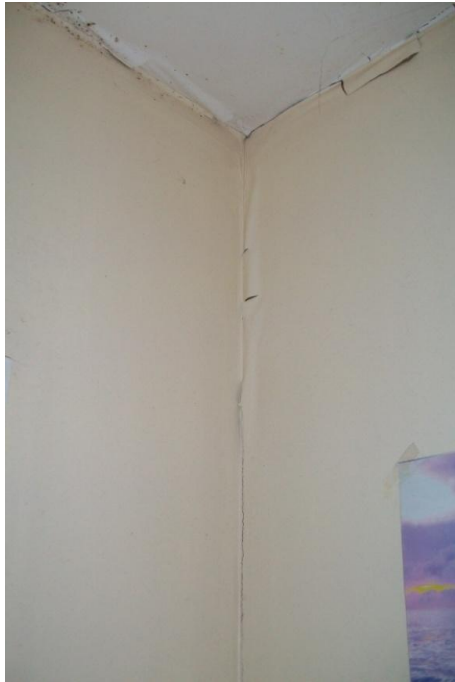
Photo 5: Photo 6: Separation of the plasterboard linings along the wall to ceiling junction and wall to wall junction

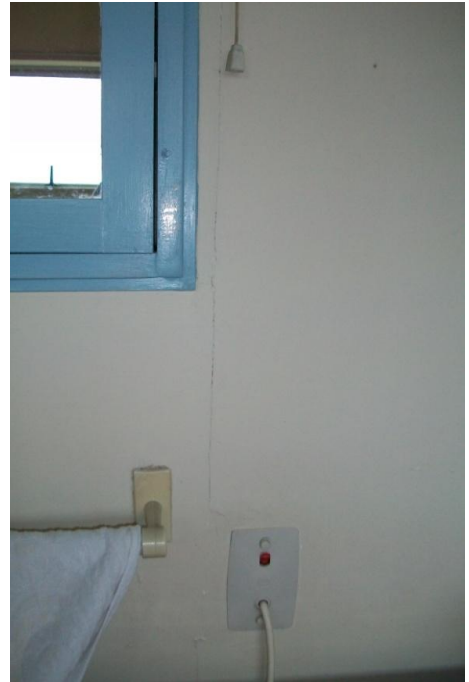
Photo 7: Vertical cracking through the plasterboard linings

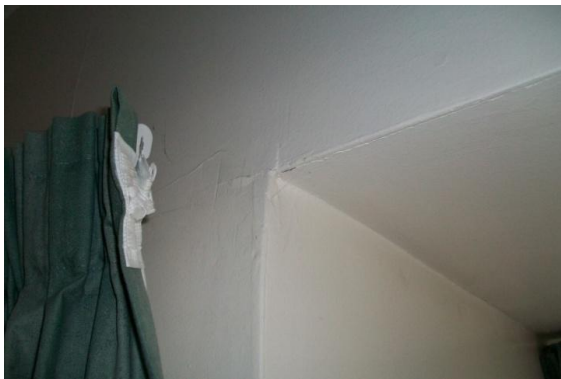
Photo 8: diagonal cracking from door penetrations

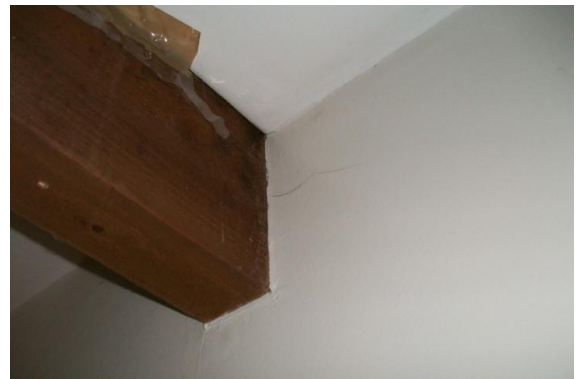
Photo 9: Plasterboard cracking around the timber roof beams

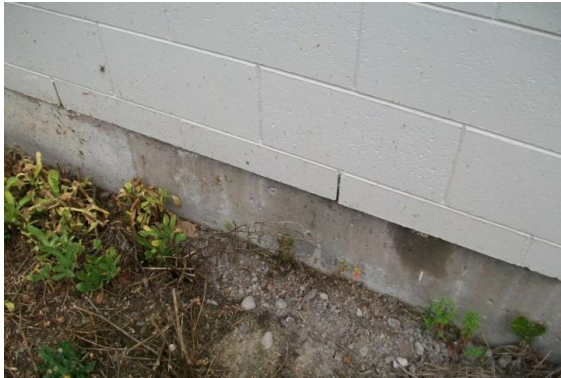
Photo 10: Masonry end wall on concrete strip footing

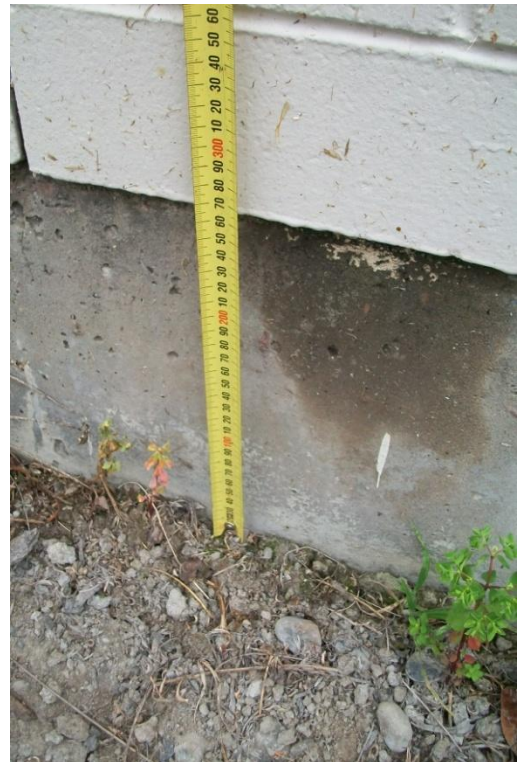
Photo 11: Strip footing 500mm deep with 300 mm above ground

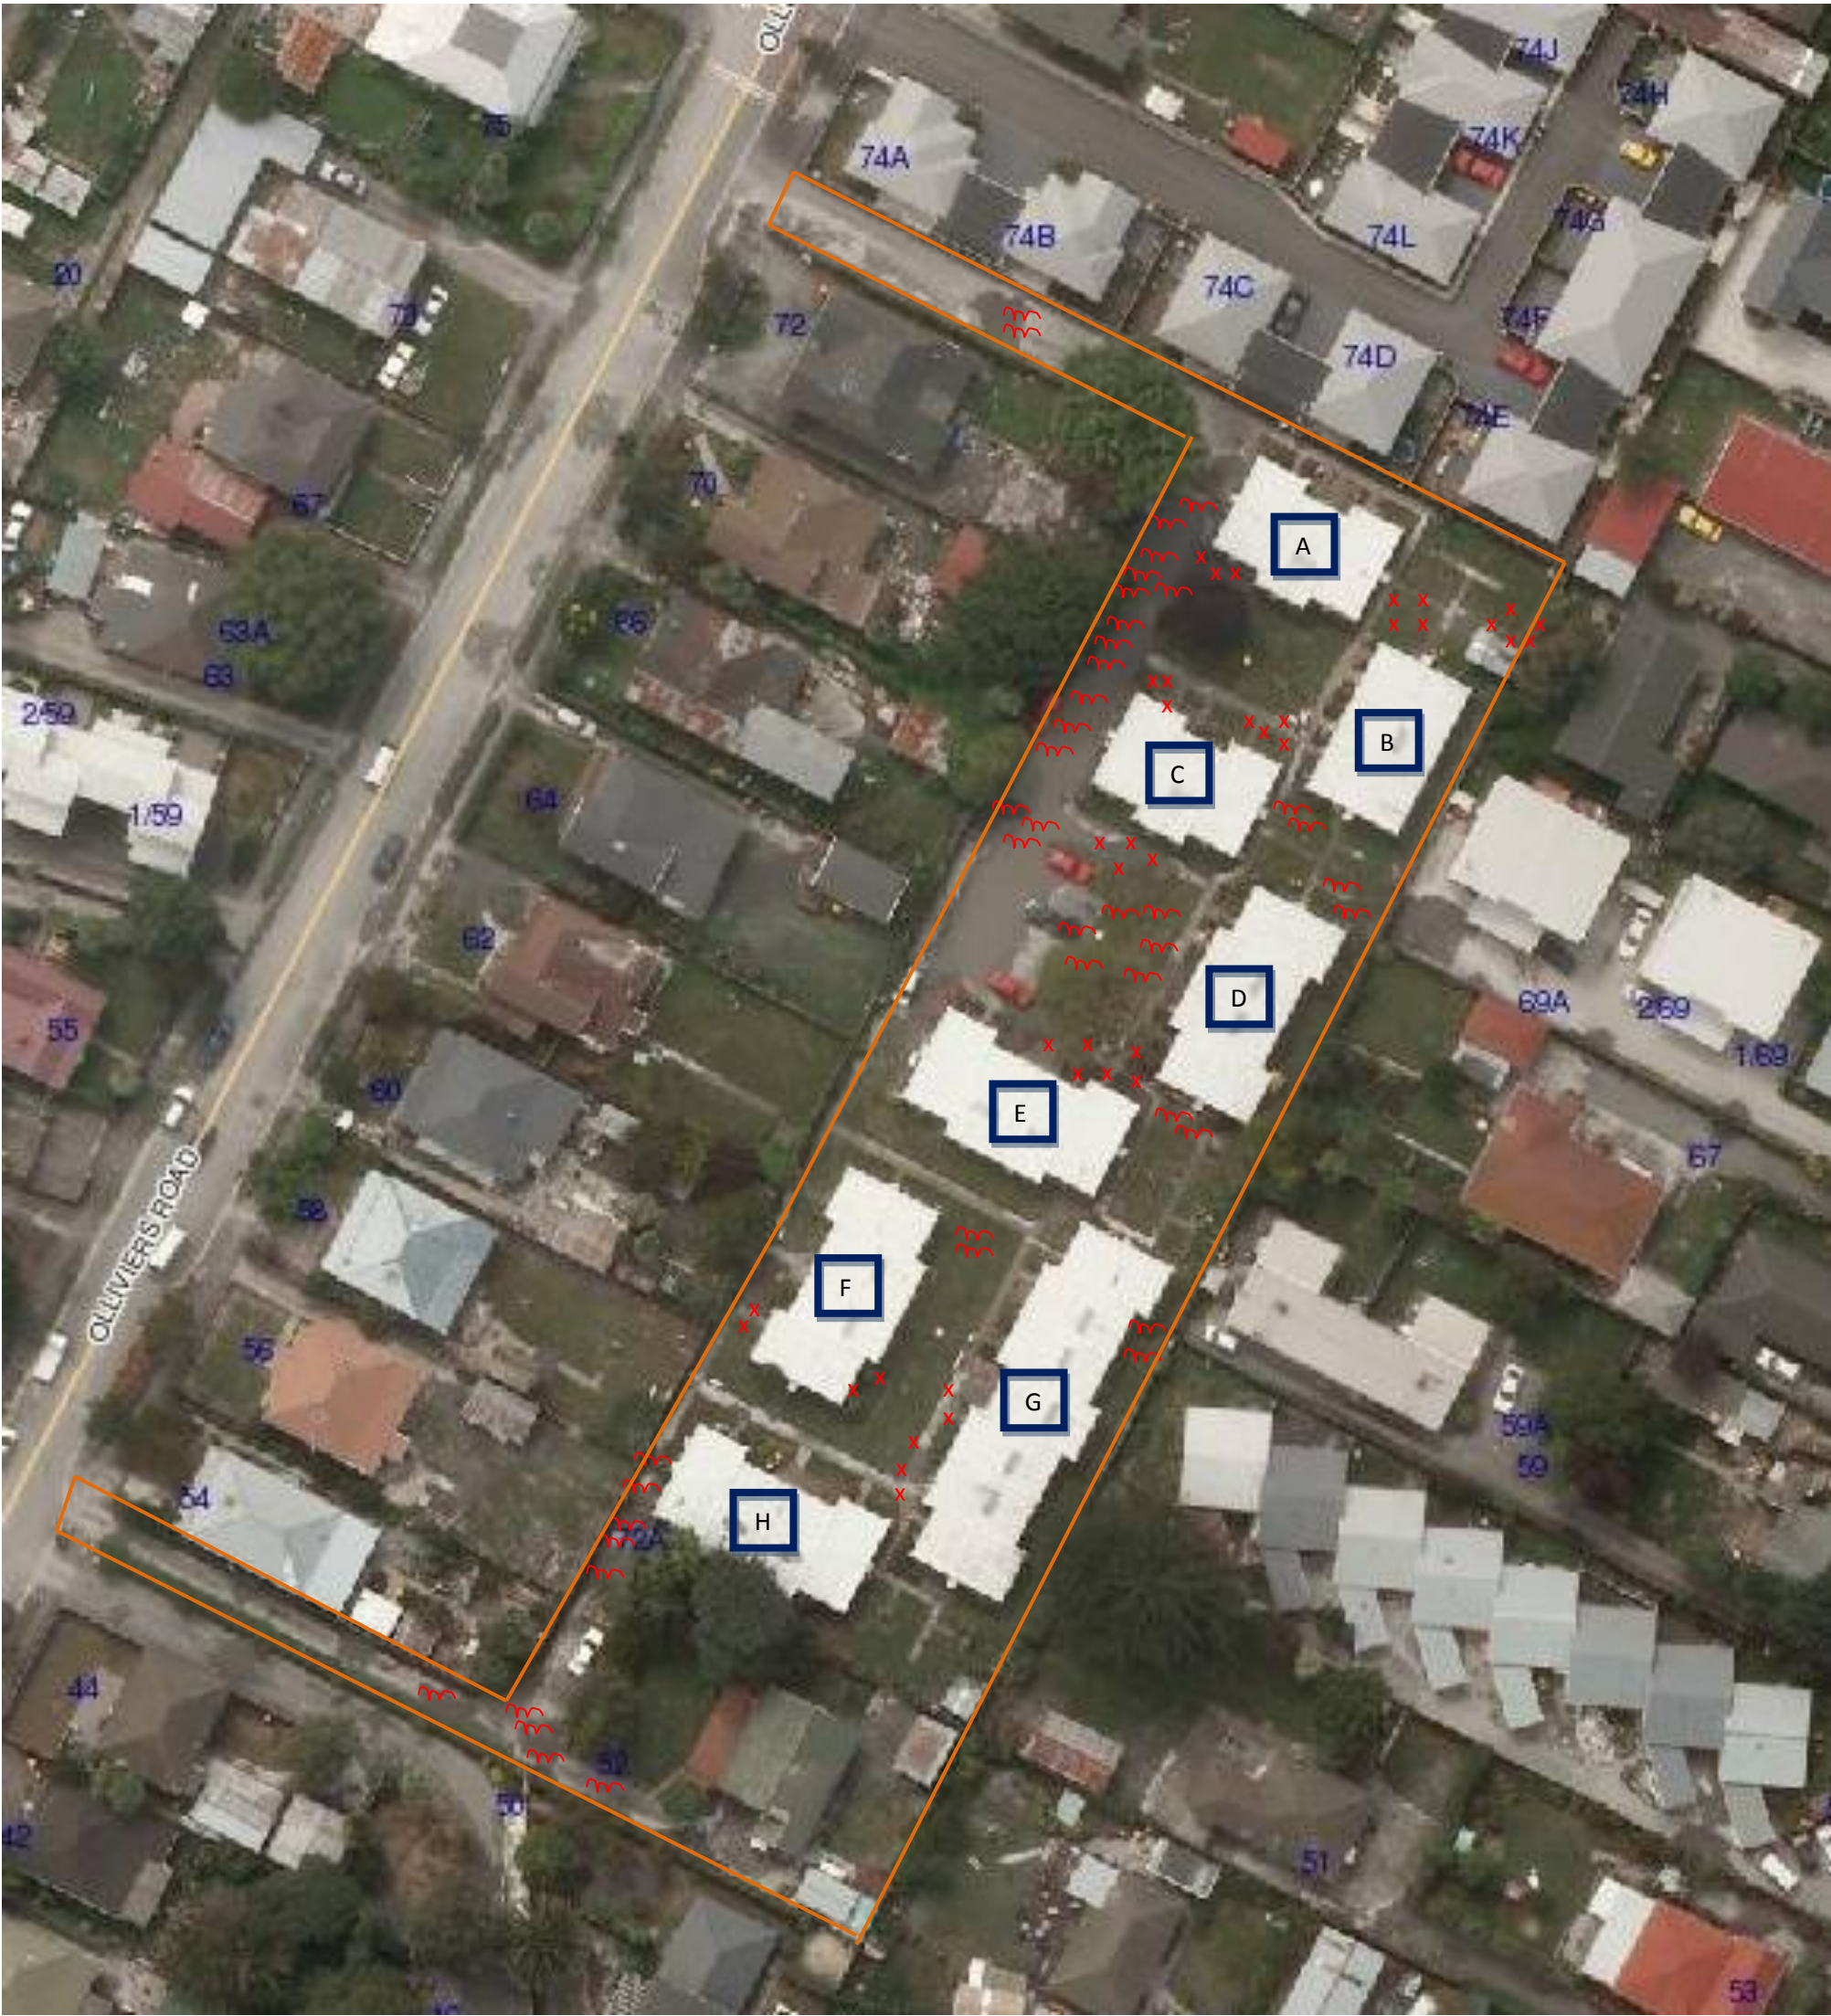
Appendix D – Site Plan showing observed land damage

Undulating Ground Observed
-
