CHRISTCHURCH CITY COUNCIL
BU 0812-004 EQ2
Guthrey Courts – Block D
72a Olliviers Road, Phillipstown

QUANTITATIVE ASSESSMENT REPORT
FINAL

- Rev E
- 03 May 2013

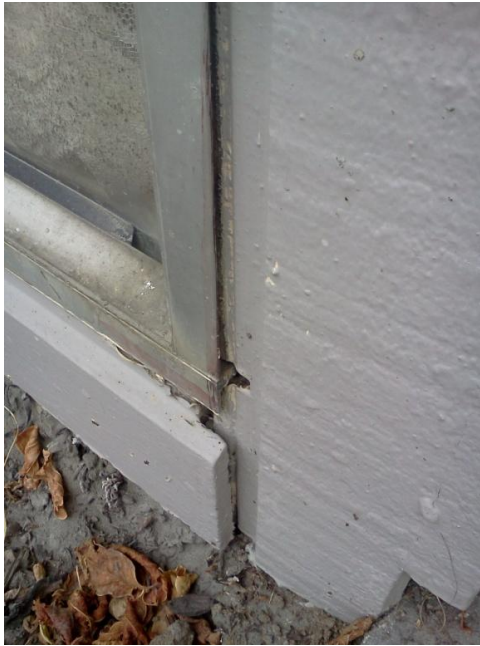
Photo 5: Gap opening around the window frames

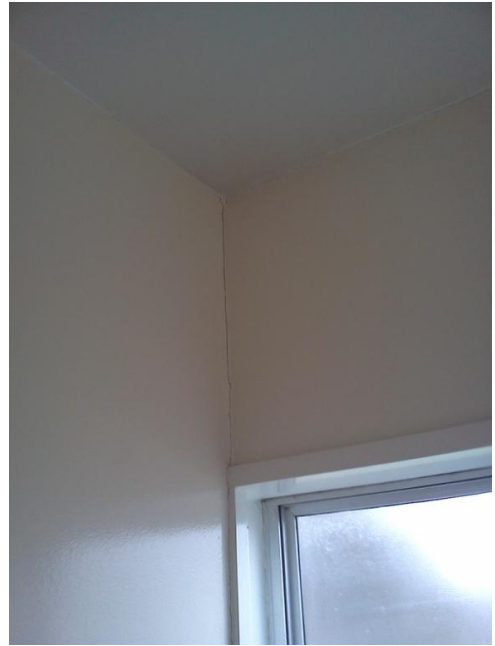
Photo 6: Separation along the wall junction plasterboards

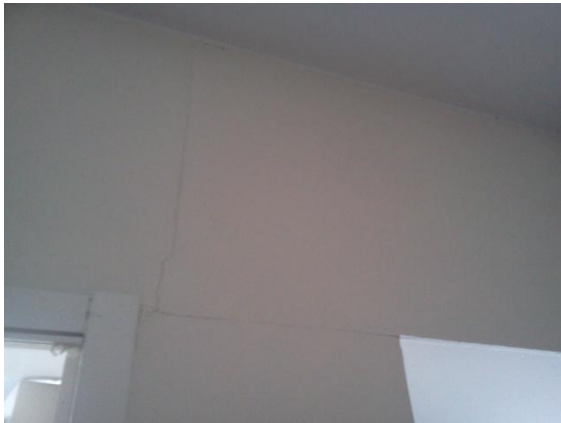
Photo 7: Vertical and horizontal cracking through the plasterboard sheets from wall penetrations

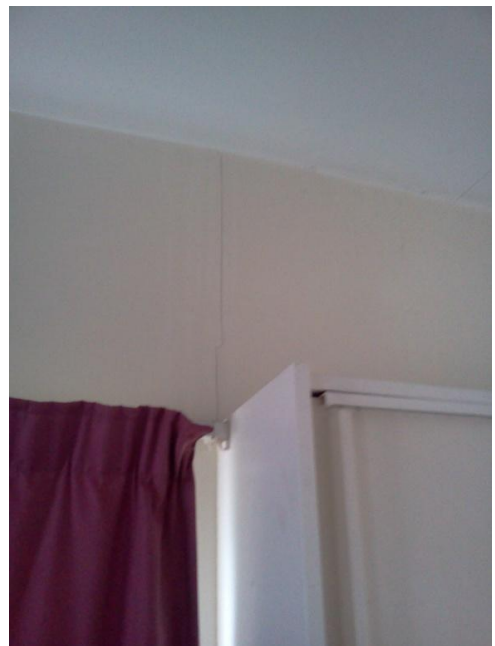
Photo 8: Vertical cracking through plasterboard sheets

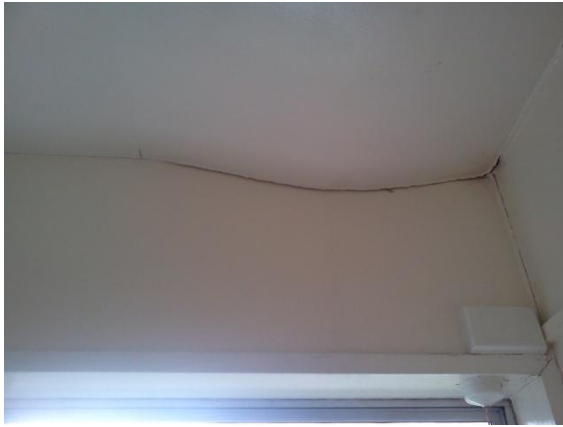
Photo 9: Sagging of the roof lining, unclear whether this is due to the individual boards

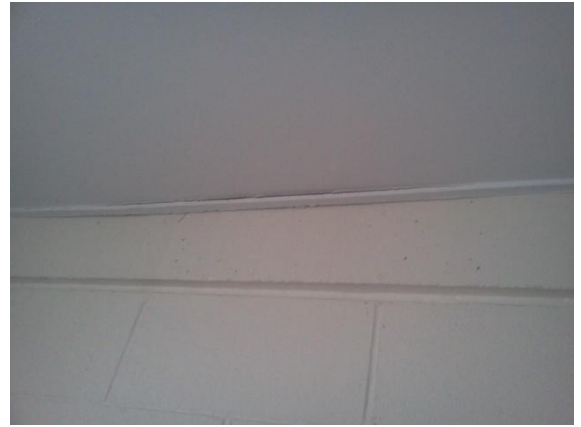
Photo 10: Sagging to the roof linings

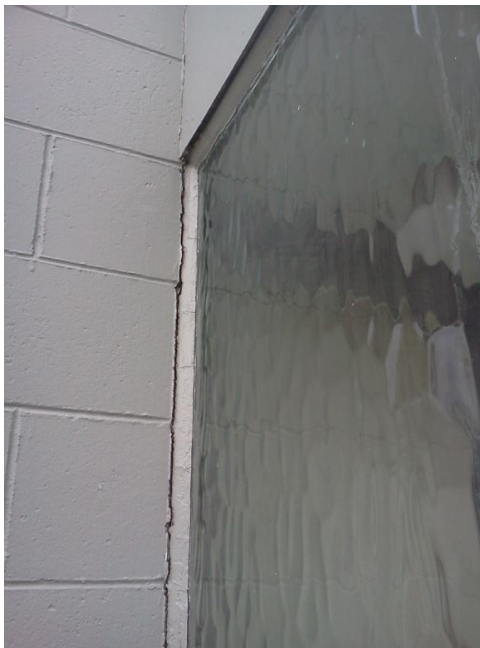
Photo 11: Separation between the masonry brick work and light timber framed wall

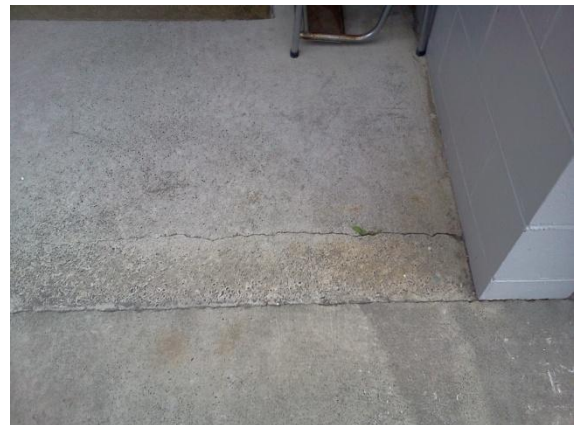
Photo 12: Cracking through the concrete slab on grade extending from the masonry wall.
