CHRISTCHURCH CITY COUNCIL  
BU 0812-006 EQ2  
Guthrey Courts – Block F  
72a Olliviers Road, Phillipstown

QUANTITATIVE ASSESSMENT REPORT  
FINAL

- Rev E
- 03 May 2013

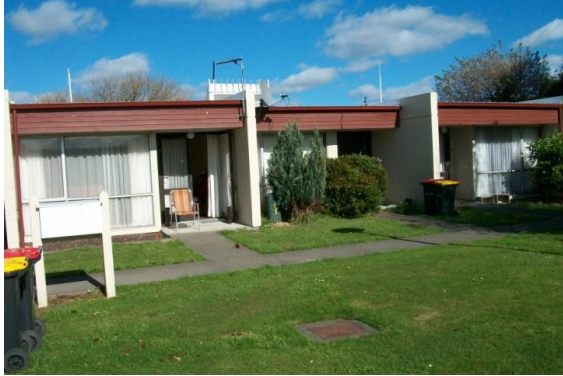
Photo 1: North elevation of Block F

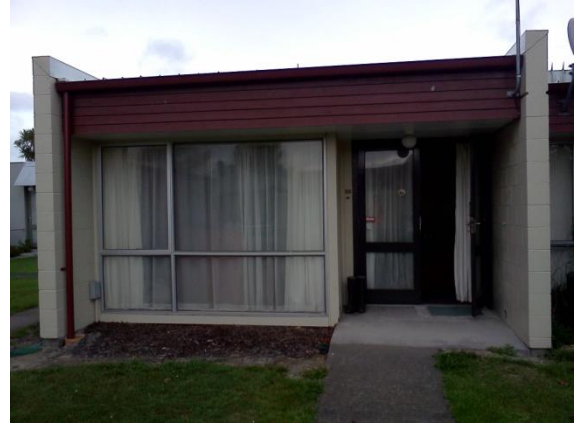
Photo 2: Front of typical unit. Predominantly glazing

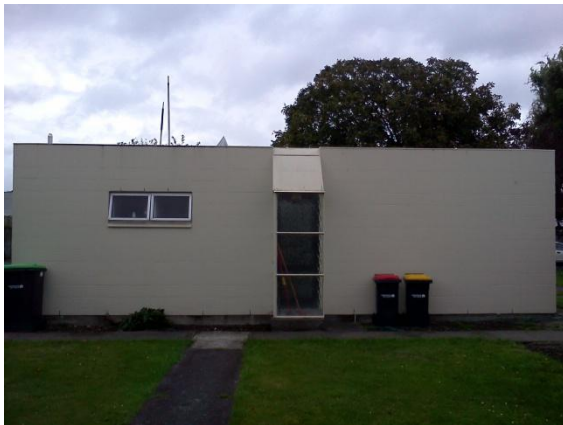
Photo 3: Typical block end walls consist of 200 series block

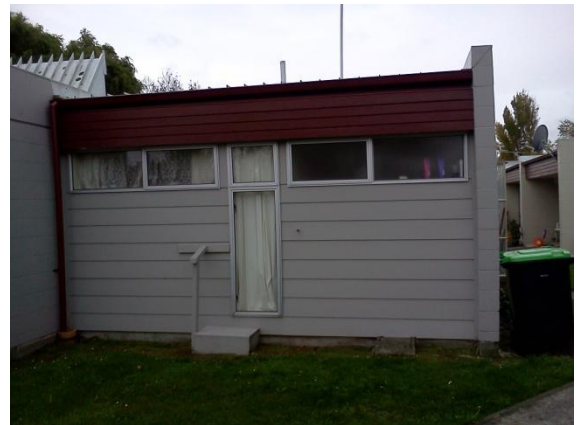
Photo 4: Typical rear of unit, light timber framed with weatherboard cladding.

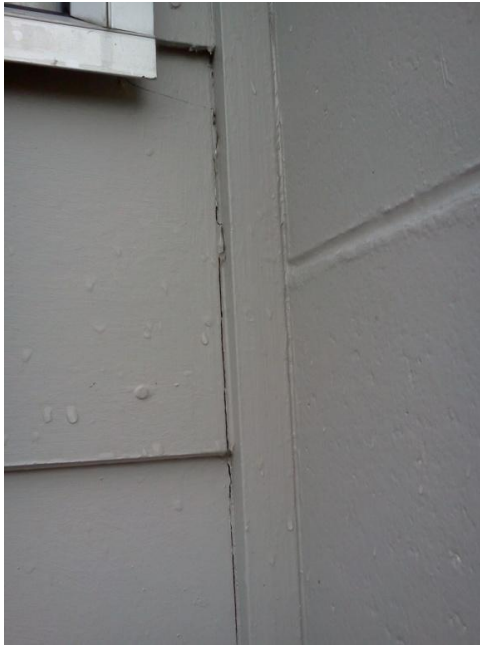
Photo 5: Separation along the weatherboards at the the wall junction

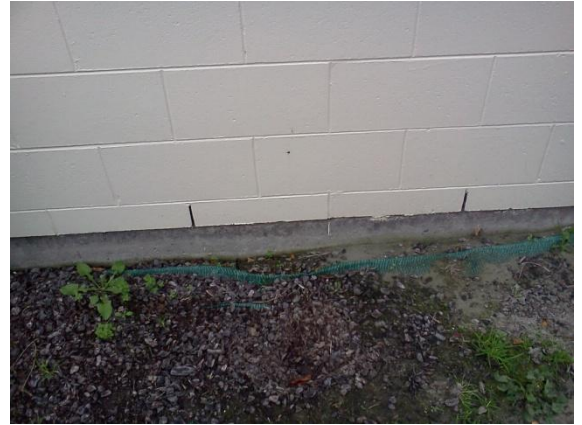
Photo 6: Masonry walls on perimeter footings

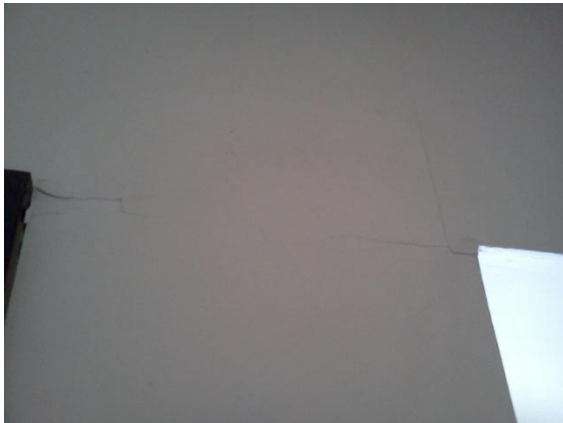
Photo 7: Typical cracking extending from a door frame to the left of shot and a window to the right

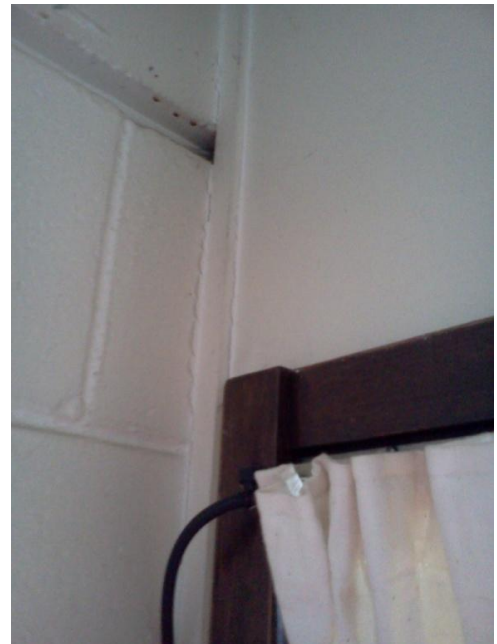
Photo 8: Separation typical along the wall junctions between masonry and timber

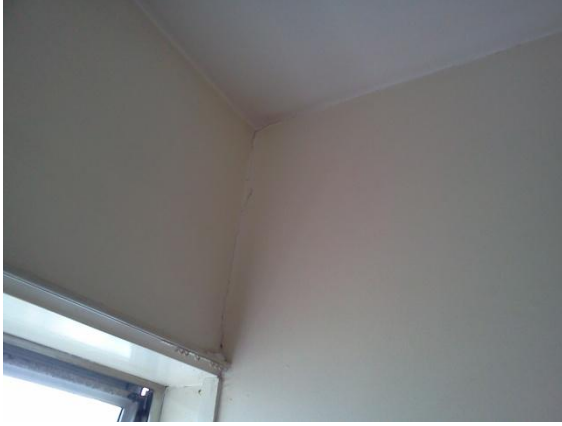
Photo 9: Plasterboard cladding separation along the internal wall junctions

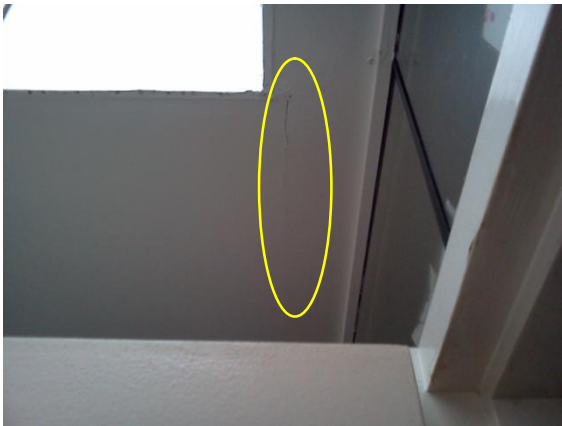
Photo 11: Cracking to the plasterboard ceiling linings extending from the skylight

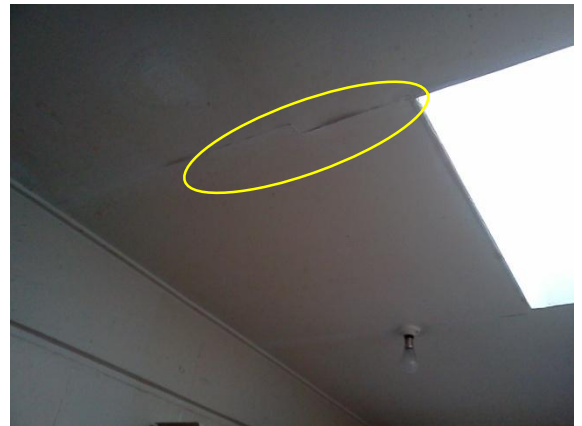
Photo 12: Cracking to the plasterboard ceiling linings extending from the skylight

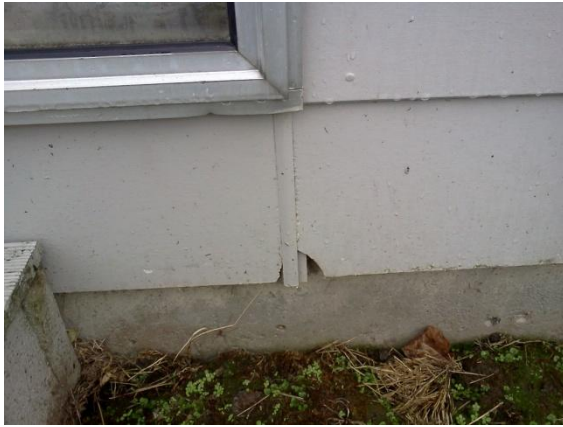
Photo 13: Typical damage to the weatherboard corners

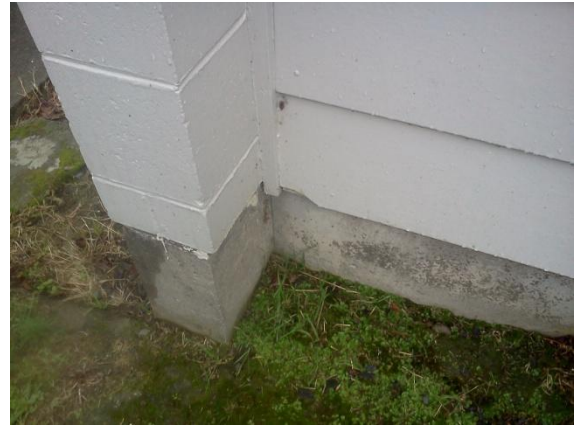
Photo 14: Timber to masonry wall junction detail and strip foundation

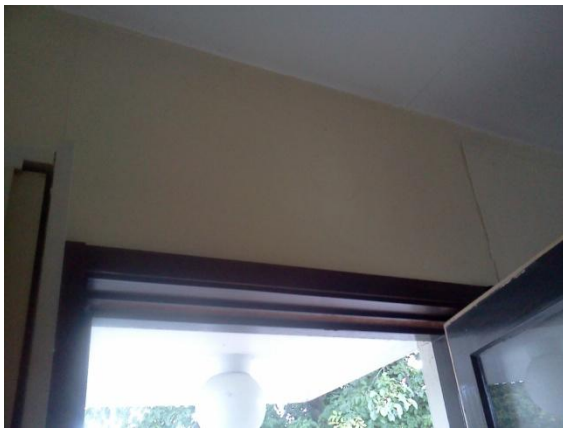
Photo 15: Separations between plasterboard sheets along the join

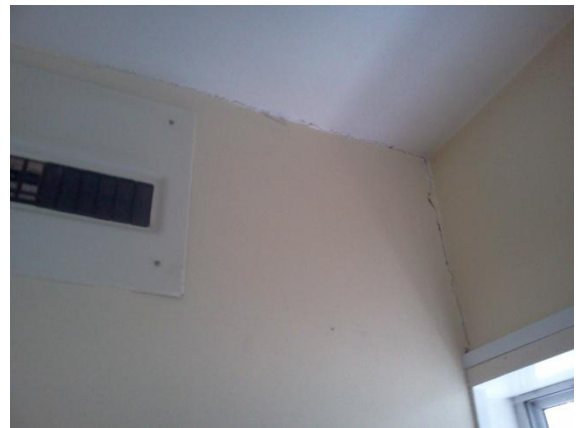
Photo 16: Junction separation

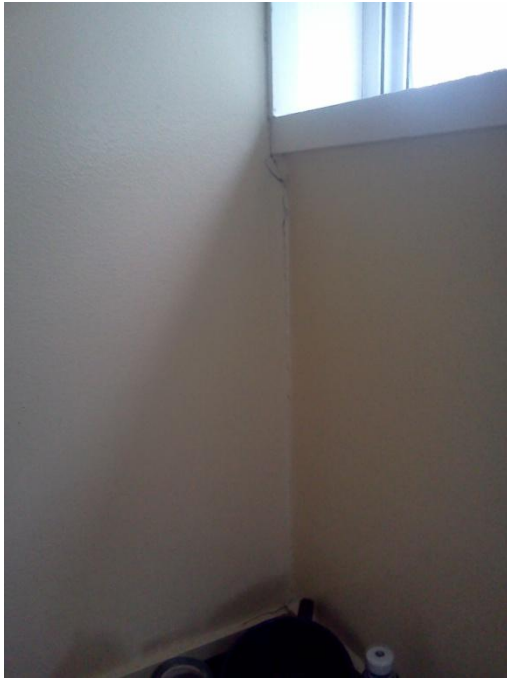
Photo 17: Corner cracking extending from window framing

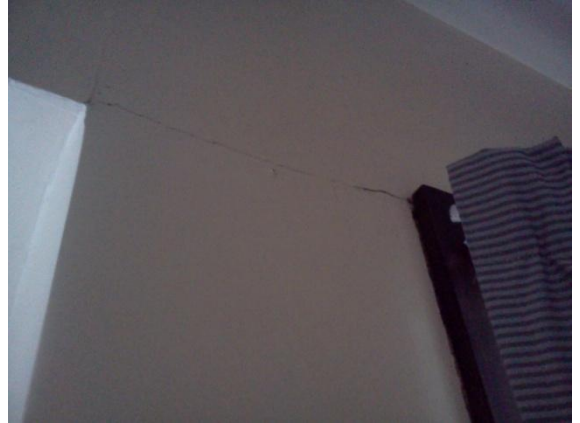
Photo 18: Horizontal cracking from doors

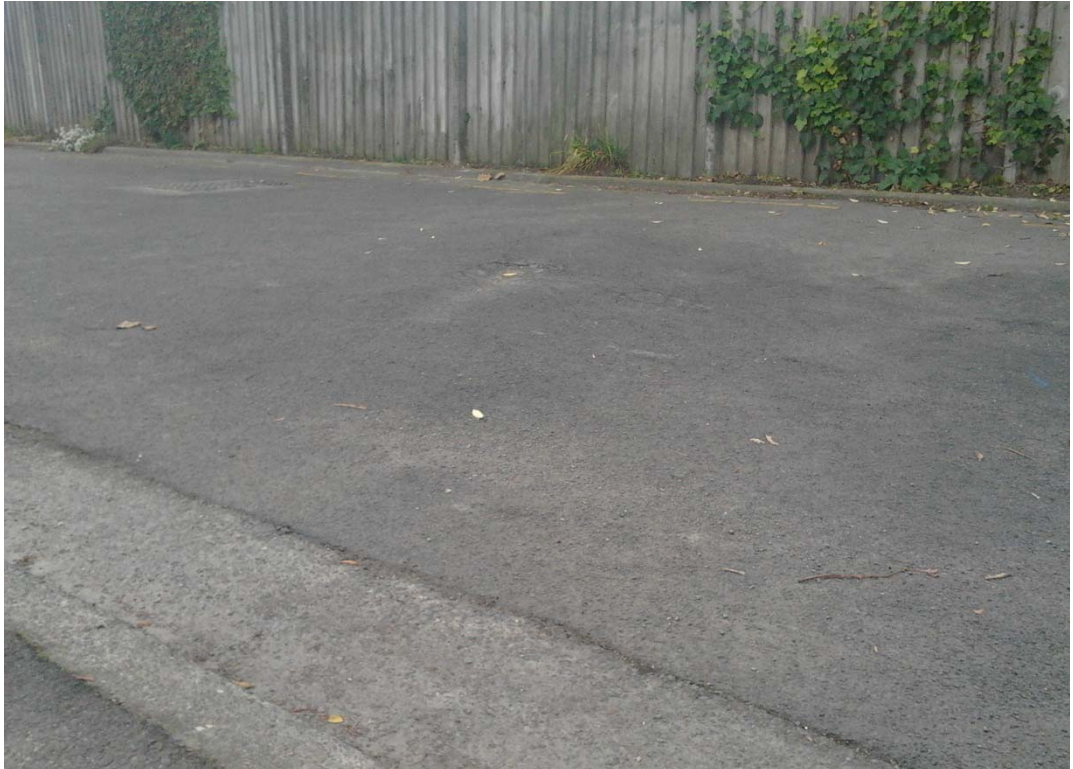
■ **Figure 8 Observed undulations on driveways**

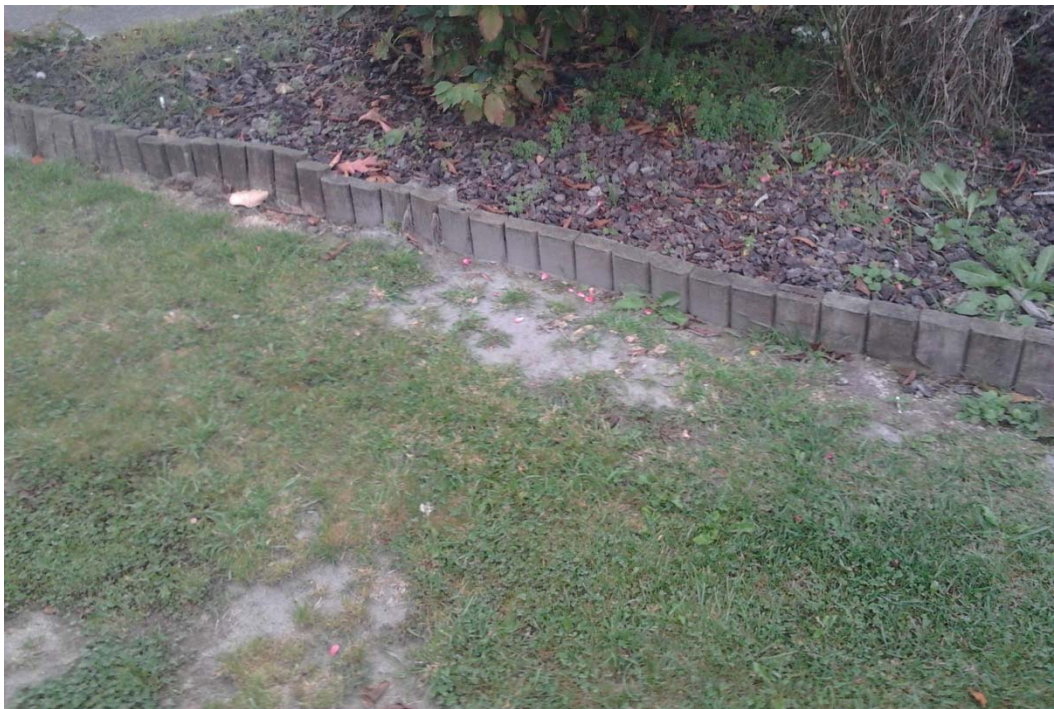
■ **Figure 9 Remaining evidence of liquefied material ejecta**

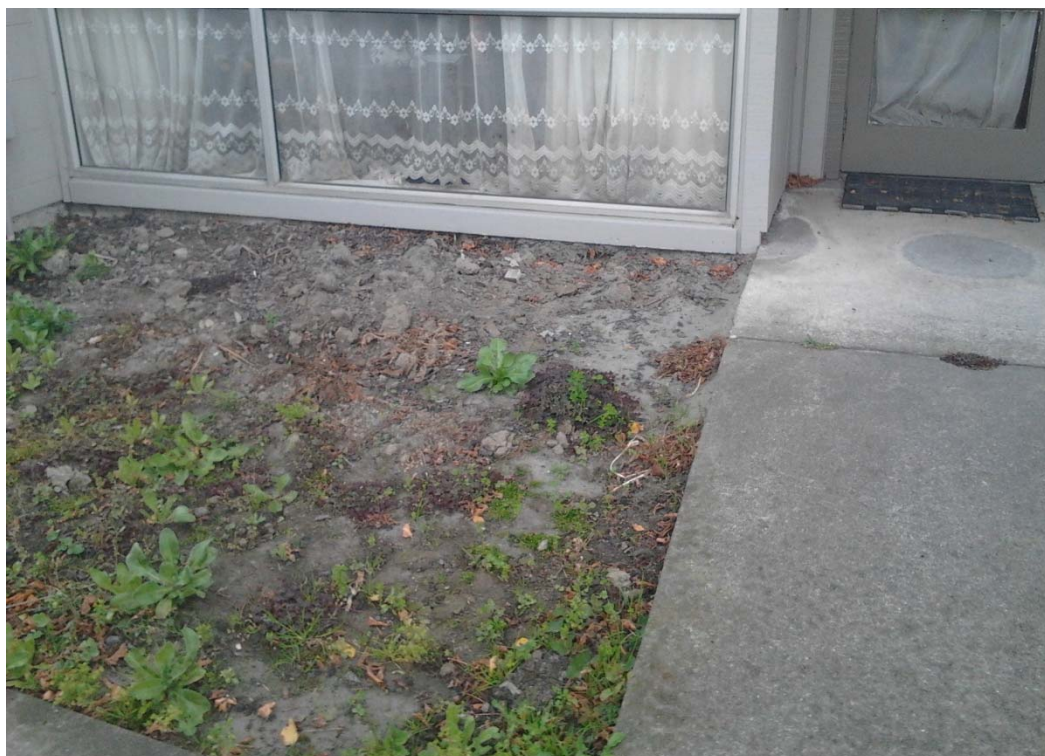
■ **Figure 10 Remaining evidence of liquefied material ejecta**
