CHRISTCHURCH CITY COUNCIL  
BU 0812-007 EQ2  
Guthrey Courts – Block G  
72a Olliviers Road, Phillipstown

QUANTITATIVE ASSESSMENT REPORT  
FINAL

- Rev E
- 03 May 2013

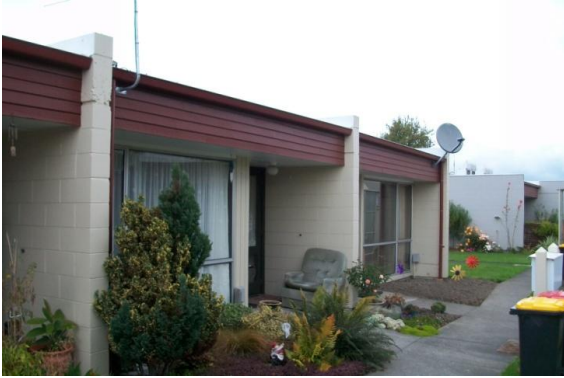
<p>Photo 1: View looking south east along Block G of Guthries Court</p>	<p>Photo 2: Typical unit with masonry end walls and an internal timber wall entry walls are predominantly glass. Rear walls are weatherboard clad.</p>

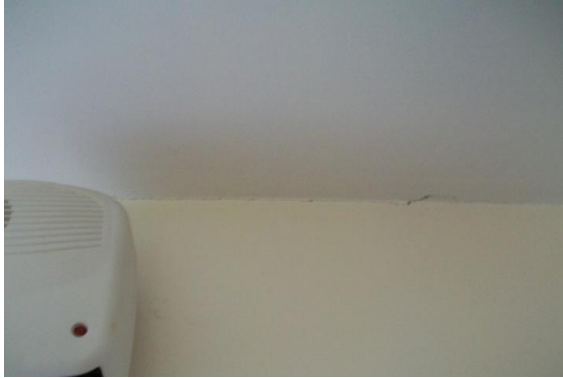
Photo 5: Lining separation along the wall and ceiling junction

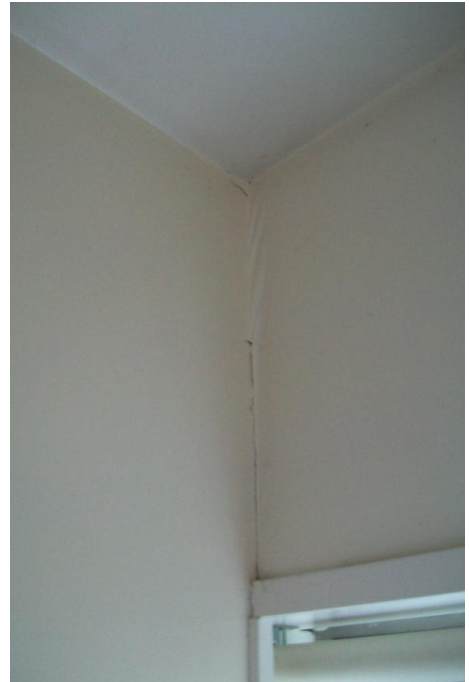
Photo 6: Vertical separation between plasterboard wall elements

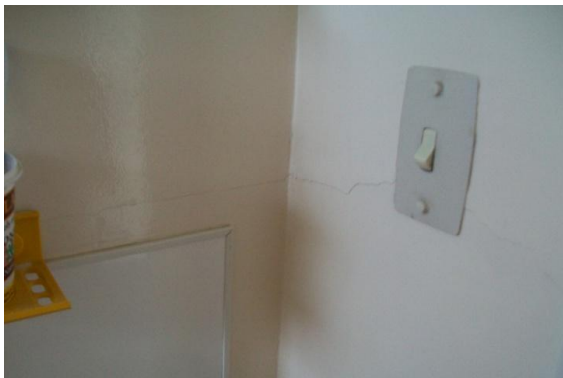
Photo 7: Hairline cracking through plasterboard lining extending from plasterboard penetrations

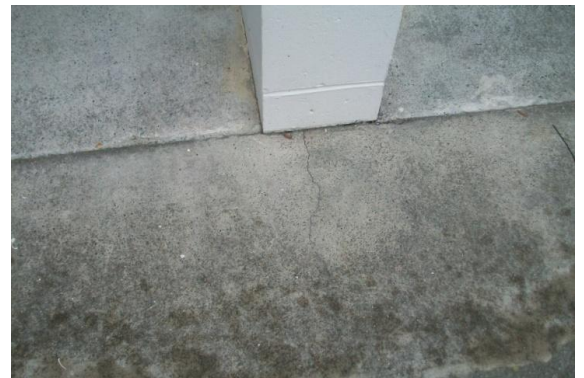
Photo 8: Minor cracking extending from the end of masonry walls

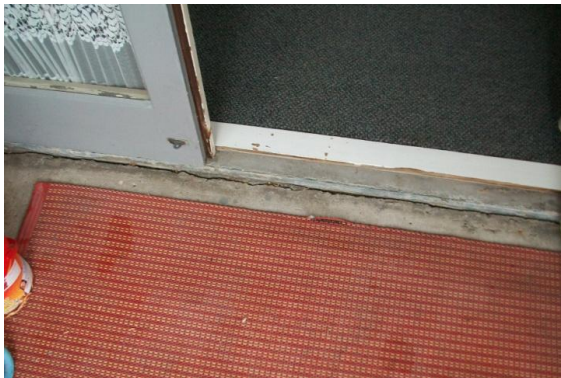
Photo 9: Concrete separation from the door penetration

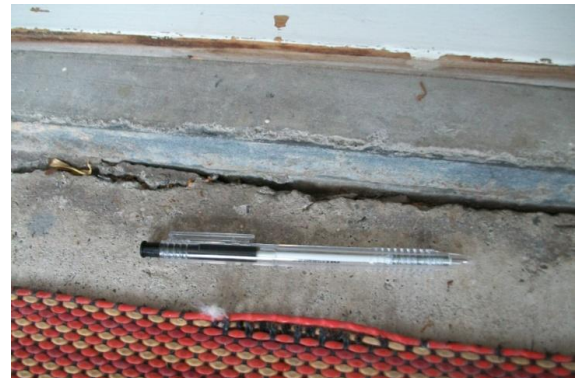
Photo 10: Gap opening of approximately 2mm with 5mm wide spalled at top

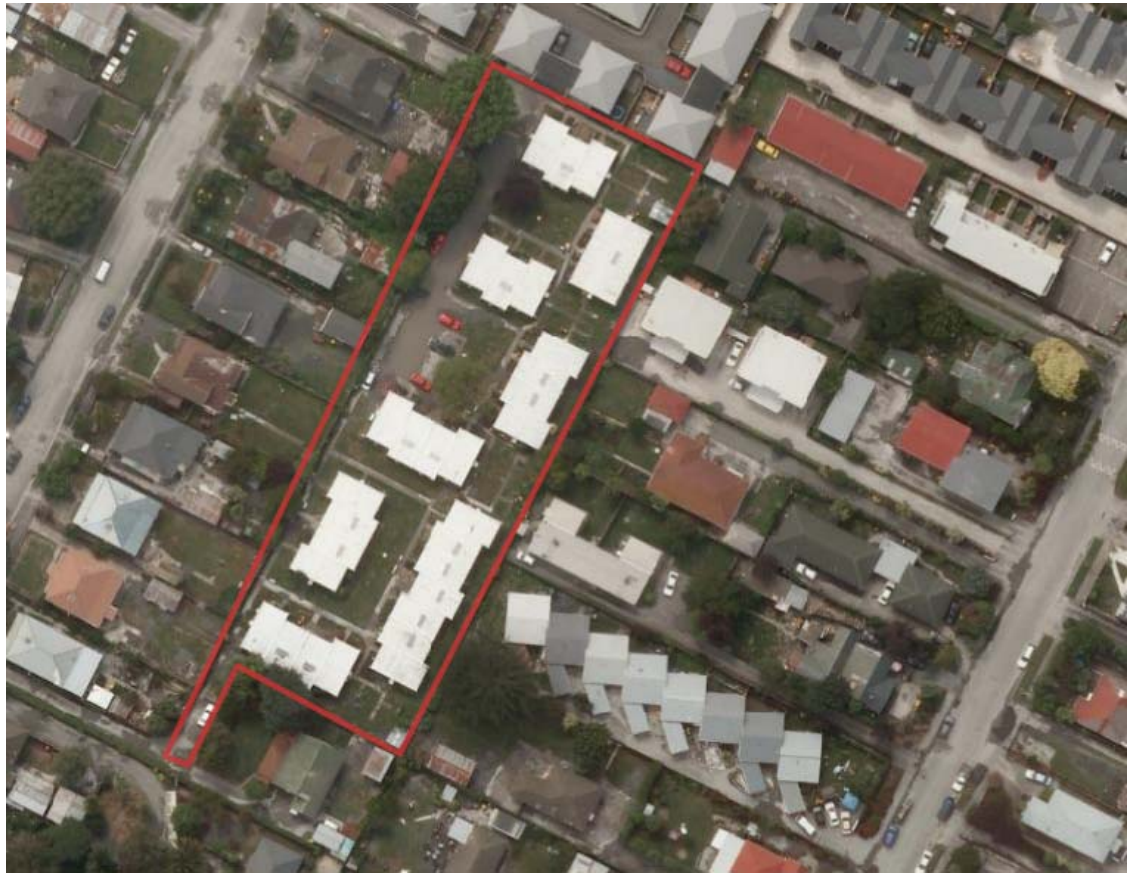
■ **Figure 5 – Aerial photography from 24 Feb 2011 (<http://viewers.geospatial.govt.nz/>)**

A significant amount of liquefied on Olliviers Road and Bordesley Street could be seen from the aerial photograph. Additionally, liquefaction around the property and on the driveways of residential properties could also be seen. The findings from the aerial photograph seem to contradict the conclusions from the reconnaissance undertaken between 23 February and 1 March 2011.

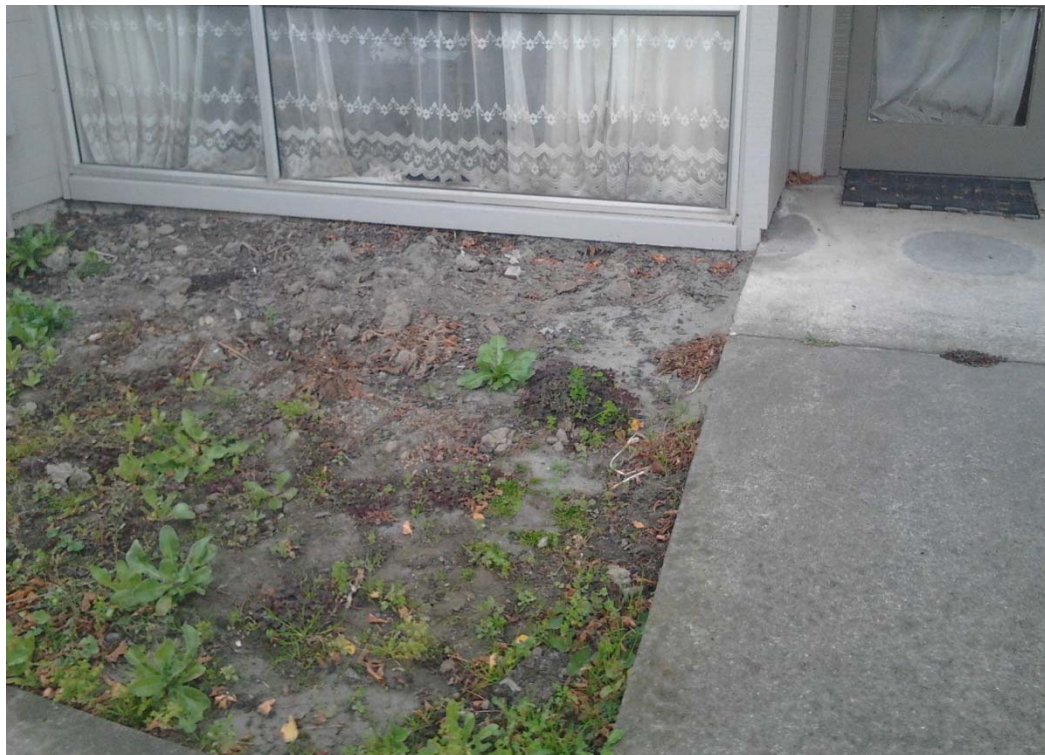
■ **Figure 10 Remaining evidence of liquefied material ejecta**
