# HP Smith Courts

## Detailed Engineering Evaluation Report

**Prepared for Christchurch City Council (Client)**

**By Beca Carter Hollings & Ferner Ltd (Beca)**

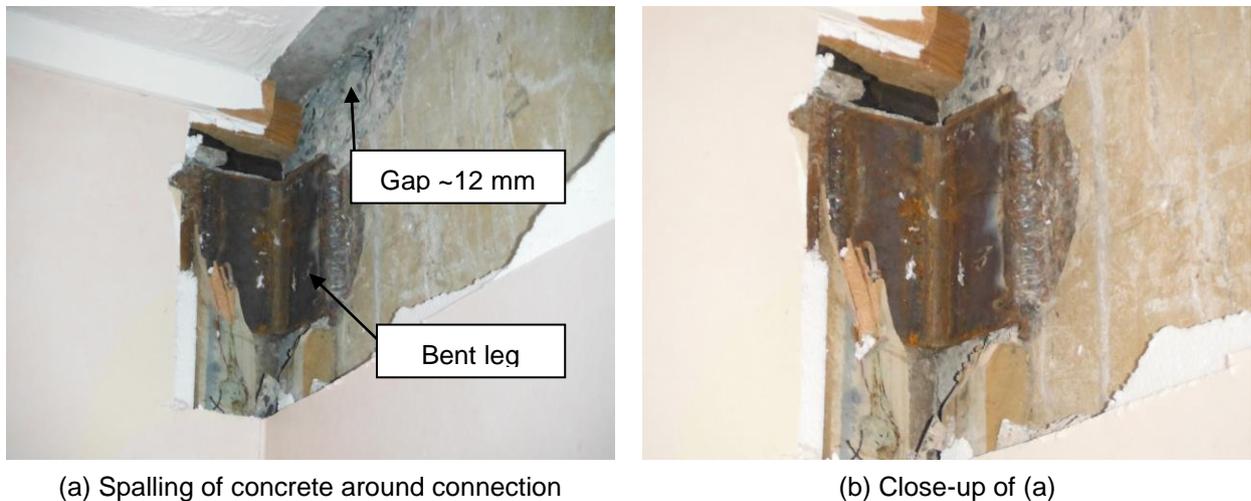
**Figure 5.1: Precast wall to 1<sup>st</sup> floor slab connection (Unit 11, Block B)**

Opus carried out intrusive investigations on Block A and Block B on 14 May 2014. Refer to Appendix G for Opus site reports. The main dividing wall in Block B was found to have pulled apart from the level 1 floor slab with damage observed to the connections between the precast wall and the reinforced concrete floor slab. Beca carried out a further damage inspection on 28 May 2014 to investigate the panel connection to the first floor slab in Unit 11 and a gap of approximately 12 mm

was found between the slab and precast wall. The leg of the wall to wall steel angle connection have also been found to be bent to approximately 105 degrees, indicating bending of the leg by approximately 15 degrees. Figure 5.1 shows the subject slab-wall connection.

This connection has failed in a brittle manner, most likely when subjected to the differential settlement between the two parts of the block on either side of this main dividing wall. The floor slab is therefore considered to be a collapse hazard.

- The building is not occupied until the damage has been repaired.
- The damaged connection between the precast wall panel and the first floor slab in Units 11/12 is repaired.
- Strengthening of first floor slab to precast wall panel connection in all units is strongly recommended.
- A full damage assessment is carried out for insurance purposes.
  - The results of the verticality and level survey should be considered further in relation to the damage investigations and observations. The measured tilt and differential settlement are considered likely to have resulted from earthquake shaking. Further investigation as part of a damage inspection should be carried out to determine if this movement recorded has caused additional damage to the structure, that may be hidden, and not yet identified.

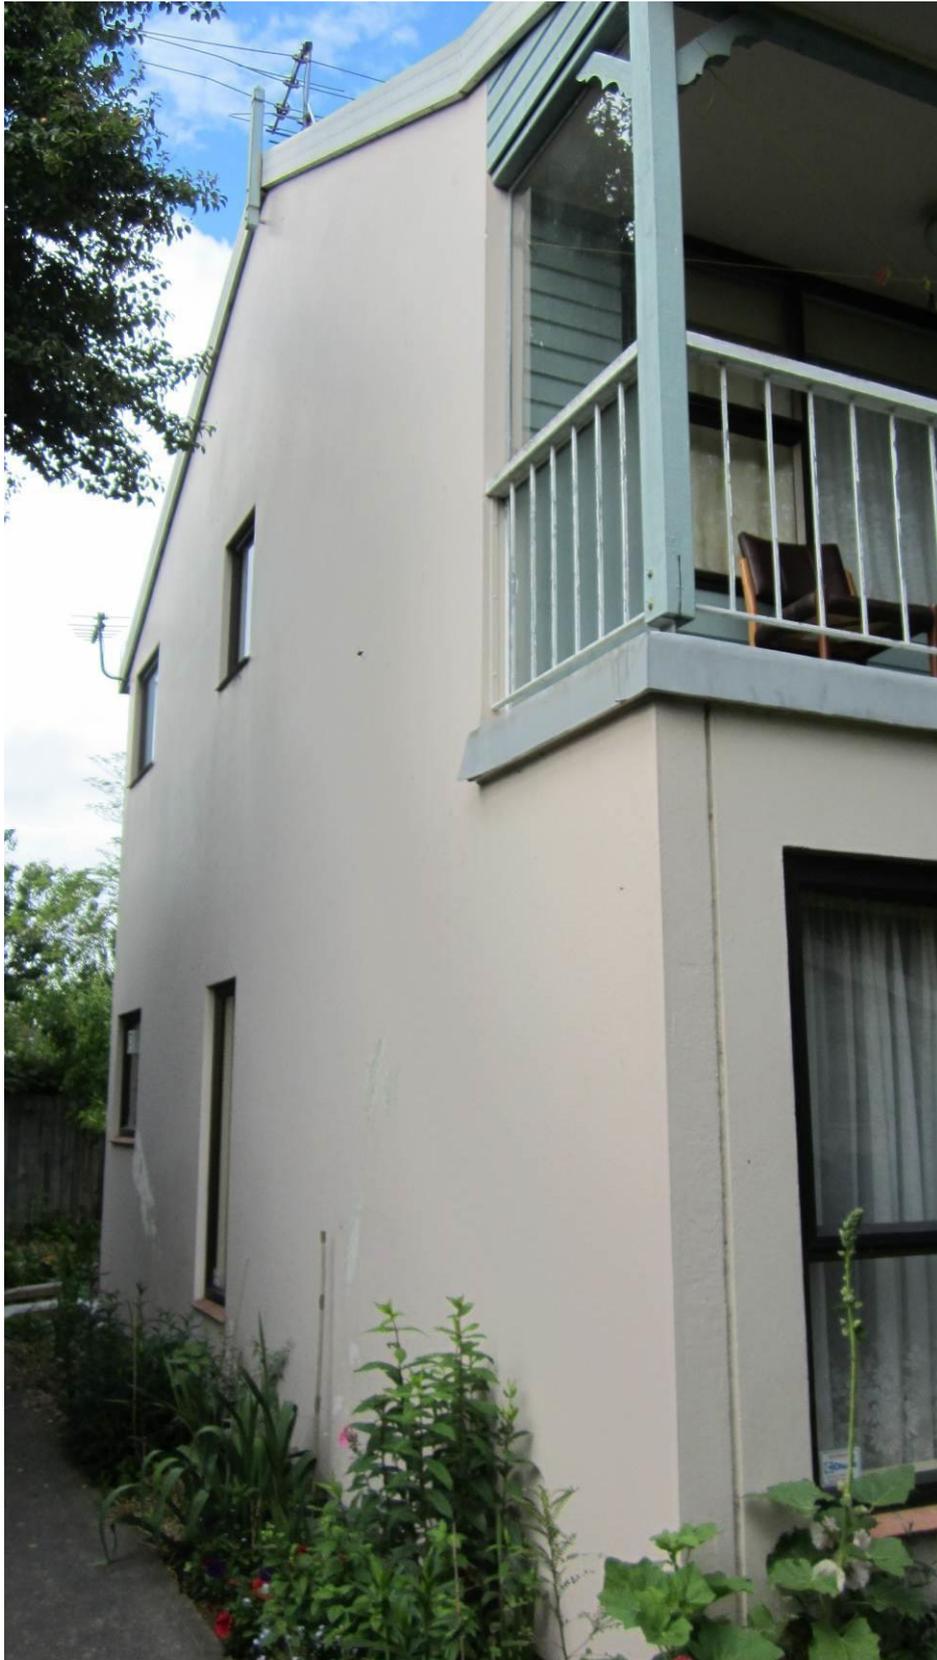
**Photo 6:** Side elevation of Block B. Detail is typical for both ends of Block A and Block B. (0.1mm crack width)

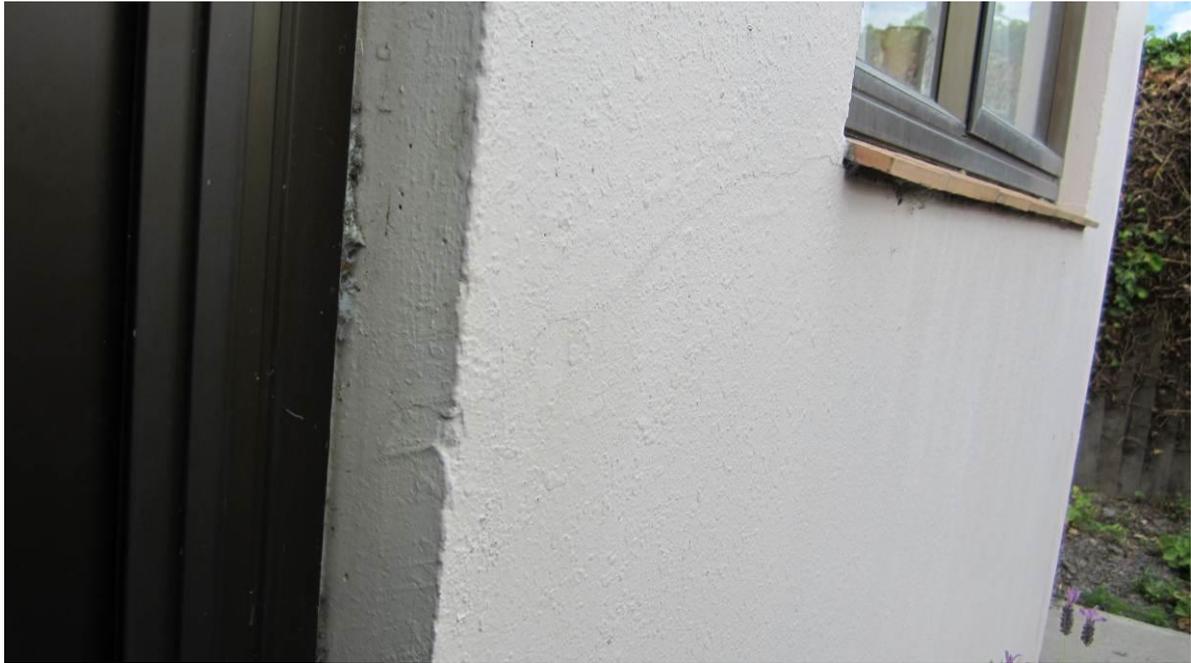
**Photo 7:** Precast concrete wall panel at rear of Block A.

**Damage Description:** Cracking of precast reinforced concrete panel. (0.1mm crack width)

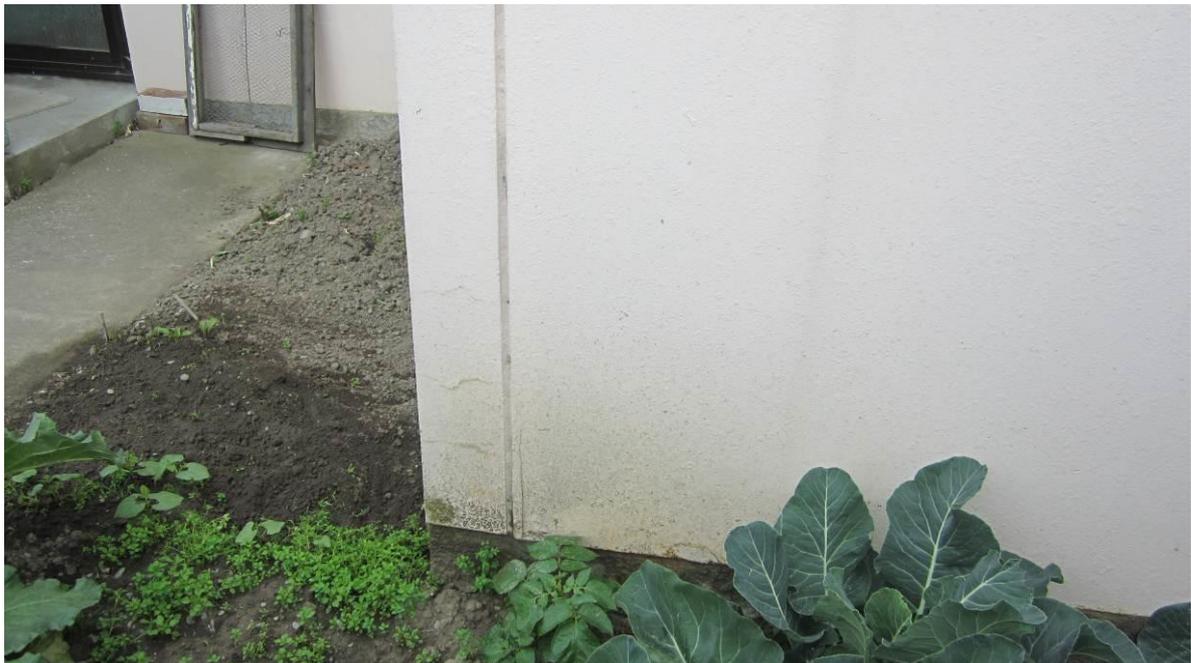
**Photo 8:** Precast concrete wall panel at rear of Block A.

**Damage Description:** Cracking of precast reinforced concrete panel. (0.1mm crack width)

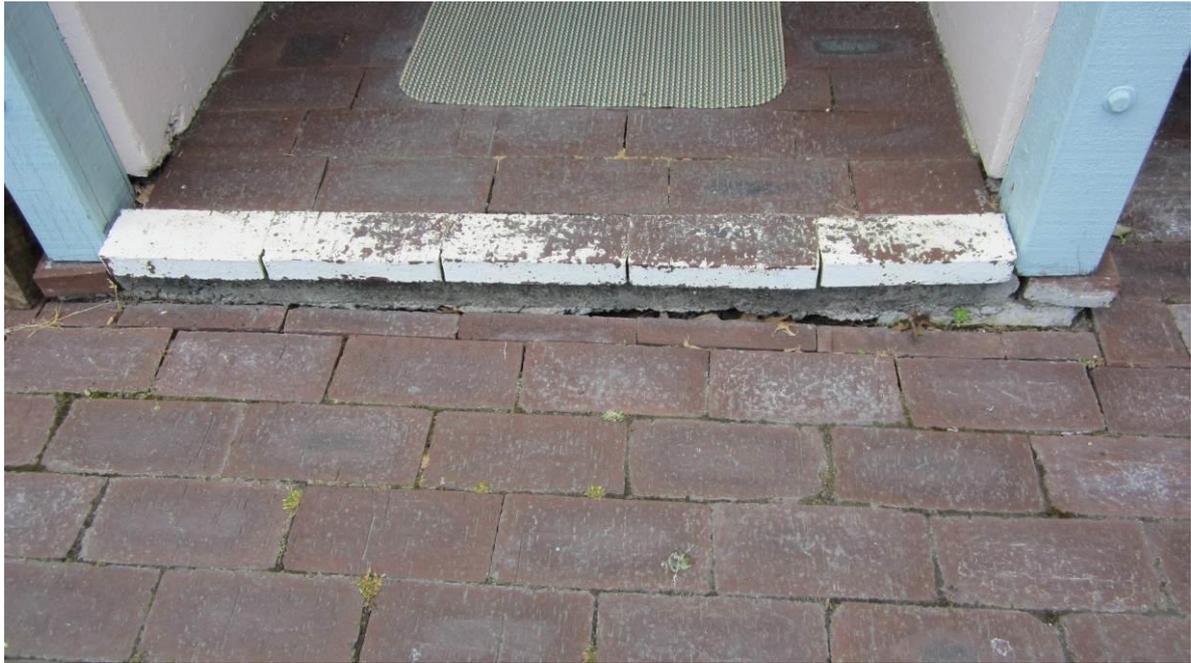
**Photo 9:** Typical paving at front of Block A and Block B.

**Damage Description:** Settlement of external ground/paving.

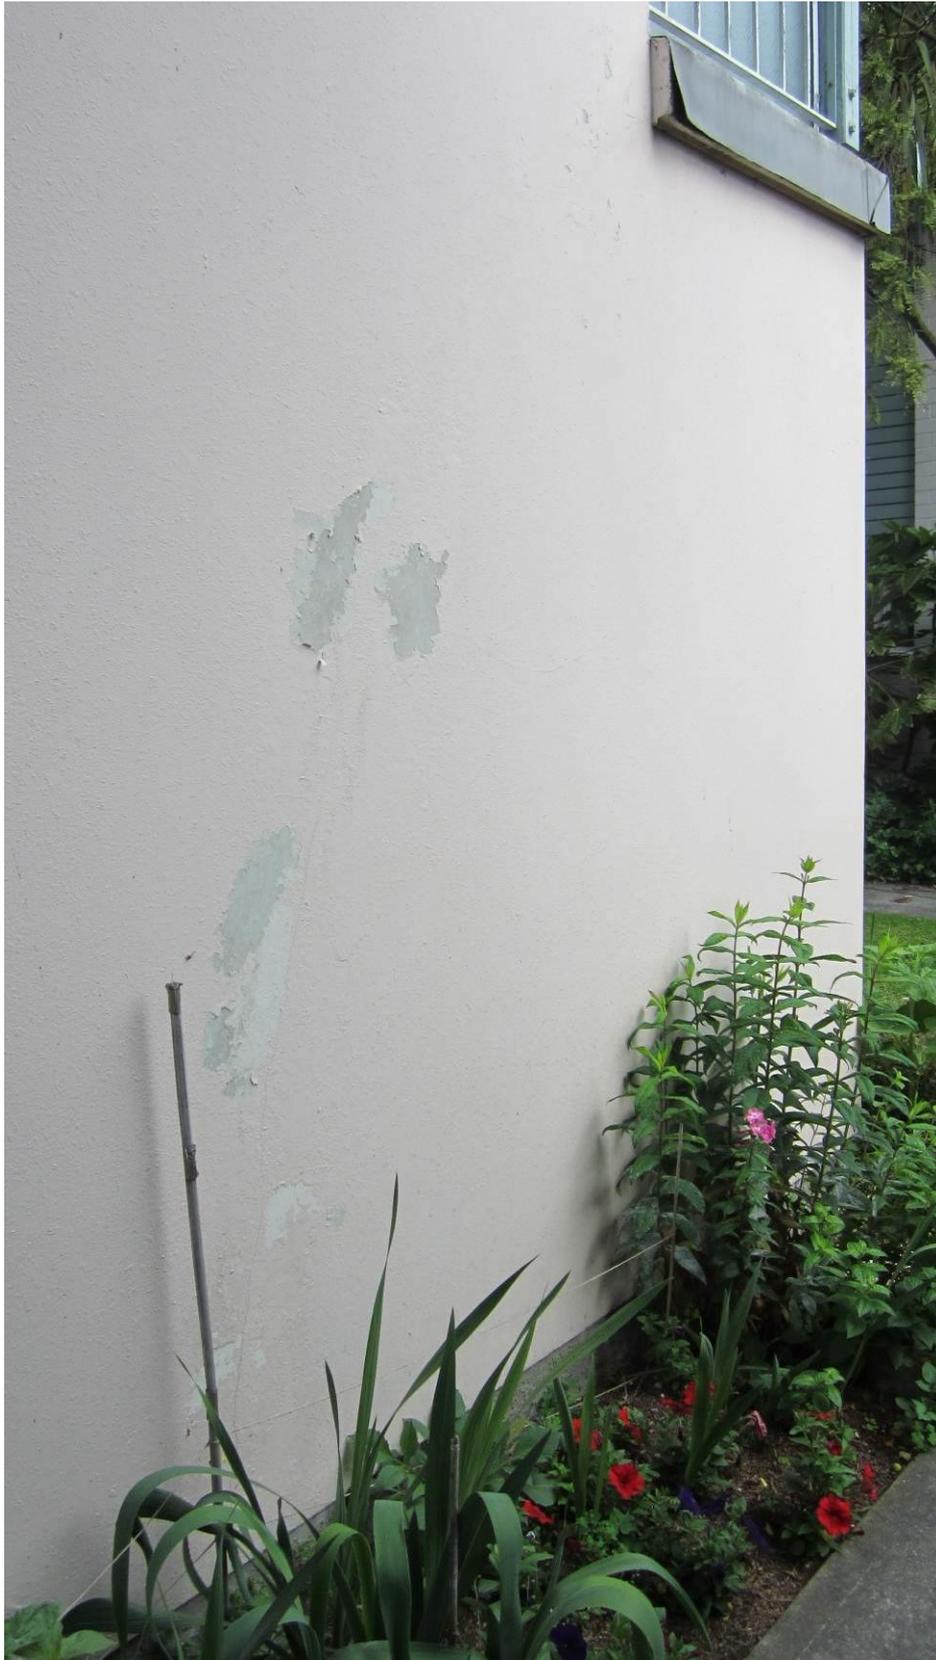
**Photo 10:** Precast concrete wall panel at end of Block B.

**Damage Description:** Cracking of precast reinforced concrete panel (diagonal from balcony - 0.1mm crack width)

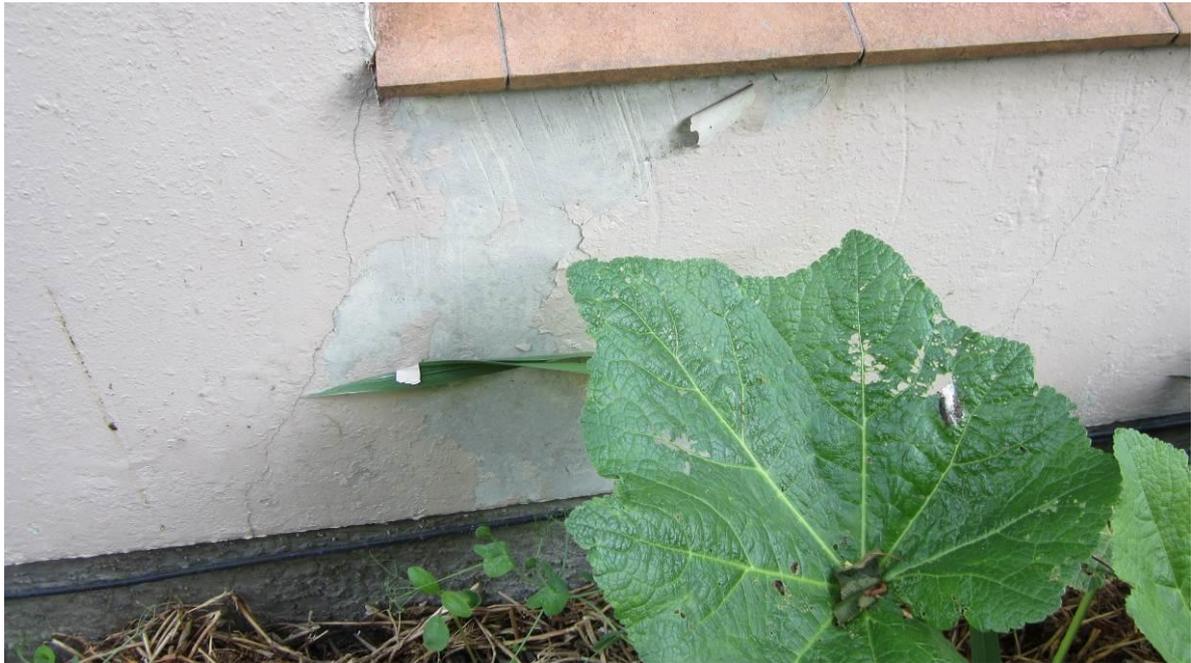
**Photo 11:** Precast concrete wall panel at end of Block B.

**Damage Description:** Cracking of precast reinforced concrete panel. (0.1mm crack width)

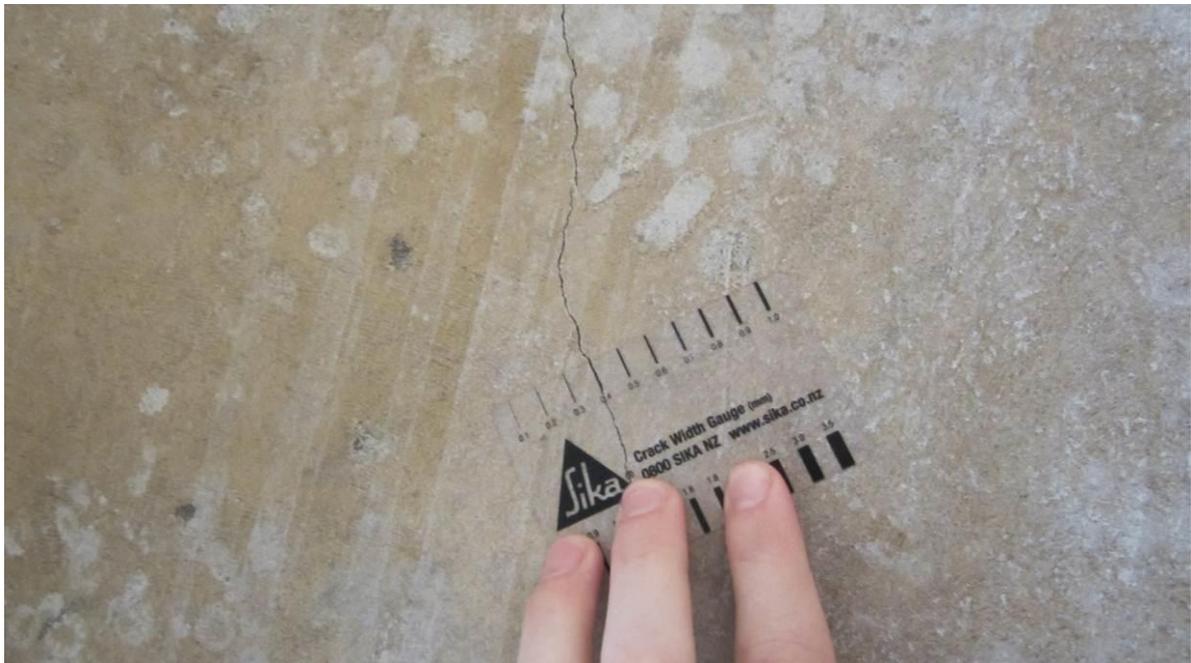
**Photo 12:** Precast reinforced concrete panel beneath stairs in Block B.

**Damage Description:** Cracking of precast reinforced concrete panel. (0.4mm crack width)

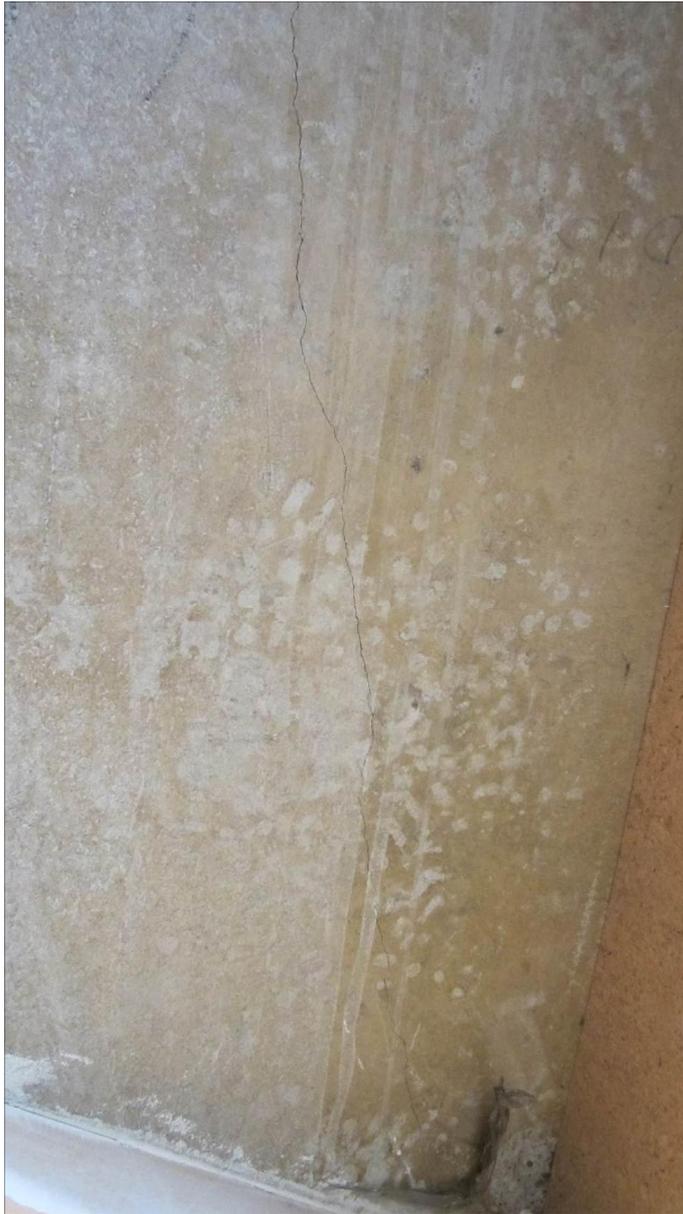
**Photo 13:** Precast reinforced concrete panel beneath stairs in Block B. (Transverse wall)

**Damage Description:** Cracking of precast reinforced concrete panel. (0.4mm crack width)

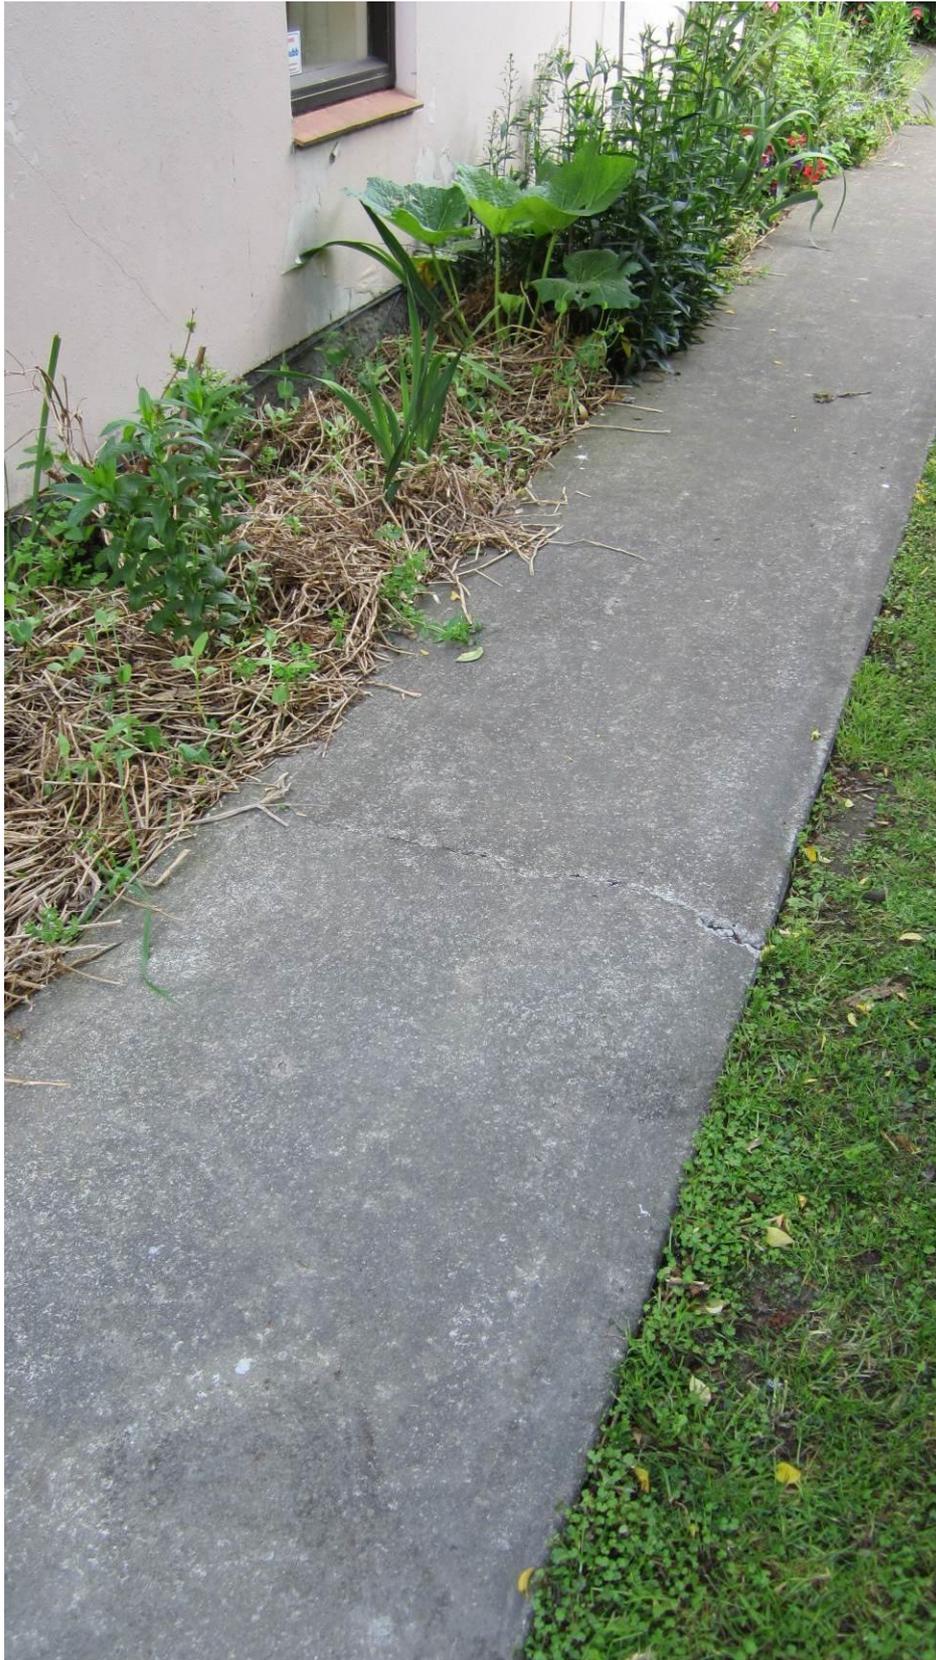
**Photo 14:** Typical pavement surrounding all buildings.

**Damage Description:** Cracking of external pavement.

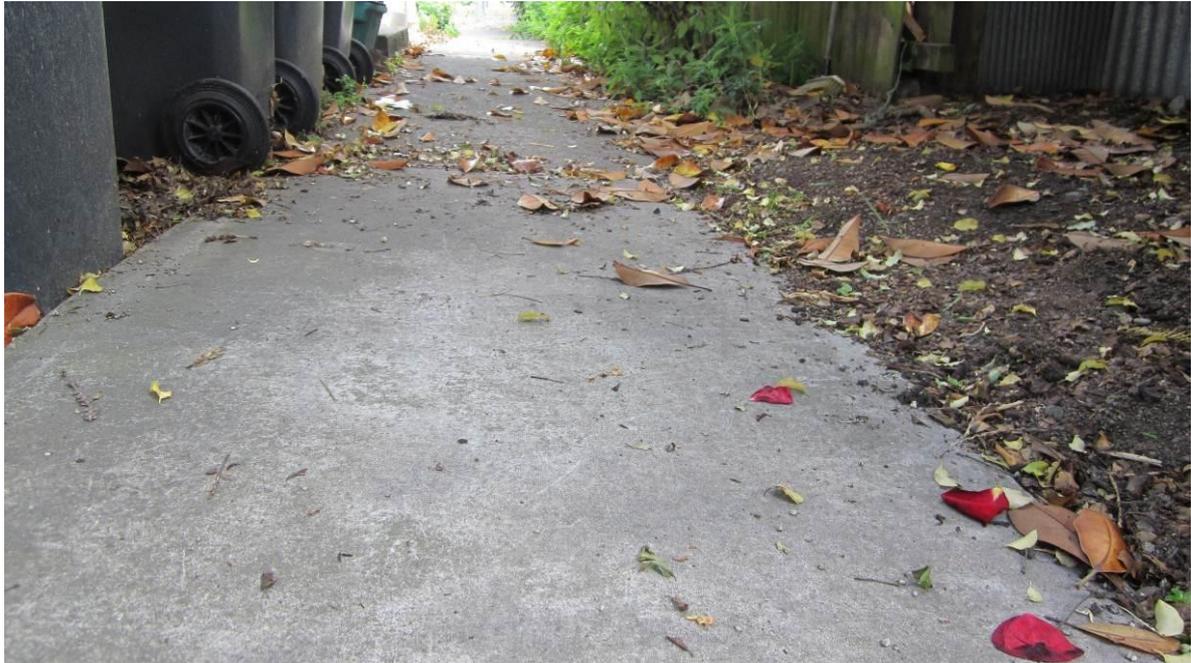
**Photo 15:** External pavement at rear of Residents' Lounge

**Damage Description:** Differential settlement of external ground.

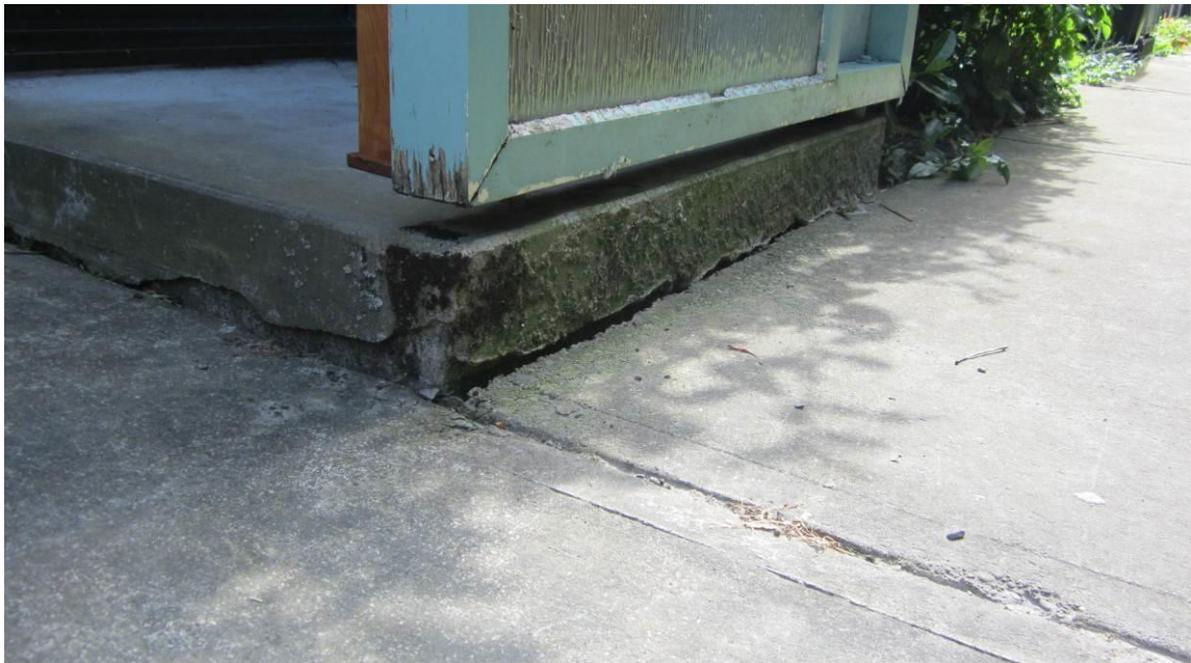
**Photo 16:** Rear porch entrance and pavement (typical for Block A, Block B and Block C).

**Damage Description:** Settlement of external paving.

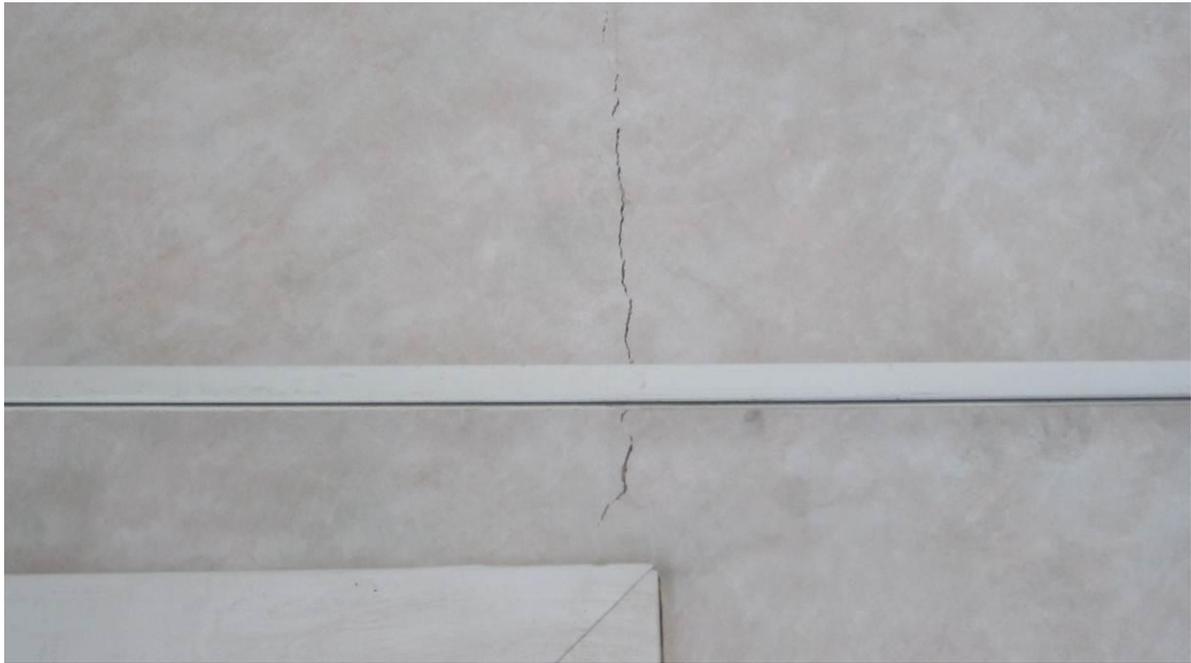
**Photo 17:** Internal wall linings, typical for all buildings.

**Damage Description:** Cracking of wall linings.

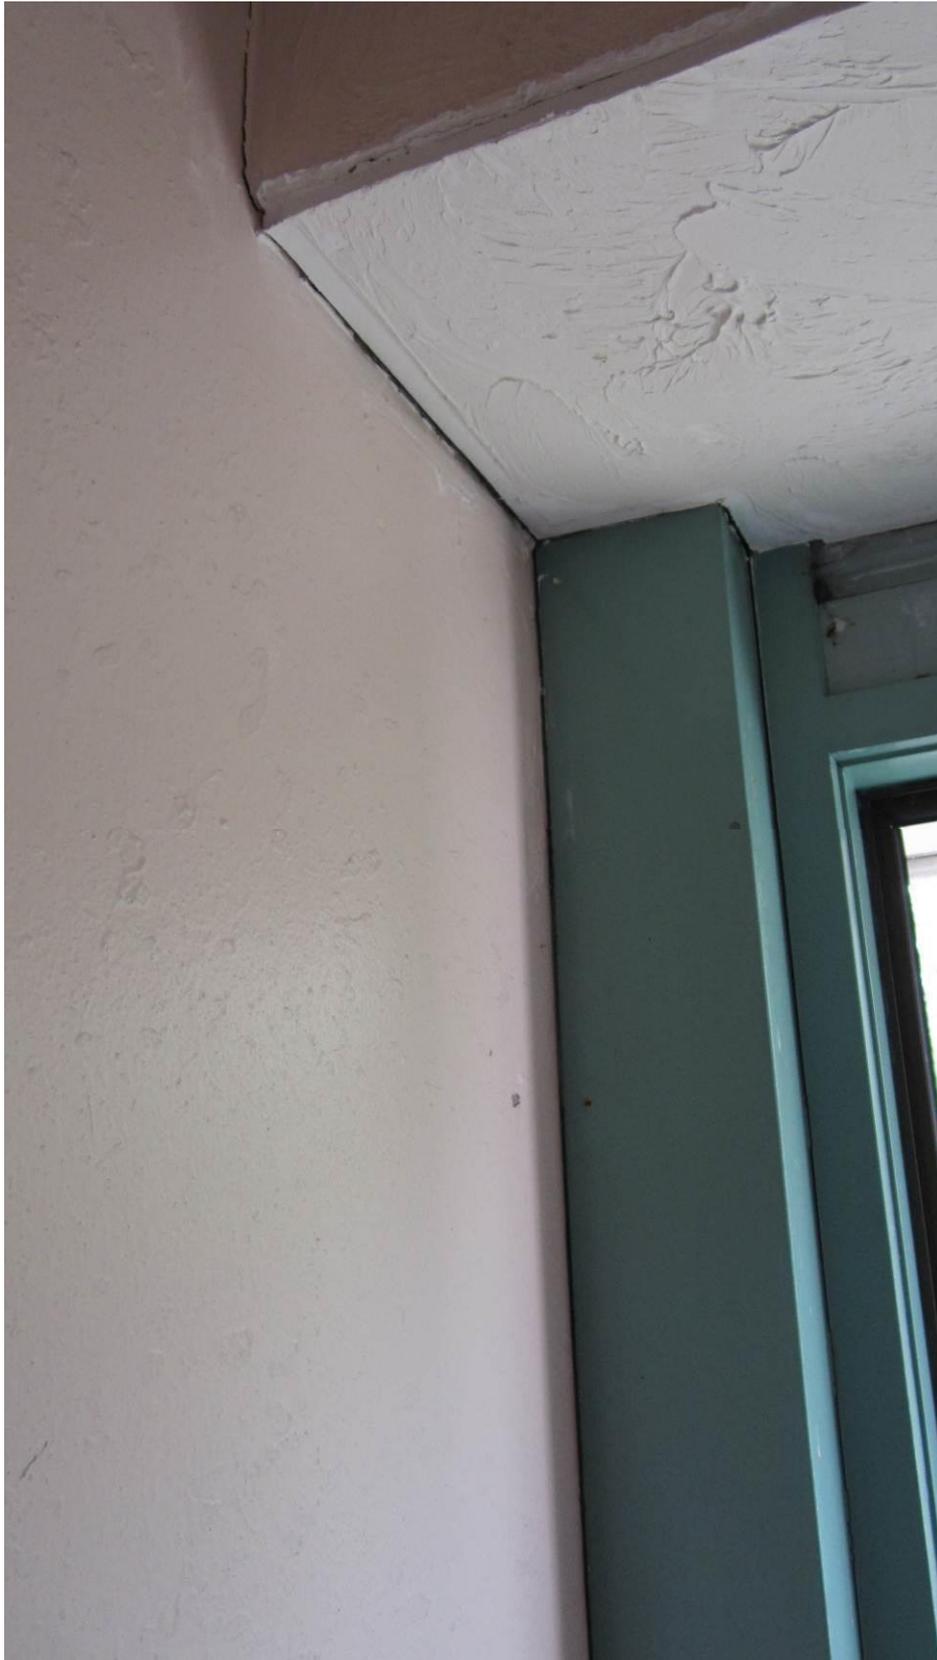
**Photo 18:** Typical internal wall and ceiling linings.

**Damage Description:** Separation of wall and ceiling linings.

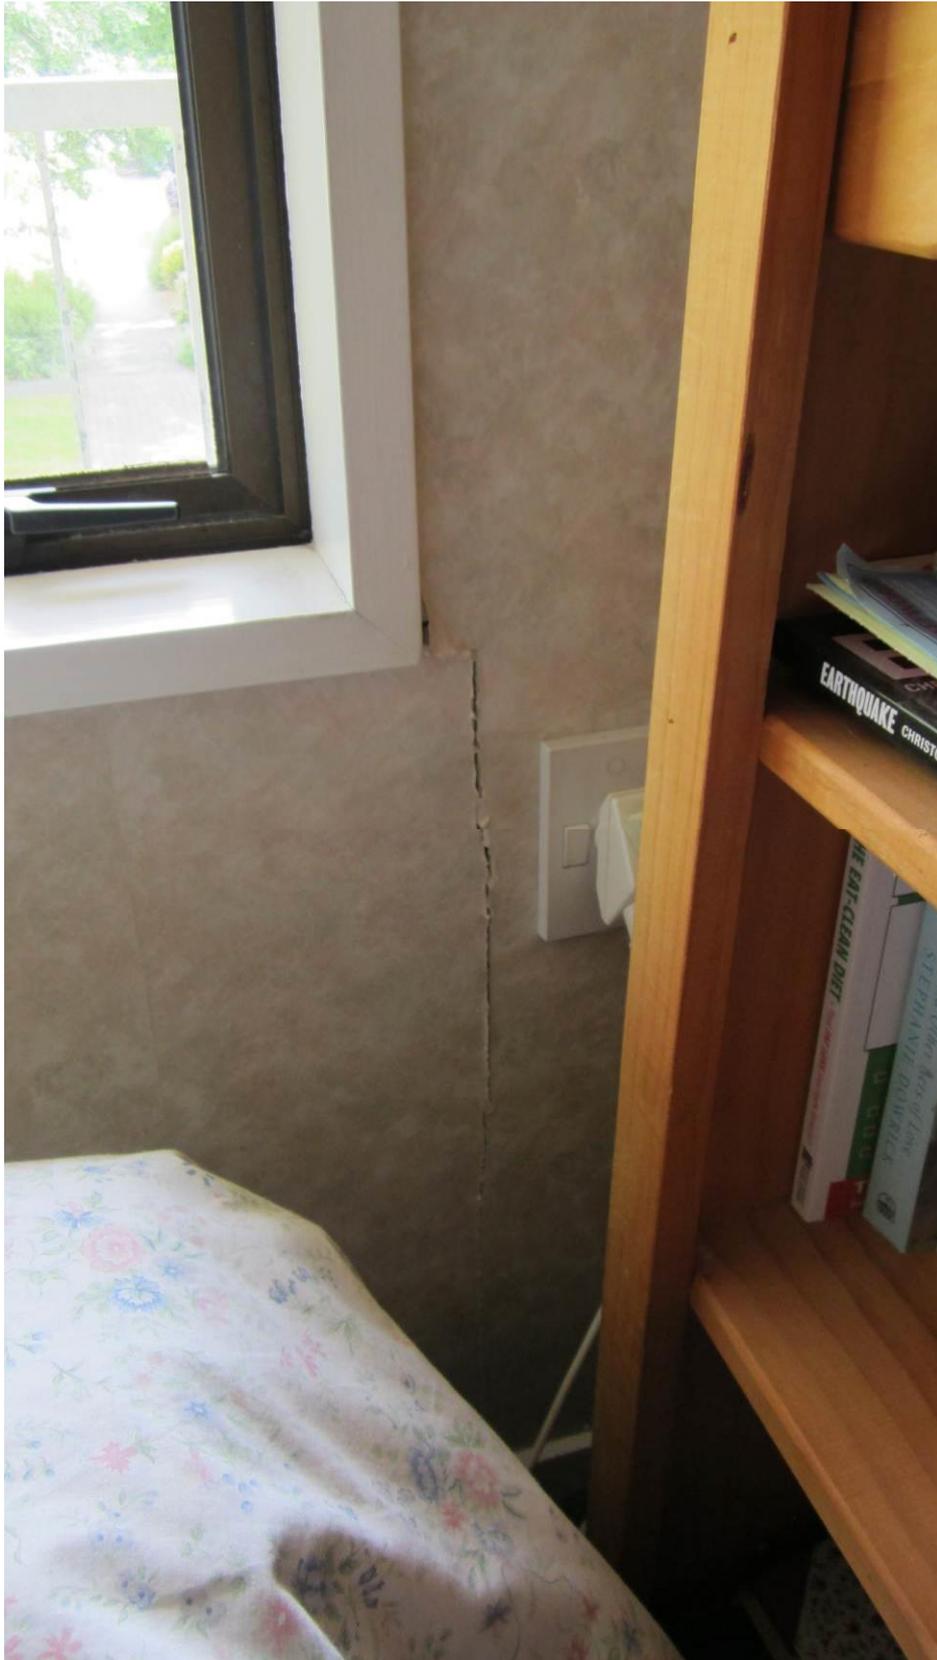
**Photo 19:** Internal wall linings.

**Damage Description:** Cracking of internal wall lining.

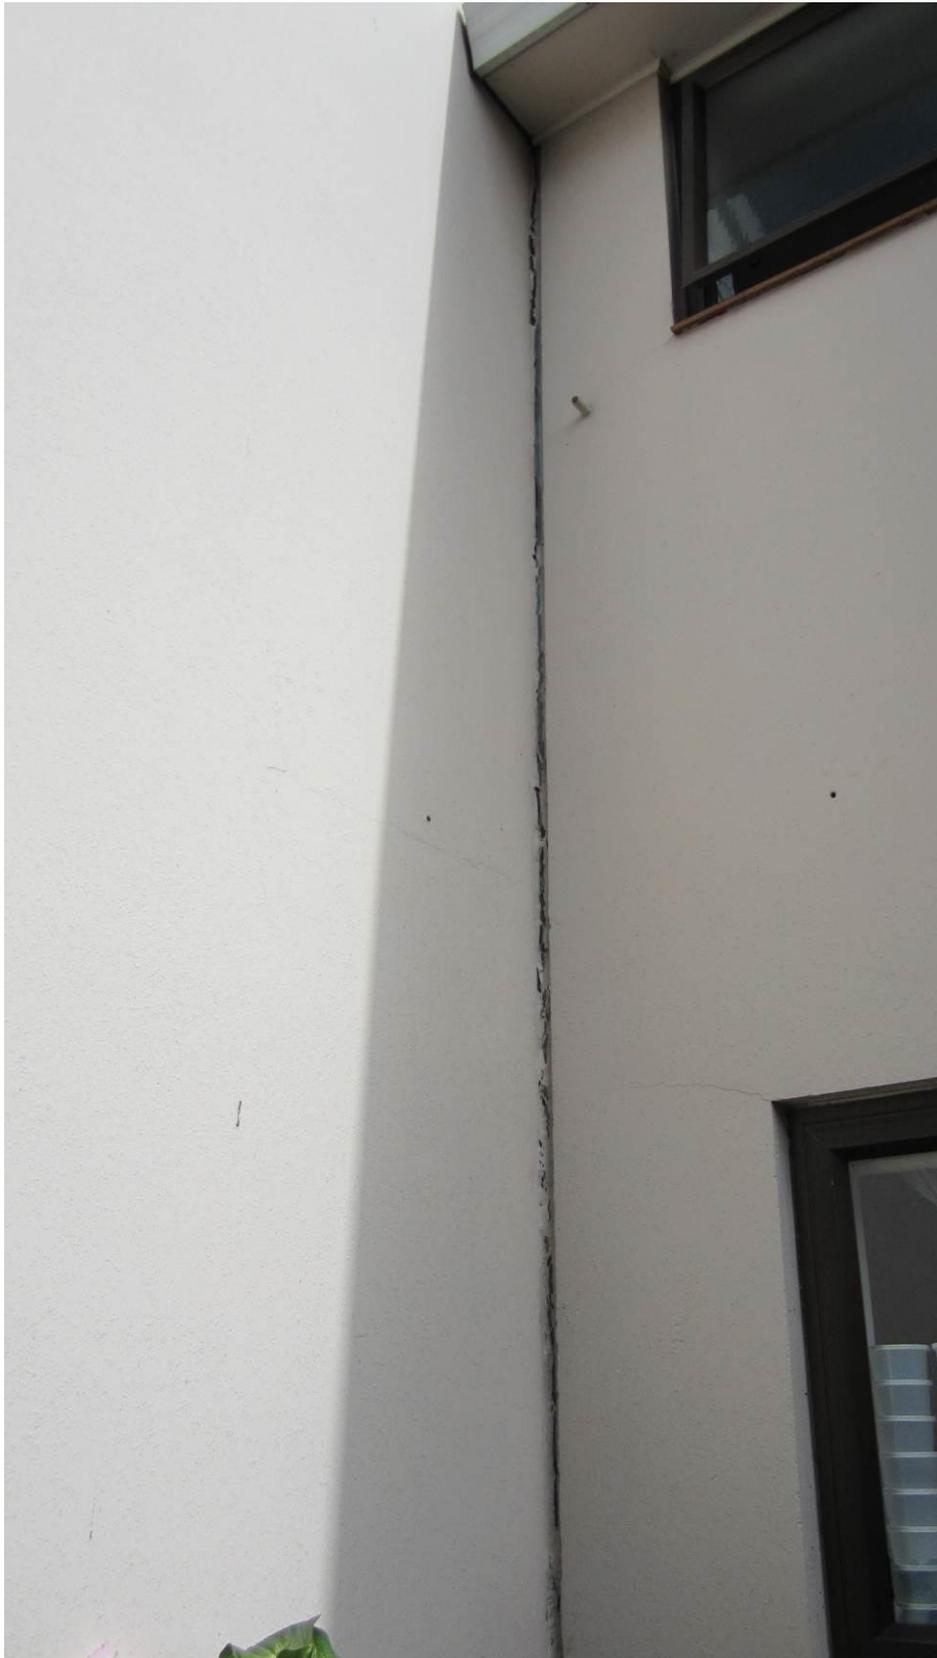
**Photo 20:** Centre precast concrete wall panel of Block B (view from south).

**Damage Description:** Tilt and residual movement of precast reinforced concrete wall.

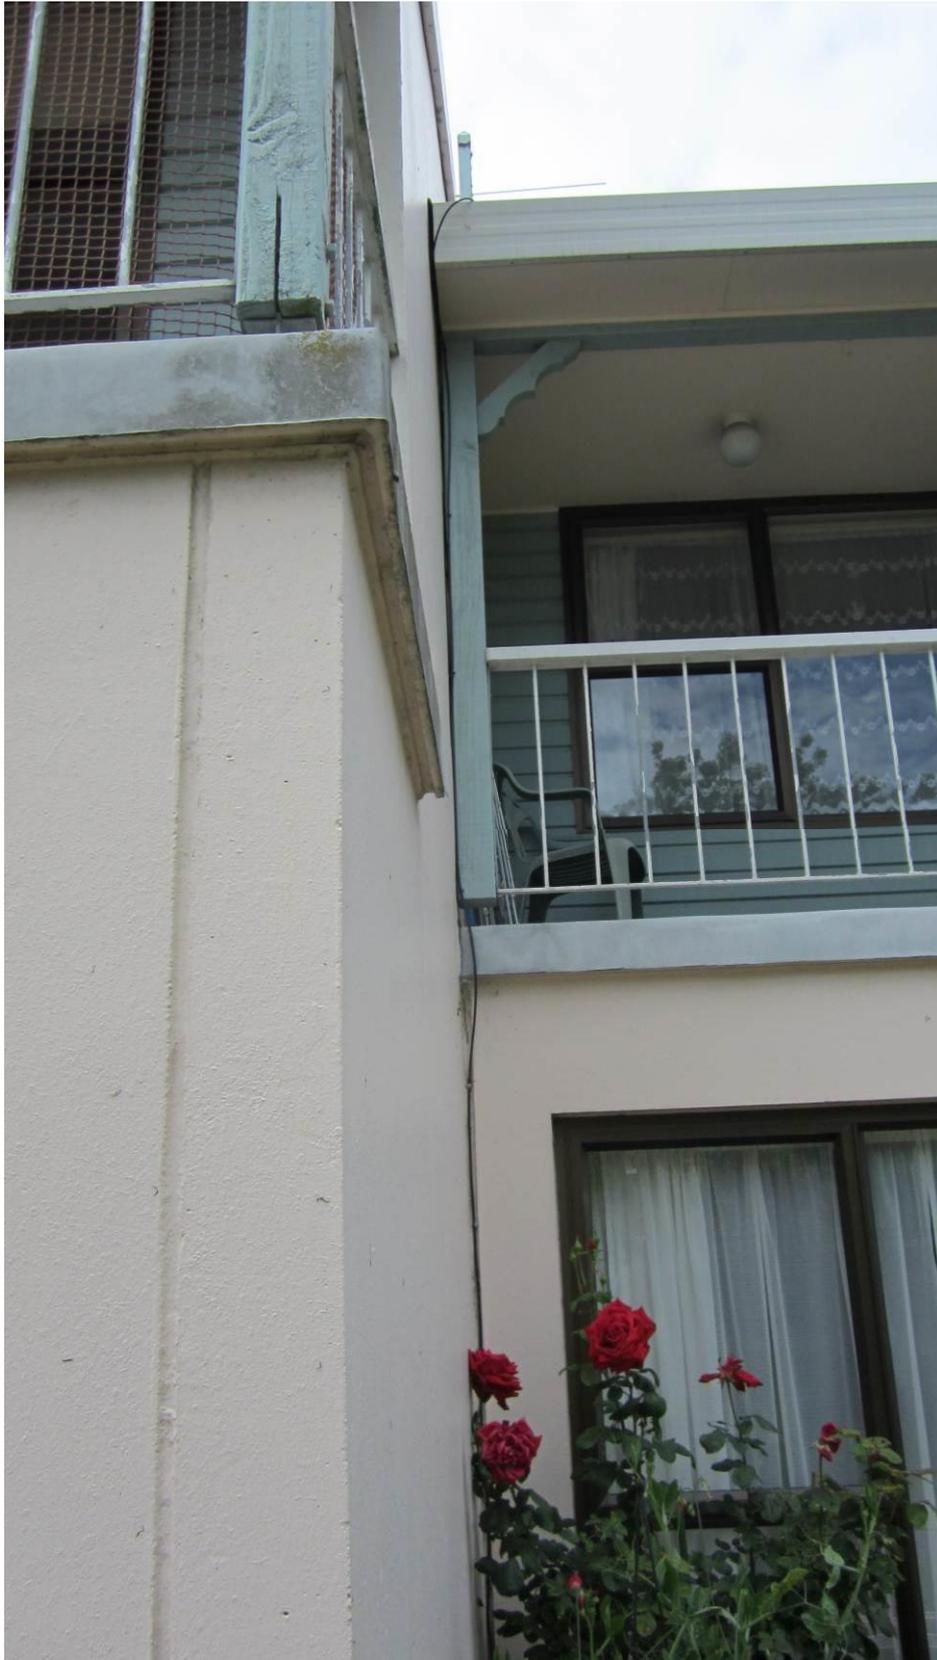
**Photo 21:** Centre precast concrete wall panel of Block B (view from north).

**Damage Description:** Tilt and residual movement of precast reinforced concrete wall.

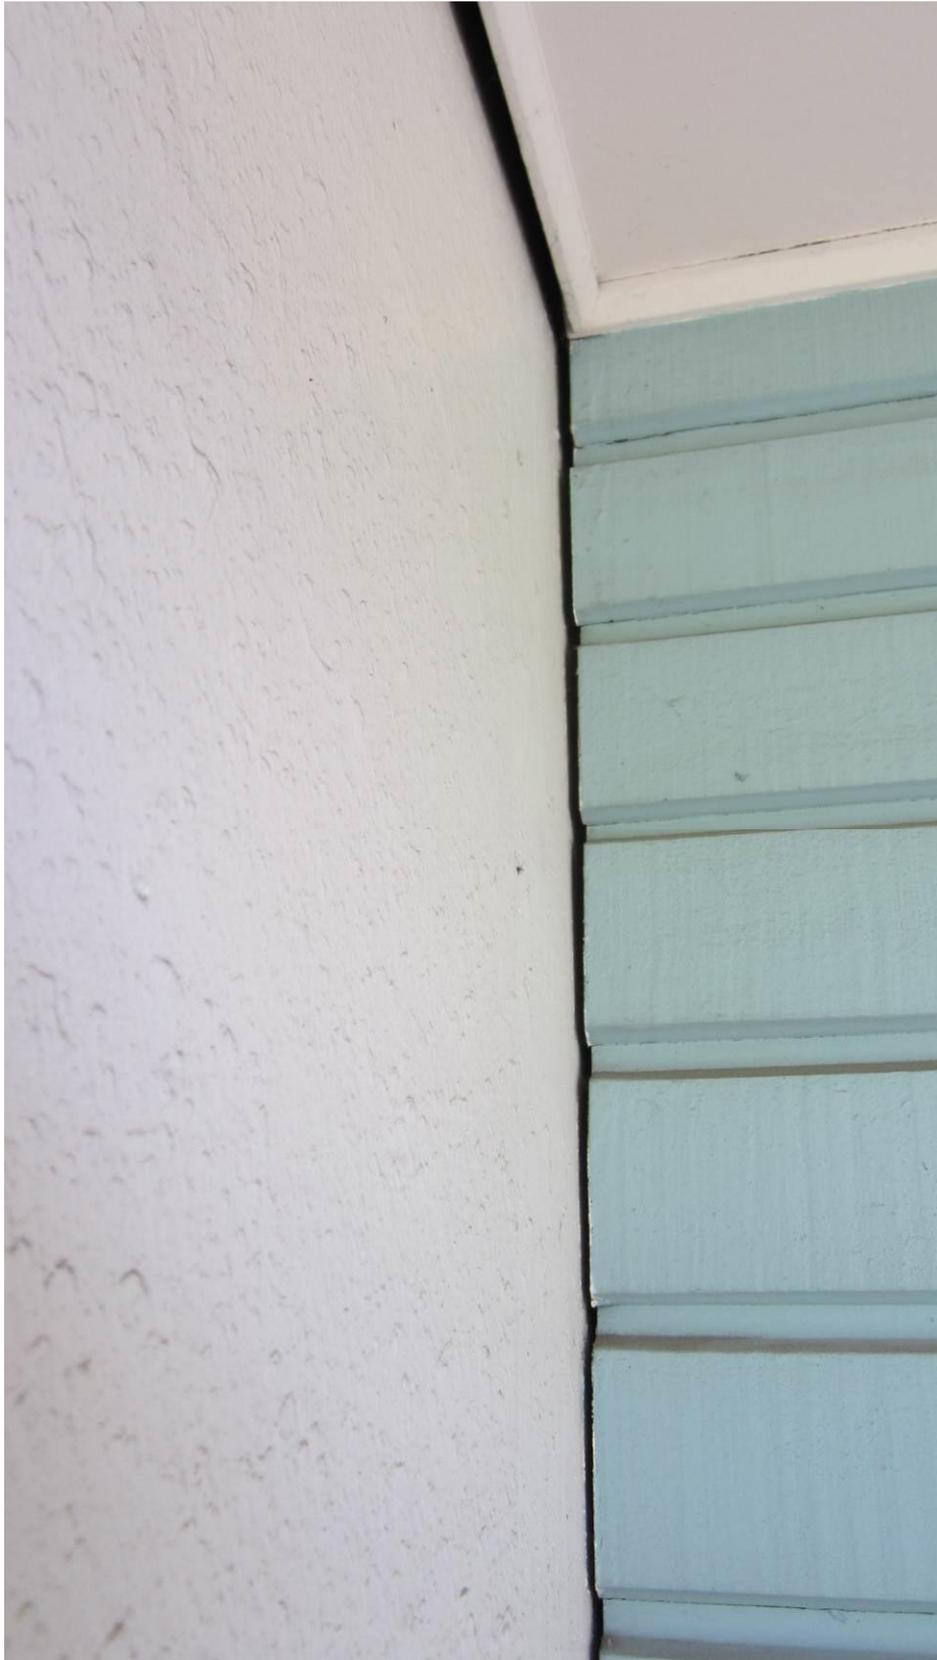
**Photo 22:** Centre precast concrete wall panel of Block B (view from north).

**Damage Description:** Tilt and residual movement of precast reinforced concrete wall.

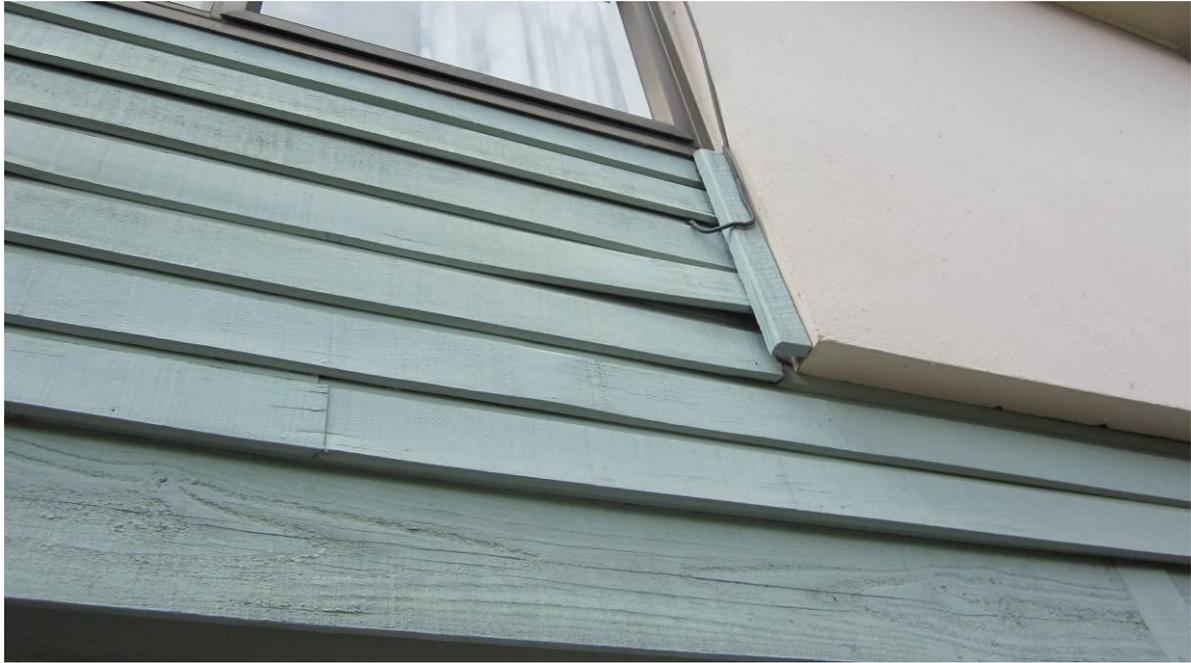
**Photo 23:** Timber wall cladding on Block B.

**Damage Description:** Buckled timber weatherboards due to movement of precast reinforced concrete walls.

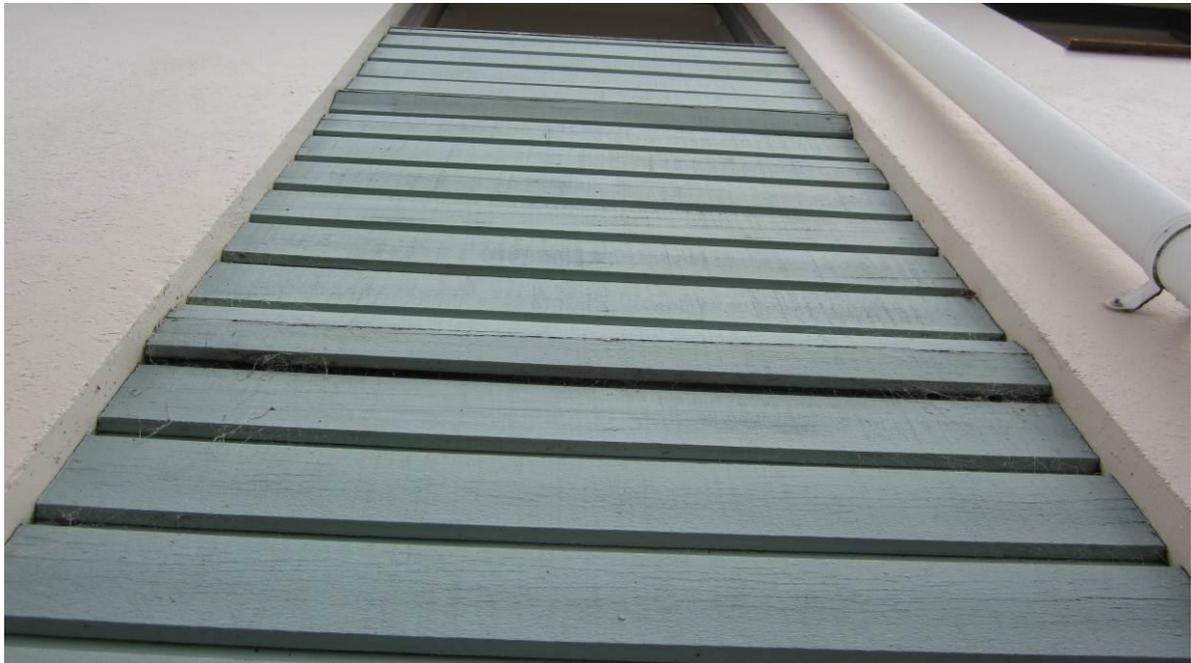
**Photo 24:** Timber wall cladding on Block B.

**Damage Description:** Buckled timber weatherboards due to movement of precast reinforced concrete walls.
