# HP Smith Courts

## Detailed Engineering Evaluation Report

**Prepared for Christchurch City Council (Client)**

**By Beca Carter Hollings & Ferner Ltd (Beca)**

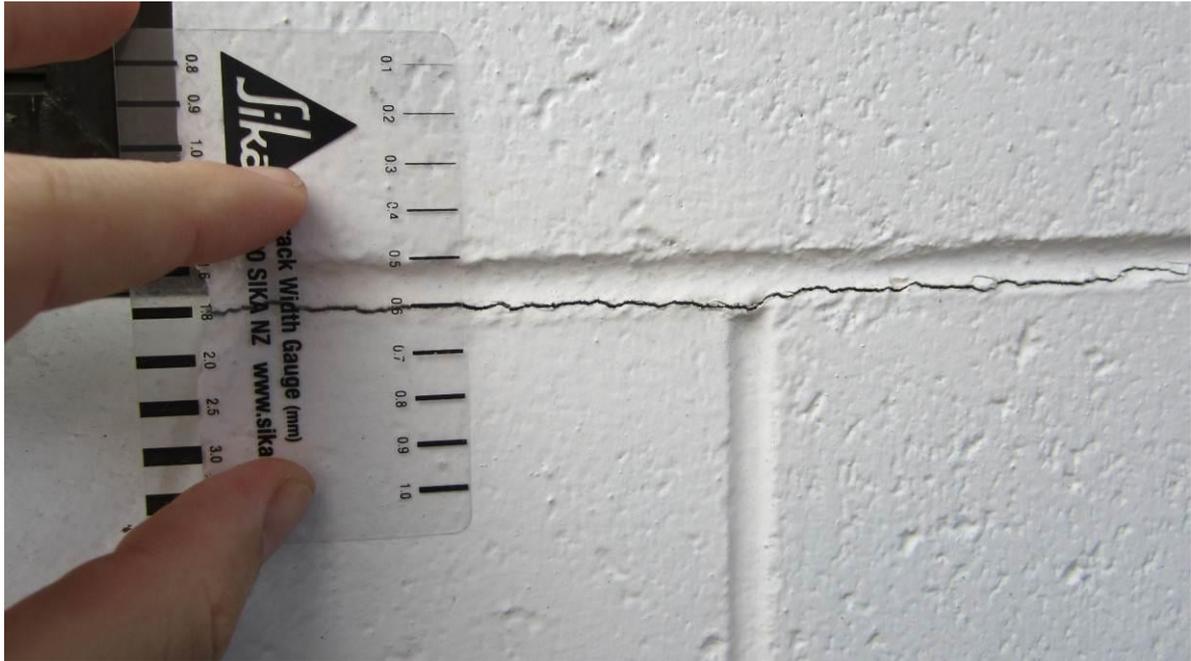
**Photo 25:** External concrete masonry block veneer of Block C.

**Damage Description:** Cracking in concrete masonry block veneer mortar.

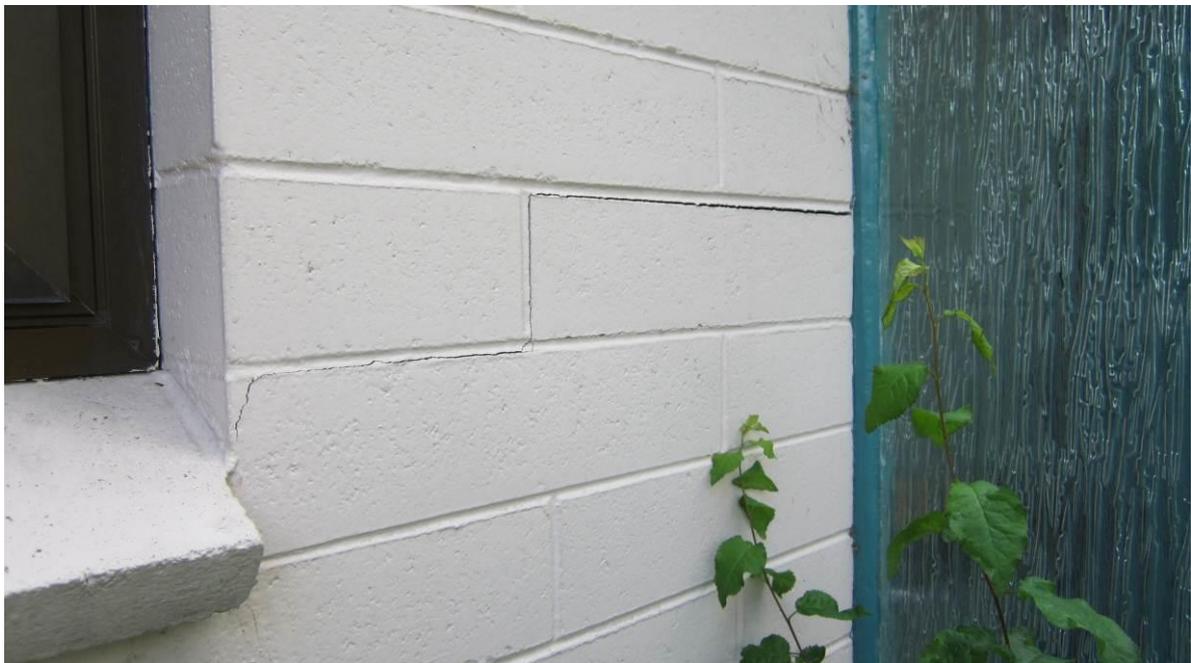
**Photo 26:** External concrete masonry block veneer of Block C.

**Damage Description:** Cracking in concrete masonry block veneer mortar.

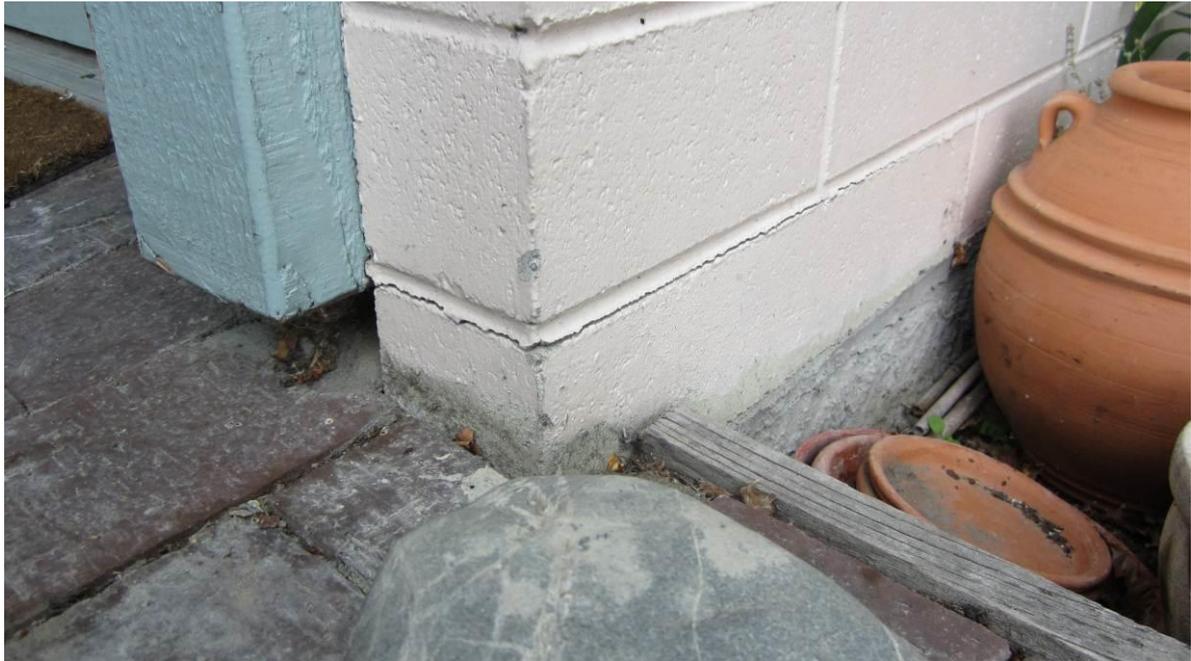
**Photo 27:** External concrete masonry block veneer at front terrace of Block C.

**Damage Description:** Cracking in concrete masonry block mortar and vertical separation of paving and timber column indicates tilt of building / differential settlement.

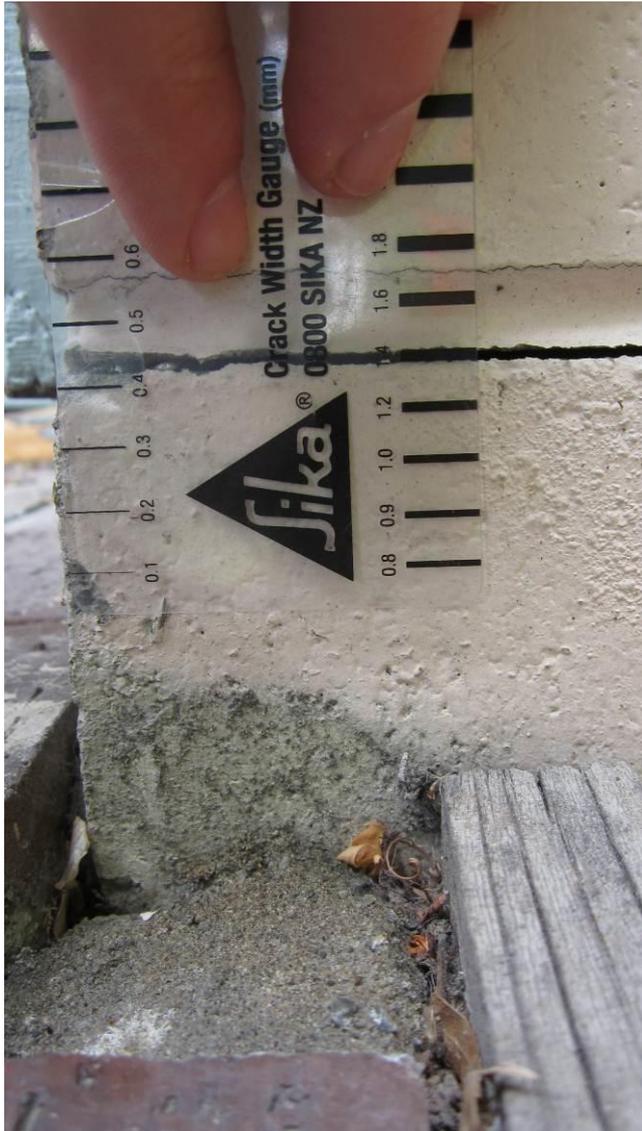
**Photo 28:** External concrete masonry block veneer at front terrace of Block C.  
**Damage Description:** 1.4mm crack in concrete masonry block mortar.

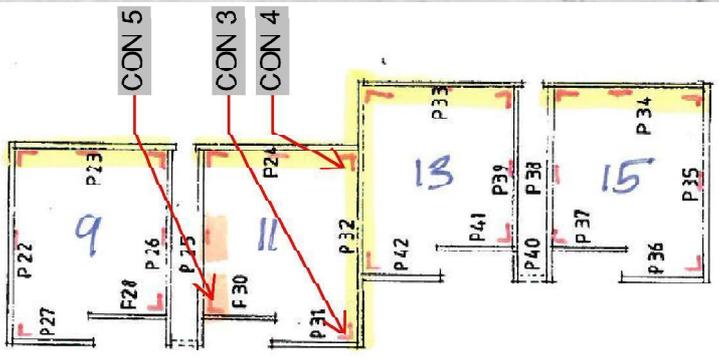
HP Smith Courts  
Unit 11  
Connection No. 4  
21.11.13 ZH//H

Small welds

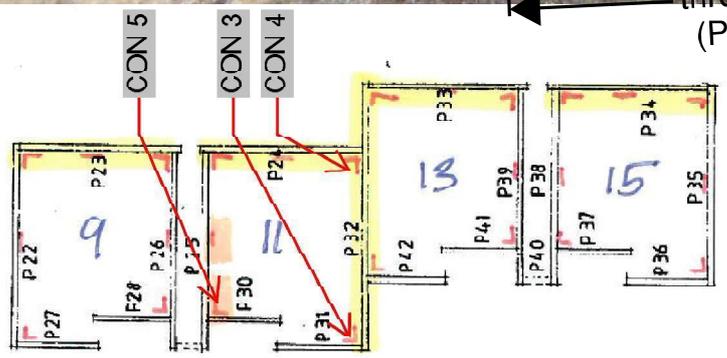
HP Smith Courts  
 Unit 11  
 Connection No. 5  
 21.11.13 ZH////

50 mm  
throat ~3-4 mm  
(Poor quality)

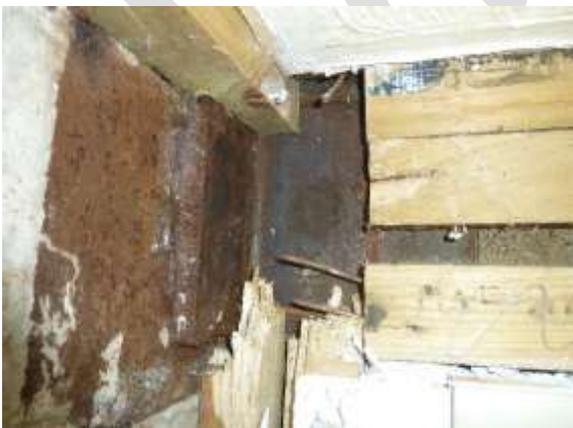
Unit 8 weld plate showing 2 welded sides

The drawing specifies that the weld is all round (implying at least 3 sides are welded). Block A has good contact between the cast in plate and the angle bracket. However the vertical alignment is such that only two sides of the bracket could be welded. In unit 4 the weld along the top was very small. There were no visible signs of damage in or around the weld plates.

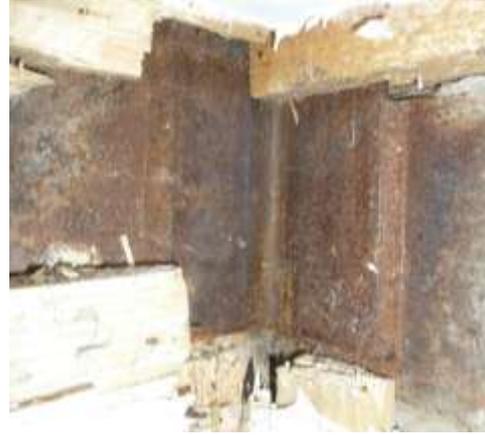
Unit 2 weld plate showing 2 welded sides

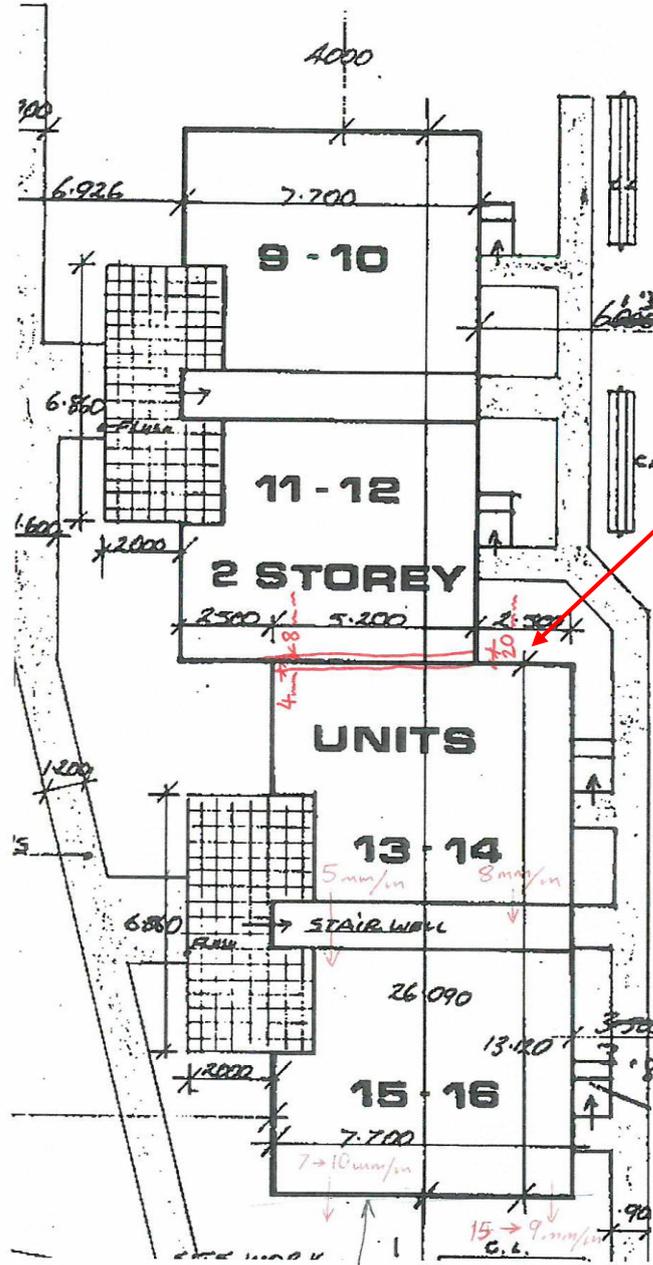
Crack width between floor slab and precast concrete wall

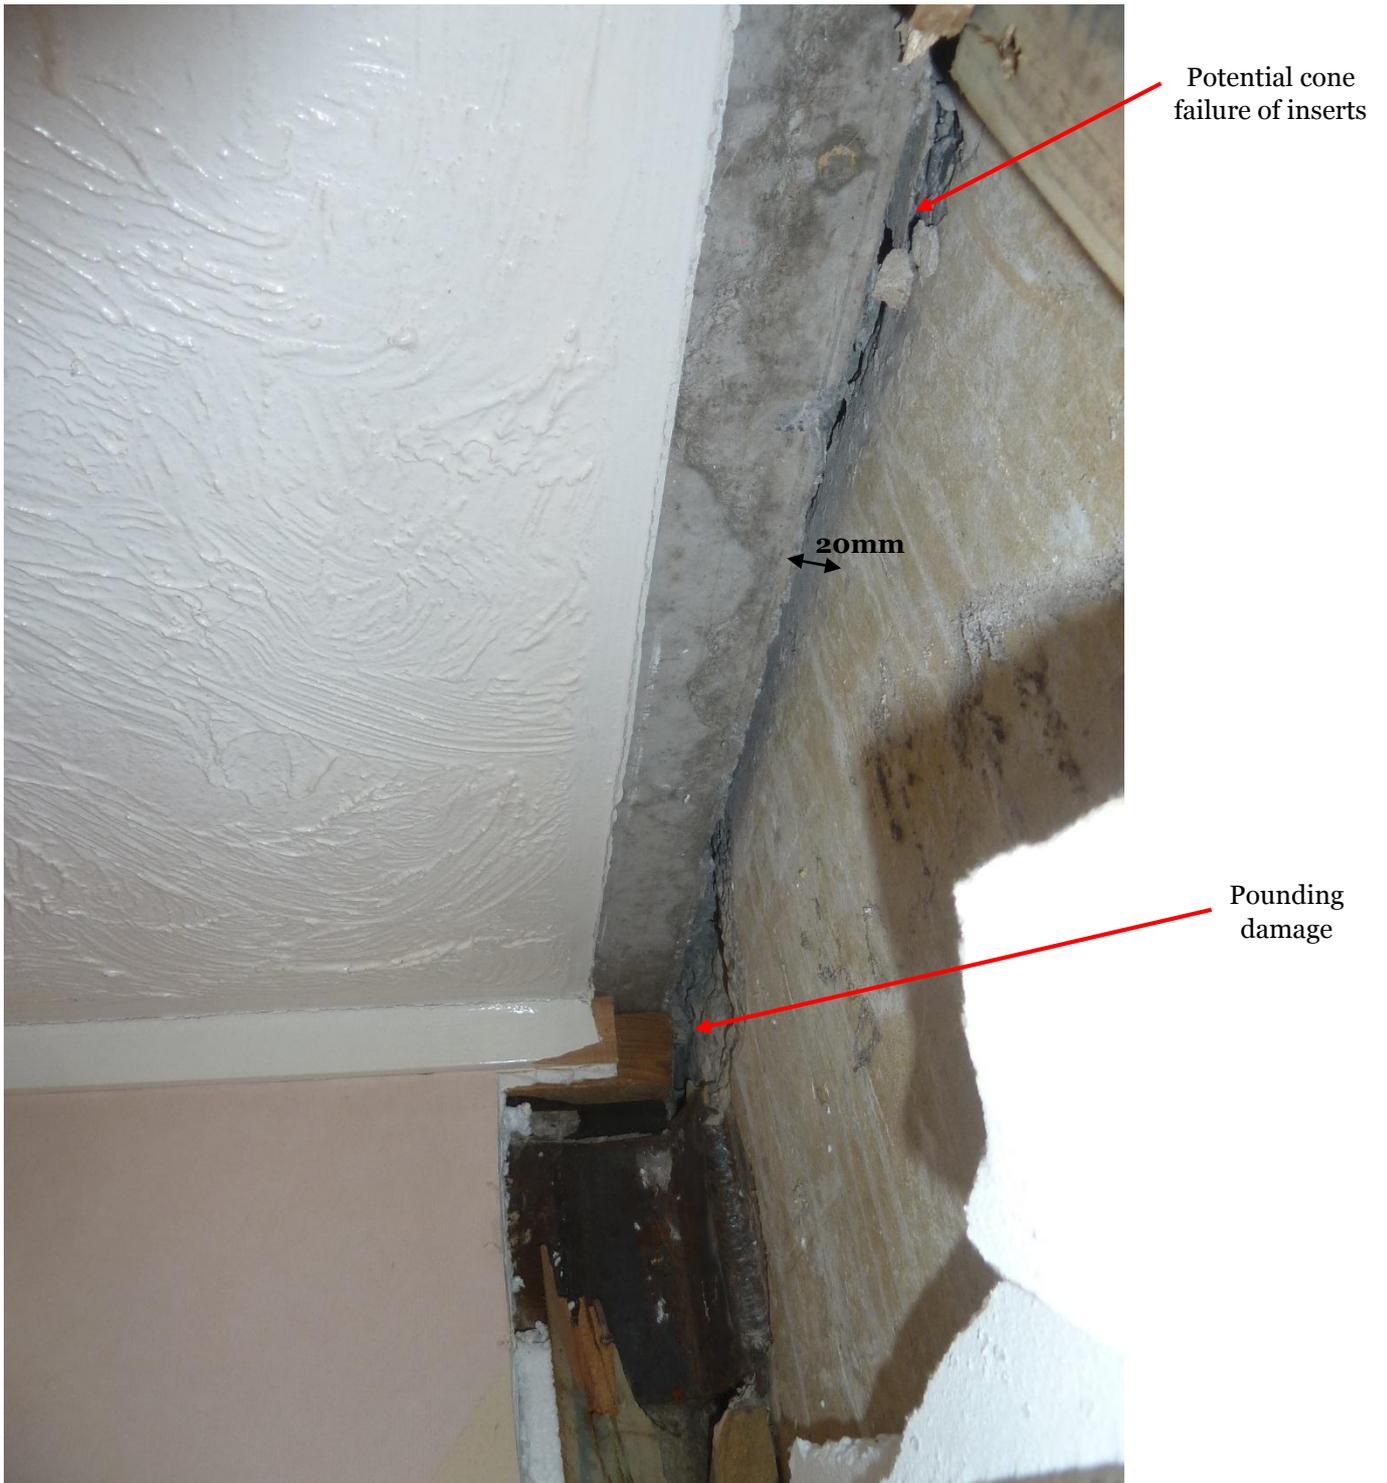
- The floor to wall connection was detailed with Conserts and a shear key. The spalled concrete in this area suggests that they have failed. Typically these sorts of connections have not performed well in earthquakes.

Photo 1: Unit 11 First floor slab pulling away from the tilt slab intermediate wall

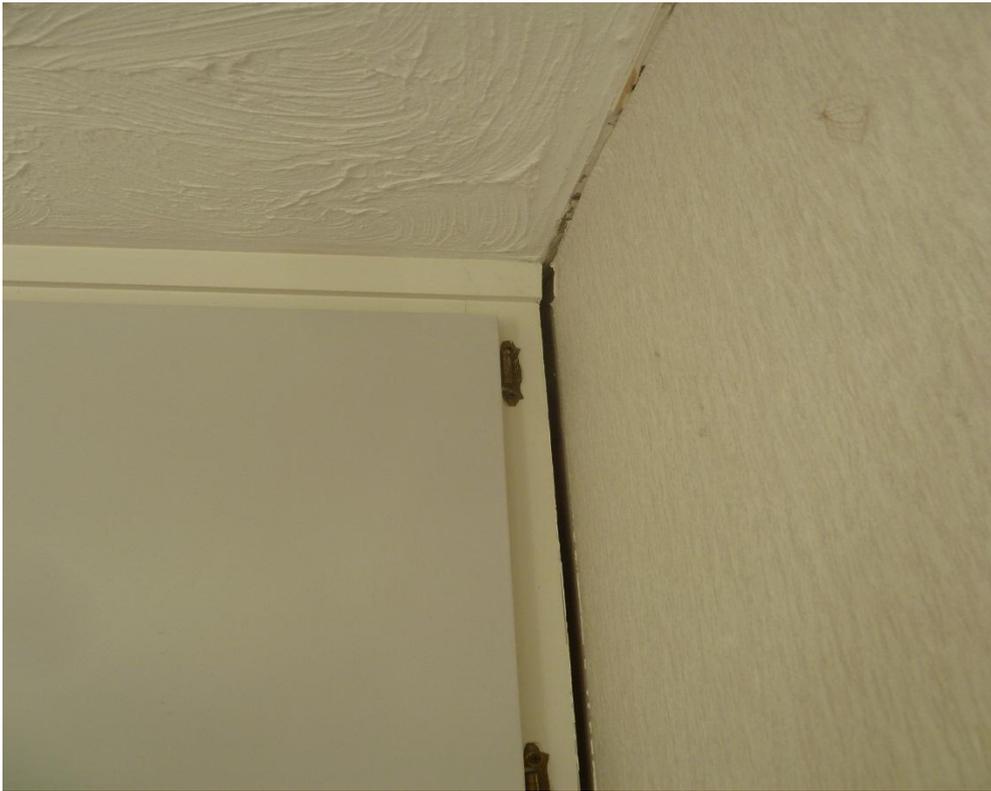
Photo 2: Unit 11 First floor slab pulling away from the tilt slab intermediate wall

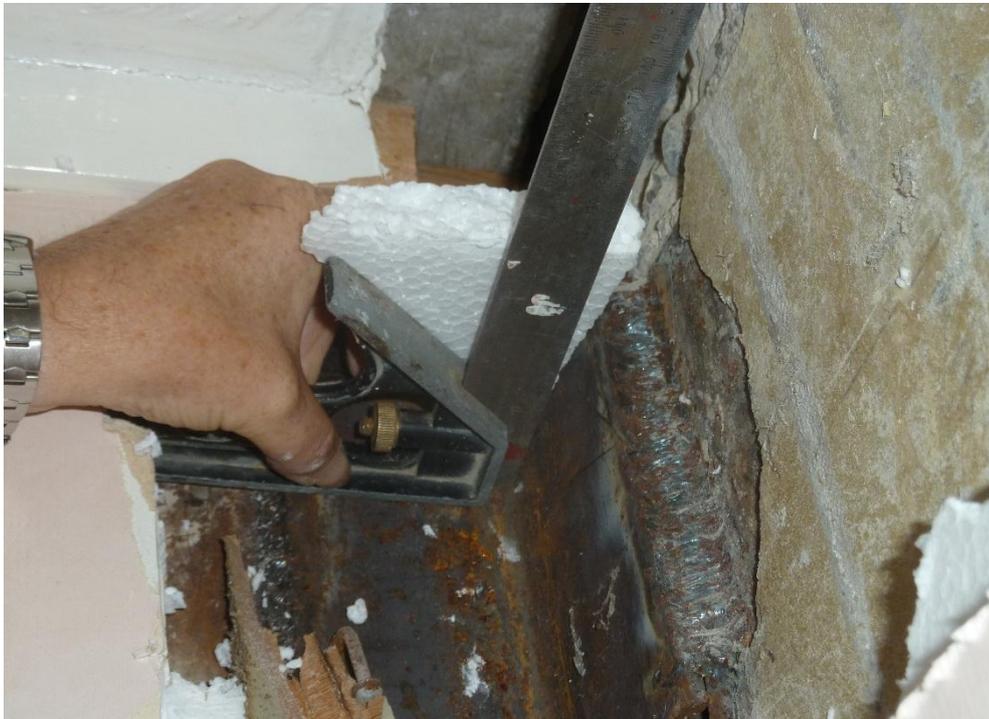
Photo 3: Unit 11 Weld plate no longer 90 degrees

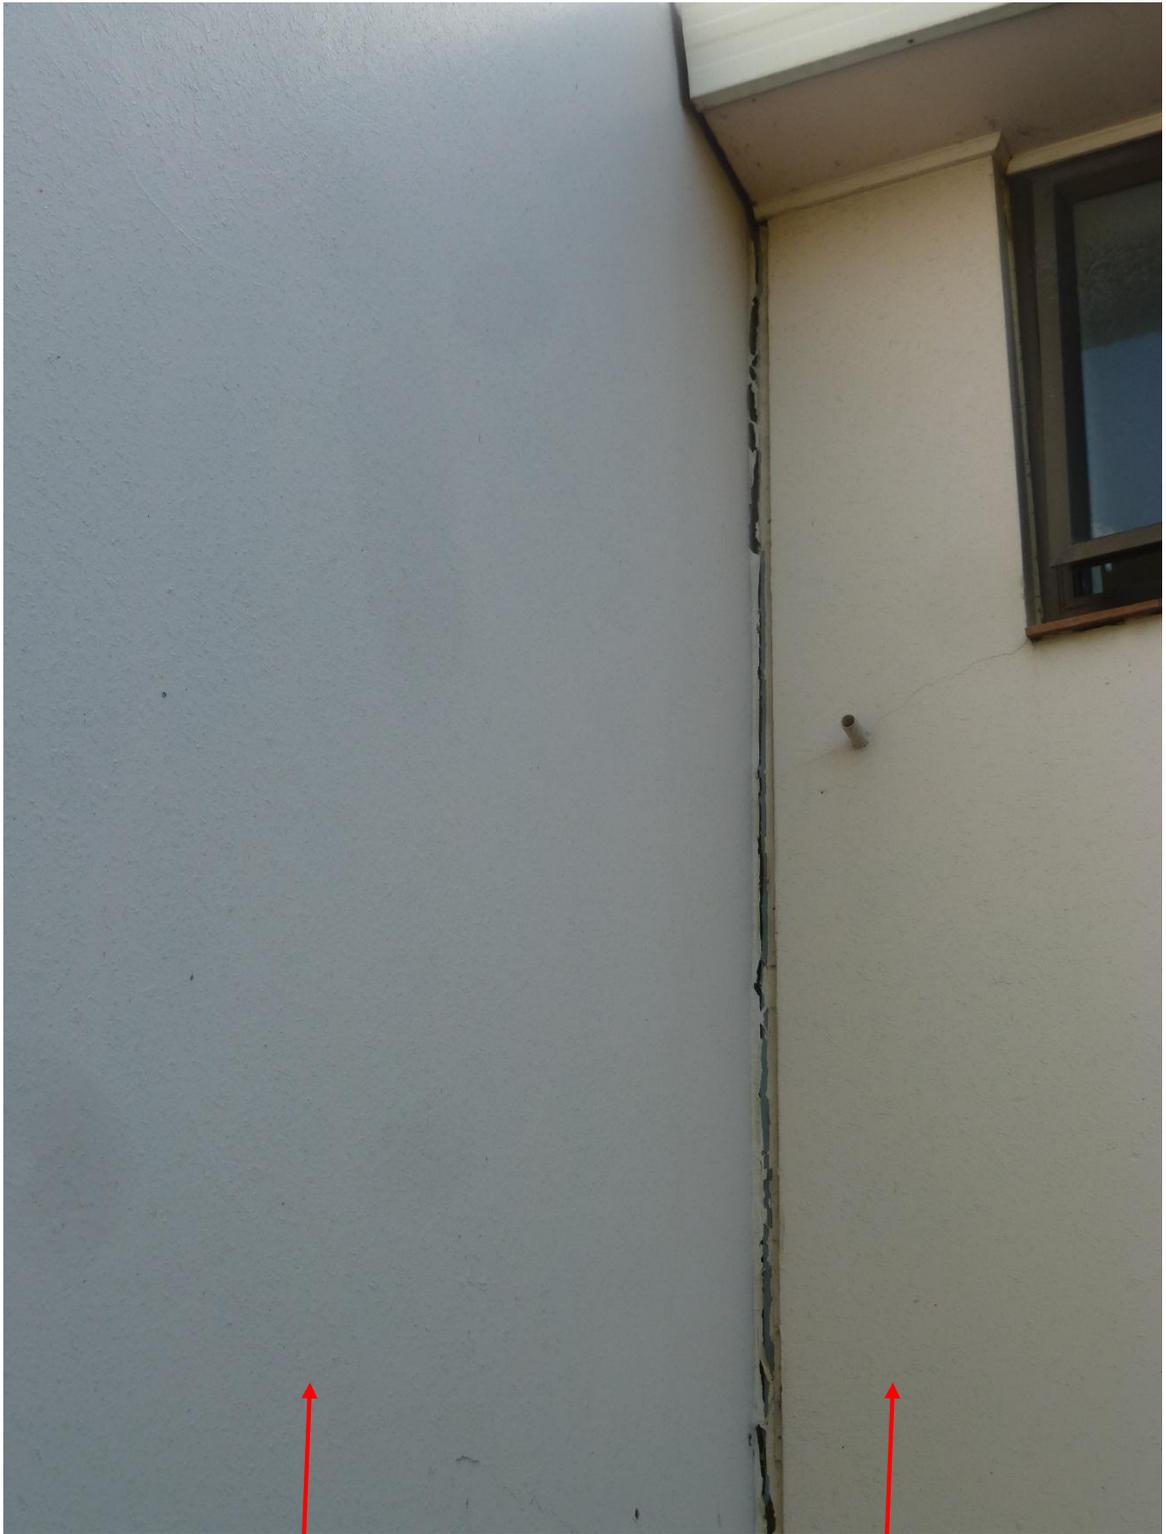
Photo 4: Units 13 & 14 moving away from units 11 & 12
