**Haast Courts Block D**  
**BU 0792-004 EQ2**  
Detailed Engineering Evaluation  
Quantitative Report  
Version FINAL

Units 1 to 5, 149 Stanmore Rd., Linwood

Christchurch City Council

**Date**  
**31 October 2012**

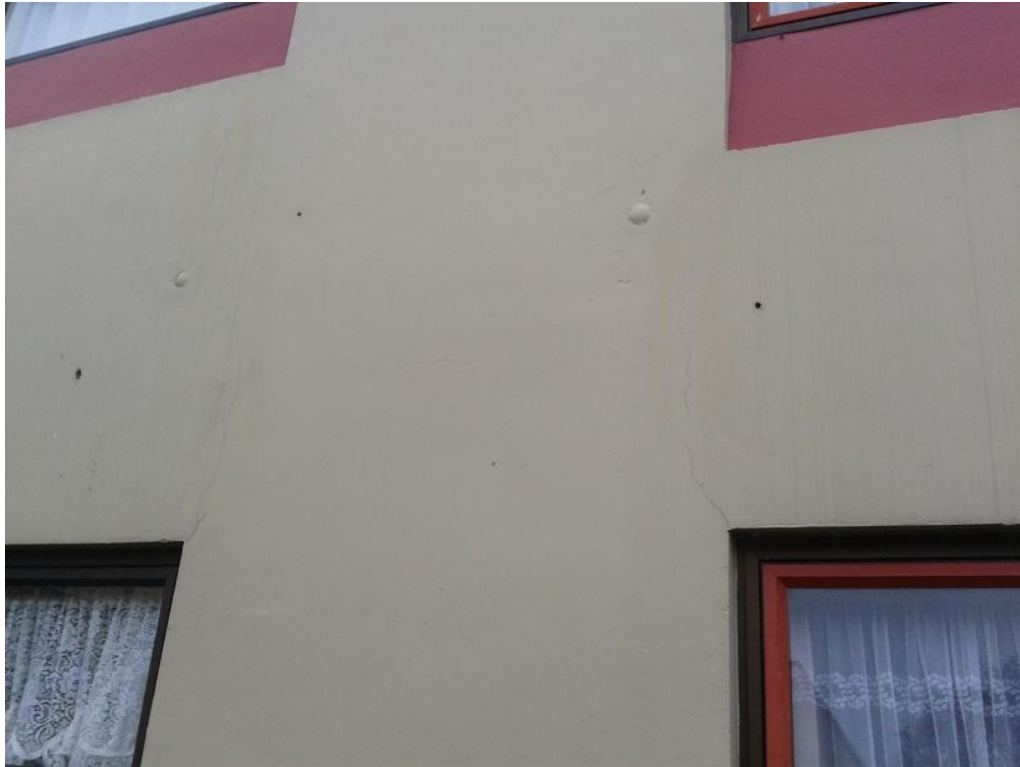
Minor cracking was noted to the exterior of the building. These cracks may be original shrinkage cracks that may have opened up slightly during the recent seismic activity.

**Photograph 3 Cracking to exterior walls at window corners.**

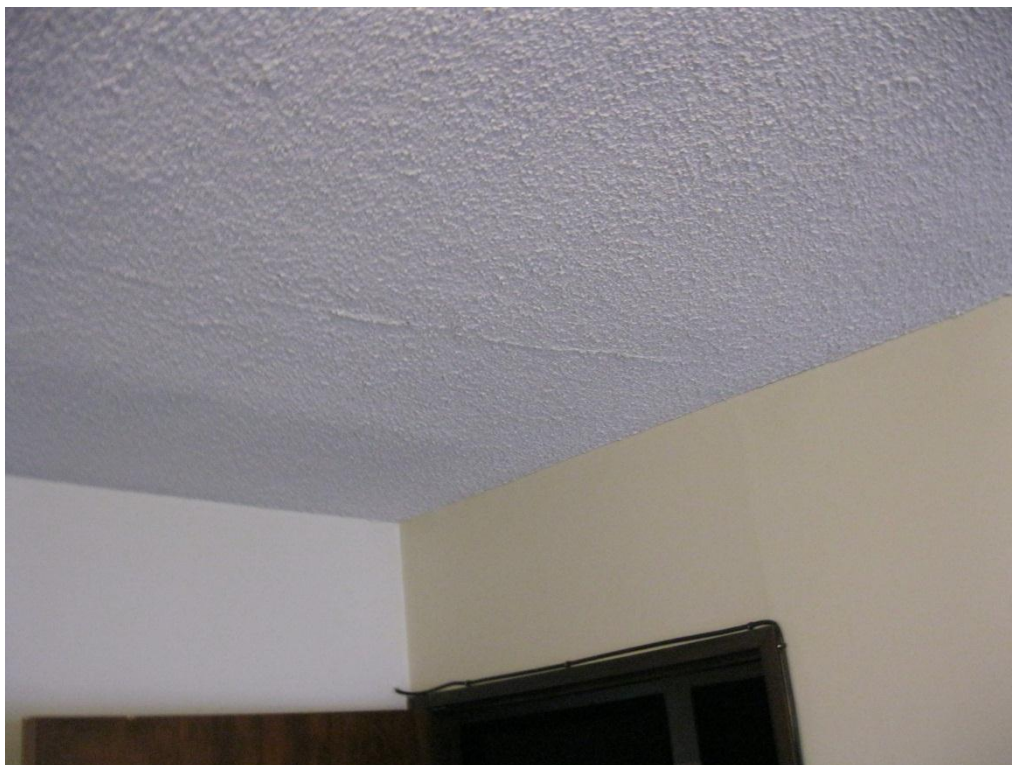
Minor cracking was evident in the asbestos plaster finish to the underside of the first floor slab. It was not clear if these cracks penetrate into the concrete slab.

**Photograph 4 Cracking to plaster finish on the underside of the suspended floor slab.**

Due to the presence of cracking to the asbestos plaster ceiling lining in a number of the units throughout the complex, GHD Limited recommends that all the ceiling linings be inspected by asbestos specialists and dealt with according to their recommendations.

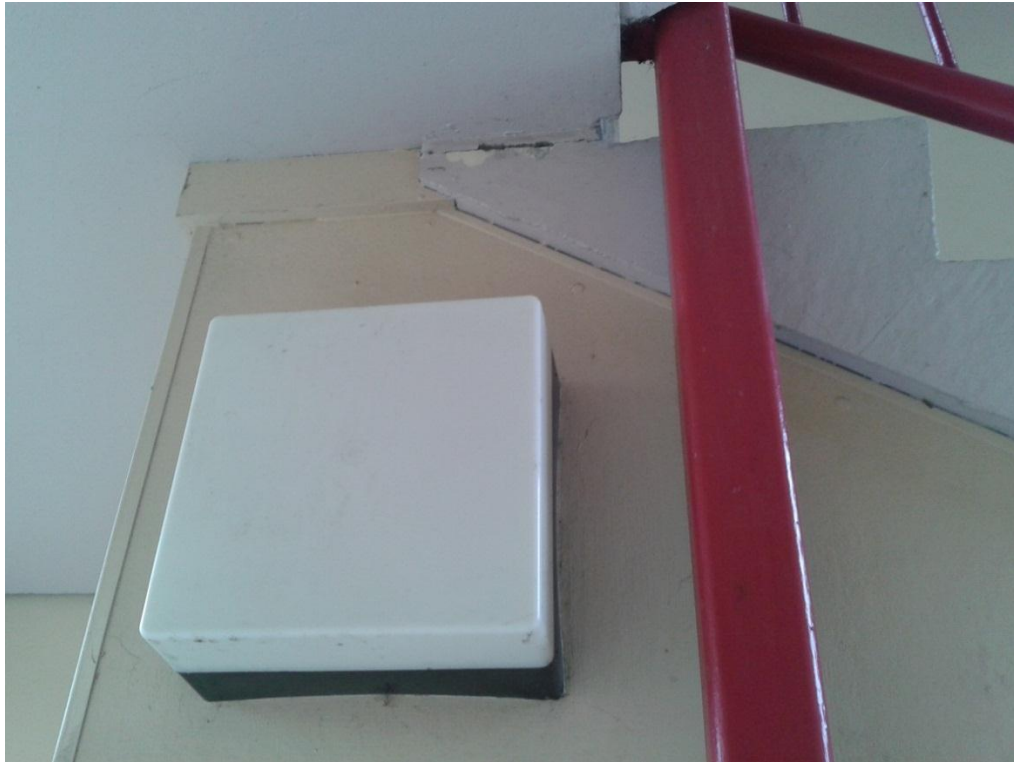
**Photograph 5 Connection of stairs to first floor landing.**

As the connections between the staircase and the supporting precast panel walls do not allow for adequate seismic lateral movement in the plane of the panel, it is recommended that secondary supports be provided to all landings in the form of equal angle supports fixed to the panel walls. The stairs are the only means of egress from the upper floors and this issue should be addressed immediately.

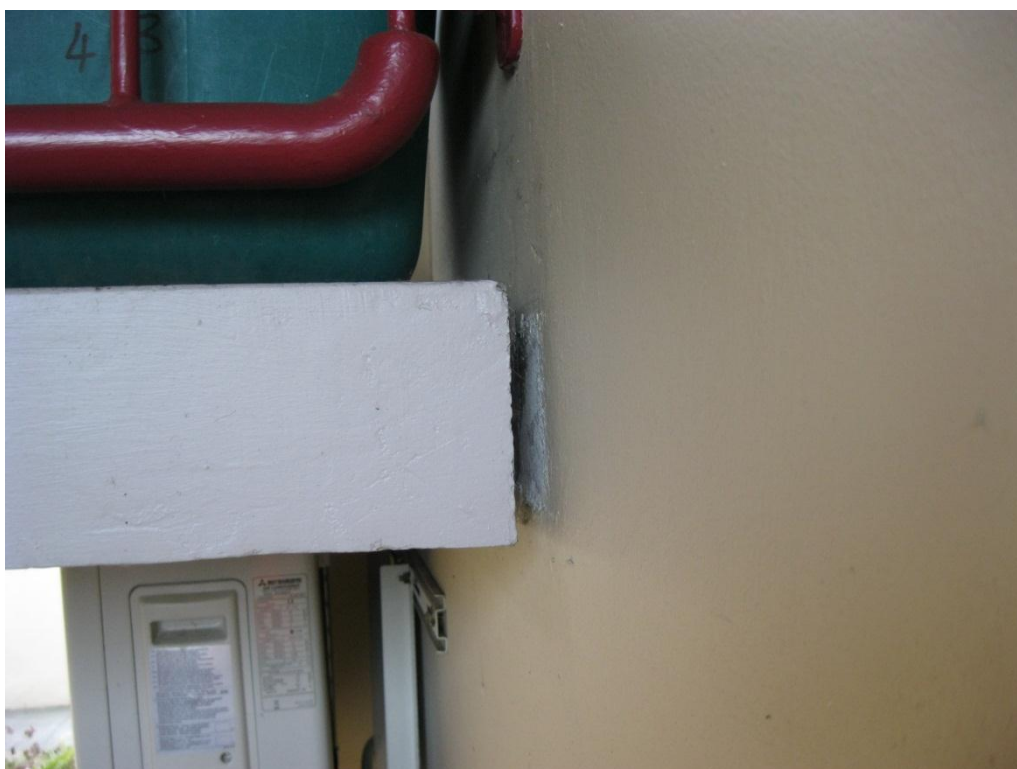
**Photograph 8 Seismic gap between stairs landing and precast concrete wall panel.**

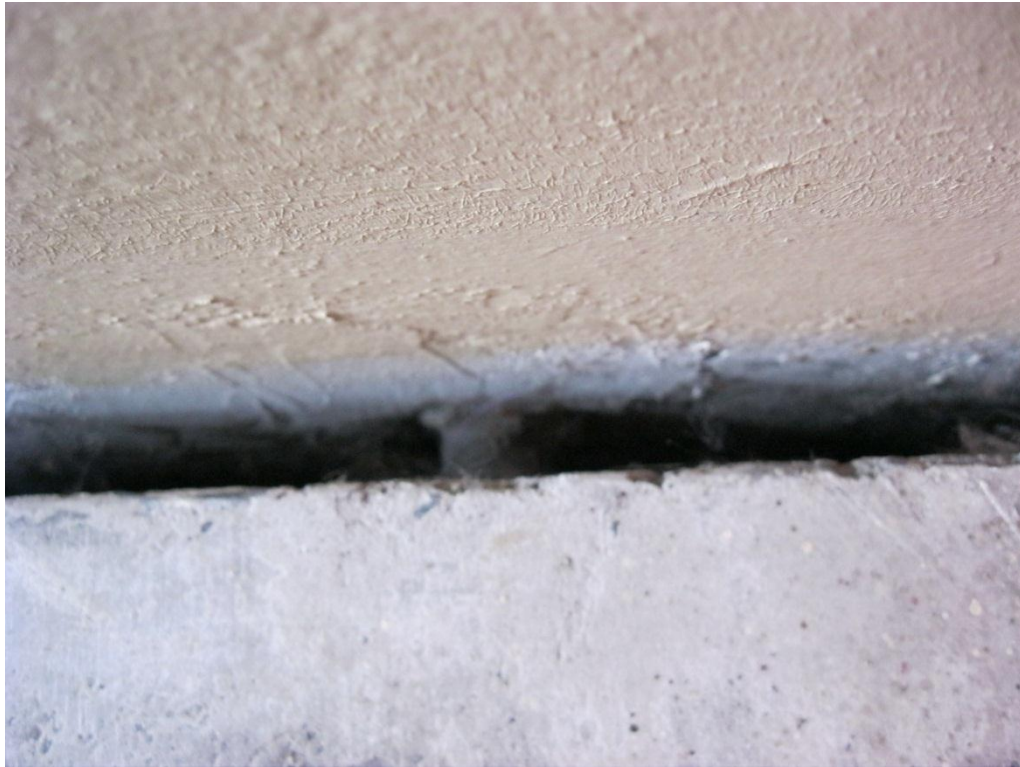
**Photograph 9 Seismic gap between stairs landing and precast concrete wall panel showing steel dowel pin connection.**

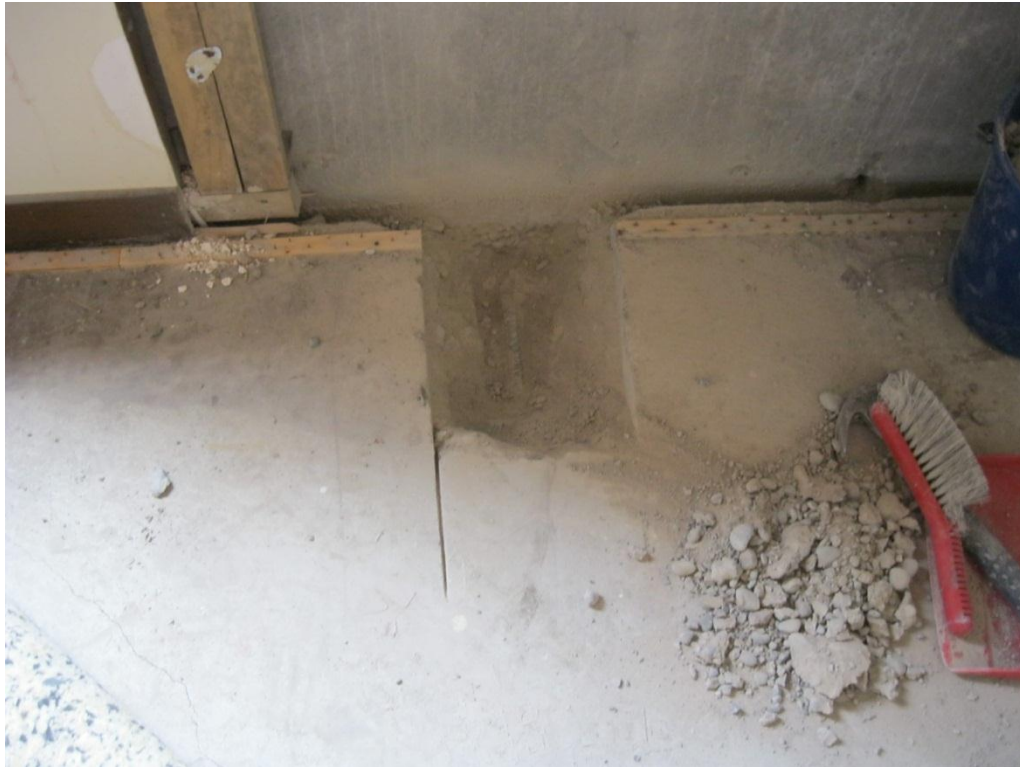
**Photograph 21** Suspended slab steel reinforcement cage found not to be tied into precast wall from the top.

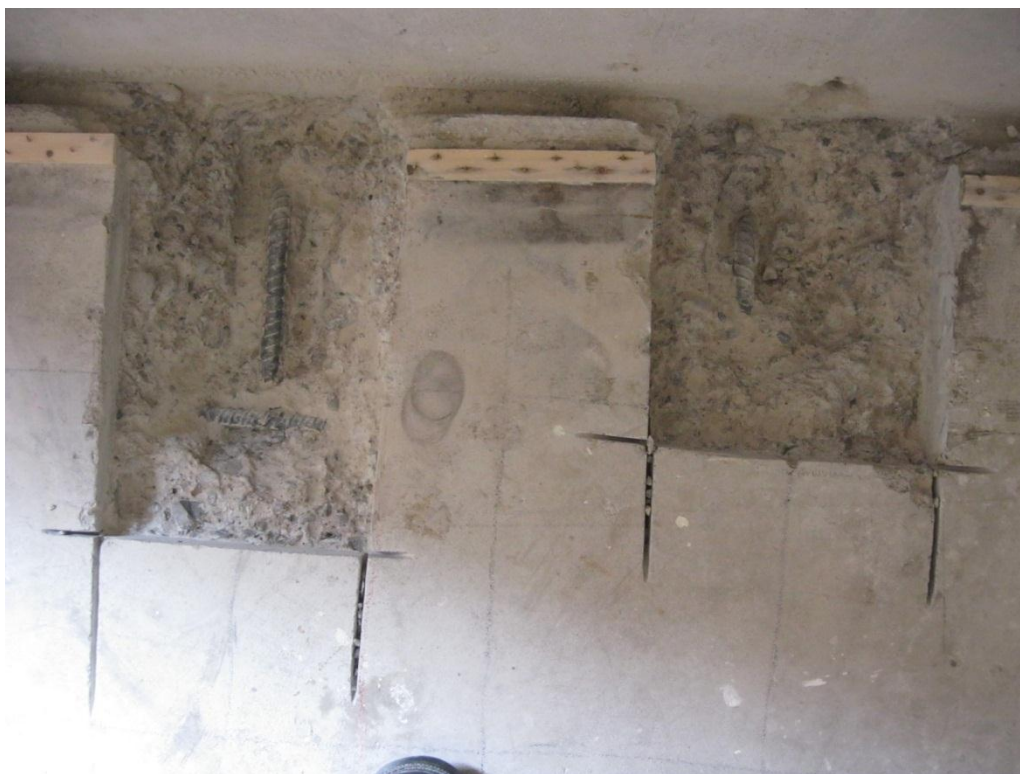
**Photograph 22** Further opening up of the suspended slab showed the steel reinforcement cage not to be tied into precast wall from the top.

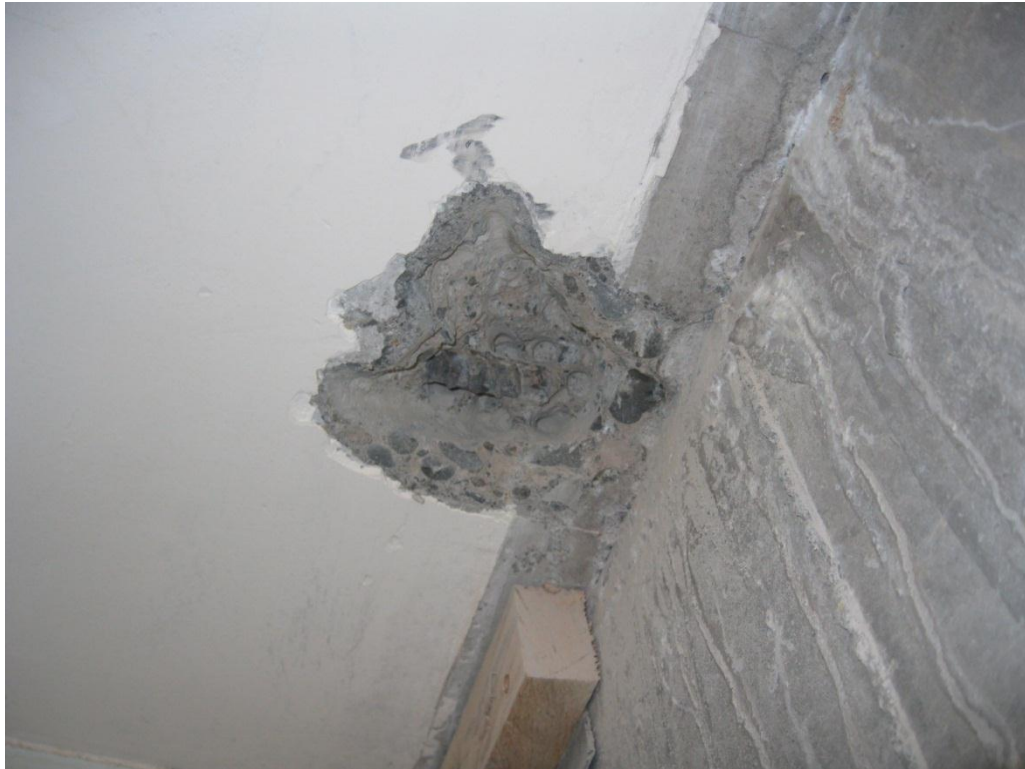
**Photograph 23** Opening up to the underside of the second floor suspended slab showed the steel cage reinforcement not tied into the precast wall.

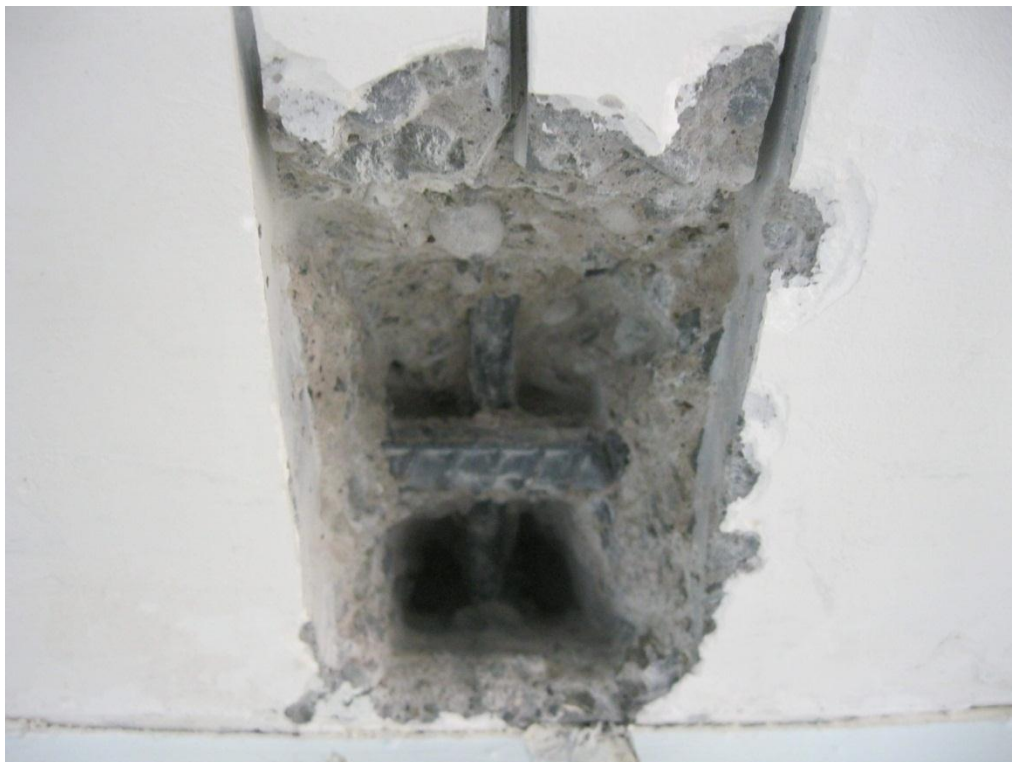
**Photograph 24** Opening up in another location revealed a 10mm diameter steel bar tying the suspended slab back into the precast concrete wall panels.

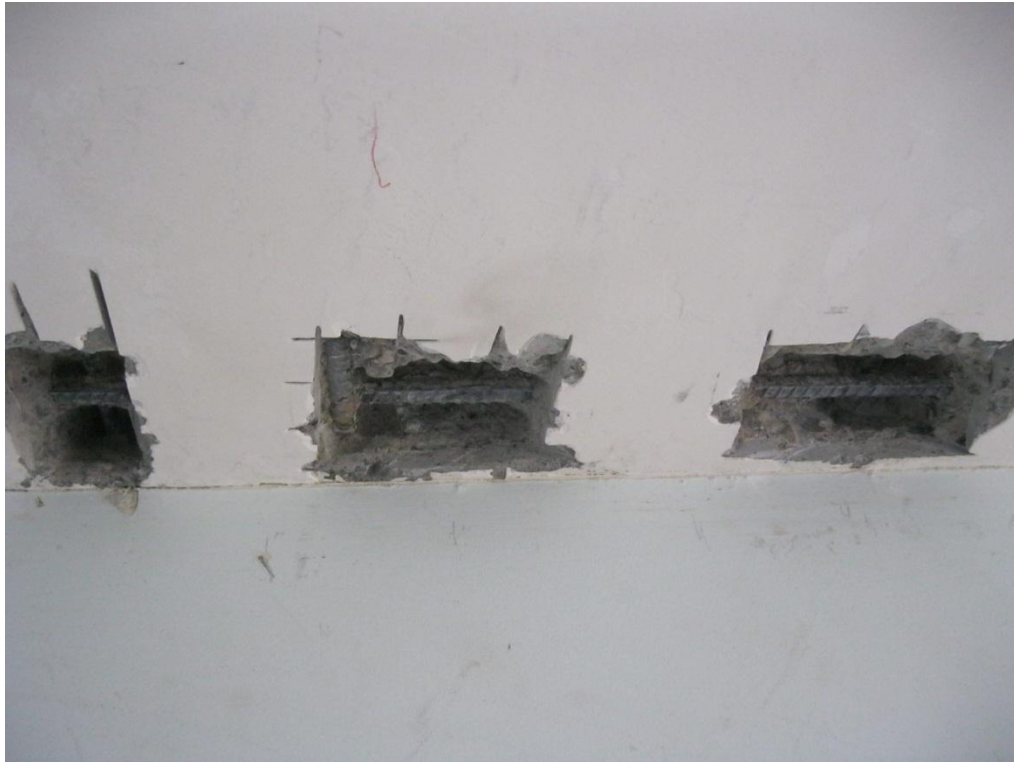
**Photograph 25 Further opening up and reinforcement scanning revealed regular spacing of bars tying the slab into the precast panels at 250mm centres along all walls.**
