**Haast Courts Block F**  
**BU 0792-006 EQ2**  
Detailed Engineering Evaluation  
Quantitative Report  
Version FINAL

151 Stanmore Road, Linwood

Christchurch City Council

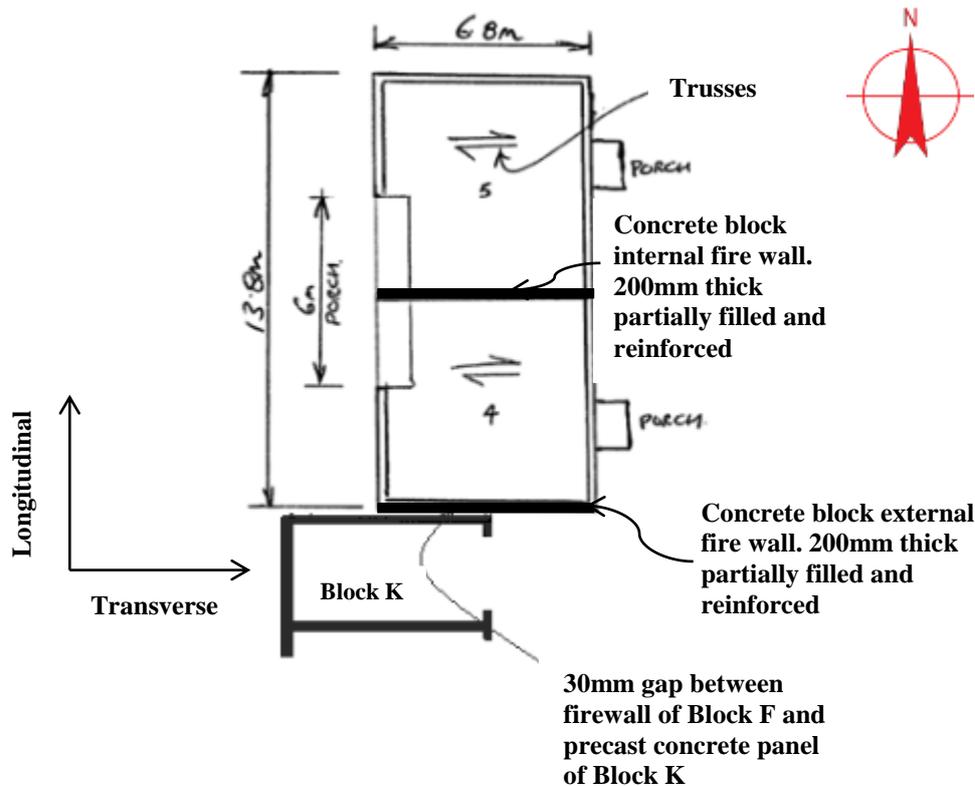
Figure 2 Plan sketch show key structural elements

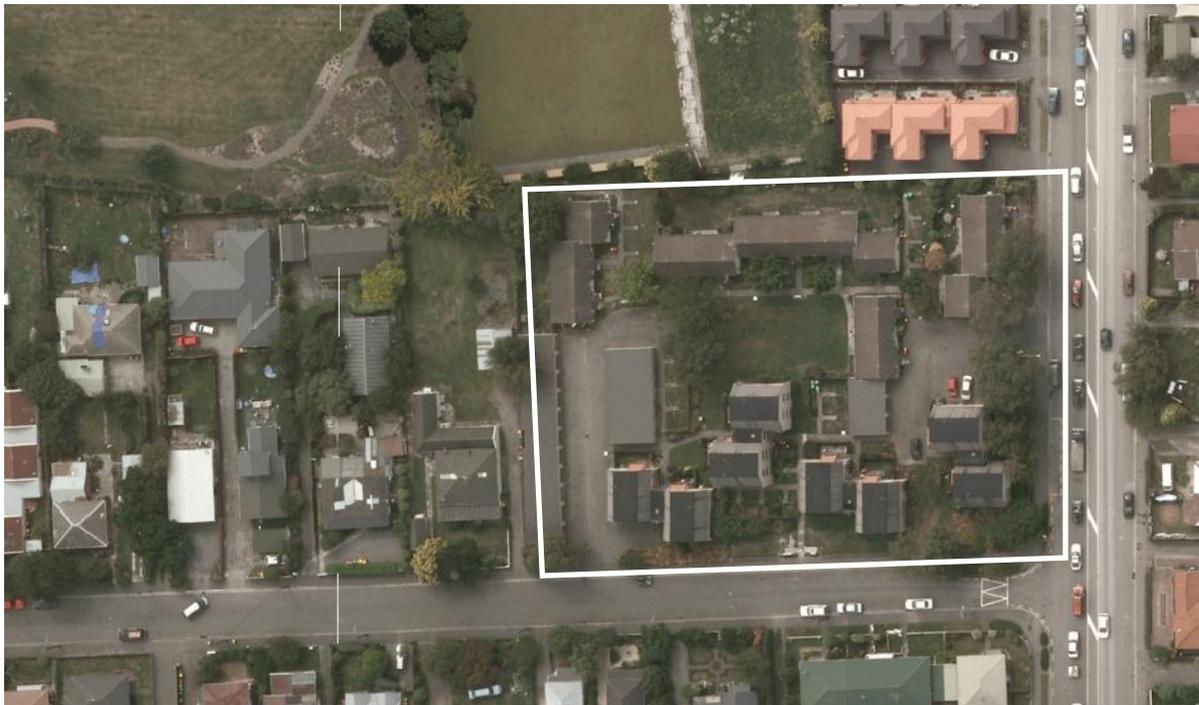
Aerial photography taken following the 22 February 2011 earthquake shows no signs of liquefaction outside the building footprints or adjacent to the site, as shown in Figure 7.1.

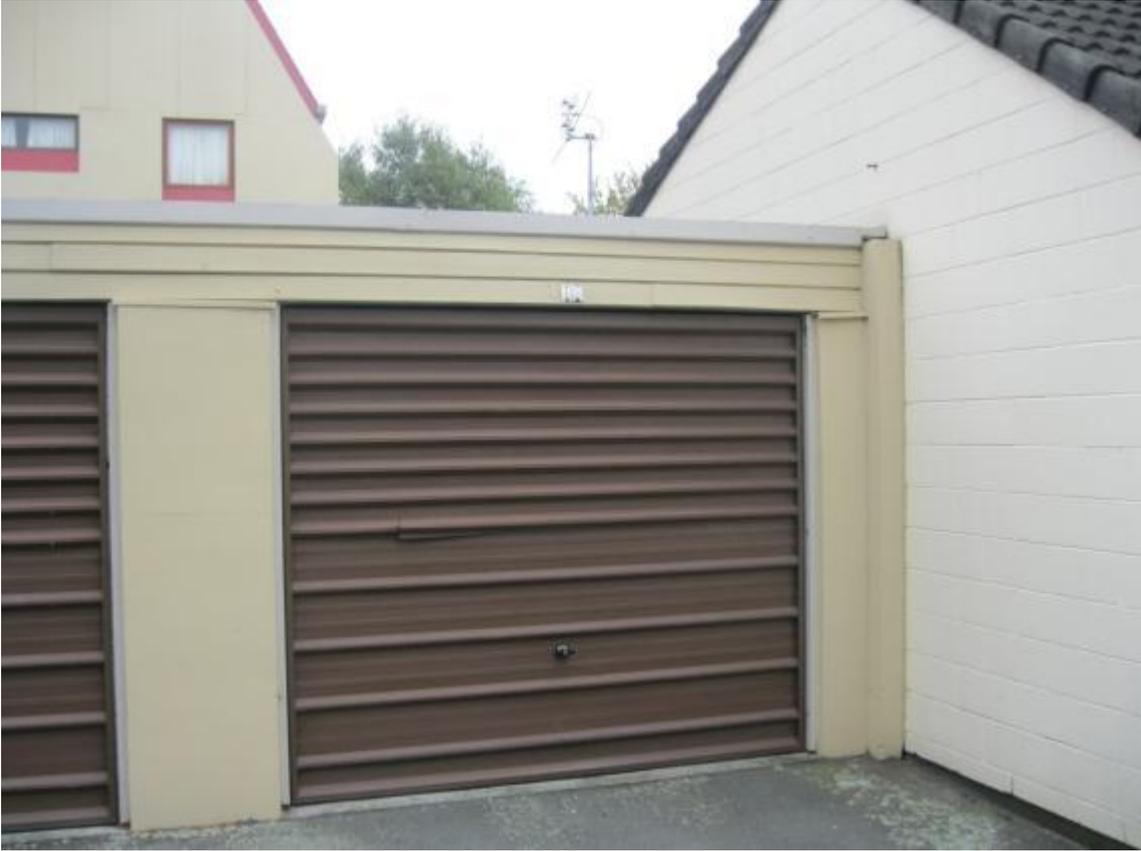
Photo 5 Southern gable of the building adjoining garage Block K.

- ▶ The upper section of the gable walls are either removed or tied back to the building frame immediately as collapses of these sections are possible under earthquake load.
- ▶ The masonry walls are apparently unreinforced and the drawings do not indicate that there are tied back to the wall framing. Localised removal of the linings is recommended to identify if the veneer is tied back.
- ▶ If the veneer is found not to be tied back to the wall framing it is recommended that the veneer is either removed and replaced with light weight cladding or is tied back to the framing with masonry ties.
- ▶ The areas adjacent to the unreinforced gable walls should be cordoned off until the above recommendations have been completed.

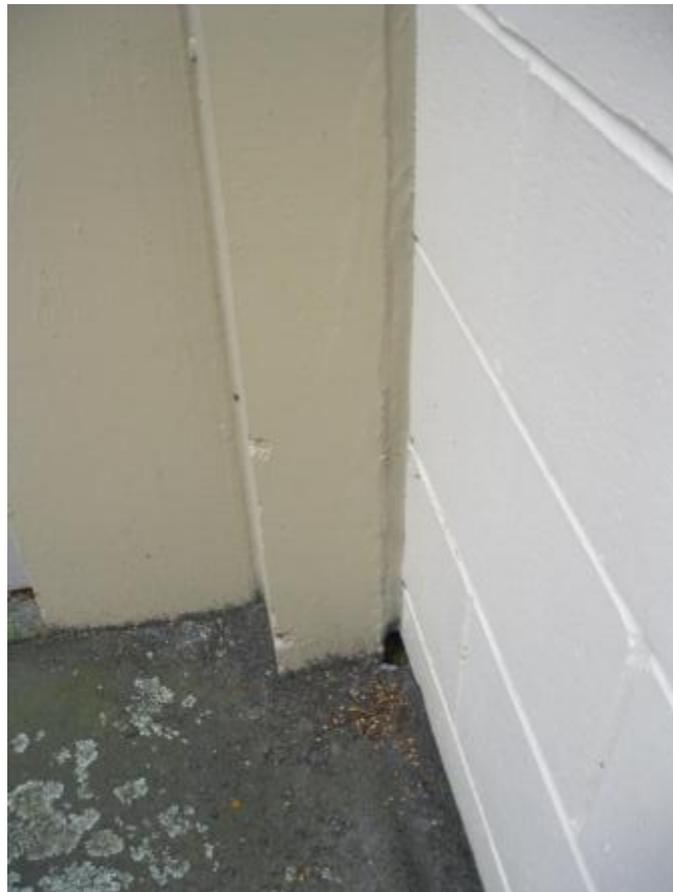
Photo 6 Minimal gap between buildings filled with flexible seal.

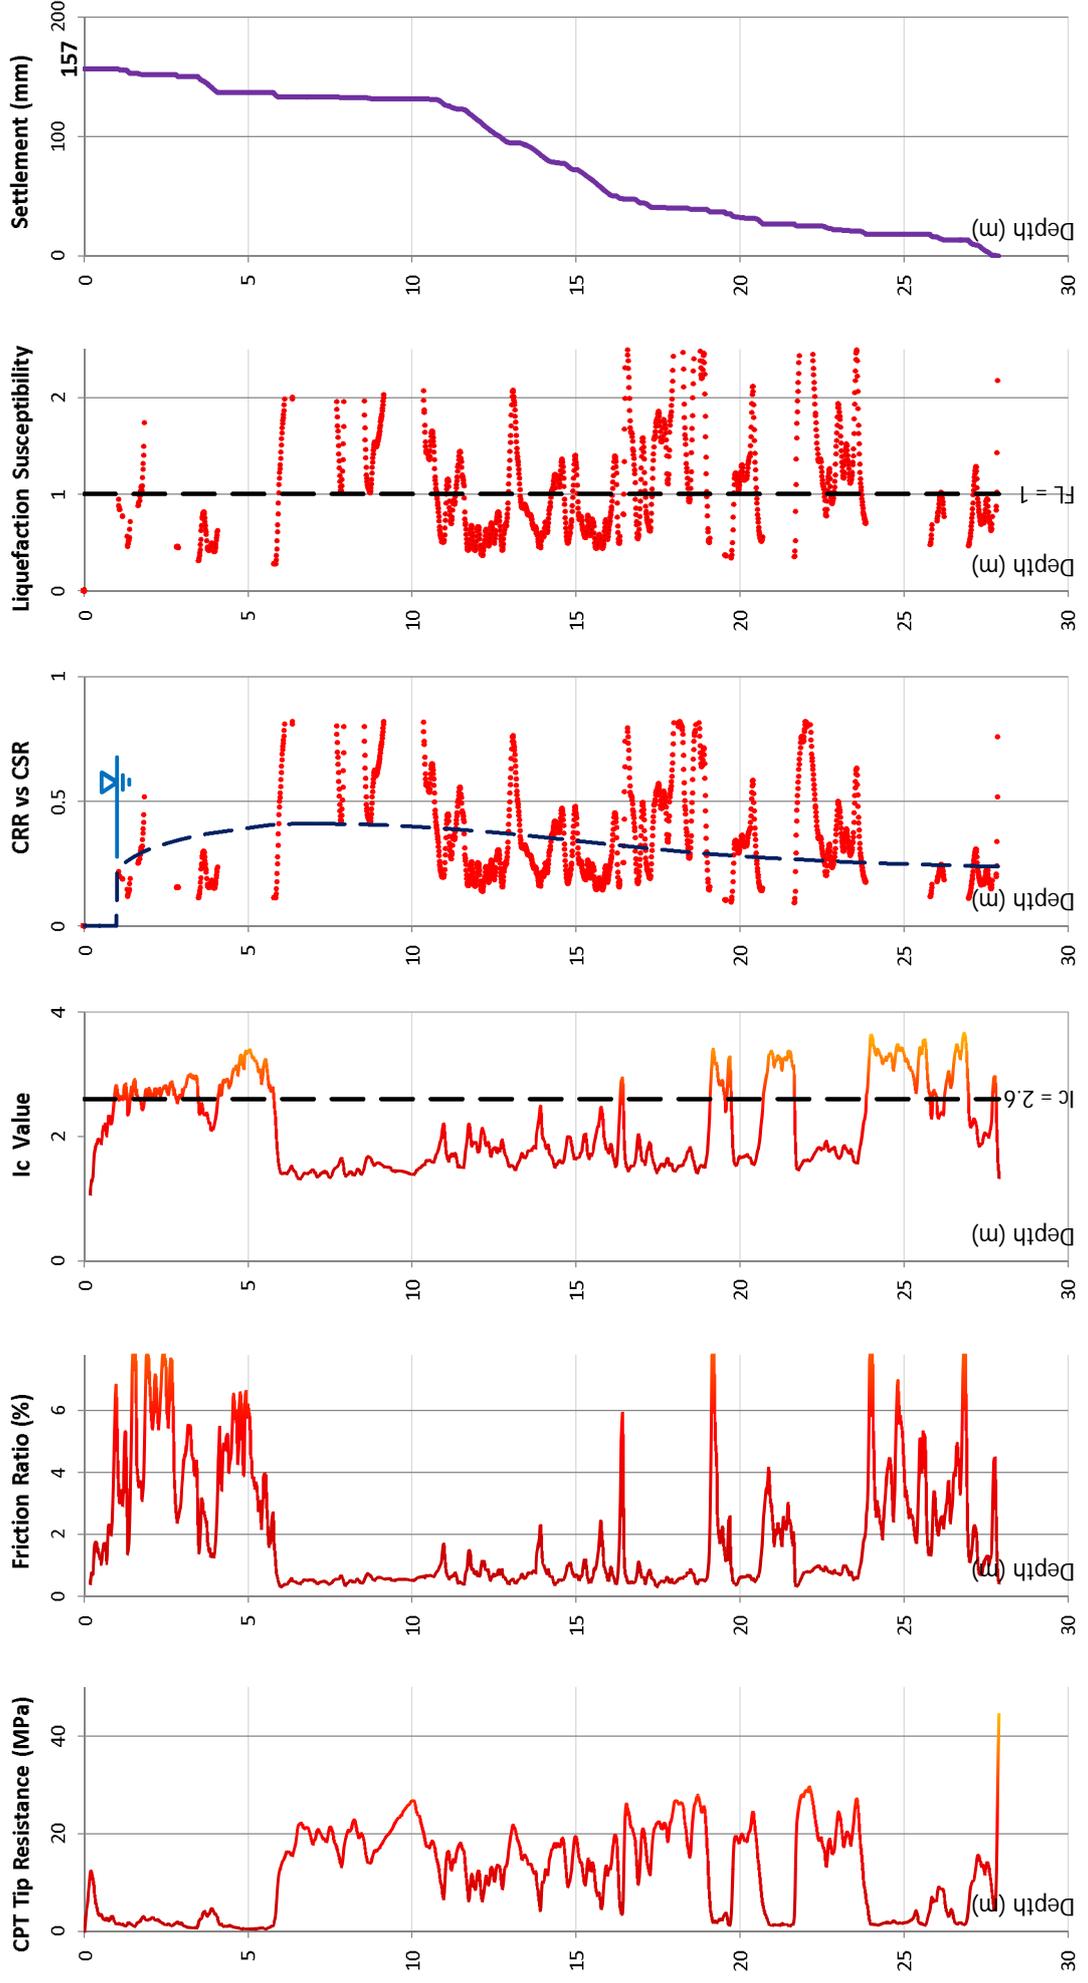
LOCATION : CPT 2  
 PROJECT : Haast Courts - 149 Stanmore Road  
 JOB NO : 51 30596 41  
 TEST DATE : 28 Jun 2012  
 SHEET : 2  
 CALCULATED : HNN  
 CHECKED BY :  
 DATE : 4 Jul 2012

Settlement estimates for the CPT points are between 150mm and 270mm for ULS conditions.

PGA ( $a_{max}$ ): 0.35 g  
 EQ Magnitude: 7.5  
 Groundwater Level (m bgl): 1.0  
 Atmospheric Pressure (kPa): 101  
 Bore depth (m): 27.89  
 Test data step (m): 0.01  
 Total Estimated Settlement (mm): **157**

- The soil class of **D** (in accordance with NZS 1170.5:2004) recommended in Section 8 of the Qualitative DEE/IEP is still believed to be appropriate; and,
- Any remedial works to foundations (or proposed new structures) be undertaken in accordance with DBH's guidelines for **TC3** land, due to the high levels of estimated settlement.
