CHRISTCHURCH CITY COUNCIL
PRK_1190_BLDG_011 EQ2
Hagley Park North—Toilet – Lake Albert
Hagley Park, Christchurch

QUANTITATIVE ASSESSMENT REPORT
FINAL

- Rev B
- 24 September 2013

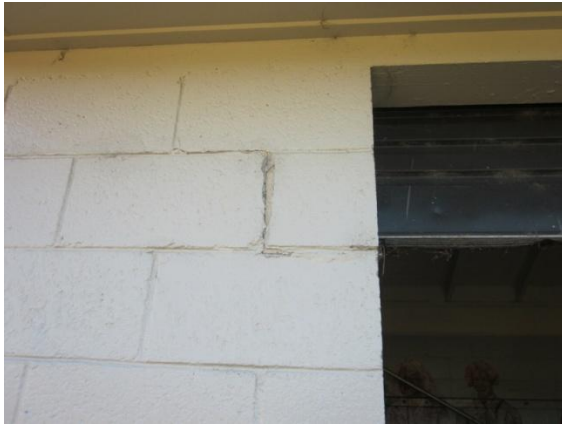
- 1) Step cracking along mortar joints on the north and east walls (approximately 0.5mm). (PHOTOS 5 and 14)
- 2) Vertical separation at joint between internal and external masonry walls in the storage rooms (approximately 3mm). (PHOTO 6)
- 3) Gap between masonry wall and soffit lining (approximately 1mm). (PHOTO 21)
- 4) Gap between masonry wall and timber elements in the soffit on the east wall (approximately 4mm). (PHOTO 15)
- 5) Gap between masonry wall and internal cladding in the toilet entrances (approximately 2mm). (PHOTO 17)
- 6) Gap between internal wall and roof cladding in the toilets (approximately 3mm). (PHOTO 18)
- 7) Gap at the connection of the timber members in the centre of the north wall at roof level (approximately 10mm). (PHOTO 26)
- 8) Cracks in soffit lining on west side (approximately 0.5mm). (PHOTO 27)

PHOTO 5: Step cracking along mortar joints on the east wall.

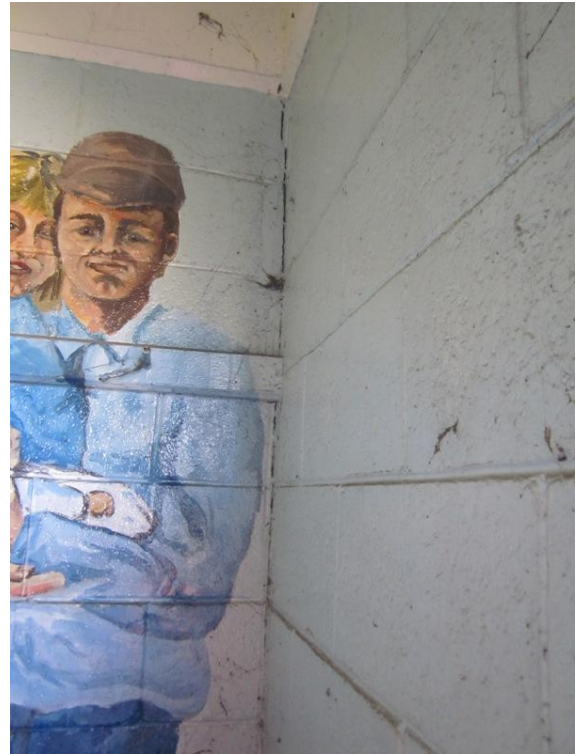
PHOTO 6: Crack between internal and external masonry wall inside the southern-most storage area.

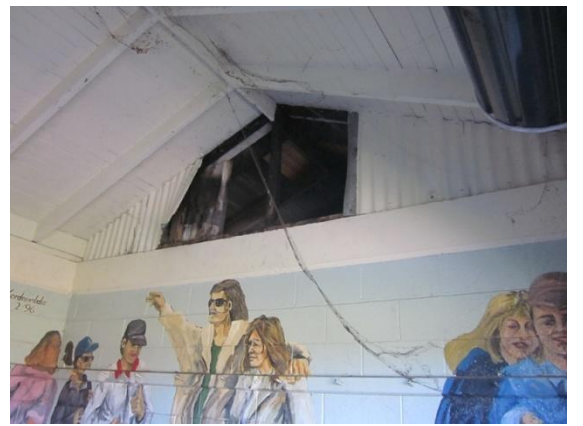
- 14) Removal of internal gable linings (lightweight corrugated material) above interior masonry wall was noted, but this is not a result of earthquake damage. (PHOTO 8)

PHOTO 8: Internal north wall of the southern-most storage area, showing removal of corrugated material.

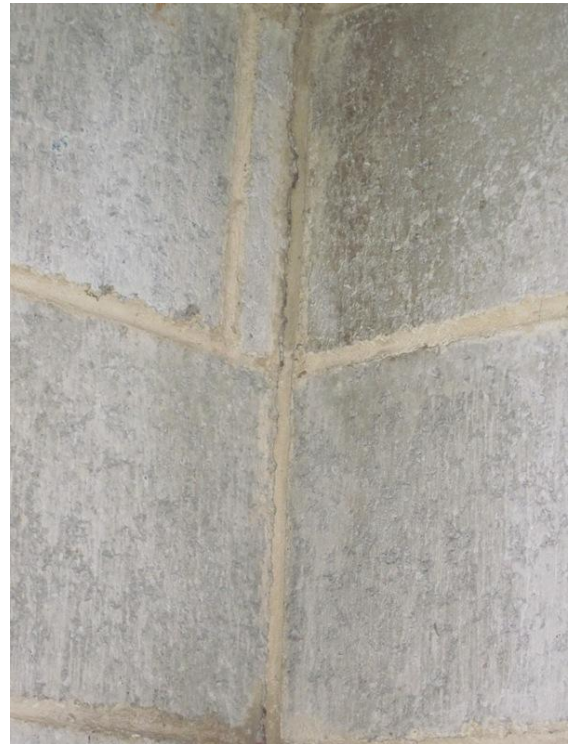
PHOTO 12: Crack between internal and external masonry walls inside the central storage area.

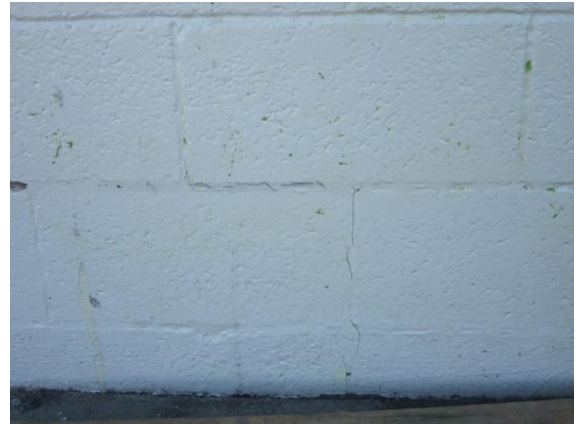
PHOTO 14: Step cracking along mortar joints on the east wall.

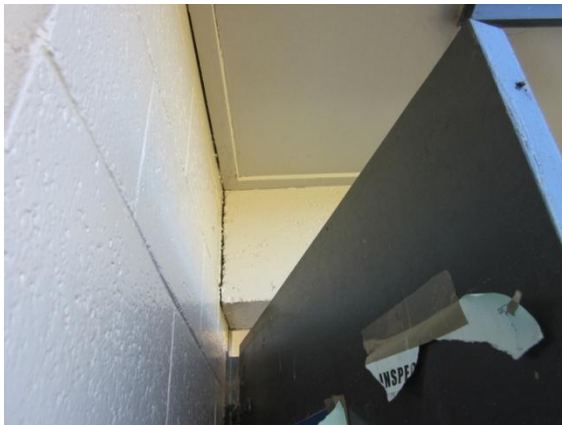
PHOTO 15: Gap opening up between masonry wall and timber ceiling elements above locked toilet on east side of building.

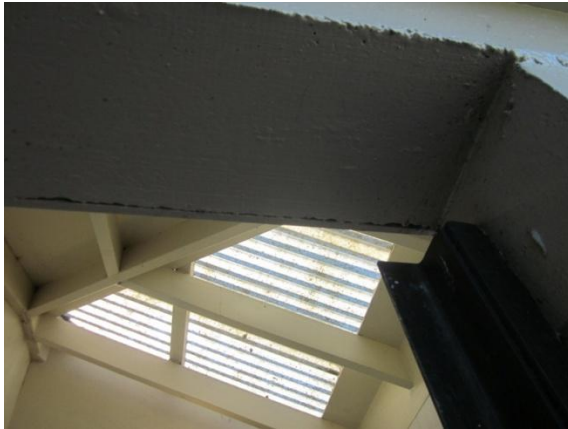
PHOTO 17: Gap opening up between masonry wall and internal wall cladding in locked toilet.

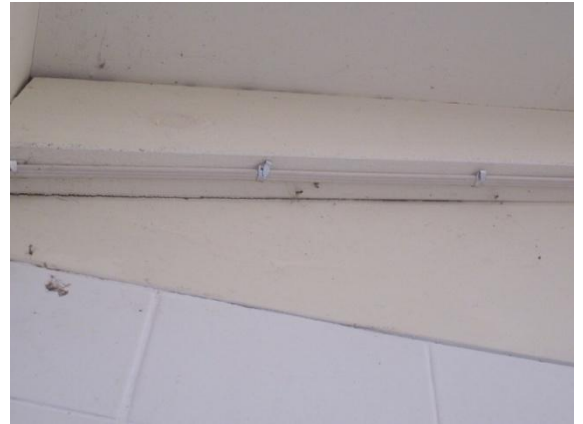
PHOTO 18: Gap opening up between interior wall and ceiling cladding and timber rafter in locked toilet..

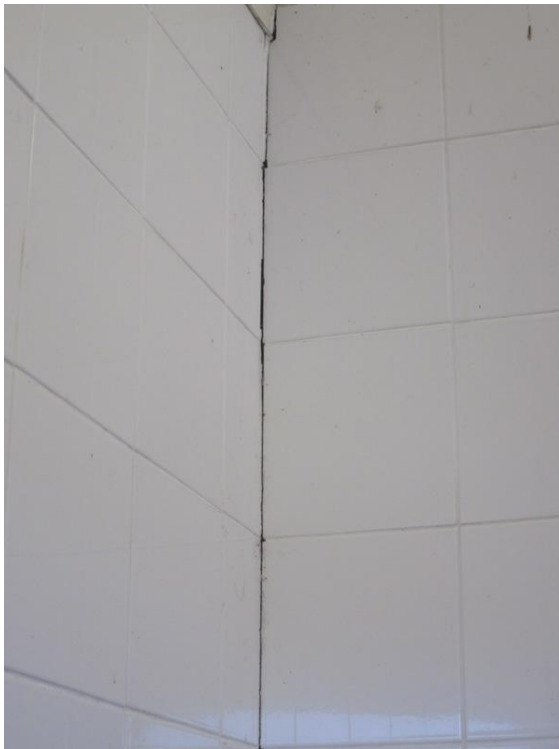
PHOTO 19: Gap opening up at internal wall joint in locked toilet.

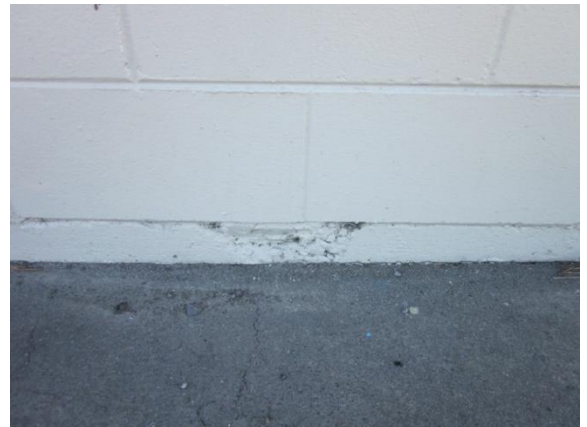
- 12) Existing low quality pointing noted in the northeast top corner of masonry. This is not earthquake related. (PHOTO 21)
- 13) Spalling of 110mm high concrete strip under masonry wall was noted, but is not as a result of earthquake damage. (PHOTO 20)

PHOTO 20: Spalling of concrete section of wall on east side.

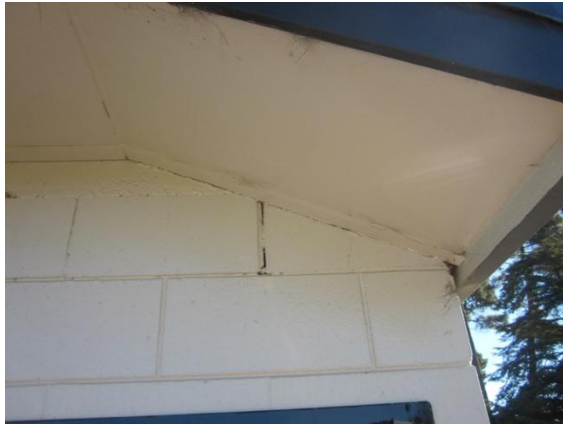
PHOTO 21: Existing low quality pointing on northeast corner.

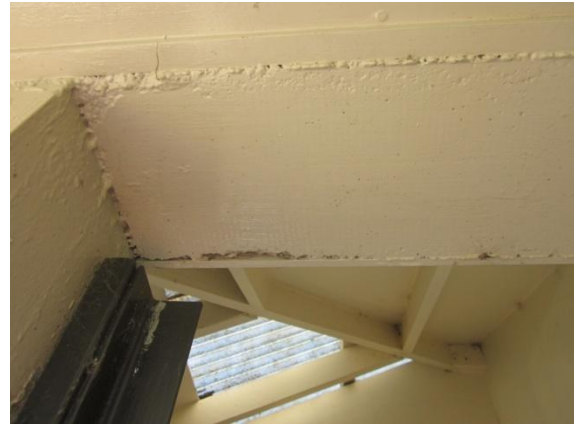
PHOTO 22: Gap opening up between interior cladding and masonry wall in north toilets (typical for both entrances).

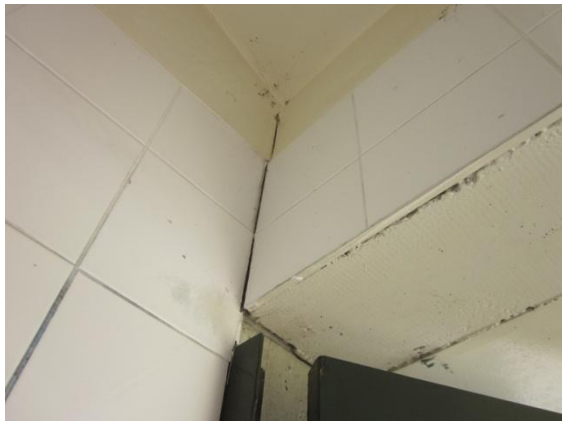
PHOTO 23: Gap opening up at interior wall cladding joints in north toilets.

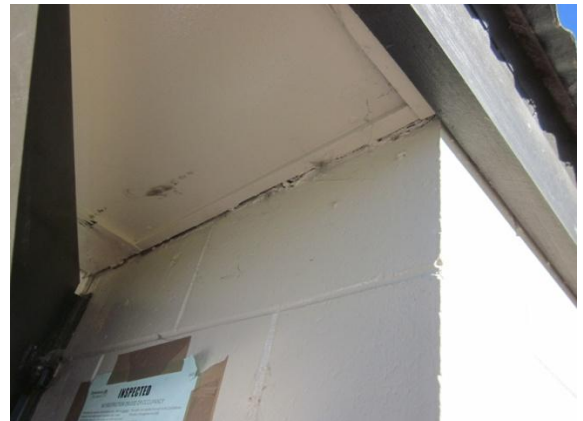
PHOTO 24: Gap opening up at wall and roof cladding at north toilet entrance.

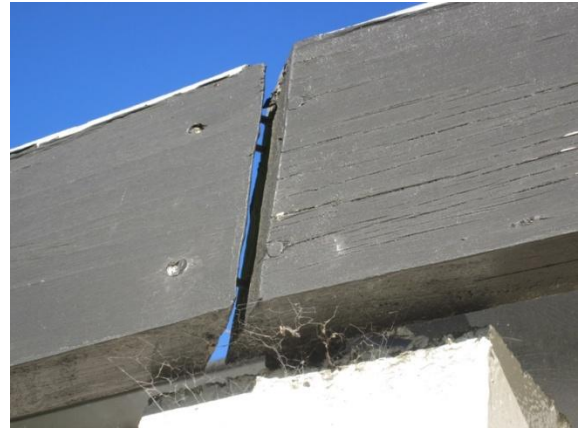
- 10) Impact damage to soffit lining on west side noted, but this is not believed to be earthquake related. (PHOTO 26)
- 11) Damage to end of external timber rafter on the south side of the building was noted, but this is not believed to be earthquake related. (PHOTO 30)

PHOTO 26: Gap opening up at connection between timber beams at roof level on the north side.

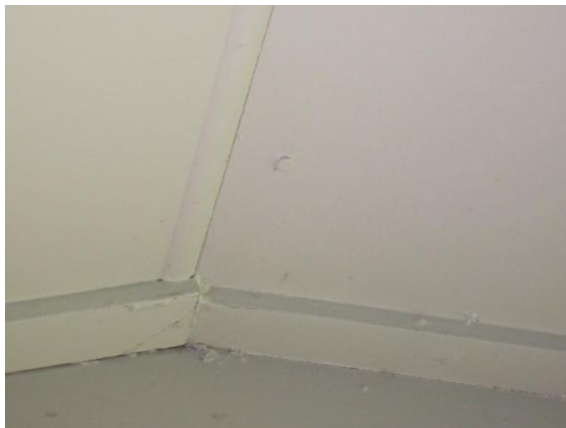
PHOTO 27: Gap opening up between joints in soffit lining on west side.

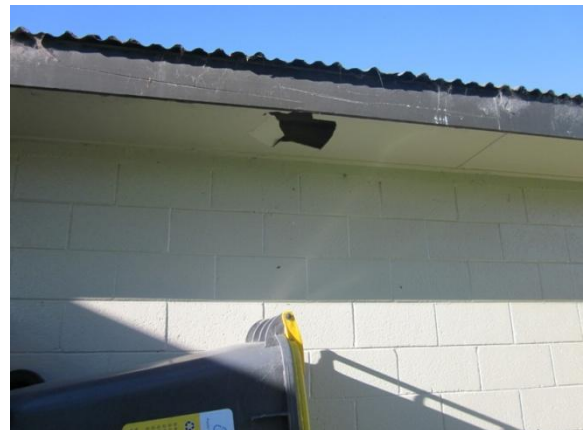
PHOTO 28: Existing impact damage to soffit lining on west side (not earthquake related).

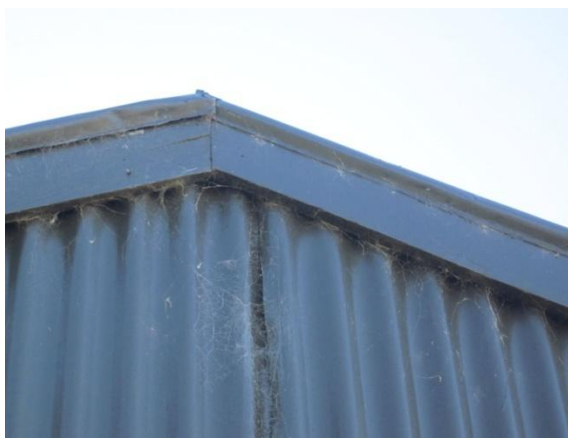
- 9) Crack in external timber rafter on the south side of the building at the apex. This is not believed to be earthquake related, but appears to be the result of weathering and thermal or shrinkage movement. (PHOTO 29)

PHOTO 29: Crack in external timber rafter at apex on south side.

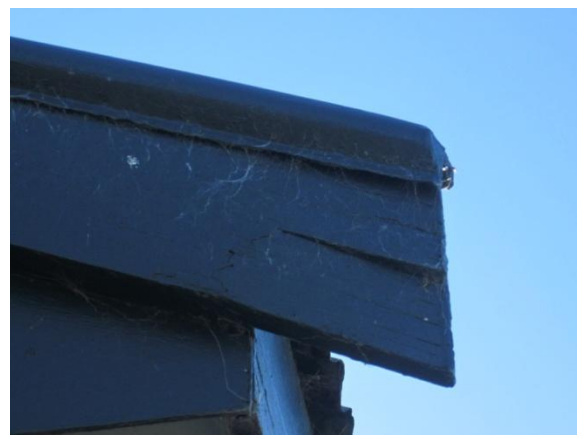
PHOTO 30: Existing defect to end of timber fascia on south side.

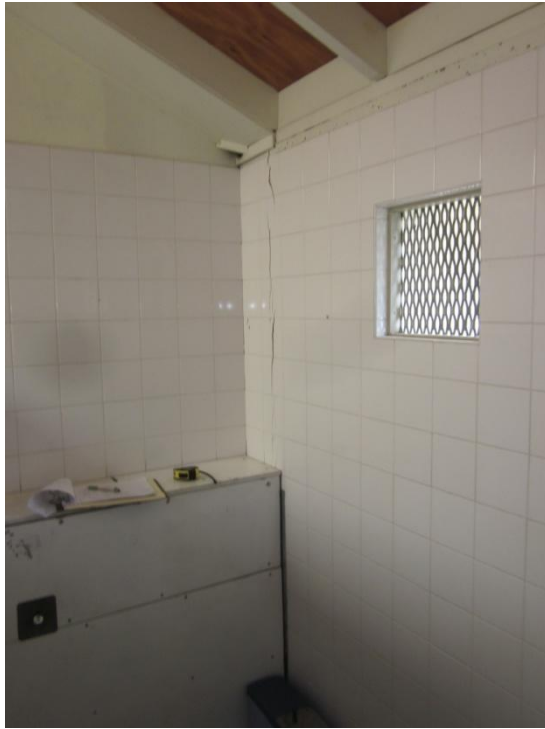
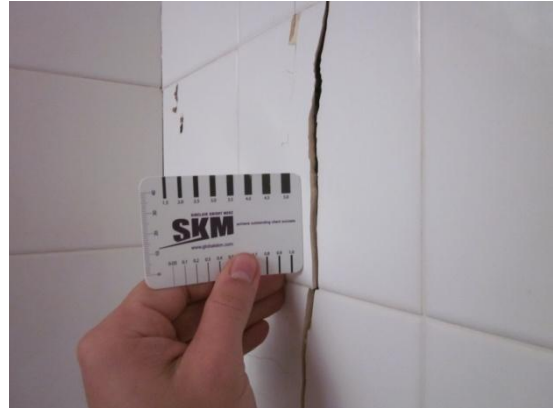
- 15) Vertical rupture in masonry wall at the intersection of grid lines 3/B. It appears that the rupture occurred at the vertical joint between older 140mm thick wall and newer 190mm thick wall, which leads to conclusion that the separation is a result of insufficient coupling of these two walls (PHOTO 43-44). As to be expected the crack has formed in the older, weaker 140mm wall.
- 16) A number of roof supporting elements in Stage 1 building (grid 2/B-C) have been compromised by fire. While such damage has likely negligible effect on seismic performance of the building, collapse hazard due to gravitational loads such as roof access and snow load may be considerable (PHOTO 45-46).

PHOTO 43: Vertical rupture in wall junction at 3/B.

PHOTO 44: Detail of Photo 43.

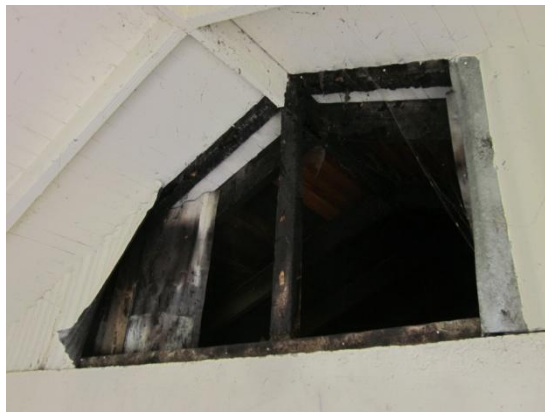
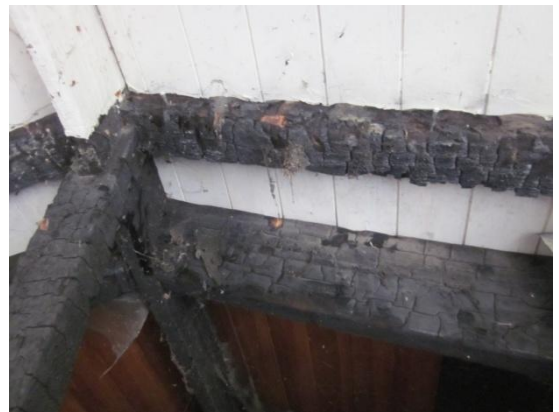
PHOTO 45: Roof timber elements compromised by fire – Stage 1 building (grid line 2/B-C)

PHOTO 46: Detail of Photo 45.
