# **Hagley Park South - Garage**

**PRK 1507 BLDG 011 EQ2**

**Detailed Engineering Evaluation**

**Quantitative Assessment Report**

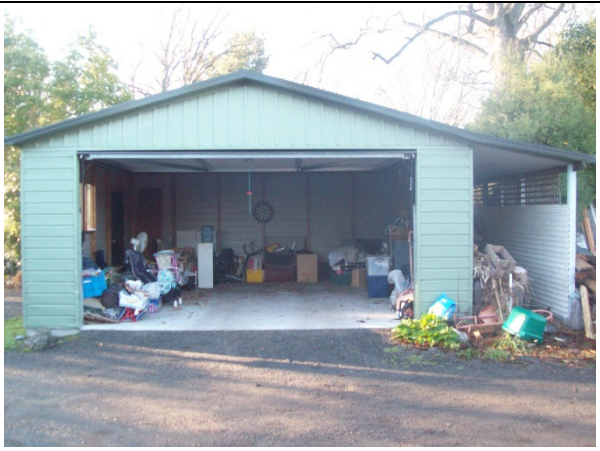
| Hagley Park South Garage | | |
|---|---|--|
| 1. | View of front of garage | |

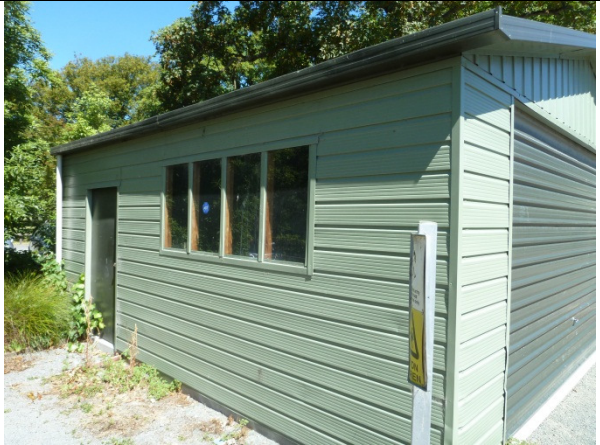
| Hagley Park South Garage | | |
|---|---|--|
| 2. | Northern side of building | |

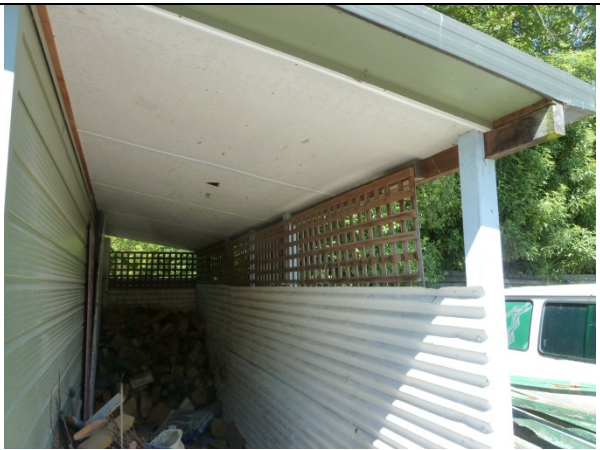
| Hagley Park South Garage | | |
|---|---|--|
| 3. | Patio on southern side of building | |

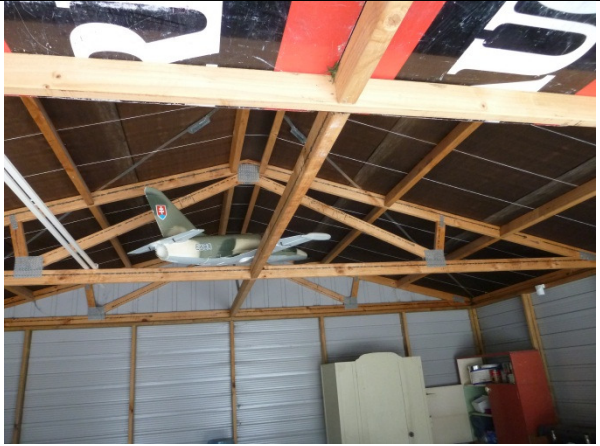
From our visual site inspections there appears to be no dedicated bracing systems compliant with current codes. Typically we would expect to find either a ceiling diaphragm or roof strap cross bracing, and in the walls either nailed sheet linings, diagonal timber braces, or strap cross bracing, to resist lateral forces. There are diagonal roof strap braces (not crossed) but they are attached to the purlins midspan, creating an ineffective load path of weak axis bending of the purlins.

| 4. | Timber truss roof with diagonal straps in roof sheeting plane. No ceiling. | |

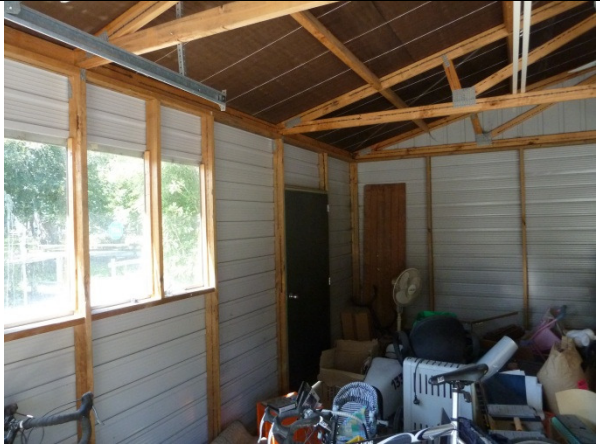
The seismic capacity of the building has been calculated to be 70% NBS. However, due to the lightweight nature of the building, the lateral load design will be governed by wind load and the wind load capacity will be less than 70% NBS.

| 5. | Timber framed walls. | |

We recommend that in light of the 70%NBS seismic capacity, that the building be investigated for wind load capacity and strengthening proposals be developed to achieve a wind capacity of 100% or more.

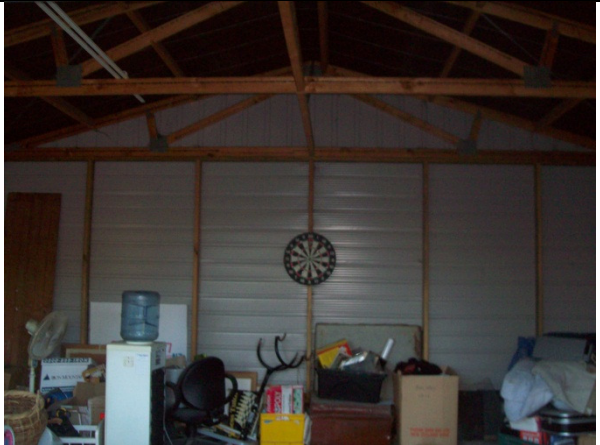
| 6. | Internal view of gable back wall. No internal lining. Timber framed. | |
