Halswell Domain Toilets
PRK 1691 BLDG 007
Detailed Engineering Evaluation
Qualitative Report
Version Final

301 Halswell Road

Christchurch City Council

Date
20th May 2013

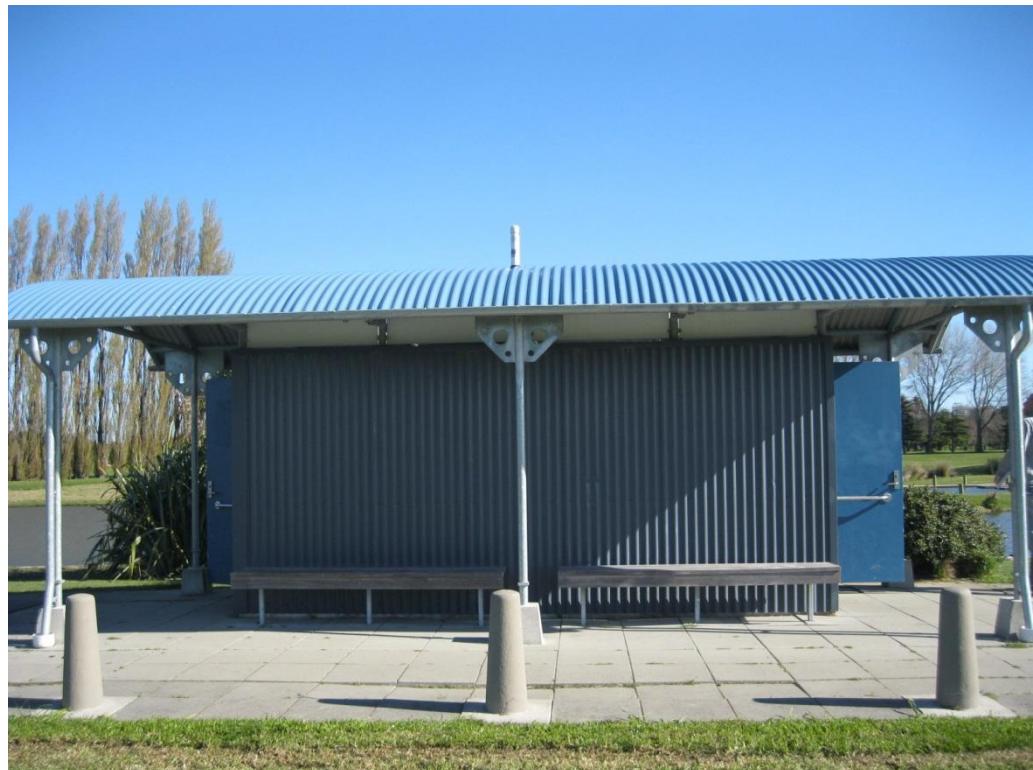
Photograph 1 Northeast elevation.

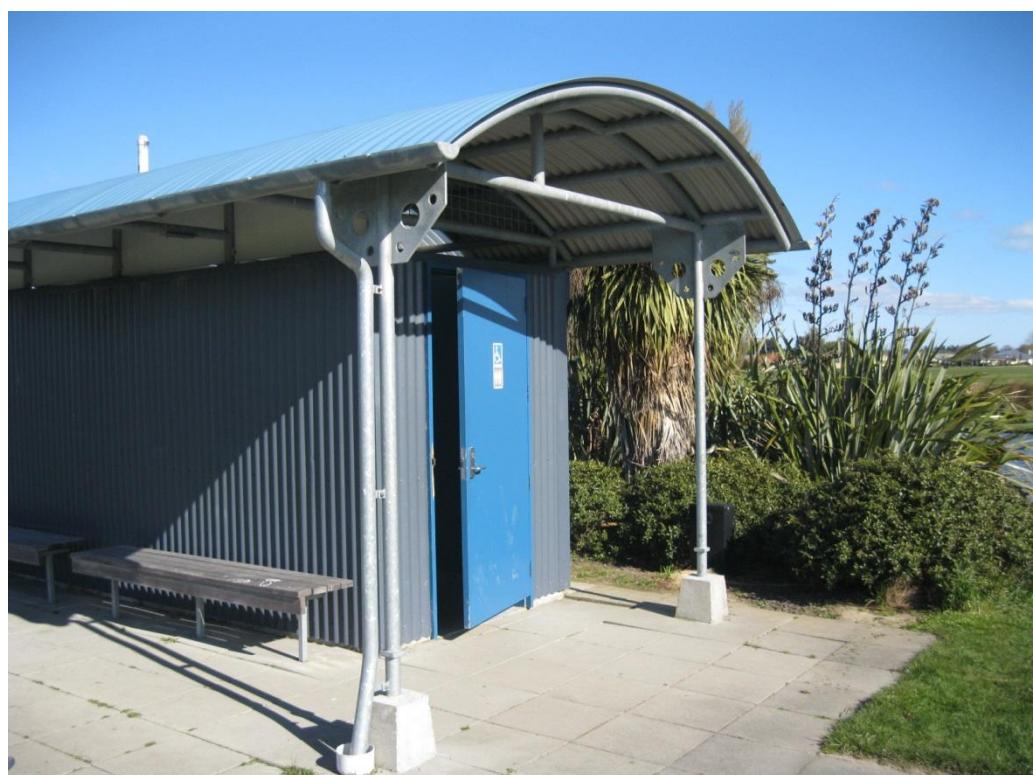
Photograph 2 View of the toilet form the northwest.

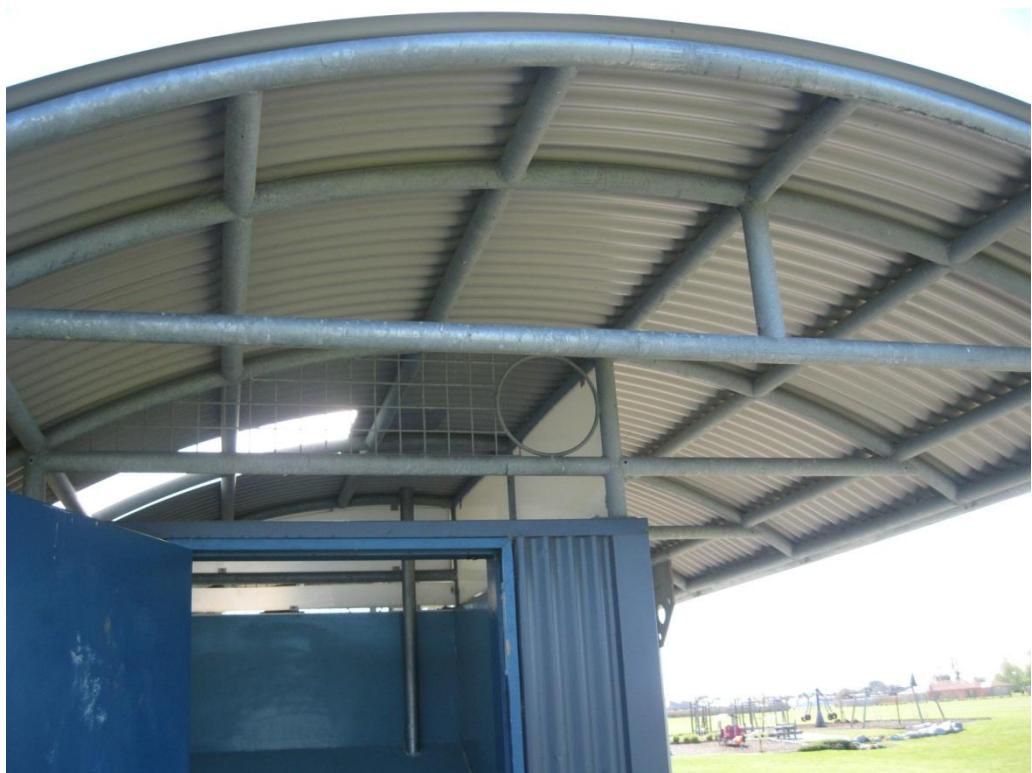
The roof formation of a steel tube grid provides a rigid roof structure and an adequate frame for roof stability.

Photograph 3 Roof frame structure formed by steel tube rigidly connected.

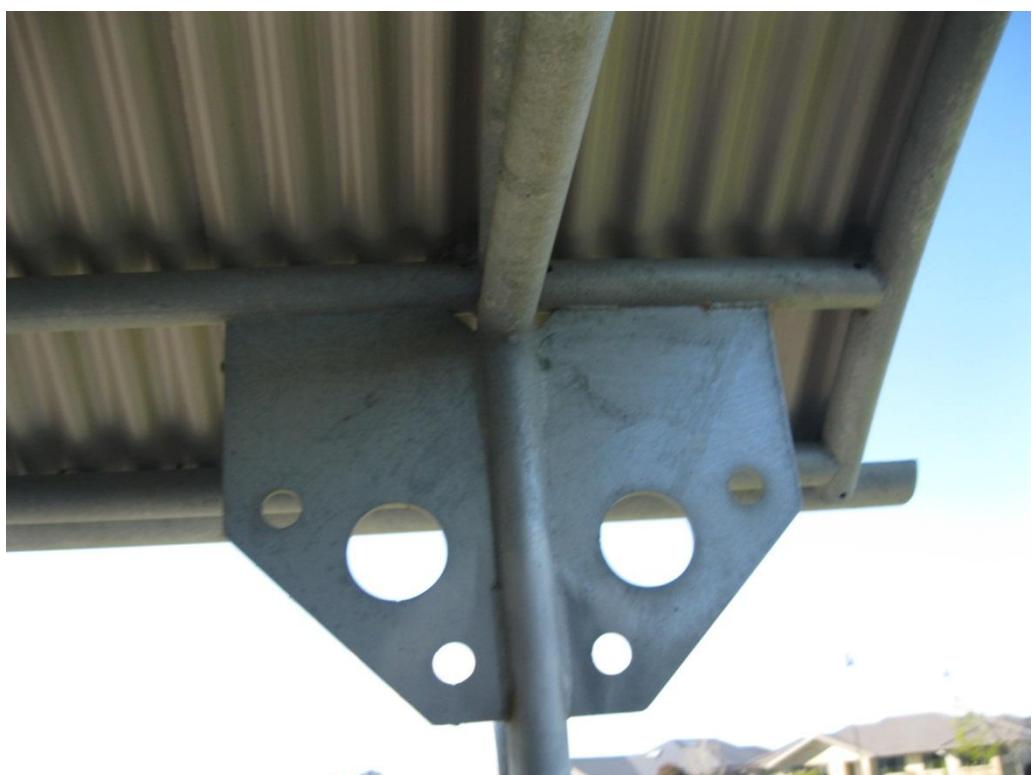
Photograph 4 Additional rigidity at steel tube connection provided by architectural stiffener.
