Halswell Domain - Toilets
Qualitative Engineering Evaluation

Reference: 232879
Prepared for:
Christchurch City Council

Functional Location ID: PRK_1691_BLDG_008

Date: 11 October 2013

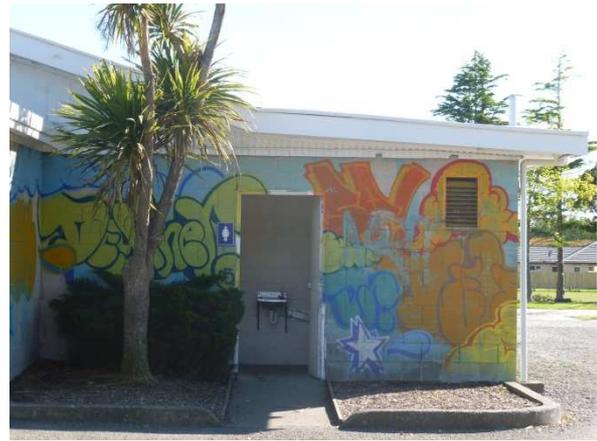
Halswell Domain - Toilets eastern side.

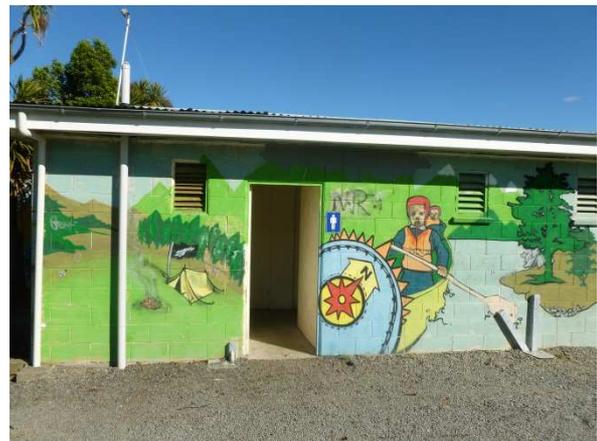
- Cracking of the mortar joints has been observed on the eastern side of the building, starting below the toilet window and running through the other property (pictures shown in Appendix A). These mortar cracks penetrate the entire width of the wall.
- Vertical cracking has been detected at the connection between orthogonal walls as can be observed in the photos in Appendix A. This results in disconnected elements in the two principal directions.
- Other damage has been observed in non-structural components (e.g. between lintel and vertical wall as shown in Appendix A).

As mentioned in section 3.1, cracking of the mortar has been observed on the eastern side of the building affecting both the toilet block and the other property. Considering that the construction is of lightly reinforced concrete blocks with reinforcement only in the corner, the out of plane failure mechanism is likely to happen.

Cracking along the mortar on the eastern side of the building.

Considering the low %NBS (less than 33%NBS) value obtained for the toilet block, strengthening is necessary. The box behaviour should be restored **ensuring the connection between the vertical elements**.

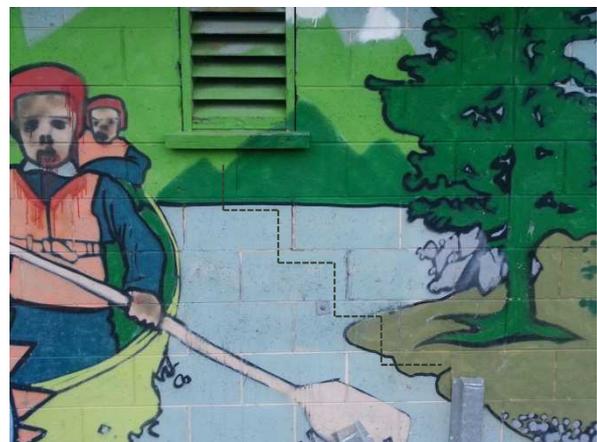
Detail of the cracking along the mortar on the eastern side of the building.

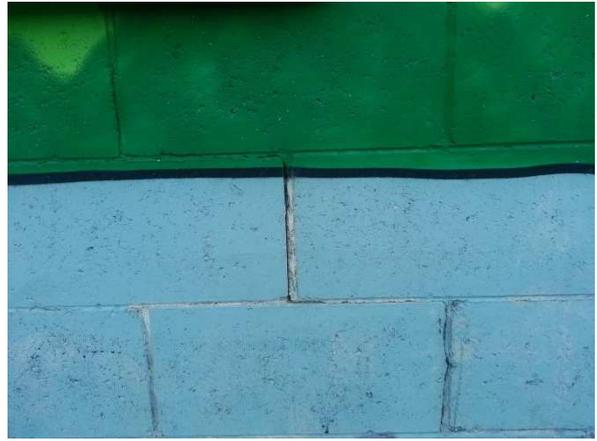
The vertical cracks observed at the edge of few walls do not compromise the stability of the block under the static loads. However, in case of a future earthquake, it is possible that this lack of connection between structural members leads to pounding between orthogonal walls causing damage to the elements and favouring the out-of-plane mechanism of the perimeter walls.

The cracking along the intersection of orthogonal walls represents a structural weakness for this structure. During a significant seismic event the movement of these walls can cause pounding between the members and it can trigger the out-of-plane mechanism of the perimeter walls.

Cracks at the connection of two orthogonal walls.

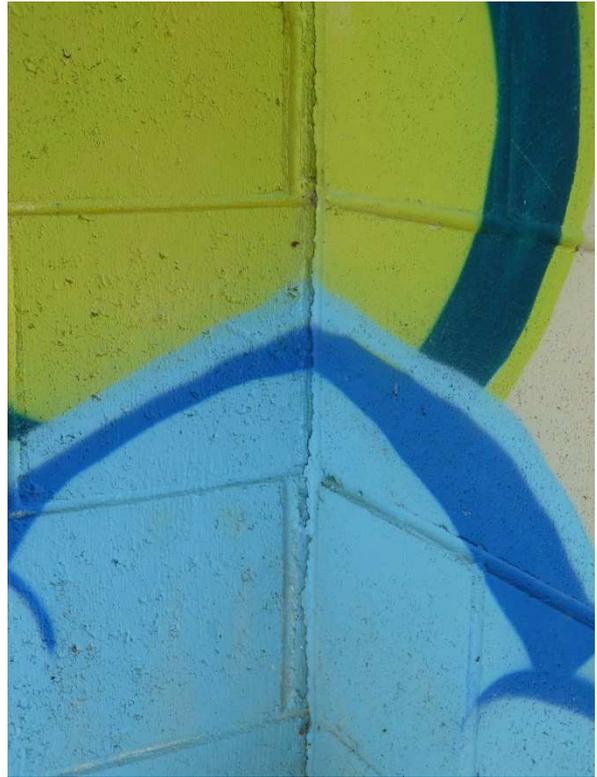
Cracking between lintel and the wall Halswell Domain - Toilets.

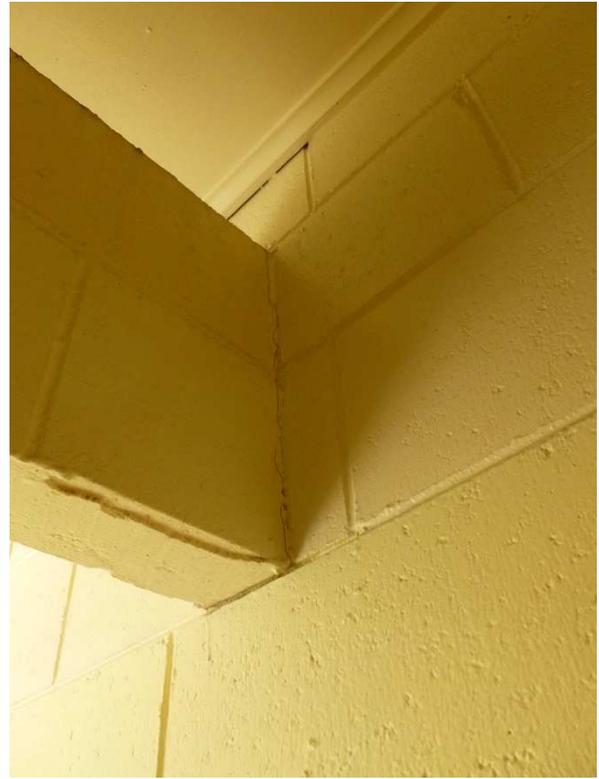
Minor damage to Halswell Domain - Toilets ceiling (non-structural)

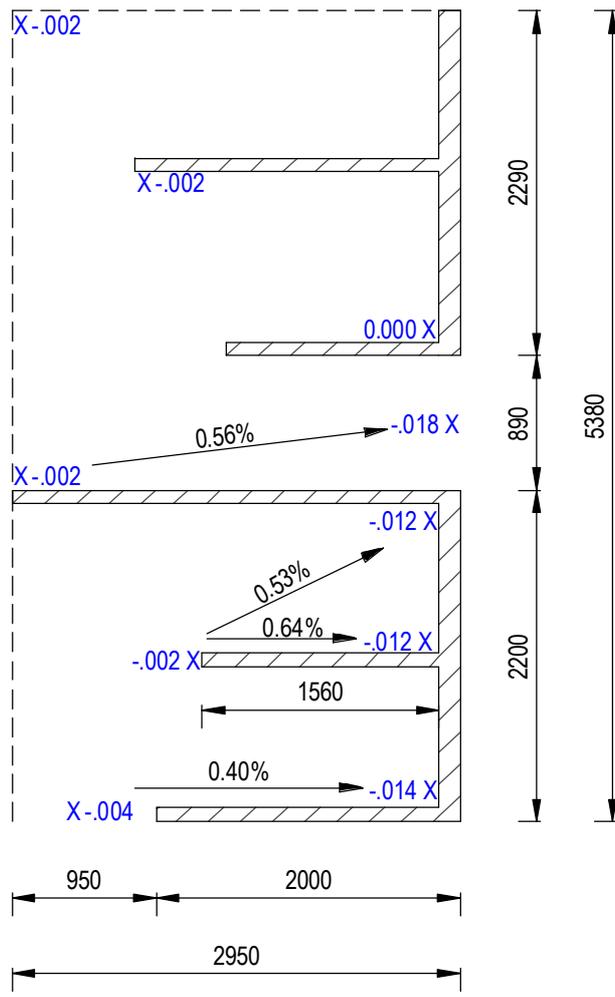
PROJECT
HALSWELL DOMAIN TOILET BLOCK
TITLE
LEVEL SURVEY

The floor levels for the Halswell Domain - Toilets are considered to be acceptable despite not being within the recommended tolerances: the limit of 0.5% has been exceeded once considering the results of level survey.

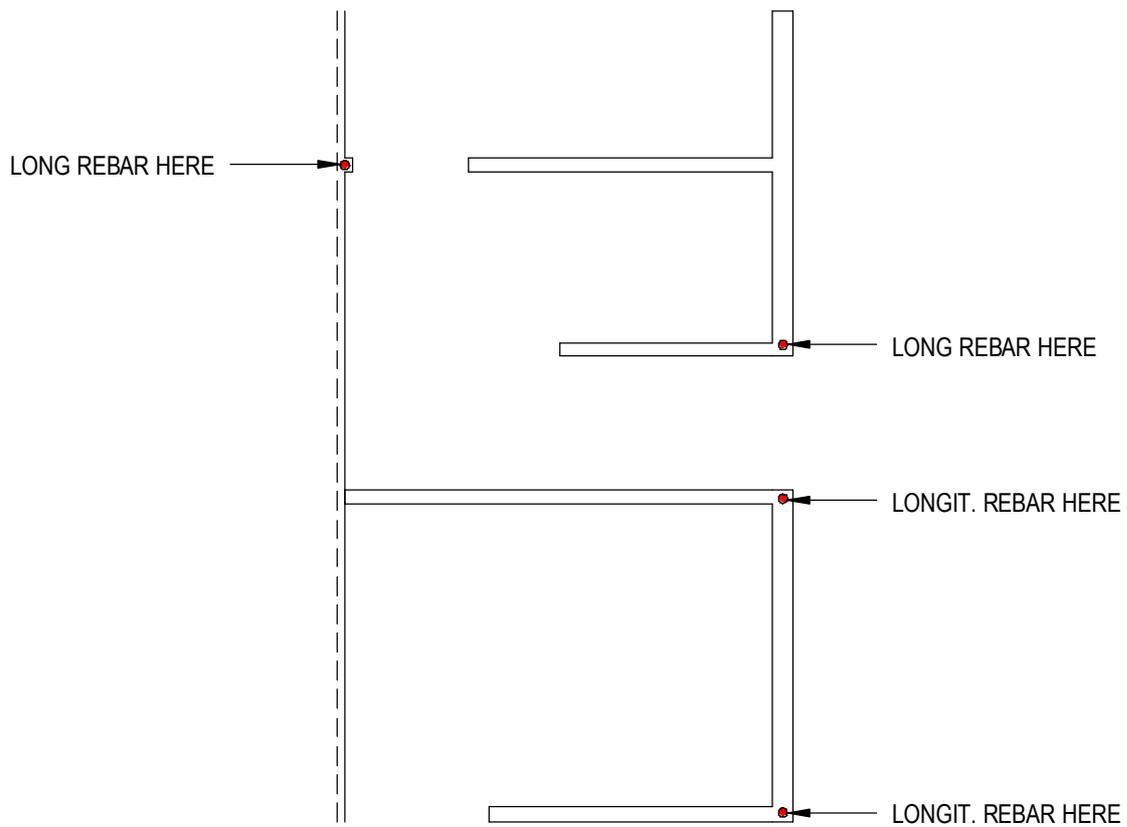
PROJECT
HALSWELL DOMAIN TOILET BLOCK
TITLE
REBAR SCANNING RESULTS

A scan of the walls using a rebar scanner has been performed along the entire building detecting a small amount of reinforcement only located in the corners of the structure. A reinforcement pattern was not identified during this survey. The lack of reinforcement can affect the strength of the structure and for this reason this aspect has been taken into account for the assessment of the structure assuming the walls as unreinforced.

In order to assess the presence of reinforcement, a rebar scanning was performed during the inspection indicating a negligible amount of steel in the walls. (Appendix B)
