Halswell Quarry - Toilet
PRK 1887 BLDG 005
Detailed Engineering Evaluation
Qualitative Report
Version FINAL

Christchurch City Council

Date
20th May 2013

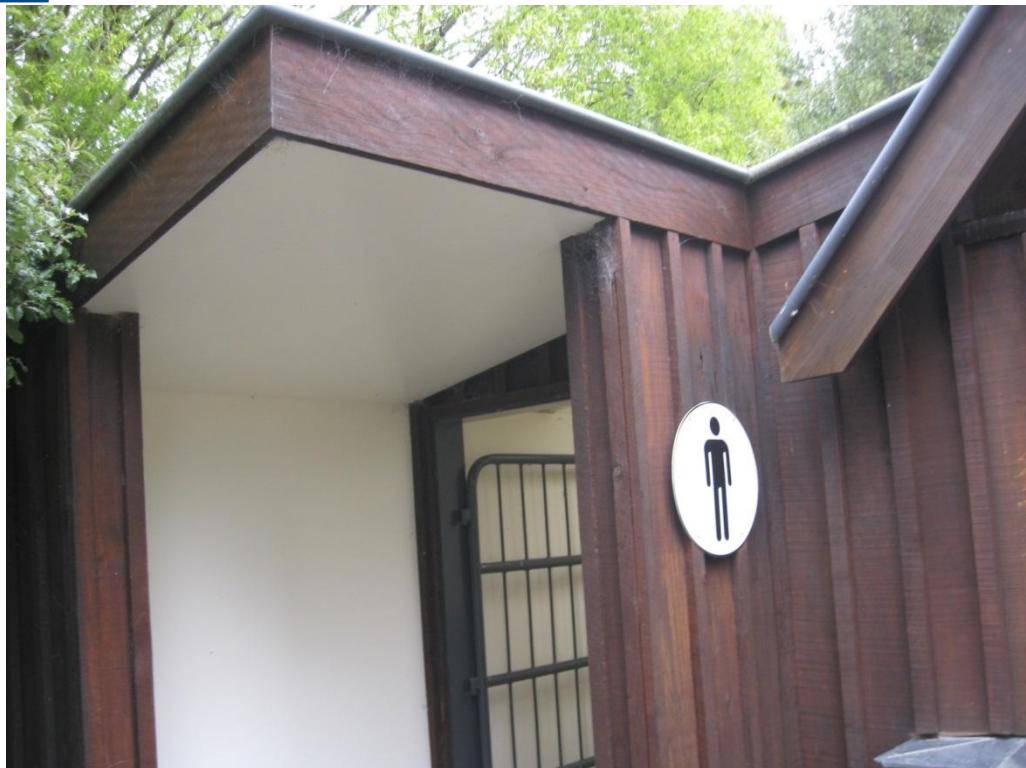
The plans do not reflect an additional roof section built over the entranceway of the additional section. The additional section has been extended 1.5m to the west with the timber framed wall extending to the south elevation. This section of roof cantilevers over this area (see photograph 3).

Photograph 3 Cantilevered Roof over entrance to the addition (section not shown in plans)

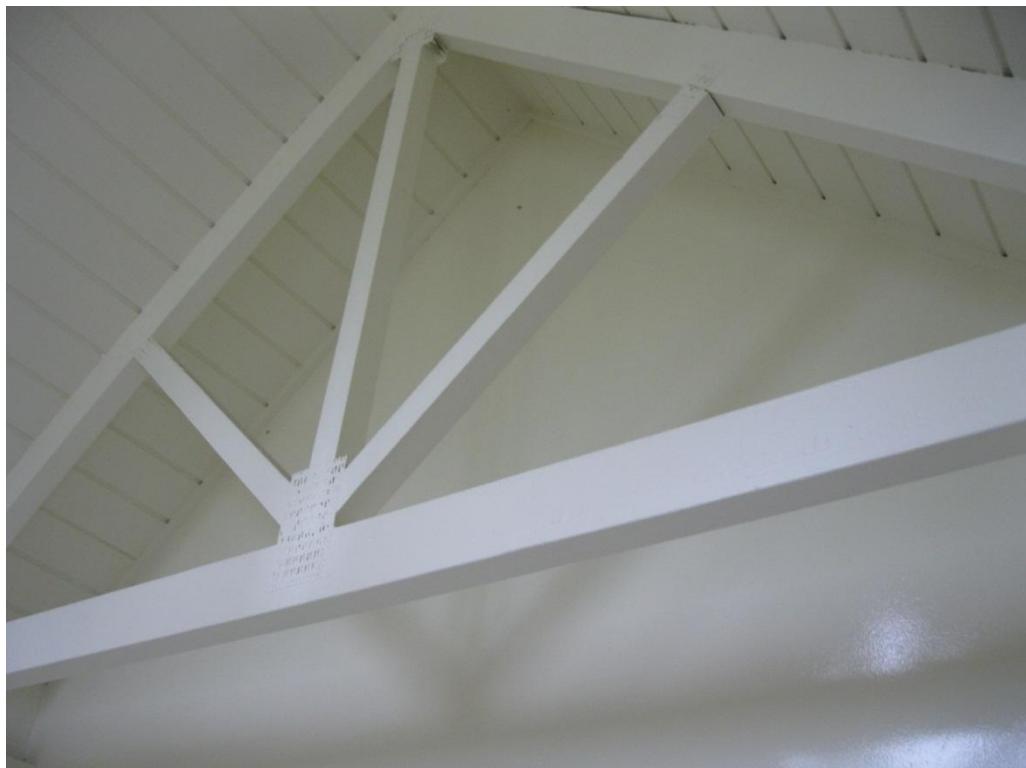
Roof elements such as timber boards, rafters and trusses were clearly visible and are expected to provide bracing to the roof structure. See photographs 4 & 7.

Photograph 4 Timber truss and boards inside original structure.

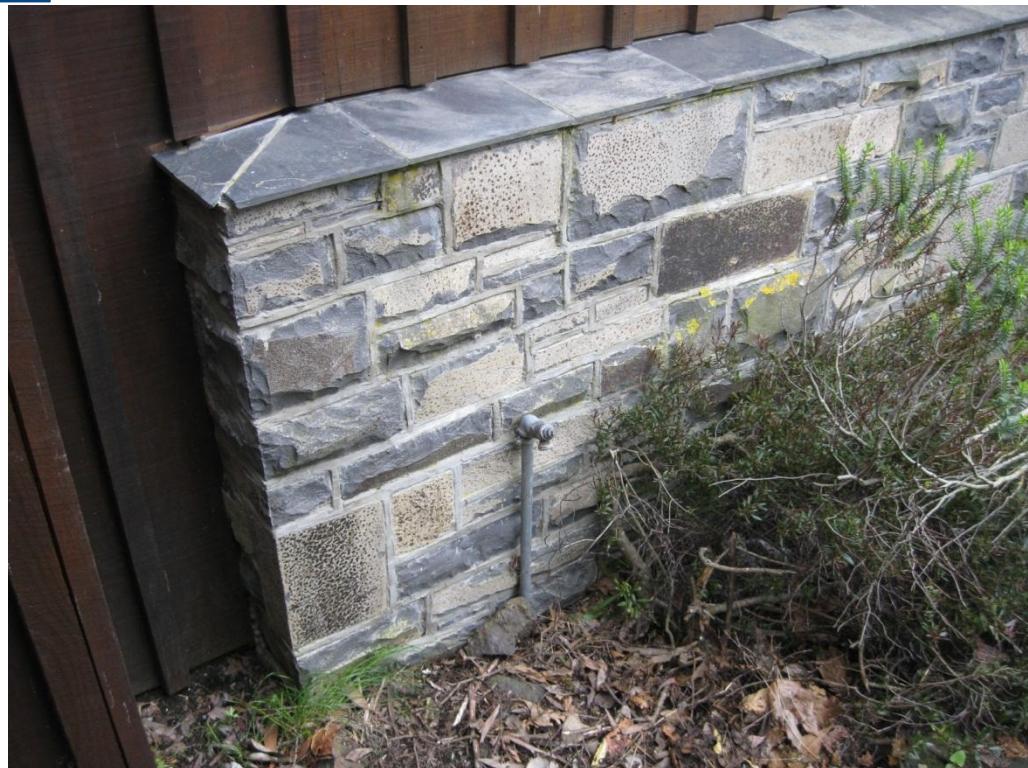
The walls of the building are clad externally with timber boards, except for the original building where the first meter has been clad with a stone veneer.

Photograph 5 Stone Veneer

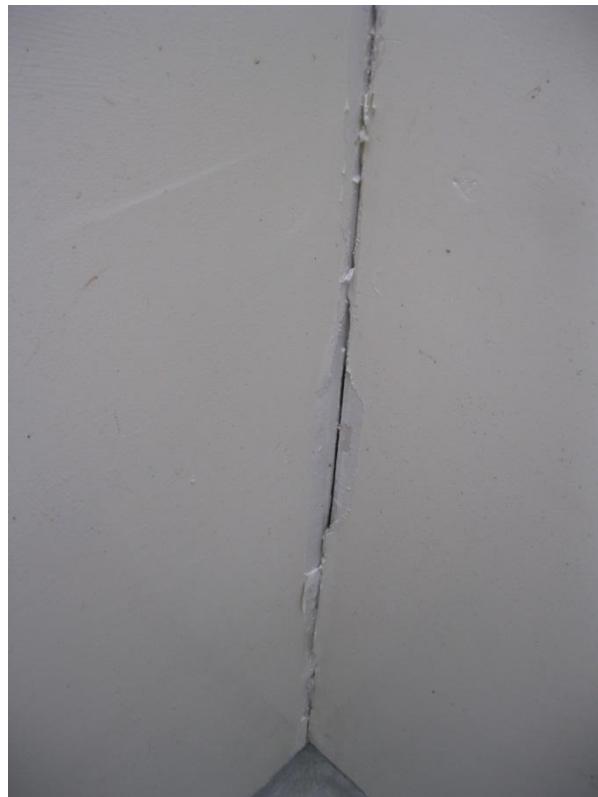
Cracking was noted to the paint in joint locations in the additional section of the building. See photograph 6. These cracks are not considered to be structurally significant however, they may indicate possible movement.

Photograph 6 Vertical crack in paint finish between adjacent walls.

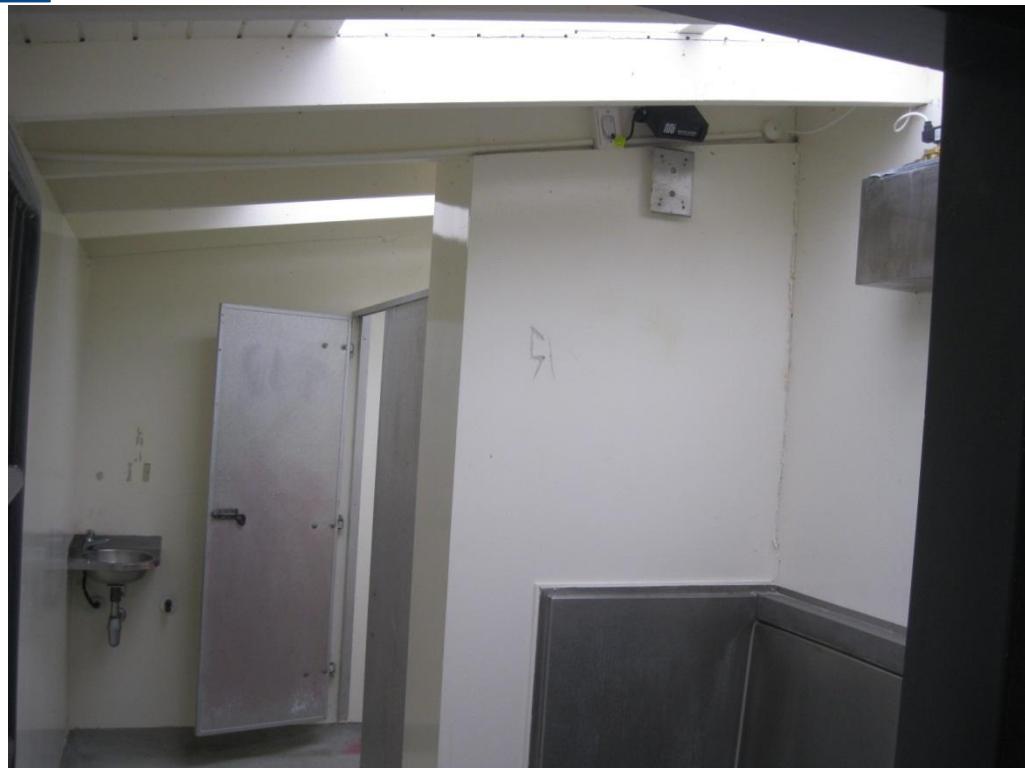
Photograph 7 Interior of the additional structure.

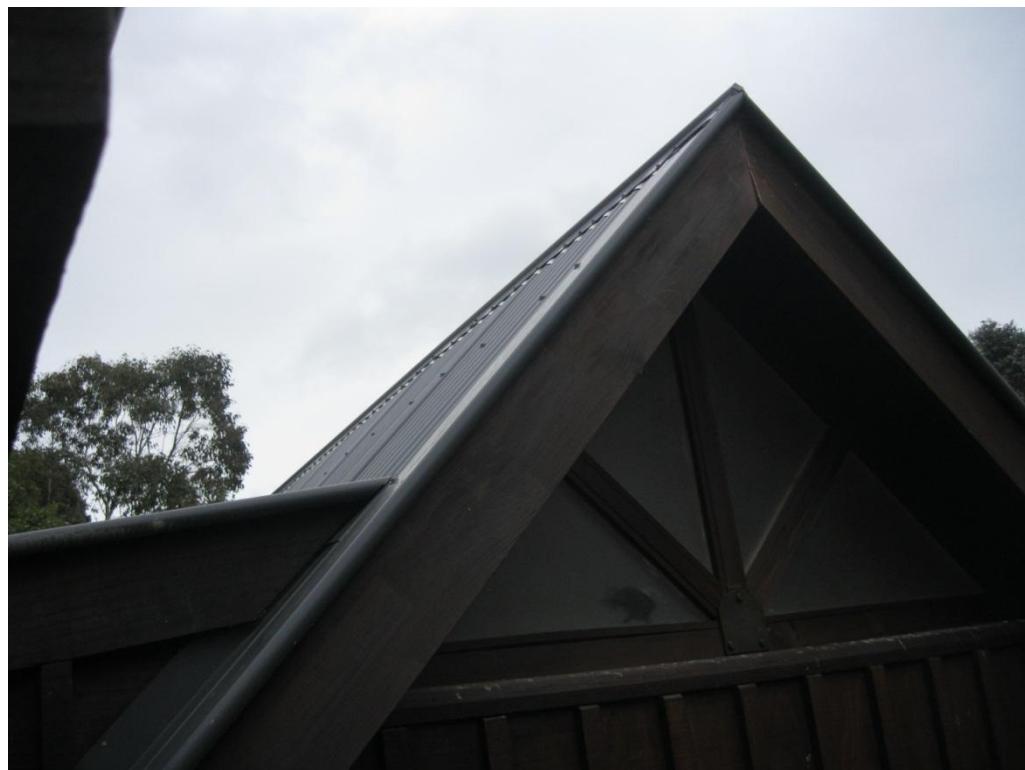
Photograph 8 Additional roof section meeting original section.

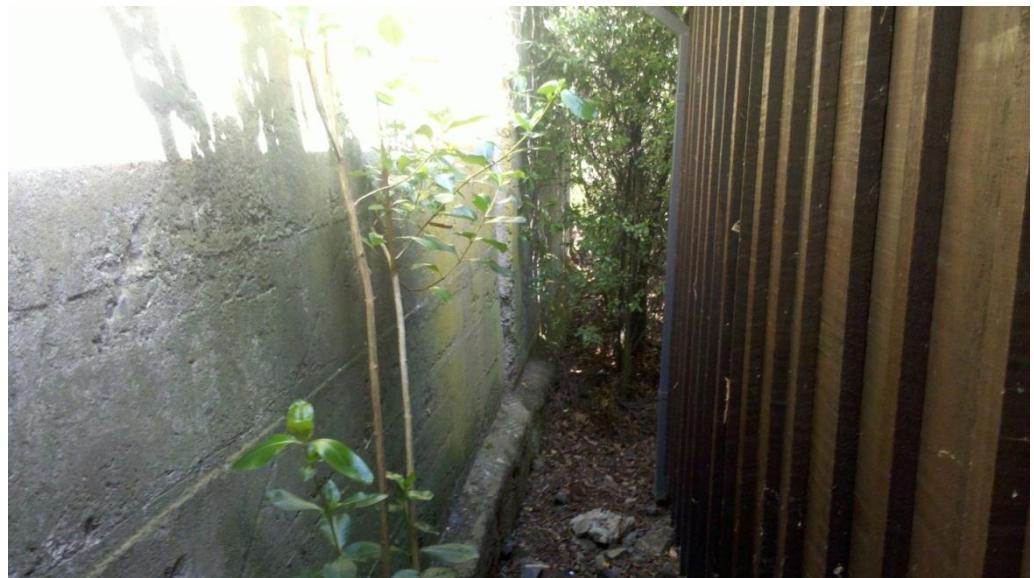
The structure has a plan area of approximately 20m², with its apex and eave standing 3.6 meters and 2.2 meters above ground level respectively. The structure is relatively isolated and there are no near waterways; it is built on a level site. A 2.2 meter high retaining wall is located to the north of the building.

Photograph 9 Retaining wall
