Halswell Quarry Farm Park - Toilet
PRK 1887 BLDG 007
Detailed Engineering Evaluation
Qualitative Report
Version FINAL

Christchurch City Council

Date
20 May 2013

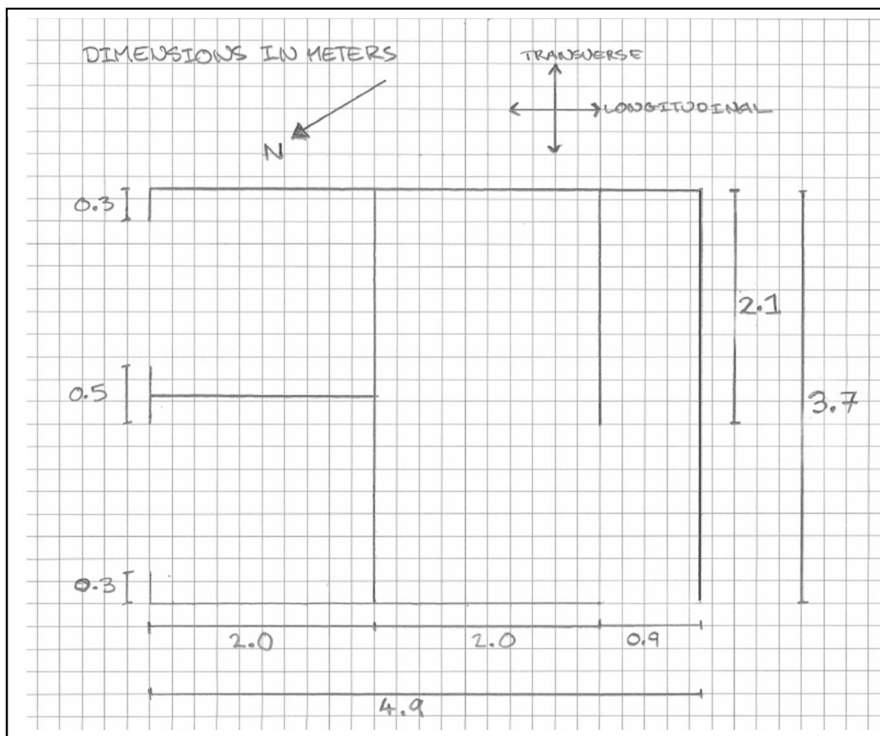
Figure 2 Plan Sketch Showing Key Structural Elements

Lightweight timber framed perimeter walls form a rectangular structure. All perimeter walls are clad externally with stone veneer to 1 meter above ground level and timber boards for their remaining height. There are two openings on the buildings north-eastern face and one on the buildings north-western face. The rooms are formed by timber framed partition walls which extend to roof level (see Figure 2)

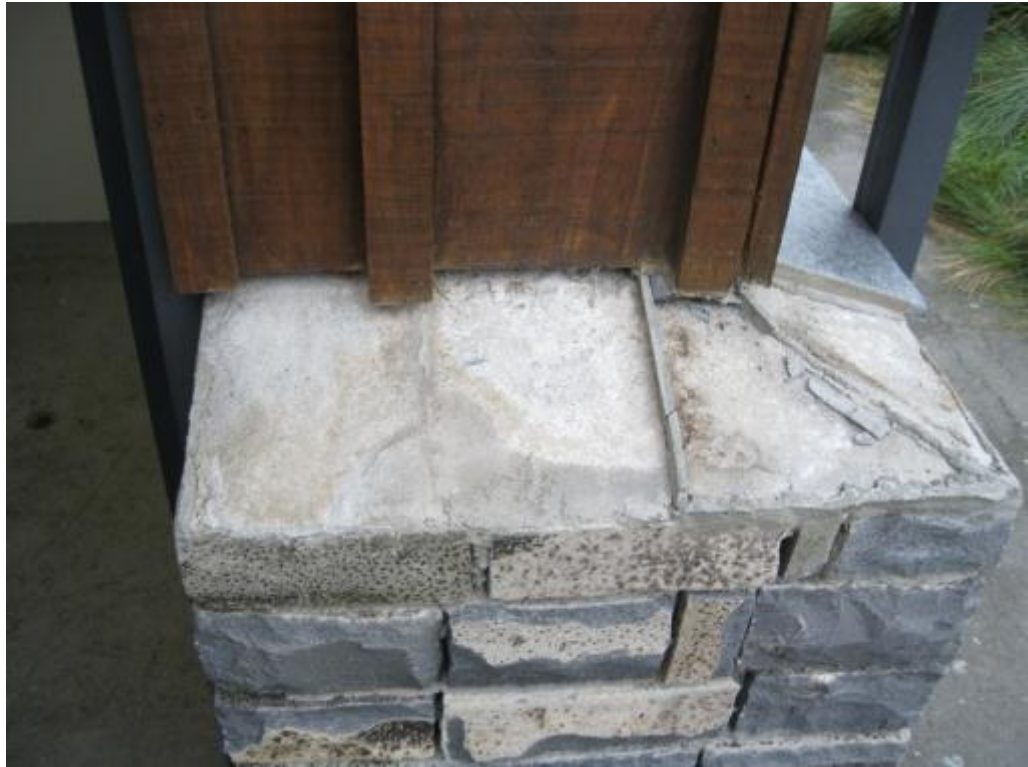
The building is in good condition and is well maintained except that the tiling on top of the stone veneer on the buildings western corner is missing. This is not related to the seismic event.

Photograph 5 Missing tiling on stone veneer

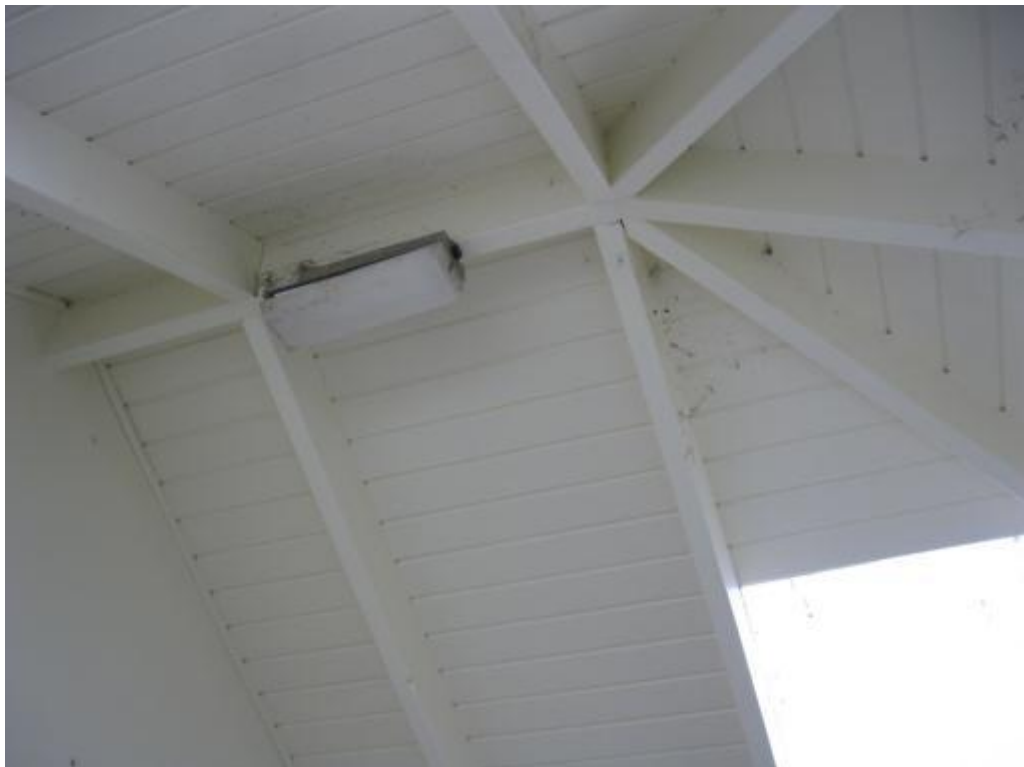
Roof elements such as timber boards, and rafters were clearly visible and are expected to provide bracing to the roof structure.

Photograph 6 Roof interior

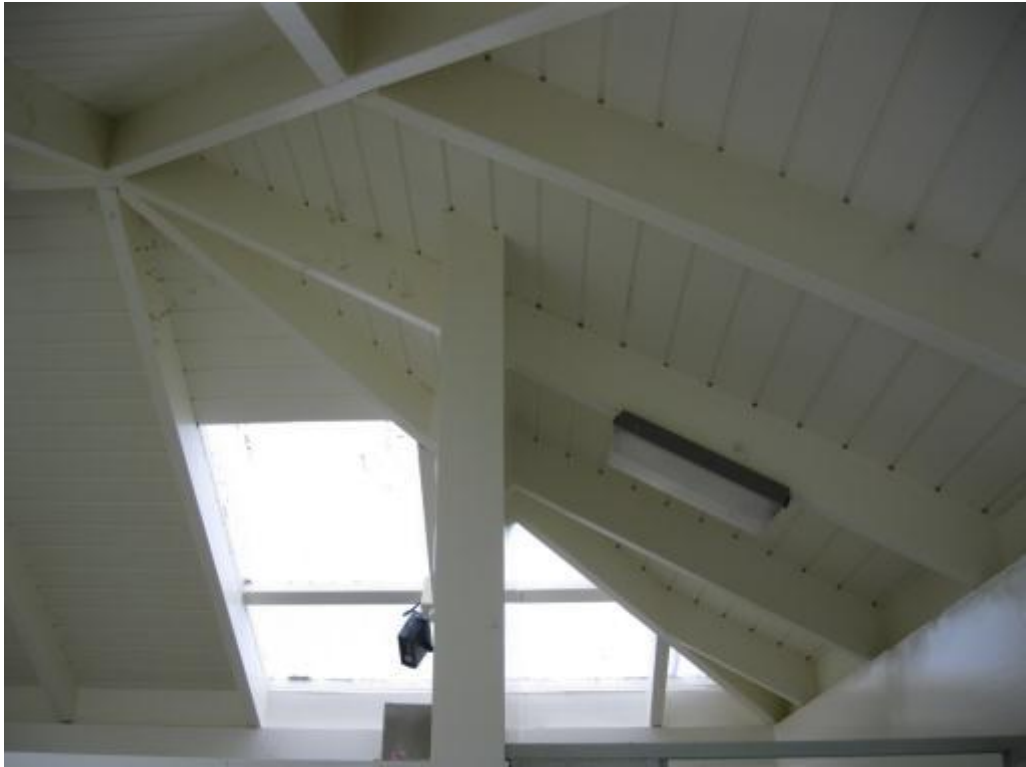
Photograph 7 Partition support to mid-point of rafter and hip beam.

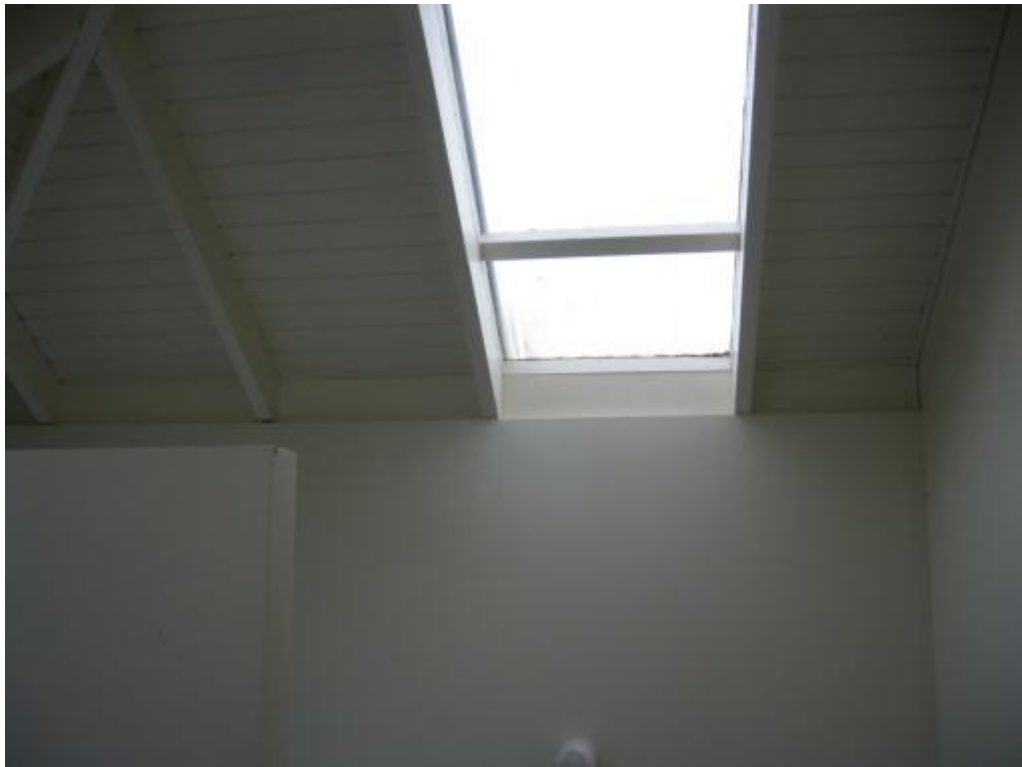
Photograph 8 Sky light.
