Halswell Quarry Old Crusher
Building
Qualitative Engineering Evaluation

Functional Location ID: PRK 1887 BLDG 003

Address: Halswell Quarry, Kennedys Bush Road

Date: 24 June 2013

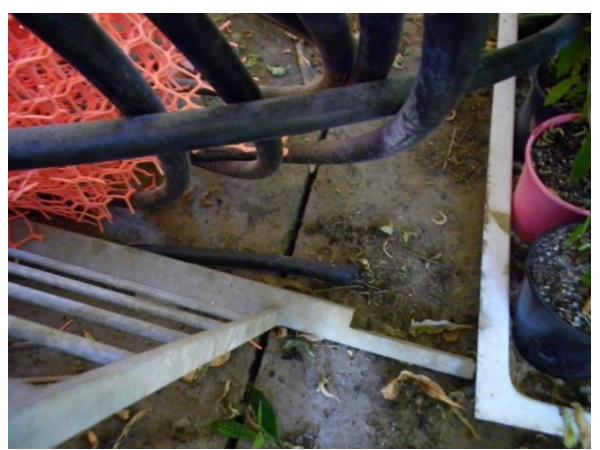
Increased crack widths and gaps in the concrete floor slab.

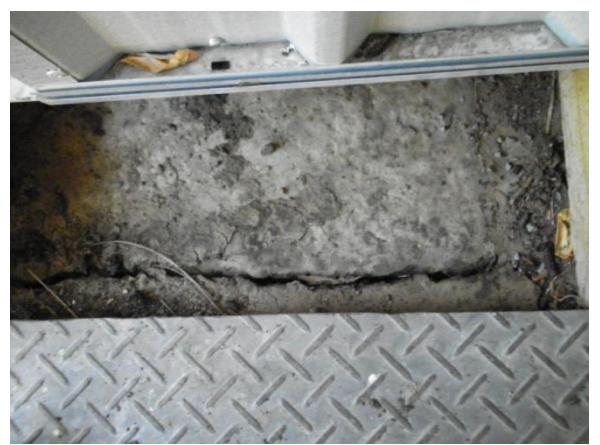
Cracking in concrete floor slab.

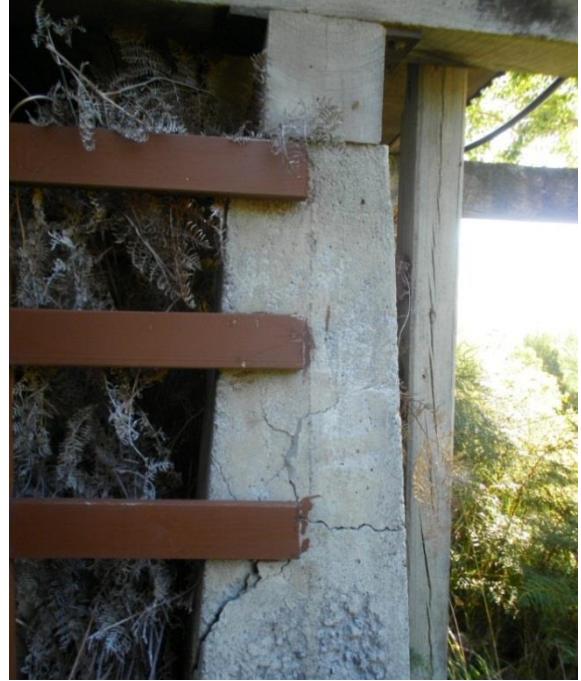
<p>Cracking in the concrete foundation piers supporting the northern elevation of the extension.</p>

The cracked concrete foundation piers supporting the northern elevation of the addition should be replaced as the size of cracks which measure up to approximately 5mm and the type of construction make them unrepairable.

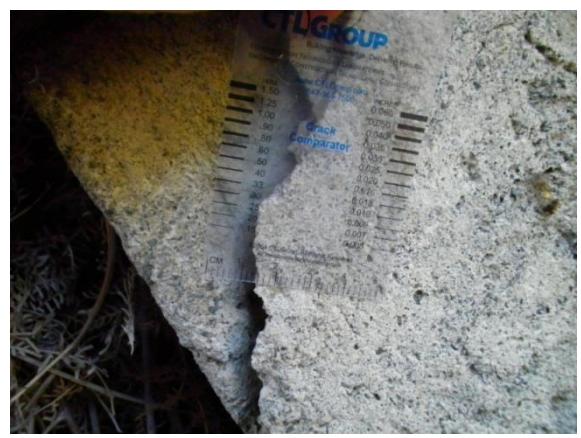
<p>Cracking in the concrete foundation piers supporting the northern elevation of the extension.</p>

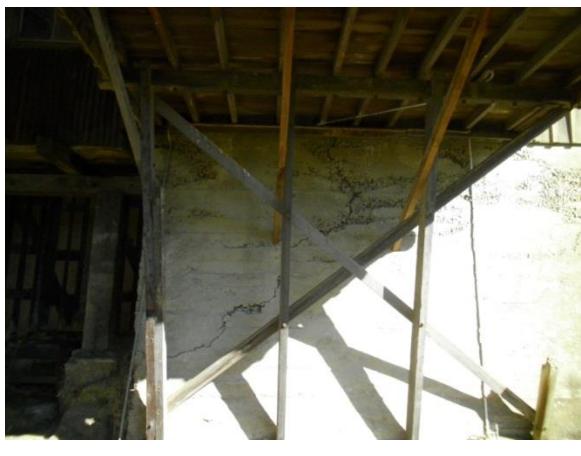
The retaining wall supporting the northern wall of the Halswell Quarry Old Crusher Building has partially failed and its residual capacity is likely to be very low given the style of construction.

<p>Cracking in the concrete retaining wall bellow the northern elevation of the building.</p>

The retaining wall that forms part of the foundations for the northern elevation of the building has partially failed and requires replacement. This would involve a significant amount of invasive works and may be uneconomical in which case demolition of the old crusher building and replacement of the retaining wall or return of the ground to a natural slope may be the preferred option.

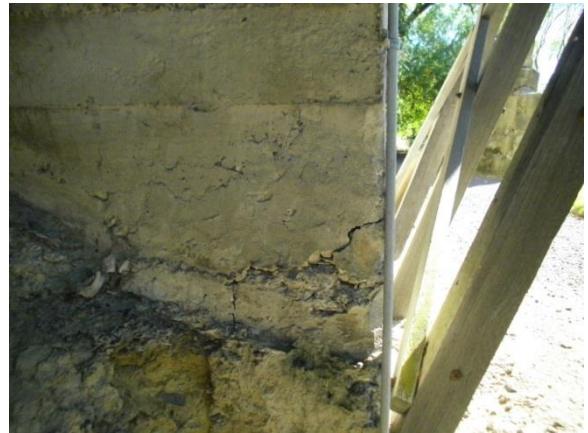
Cracking in the concrete retaining wall bellow the northern elevation of the building.

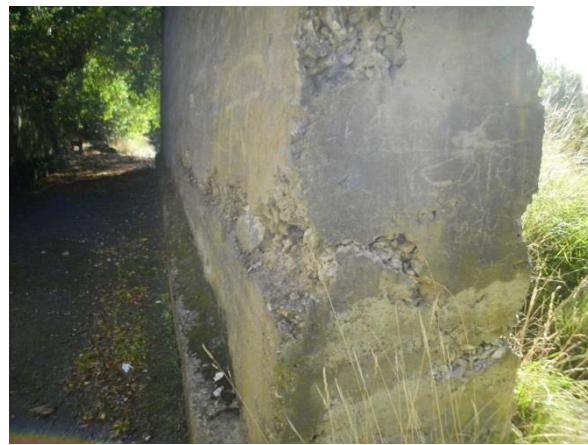
The large free standing mass concrete wall to the north of the Halswell Quarry Old Crusher Building presents a serious hazard in its current state as the top portion of the wall is loose and unstable.

The free standing mass concrete wall to the north of the Halswell Quarry Old Crusher Building appears to have partially failed as there is a horizontal crack running the length of the wall. Preliminary analysis shows that this wall is less than 33% NBS and poses a significant hazard.

Horizontal cracking in the large free standing mass concrete wall to the north of the Halswell Quarry Old Crusher Building.

The free standing mass concrete block wall to the north of the Halswell Quarry Old Crusher Building requires demolition as it currently poses a significant hazard and repair of this structure is not feasible given the type of construction.
