Halswell Quarry Park - Old  
Quarryman's Information Centre  
(Single Man's Quarter)  
Qualitative Engineering Evaluation

Functional Location ID: PRK 1887 BLDG 004

**Reference:** 228887

**Date:** 2 September 2013

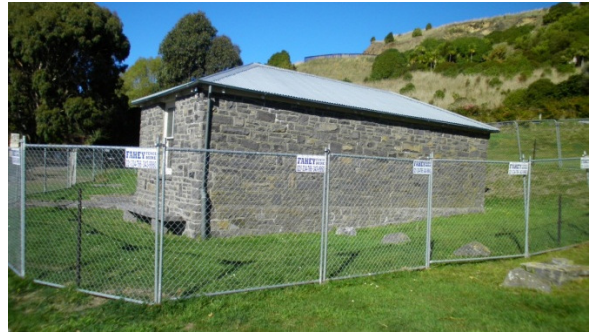
The horizontal and step cracking in the external stone walls may be the result of either out-of-plane bending and rocking of the stone or insufficient bond between the stones and the mortar to transfer the shear forces generated by the earthquakes.

Horizontal cracking in the stone wall.

The horizontal, vertical and step cracking in the stonework should be injected with grout. Some repointing may be necessary depending on the desired finish.

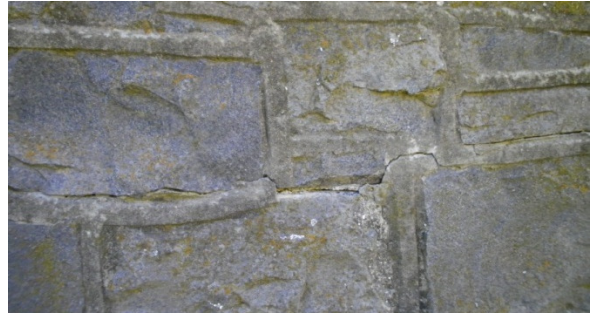
The vertical cracks in the external stone walls are the result insufficient connection strength between the internal and external walls. This has resulted in large gaps of up to 10mm opening between the external walls and perpendicular internal walls.

Vertical cracking in the stone wall.

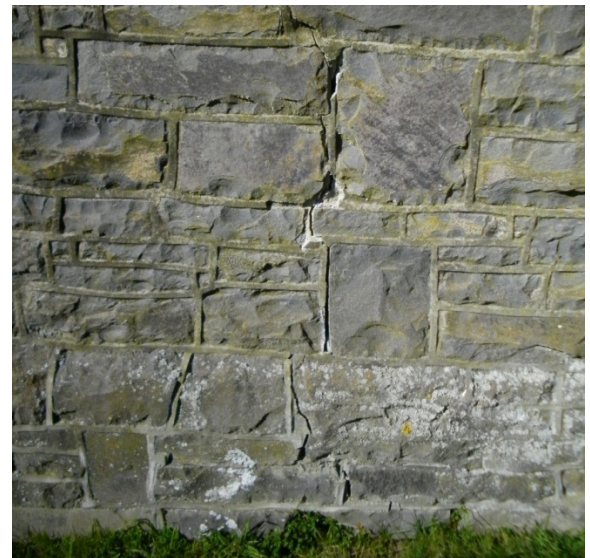
Step cracking in the stone wall.

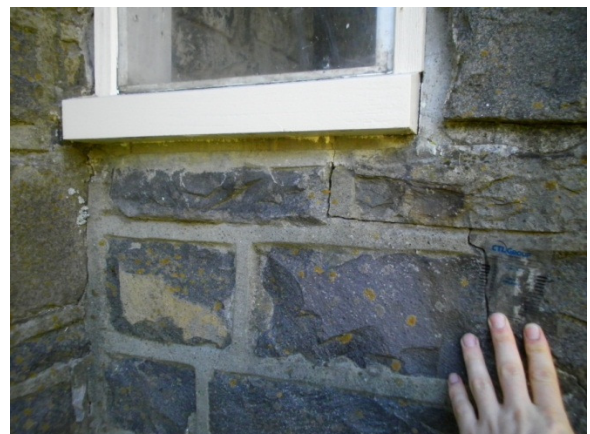
The damage to the north-western and south-eastern corners of the building is due to the concentration of the in-plane and out-of-plane forces on the walls in the stiffer corners of the building.

Displacement of stone blocks in the south-eastern corner of the building.

The displaced blocks in the south-eastern and north-western corners of the building should be removed and re-laid.

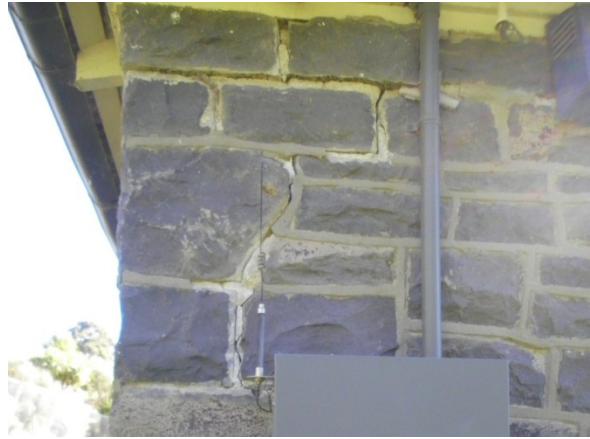
Displacement of stone blocks in the south-eastern corner of the building.

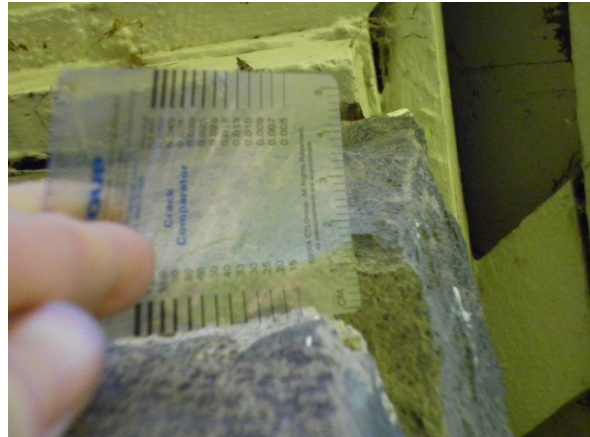
The displaced stone blocks in the top few rows of blocks and movement between the roof and walls is due to insufficient shear strength in the connection between the roof diaphragm and the walls to transfer the seismic action on the roof and out-of-plane walls into the in-plane stone walls. This also results in a lower out-of-plane capacity of the stone walls since the roof diaphragm will be unable to transfer the out-of-plane loads on the walls to the in-plane walls.

Displaced stone blocks in the top few rows of blocks.

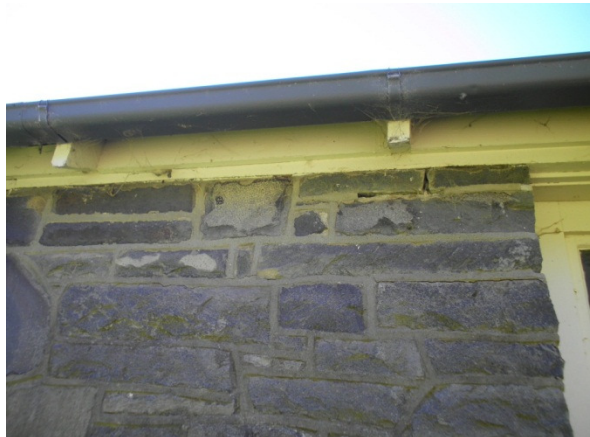
Vertical cracking in the end of a wall perpendicular to the northern elevation.

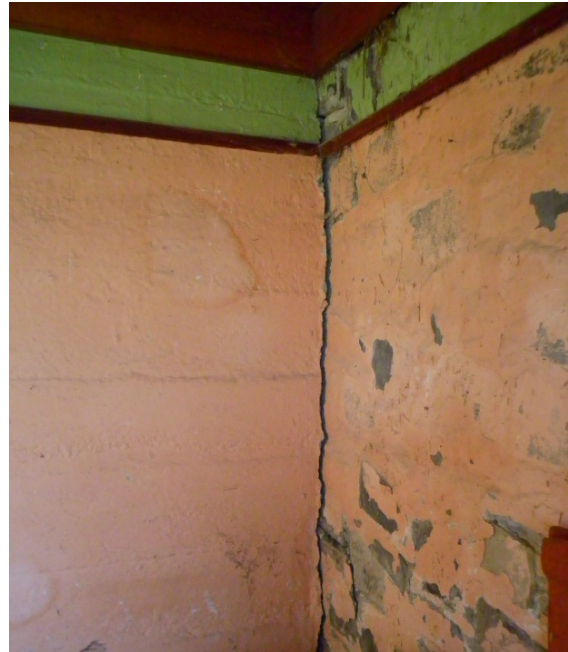
Gaps of up to 10mm have between the external walls and perpendicular internal walls.

The gaps between the external stone walls and internal concrete walls should be filled using grout.

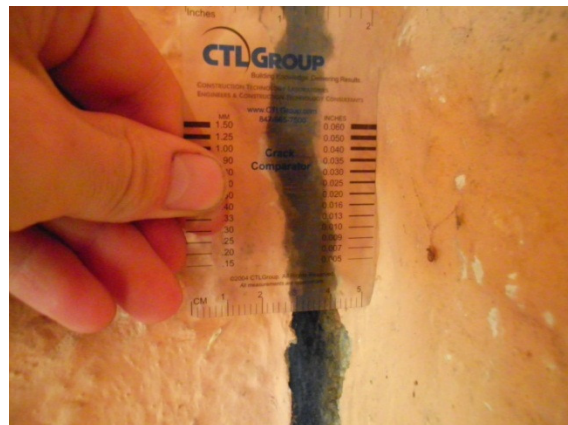
The connection between the roof diaphragm and the walls has been identified as a critical structural weakness for this building. The gaps observed between the stone walls and parts of the timber diaphragm indicate that this connection has failed under recent seismic loading.

The wall to ceiling diaphragm connection is below 33% NBS. There are signs of movement between the diaphragm and the stone blocks indicating that this connection has failed in the recent earthquakes. The connection relies on friction to transfer shear forces and is currently limiting the strength of the building as a whole to less than 33% NBS

Movement of the diaphragm indicating failure of the wall to diaphragm connection.

- Strengthening of the diaphragm, this may be achieved by adding additional cross bracing in the roof space. Alternately plywood may be added to the diaphragm in order to increase its strength and stiffness.
- Strengthening of the wall to diaphragm connection for the stone walls, this may be achieved by bolting through the diaphragm and into the top of the stone walls. Strengthening of the connection of the diaphragm to the concrete internal walls may be achieved by attaching a steel angle to the concrete wall and the diaphragm.
