Harewood Community Centre Detailed Engineering Evaluation BU 0299-001 EQ2 Quantitative Report

Prepared for Christchurch City Council (CCC)

By Beca Carter Hollings & Ferner Ltd (Beca)

19 December 2012

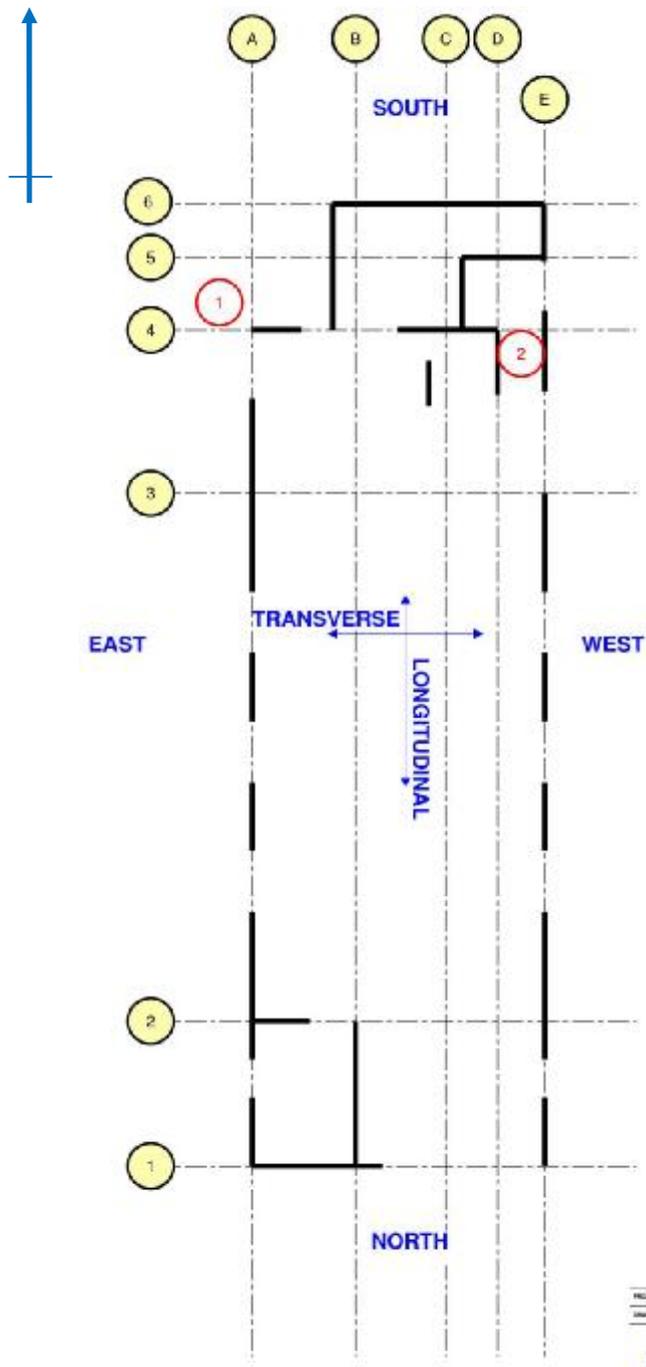
Key Plan of Building

XX DAMAGE REFERENCE
AS PER PHOTO
ATTACHED

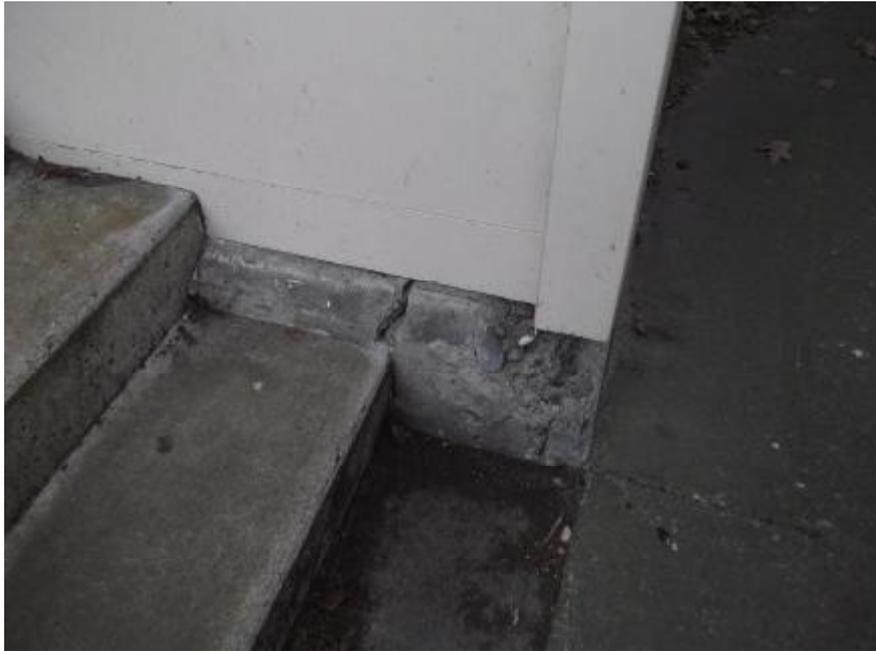
Photo 1: Cracking and spalling to foundation wall

- Cracking and spalling to foundation wall potentially due to ground movement during the earthquake.
- Cracking to plasterboard lining with minor leaking stains at the southern side of the building.

Damage type	Unknown	Minor	Moderate	Major	Comment
settlement of foundations			✓		There is typical minor cracking to perimeter foundation walls with one location with 15mm wide cracking and minor spalling. Level survey may be required to confirm.
tilt of building	✓				None observed during visual inspection.
liquefaction	✓				The aerial reconnaissance photograph from 24 th Feb 2011 indicates there was no liquefaction in this area.
settlement of external ground	✓				None observed during visual inspection.
lateral spread / ground cracks	✓				None observed during visual inspection.
Frame damage	✓				The timber roof trusses were not fully visible due to the presence of ceiling.
concrete walls damage					Not applicable
cracking to concrete floors					Not applicable
Bracing damage		✓			There is minor cracking to wall lining as the brace element with leaking stain at southern side of the building.
precast flooring seating damage					Not applicable

No geotechnical information is currently available for this site. Cracking to foundation walls indicate settlement.

Damage description: Cracking and spalling to concrete foundation wall at the southeast corner of the building with cracking width approximately 15mm.

- Further efforts are made to obtain structural drawings.
- A level survey could be carried out to determine the extent of settlement of the building for insurance purposes.
- The assessment is based on some significant assumptions; further investigations are required to confirm capacity.
- Repairs that would bring the building back to an "as new" condition are typically entitled under typical replacement insurance policies. We suggest you consult with your insurance advisor as to how you wish to proceed.

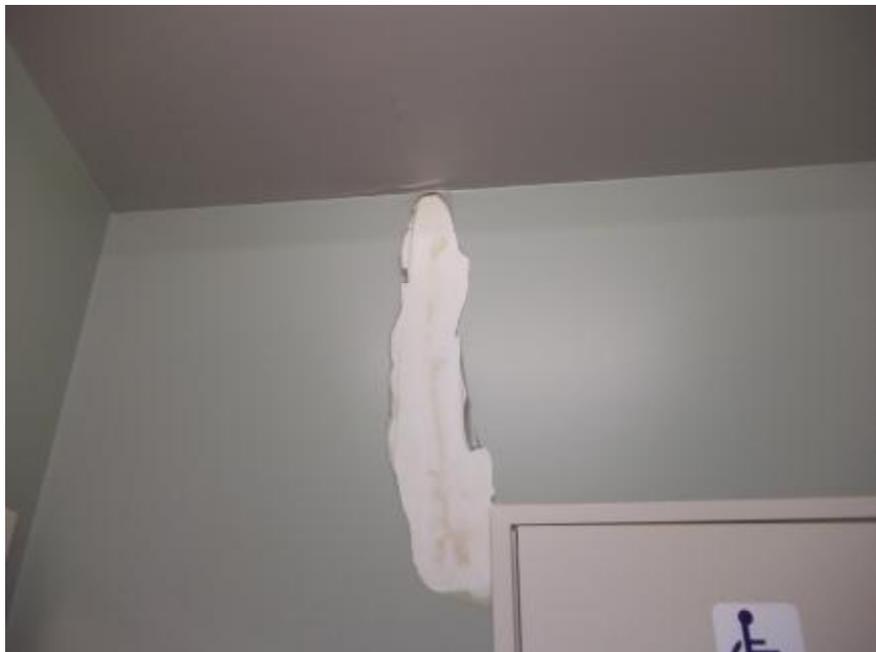
Photo 2: Cracking to wall lining with leaking stain

stairs					Not applicable
cladding /envelope	✓				No damage observed during visual inspection.
internal fit out		✓			Minor cracking to wall lining with leaking stain at southern side of the building.
building services	✓				No inspections of services were carried out.
other

Damage description: Cracking to wall lining with leaking stain at the south end of the building.

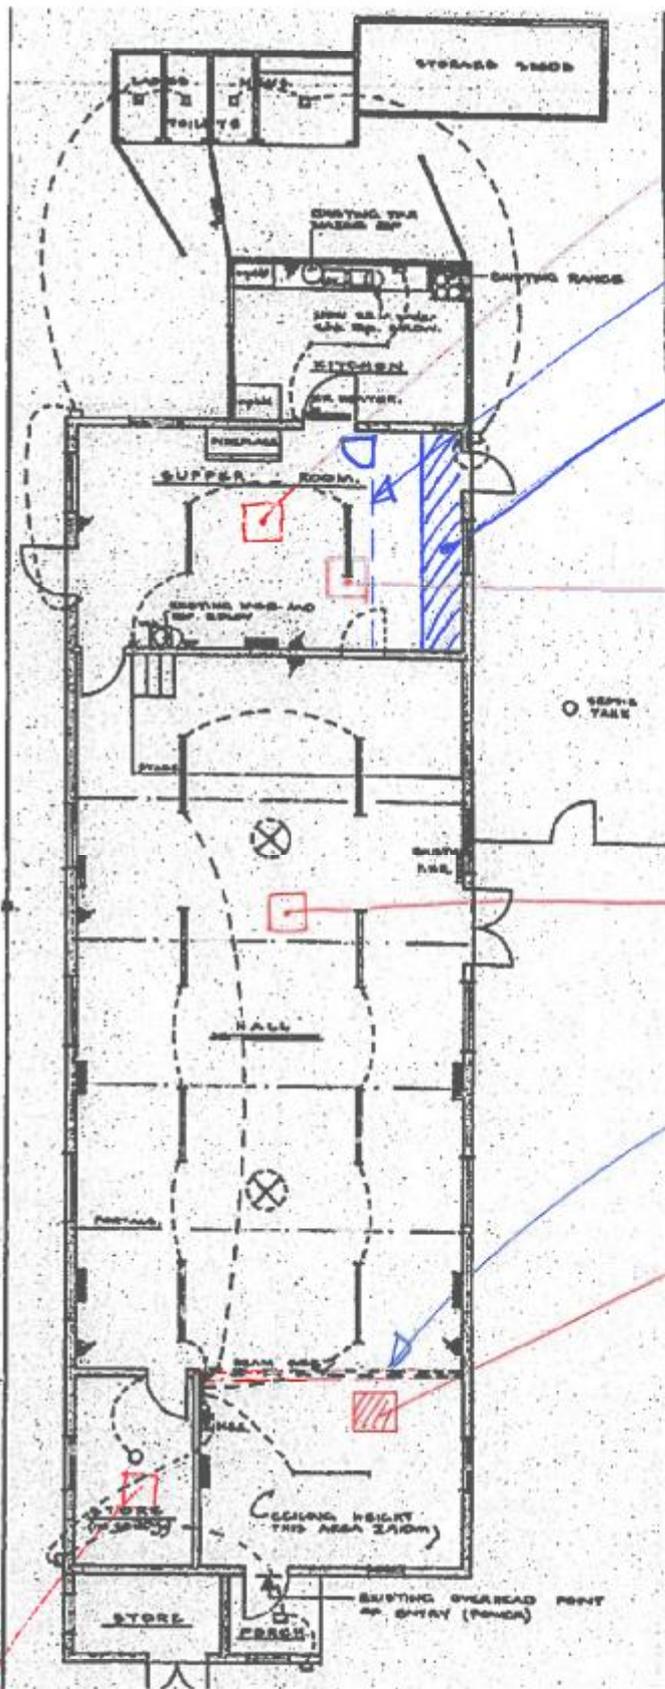
Proposed Intrusive Investigation

OPEN CEILING LINING TO CONFIRM ROOF BRACING

OPEN FLOOR HATCH AROUND KITCHEN AREA NEXT TO PARTITION TO CONFIRM FOUNDATION

No intrusive investigation has been carried out at this stage. We recommend intrusive investigation to confirm assumptions made in our calculations such as actual wall construction, type and condition of wall linings, type of existing foundations, connection and existing diaphragms (Refer Appendix D).
