CHRISTCHURCH CITY COUNCIL
PRK_0339_BLDG_001 EQ2
Harewood Nursery – Amenities Building
239 Gardiners Road, Harewood

QUANTITATIVE ASSESSMENT REPORT
FINAL

- Rev B
- 27 February 2013

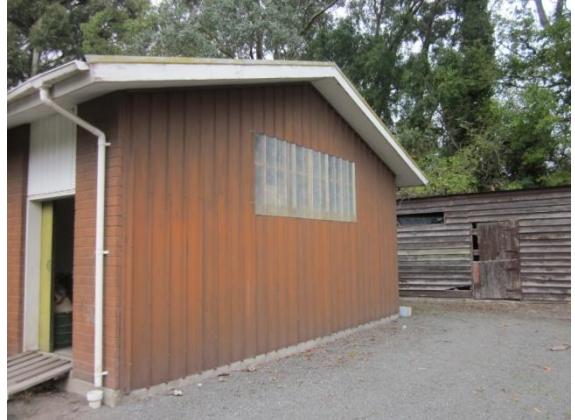
Photo 2: North Elevation

The building has limited bracing capacity along the north wall which will create a torsional response when the building is subjected to lateral loads acting in an east-west direction. However

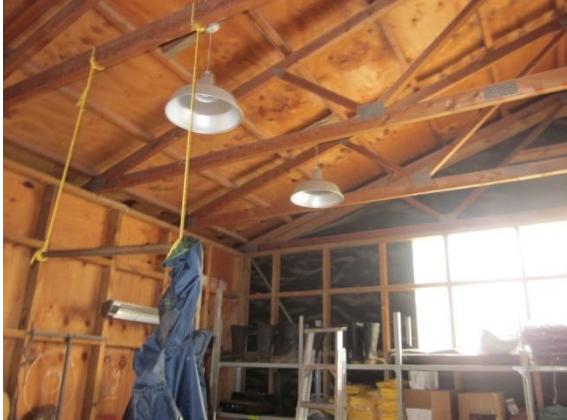
Photo 5: Internal View – Plywood Linings	Photo 6: Hairline Cracking at Hardiboard Vertical Joints

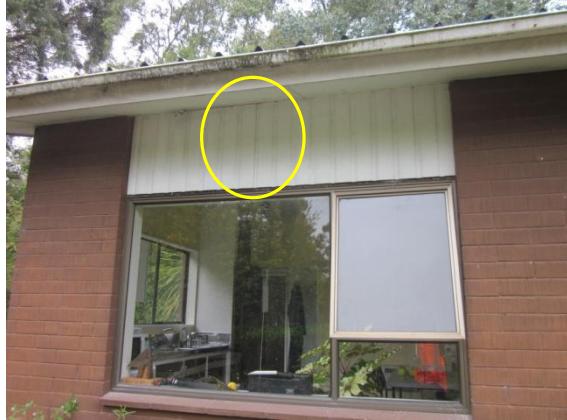
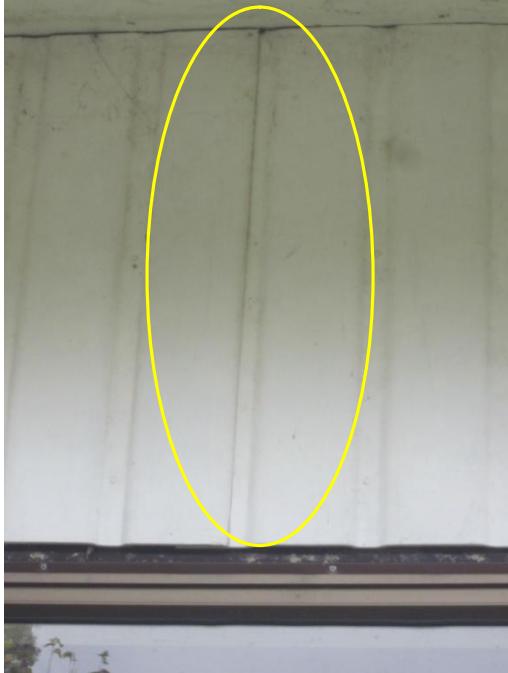
- 1) Hairline cracking to external cladding elements.
- 2) Damage to guttering – however this damage appears to not be earthquake related.
- 3) Localised damage to one of the bricks above the toilet window.

Photo 7: Close up of Photo 6	Photo 8: Hairline Cracking at Timber Fascia Joints

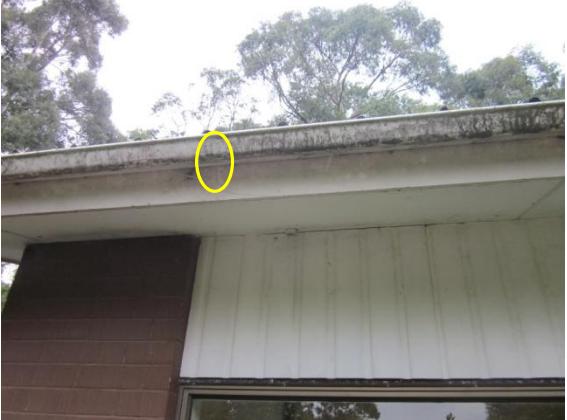
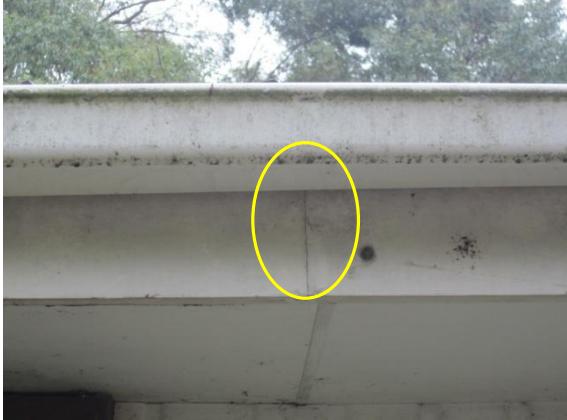
Photo 9: Close up of Photo 9	Photo 10: Damaged Guttering along West Wall

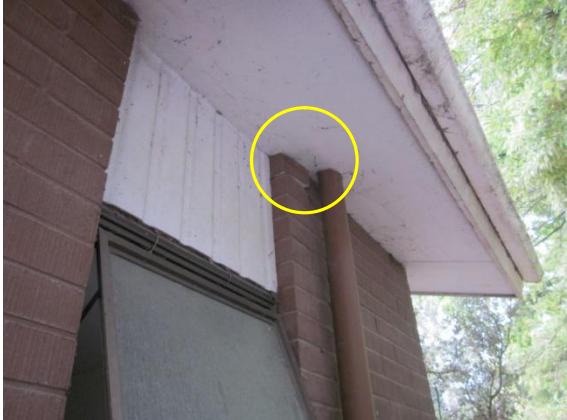
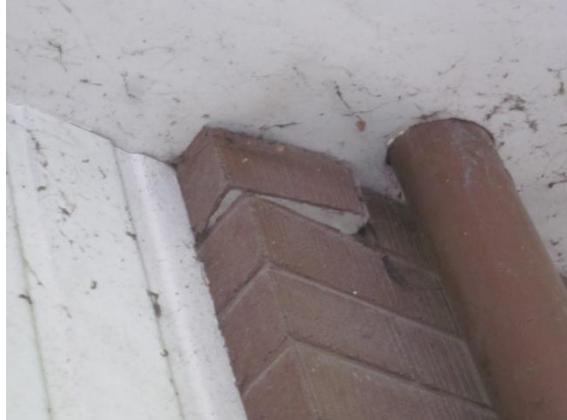
Photo 11: Loose Brick above Toilet Window	Photo 12: Close up of Photo 11

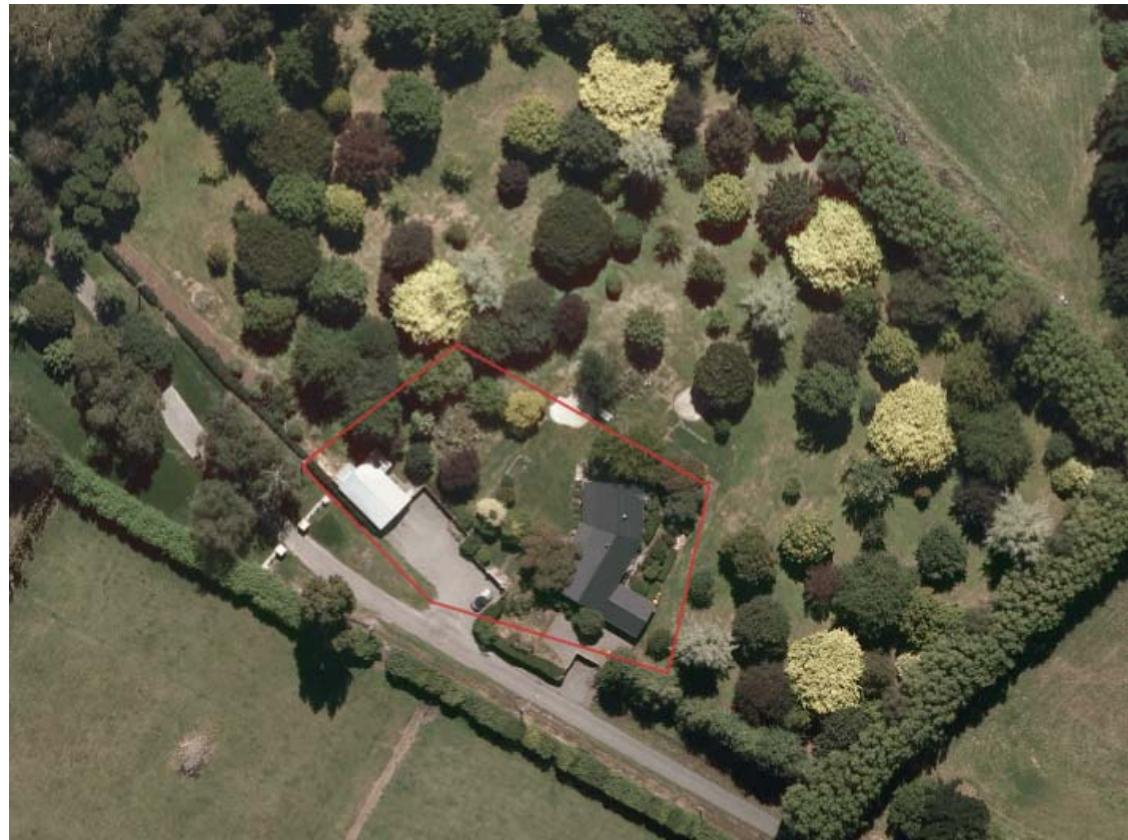
▪ **Figure 4 – Aerial photography from 24 Feb 2011 (<http://viewers.geospatial.govt.nz/>)**

Aerial photography shows relatively little damage to no damage after the 22 Feb 2011 event. There appears to be some ground disturbance shown in the bottom left hand corner of the aerial photograph, however this may not be related to the earthquakes. No liquefied material could be seen.

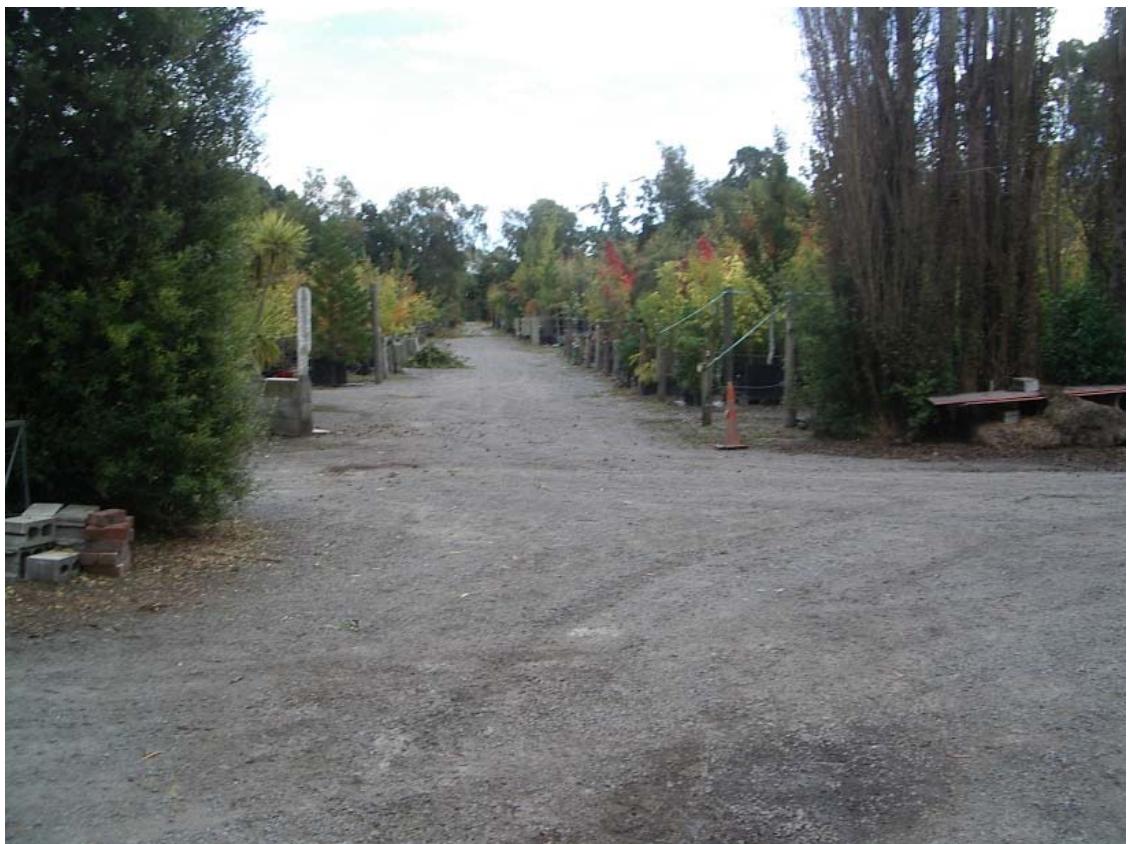
▪ **Figure 6 No visible liquefied material on the driveway**

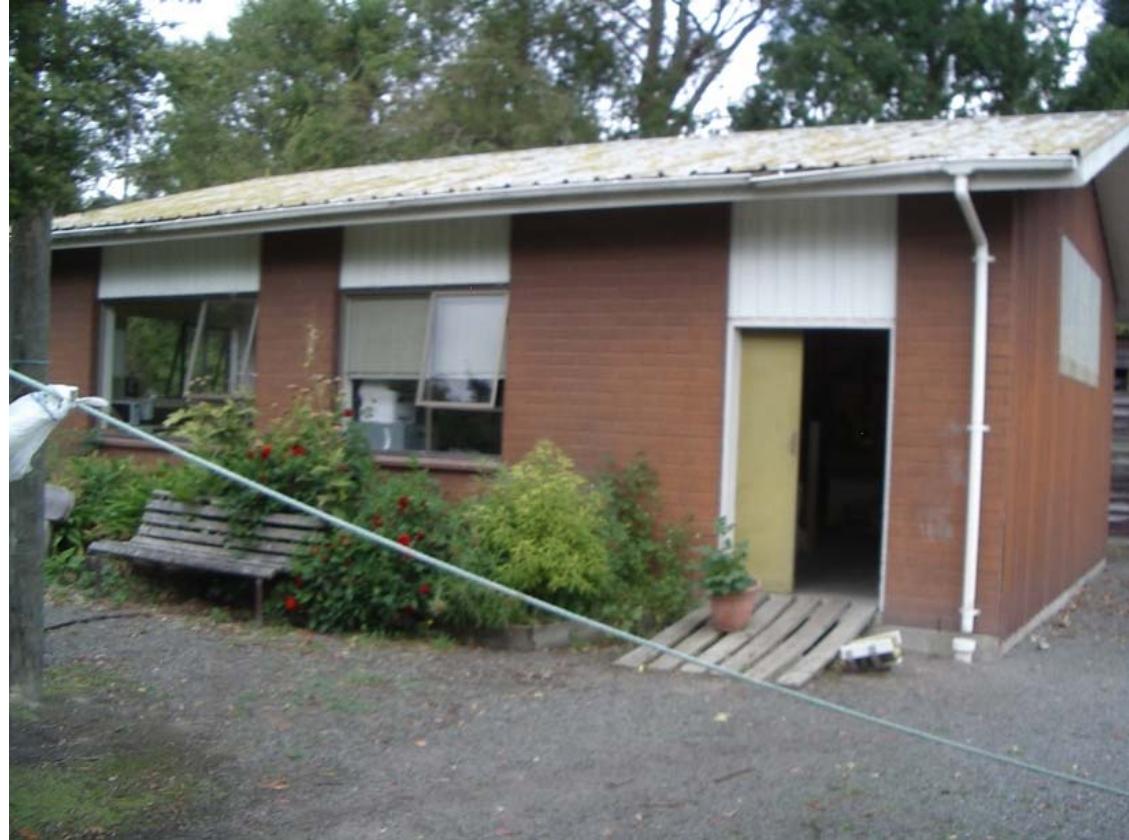
▪ **Figure 7 No visible damage to the structure**
