Hei Hei Community Link
PRO 1559-002 EQ2
Detailed Engineering Evaluation
Qualitative Report
Version FINAL Rev 2

12 Wycola Avenue, Hei Hei

Christchurch City Council

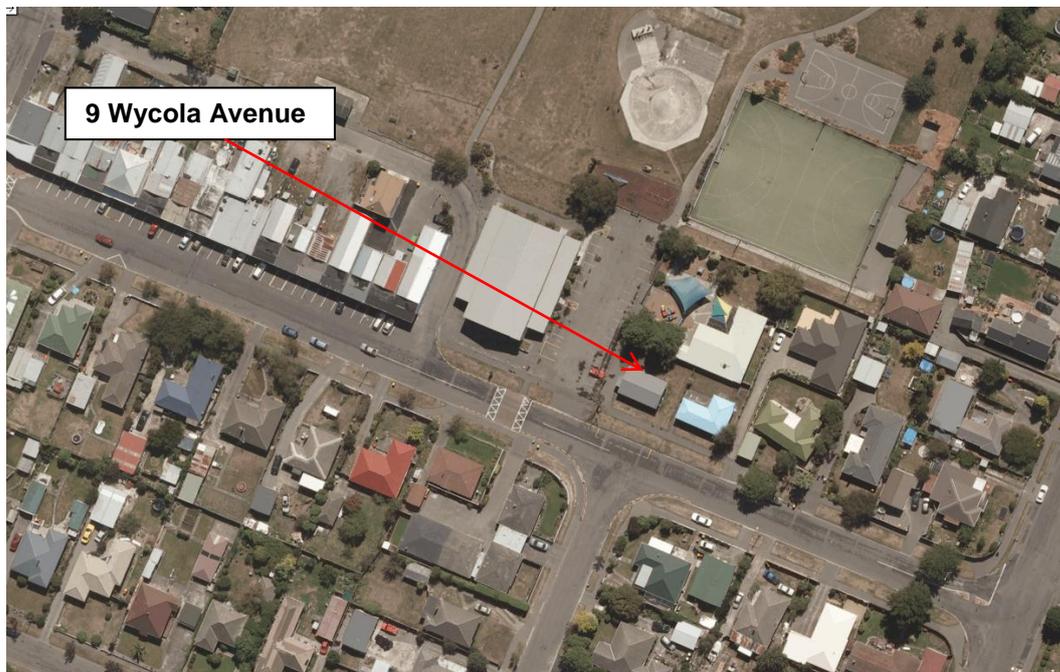
Figure 3 Post February 2011 Earthquake Aerial Photography²

Aerial photography taken following the 22 February 2011 earthquake (below) shows no signs of liquefaction outside the building footprint or adjacent to the site.

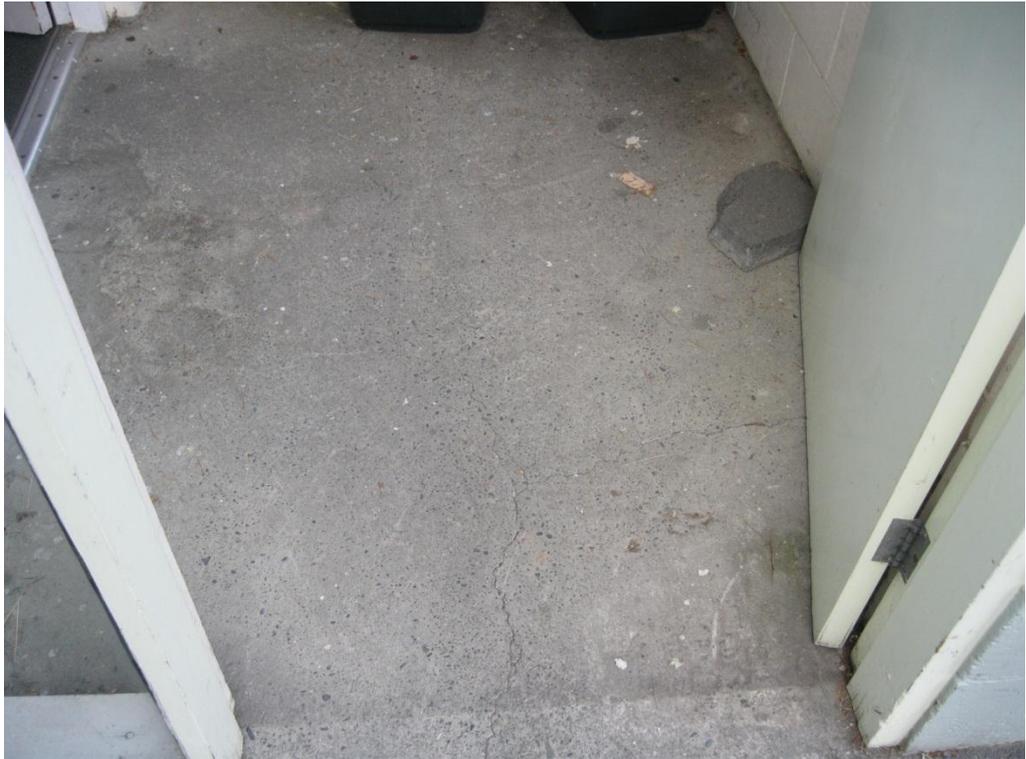
Cracks were noted in the slab on grade floor at the entrance to the building.

Photograph 5: Concrete slab on grade cracking

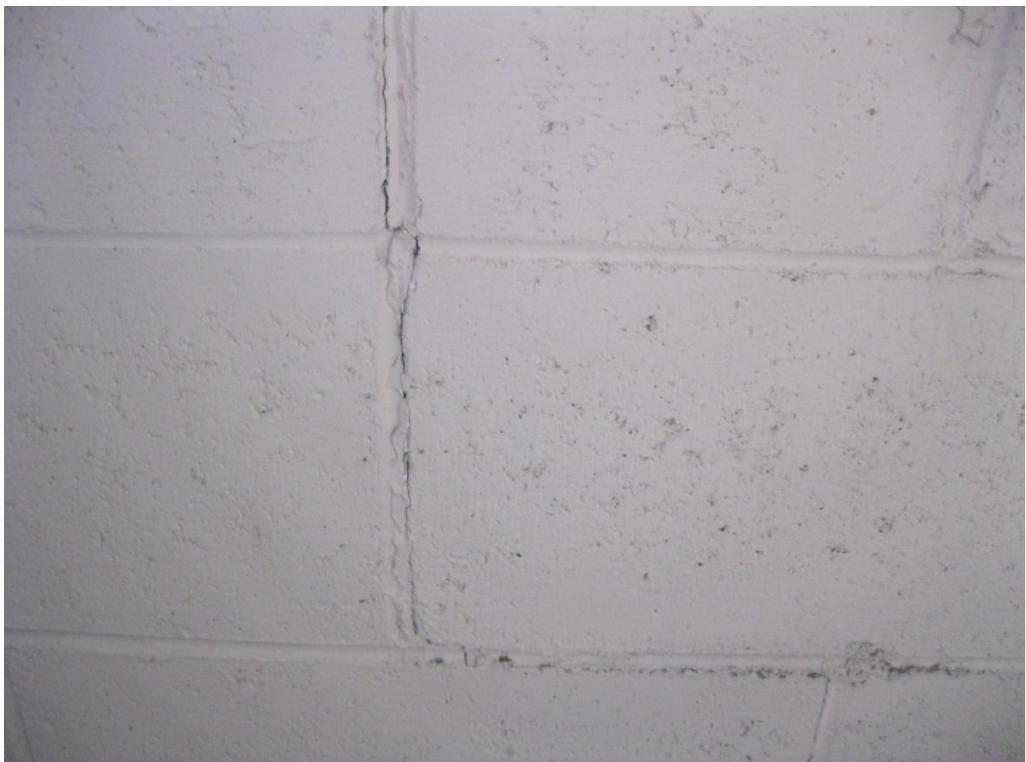
Cracking along mortar lines was noted to the blockwork walls in the toilet and kitchen areas.

Photograph 6: Cracks along blockwork mortar lines

As the building has achieved less than 33% NBS following an initial IEP assessment of the building, further assessment is required. It is recommended that a quantitative assessment be carried out and if necessary strengthening options explored.

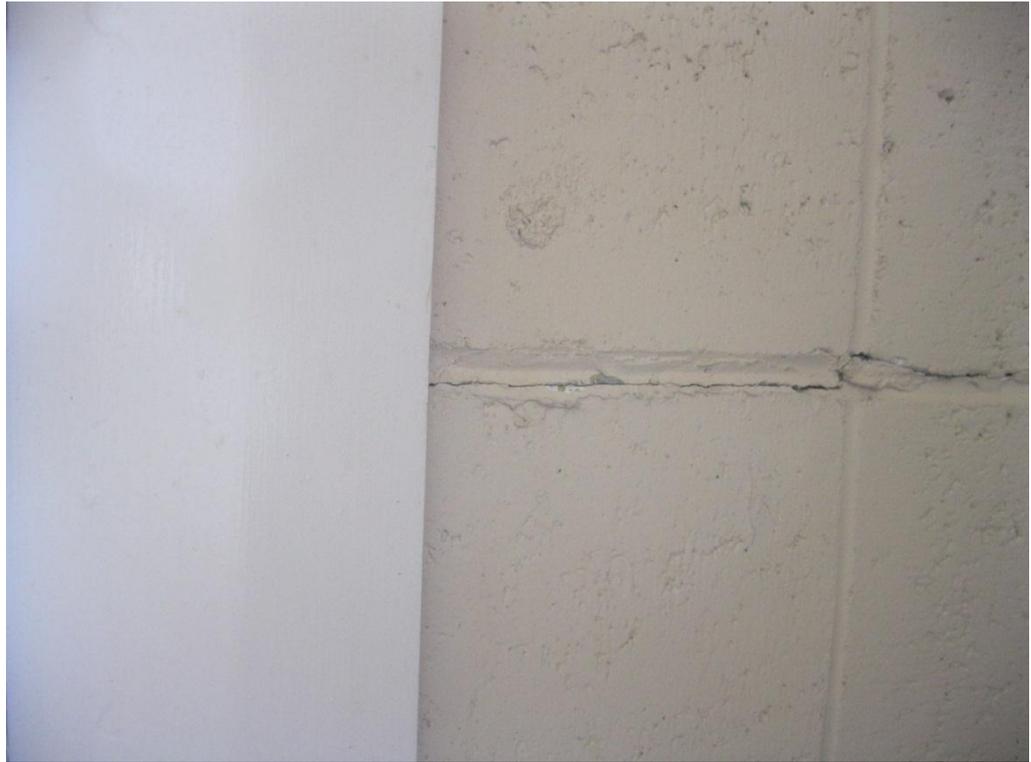
Photograph 7: Cracking along blockwork mortar lines
