Holmcroft Reserve Shed
PRK 1808 BLDG 002
Detailed Engineering Evaluation
Qualitative Report
Version FINAL

Christchurch City Council

Date
20th May 2013

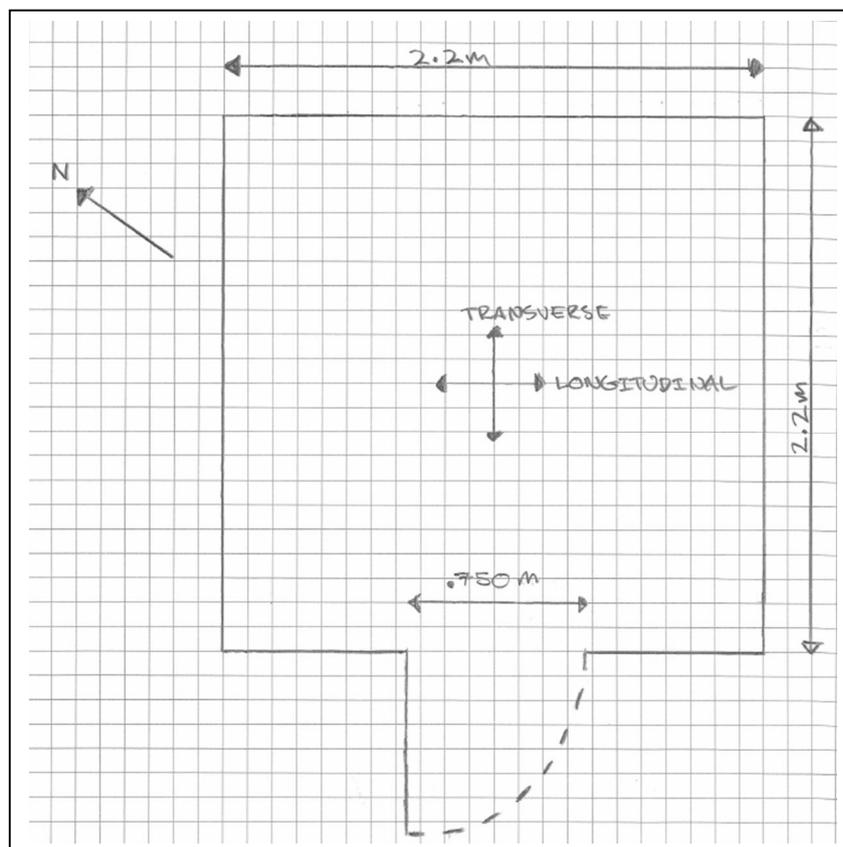
Figure 2 Plan Sketch Showing Key Structural Elements

The square building is approximately 2.0 meters in height with all sides being 2.2m in length. The building has an approximate footprint of 5m². The shed is built on a gently sloped site approximately 20m to the south of the closest building and within 200 meters of the Heathcote River.

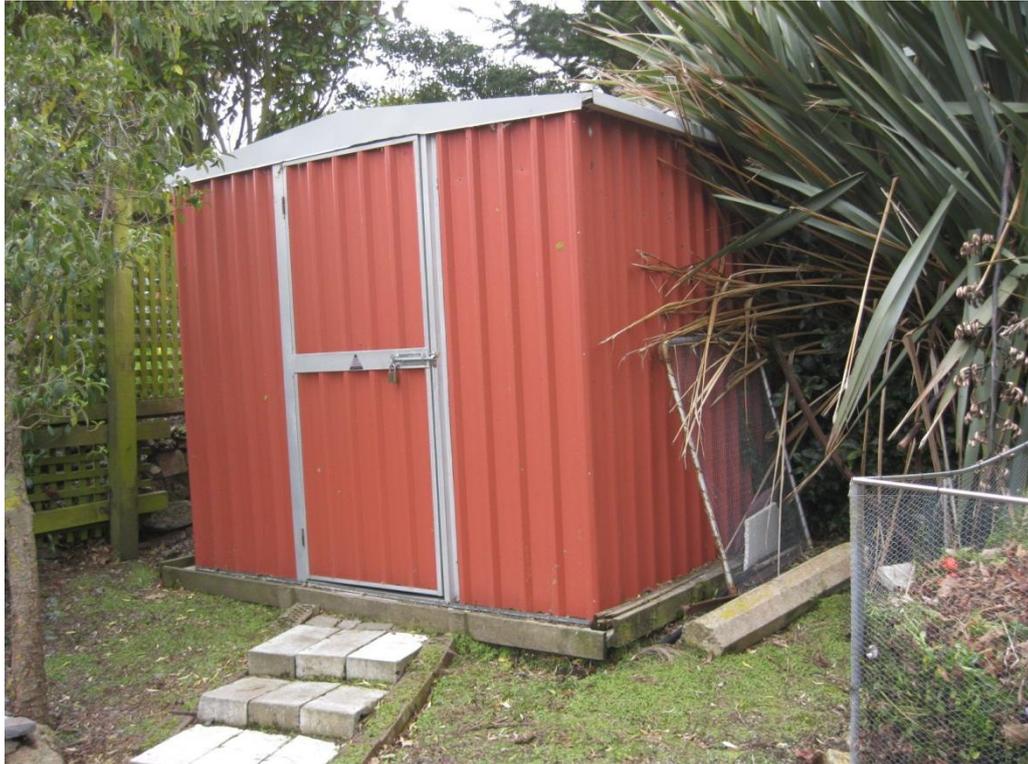
Photograph 1 View of shed from the north.

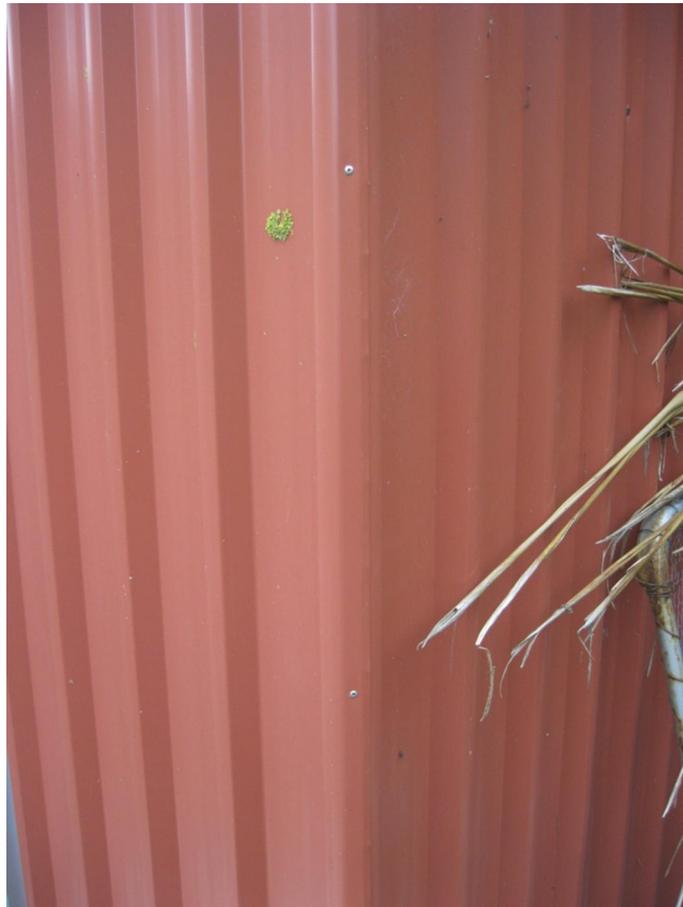
Photograph 2 Rivet connections of steel sheets at corners.

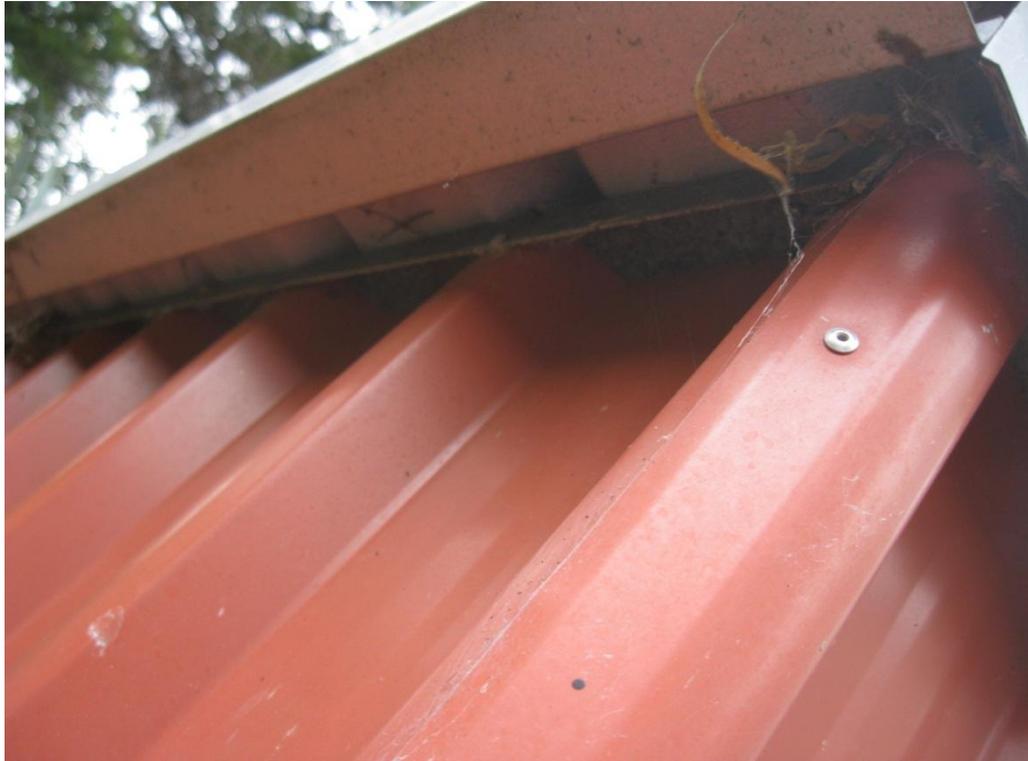
Photograph 3 Wall at eaves with gutter above.

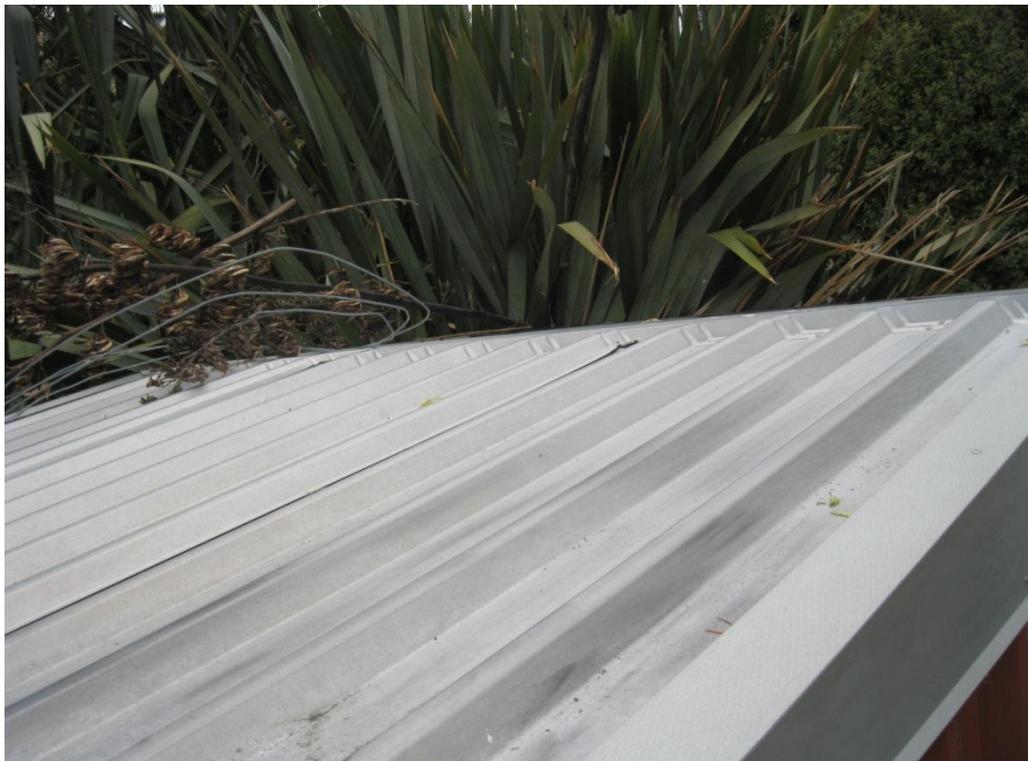
The profiled metal sheet roof was clearly visible and given its pitch is expected to perform as a diaphragm.

Photograph 4 Roof exterior
