Home and Family Building PRO 2513

**Detailed Engineering Evaluation
Quantitative Assessment Report**

56 Barrington Street, Somerfield,

Date: March 2014
Reference: 6-QC359.00
Status: Final

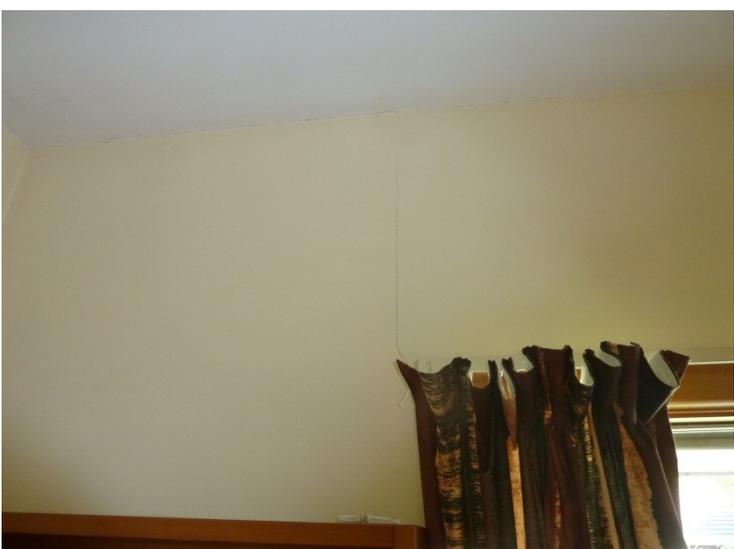
Minor damage was observed to the non-structural elements of the main building. This included cracking to the linings in most rooms around the corners of windows and where the wall linings met the ceiling linings (photo 17).

A photograph of a lounge area. A white fireplace mantel is visible, with a television mounted on the wall above it. A clock is on the wall to the right. A white cabinet is in the foreground, and a blue chair and a pink toy box are on the floor.
17.	Typical cracking from corner of window and along ceiling line

- Cosmetic repairs be undertaken as required.
- The garage parapet be removed or propped.
- The garage be strengthened to at least 67%NBS.

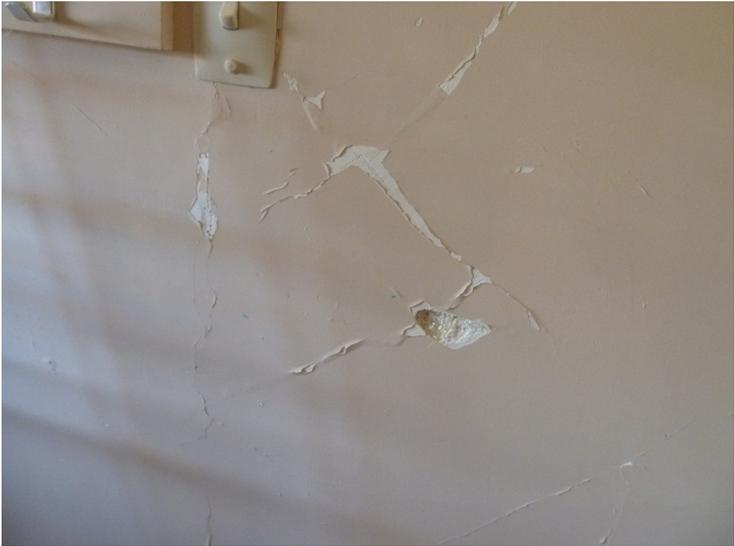
18.	Severe cracking to wall linings (laundry, the toilet by the back door and bedroom 5)

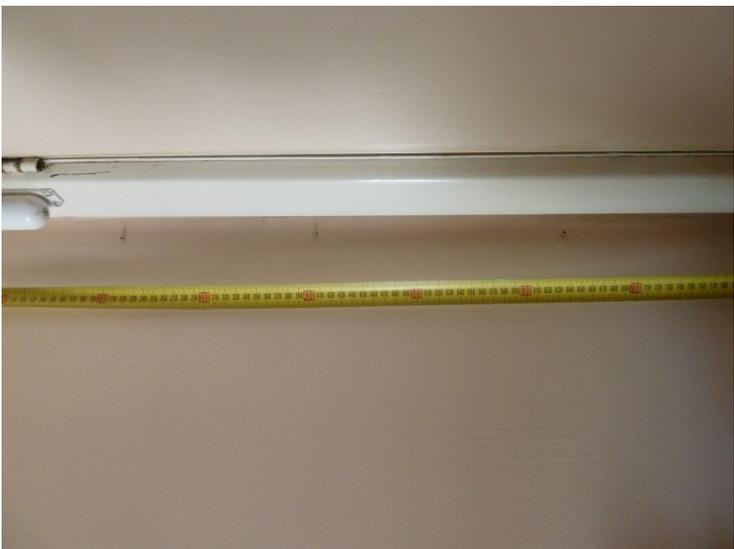
The internal lining nail spacings were measured on site to vary between 200 – 250 mm.

19.	Plasterboard nail spacings

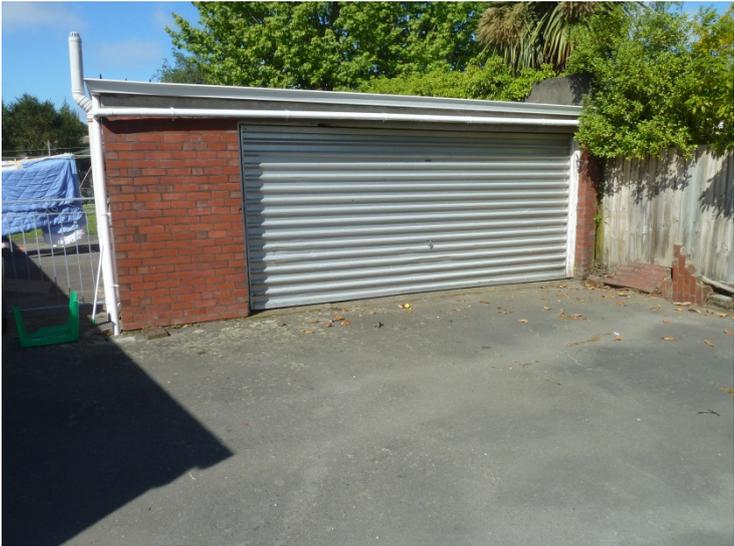
<p>21.</p>	<p>Garage exterior elevation (front) showing parapet</p>

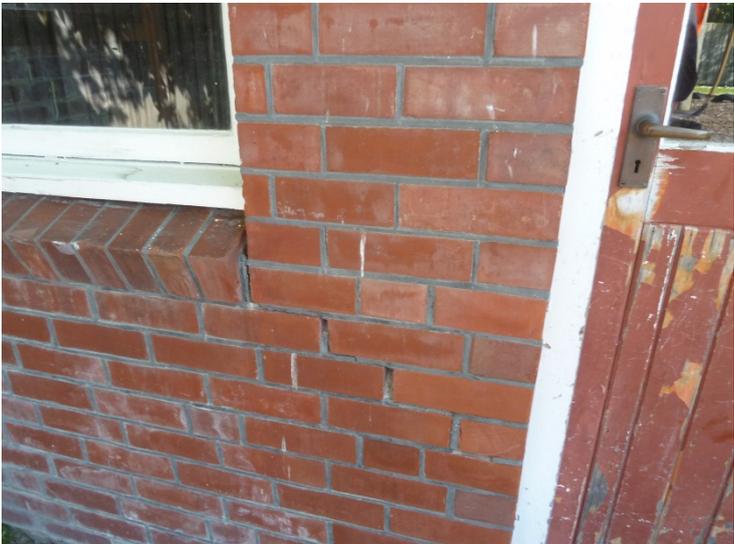
Moderate to severe damage was observed to the garage including stepped and shear cracking to brick work (photo 22) and where internal walls had separated from each other. Large cracking through the concrete beam (photo 23) was observed in the separating brick wall.

A photograph showing the exterior of a garage. The structure features a red brick parapet wall on the left side, topped with a white gutter. A large, closed, corrugated metal garage door is visible. The ground in front is paved asphalt. In the background, there are green trees and a blue sky.
<p>22.</p>	<p>Typical stepped cracking in garage</p>

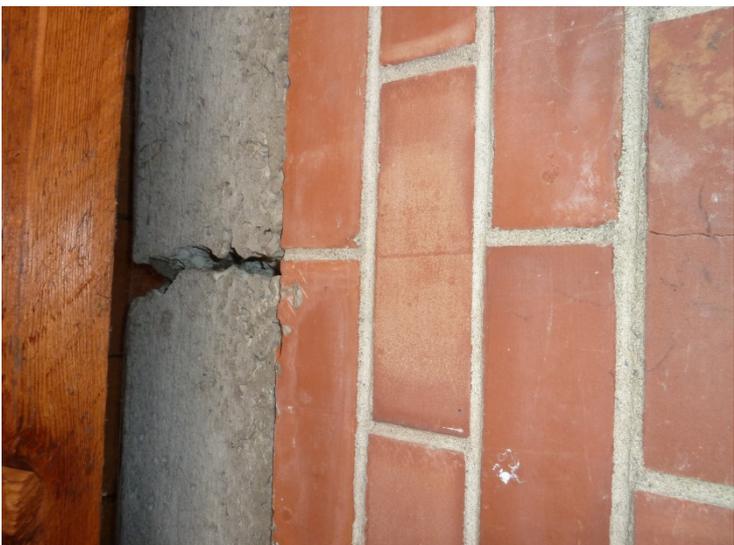
A close-up photograph of a red brick wall. The bricks are laid in a standard pattern. There is a distinct vertical crack that follows the mortar joints between the bricks, characteristic of stepped cracking. To the right, a portion of a white-painted wooden door or frame is visible.
<p>23.</p>	<p>Crack in concrete beam in garage</p>
