Hoon Hay Community Crèche
Qualitative Engineering Evaluation

Reference: 227682
Prepared for:
Christchurch City Council

Address: 113 Mathers Road

Revision: 3
Date: 28 January 2014

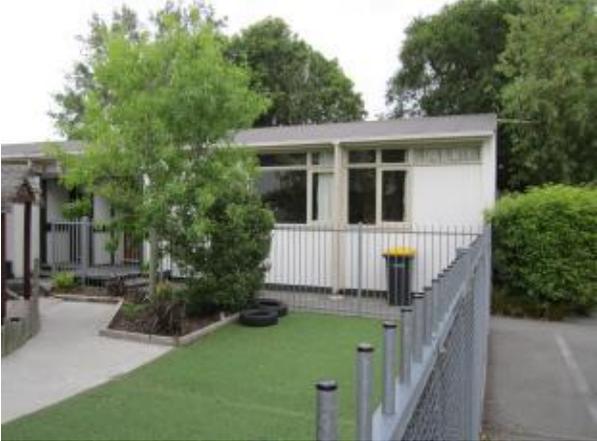
<p>Front elevation of the Hoon Hay Community Crèche.</p>

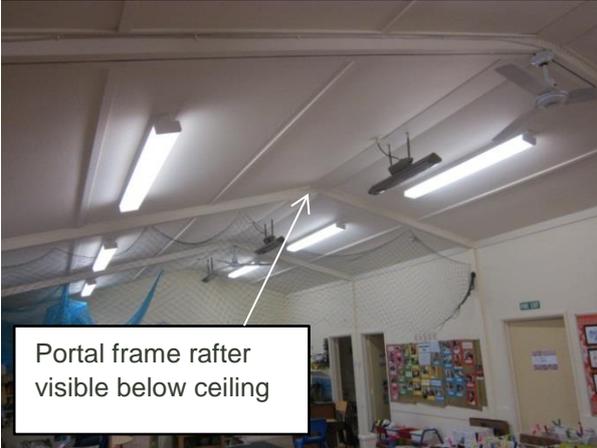
<p>Timber portals were inspected with no major damage was visible.</p>

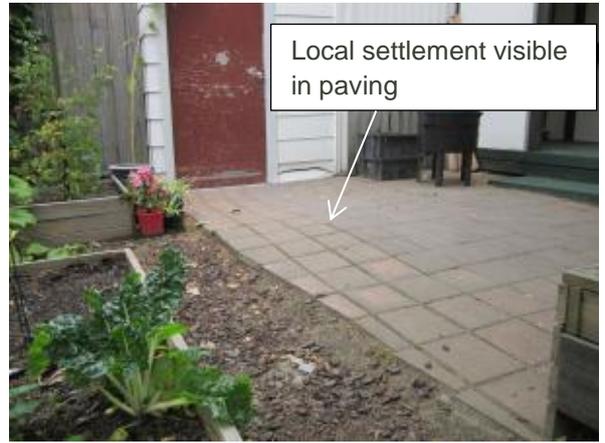
- Evidence of settlement to the playground at the north-east corner of the building.
- Possibly some settlement internally in the south east corner.
- Minor non-structural damage.

Differential settlement in north-east corner

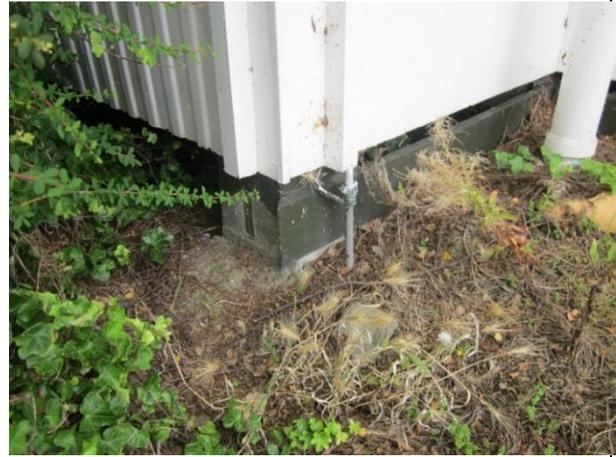
Concrete pile foundation in south-east corner

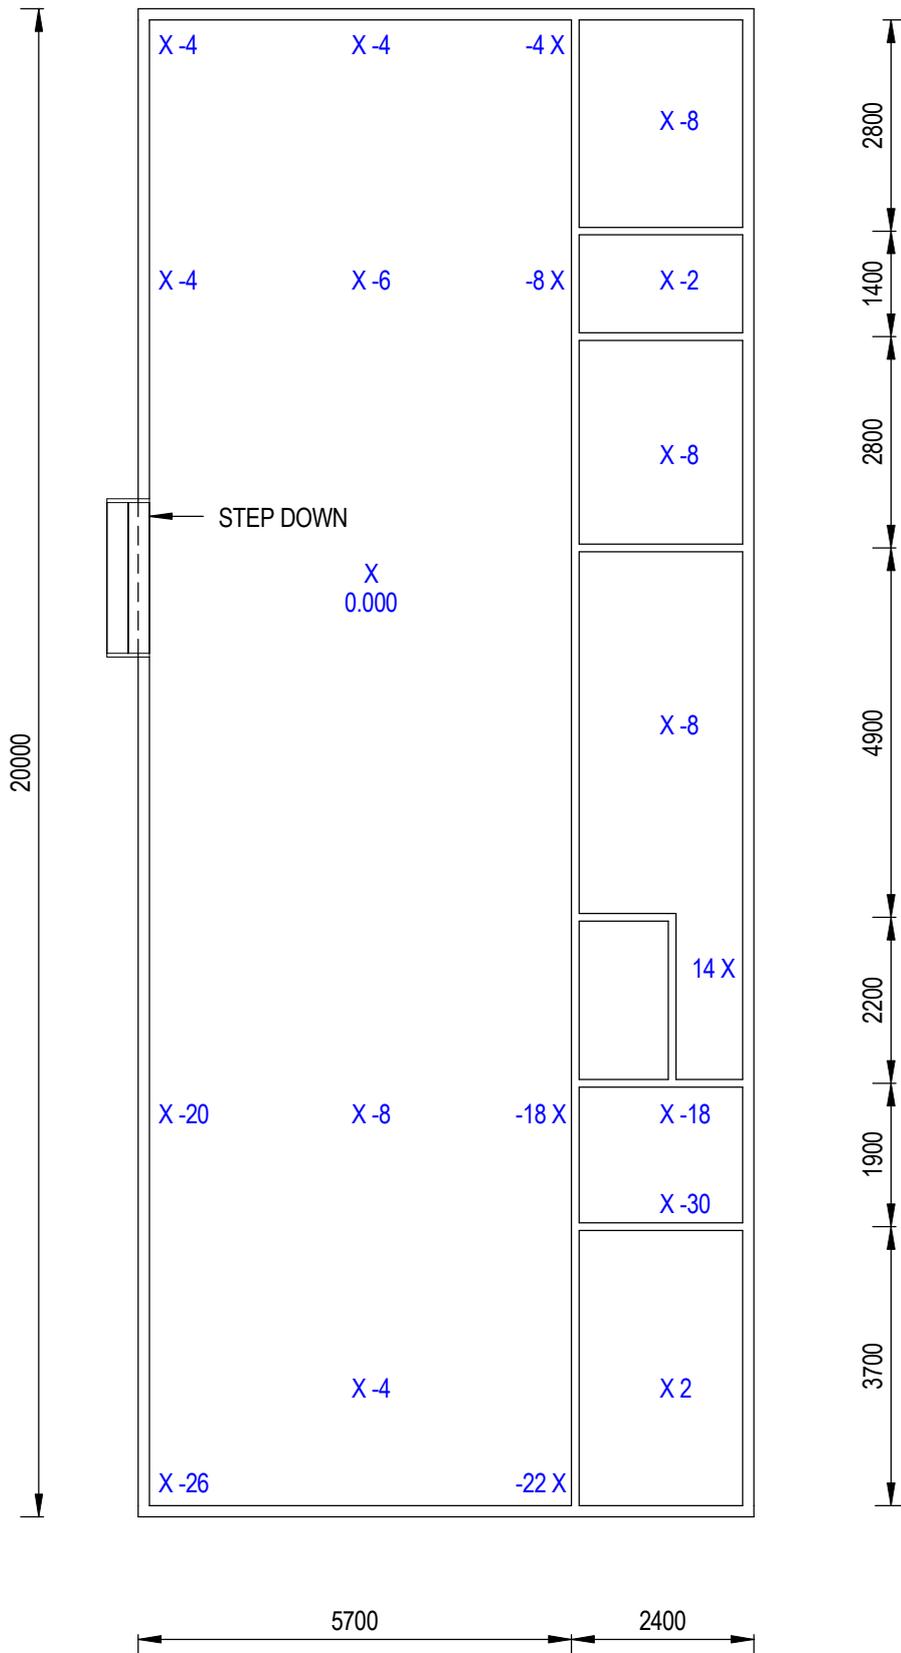
PROJECT
HOON HAY COMMUNITY CRECHE 113 MATHERS ROAD
TITLE
LEVEL SURVEY

The results of the level survey indicate the floor levels are within the above DHB guidelines.
