Shed – Hoon Hay Park  
PRK 1492 BLDG 003 EQ2  
Detailed Engineering Evaluation  
Qualitative Report  
Version FINAL

61 Mathers Road, Hoon Hay

Christchurch City Council

**Date**  
8<sup>th</sup> March 2013

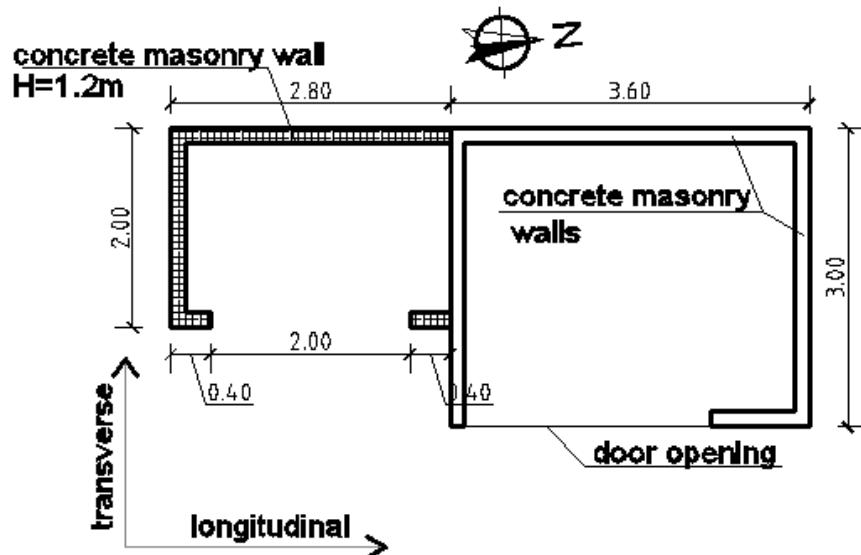
Figure 2 Plan Sketch Showing Key Structural Elements

The building is a single storied storage shed, approximately 3.6m long, 3.0m wide and 2.5m in height. The overall footprint of the building is approximately  $11\text{m}^2$ . The buildings construction was estimated to be between 1965 and 1976, given the construction date of other buildings on the park. There is the possibility that the original shed had another room; however, this seems to have been partly demolished. Remaining are two walls that are connected to the southeastern wall of the shed.

The roof structure consists of timber structural purlins without joists spanning between southeastern and northwestern walls. The structural purlins are connected to the top plate which provides the link between the roof and walls. The roof is clad with corrugated steel cladding.

The external walls are concrete masonry. The low concrete wall is grout filled but at the time of inspection it was not apparent if the building walls are grout filled or reinforced. The building has a concrete floor which appears to be a slab on grade.

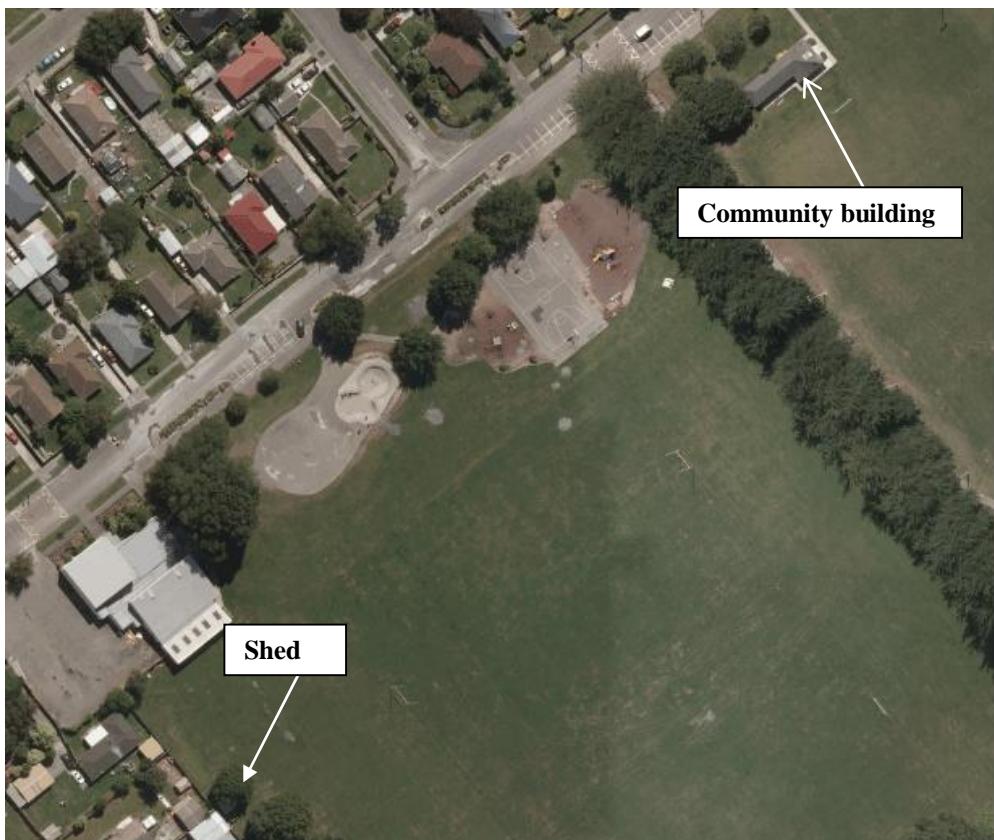
**Figure 3 Post February 2011 Earthquake Aerial Photography<sup>3</sup>**

Aerial photography taken following the 22 February 2011 earthquake shows sand boiling throughout the park (see chapter 8.2.5), however during the site inspection undertaken on 18<sup>th</sup> of June, there was no evidence of ground damage on the property or surrounding neighbours land.

Aerial photography taken following the 22 February 2011 earthquake shows minor to moderate signs of liquefaction within 150m of the building footprint, as shown in **Figure 3<sup>3</sup>**.

Further investigation is recommended to better determine subsoil conditions within close proximity to the building footprints. From this, a qualitative liquefaction assessment could be undertaken.
