**Hoon Hay Park – Toilet/Pavilion**  
**PRK 1492 BLDG 001 EQ2**  
Detailed Engineering Evaluation  
Quantitative Report  
Version FINAL

61 Mathers Road, Hoon Hay

Christchurch City Council

**Date**  
1 October 2013

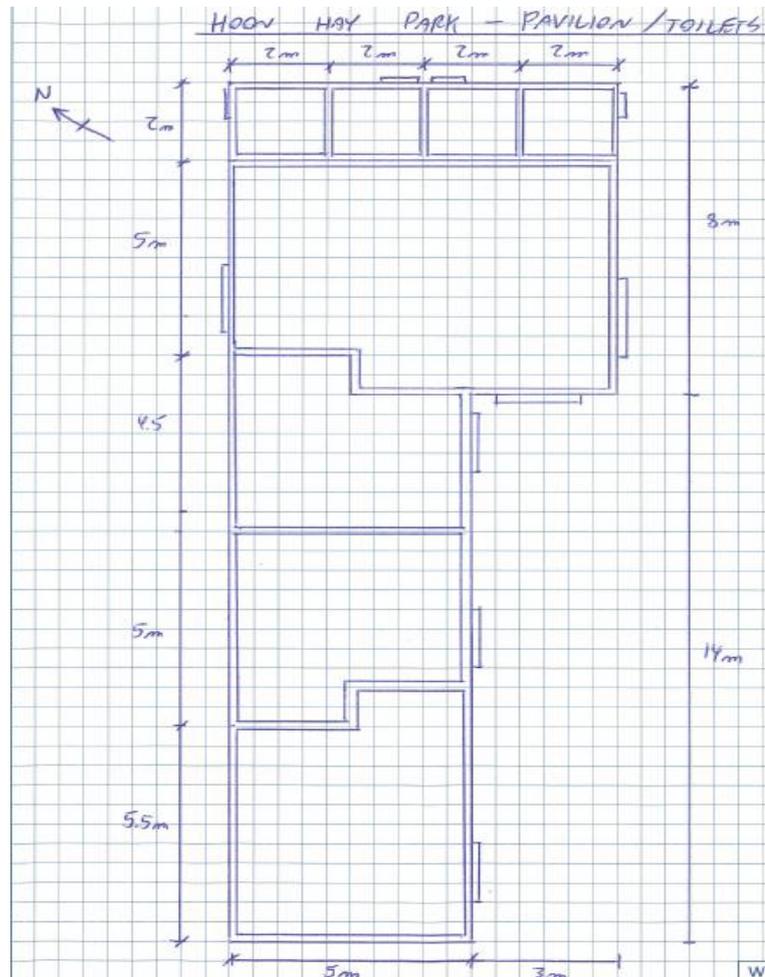
Figure 2 Plan Sketch Showing Key Structural Elements

The roof structure is supported by load bearing unreinforced concrete masonry walls. The walls appear to be partially grout filled. The connection between roof and walls was obscured and a timber top plate has been assumed to provide support to the roof. The interior of the northern section (toilets) is clad with ceramic tiles and plasterboard. All other walls have no lining. The building sits on a reinforced concrete slab on strip foundations.

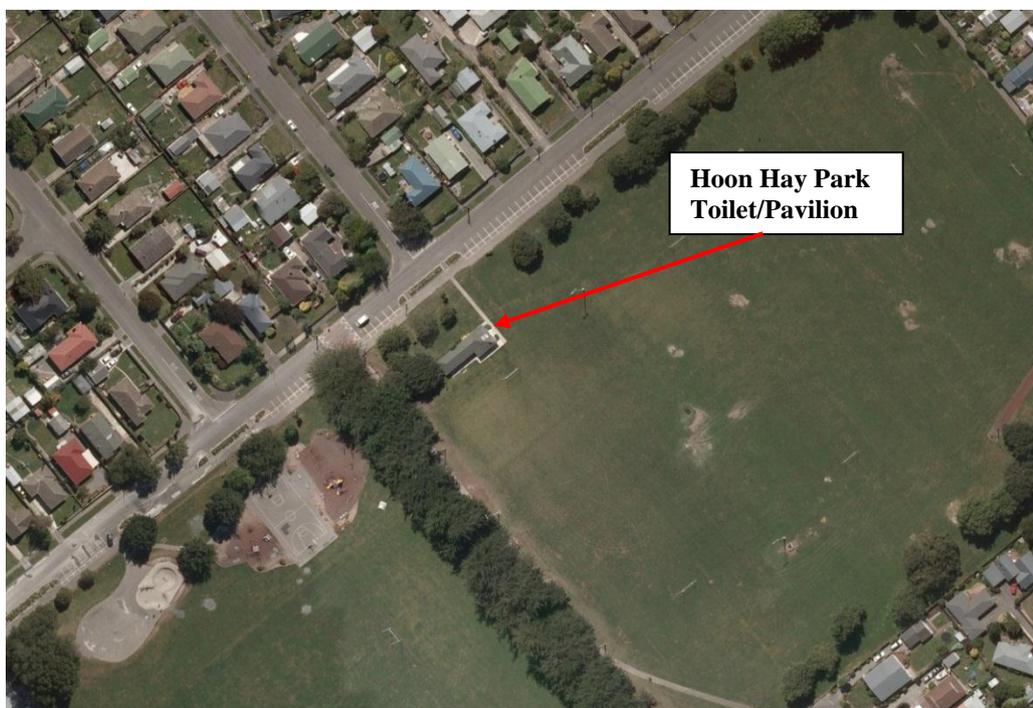
**Figure 3 Post February 2011 Earthquake Aerial Photography**<sup>5</sup>

Aerial photography<sup>4</sup> taken following the 22 February 2011 earthquake shows minor signs of liquefaction outside the building footprint or adjacent to the site, as shown in Figure 3. All other aerial photography following the major earthquakes of the Canterbury earthquake sequence does not cover the location of the site.

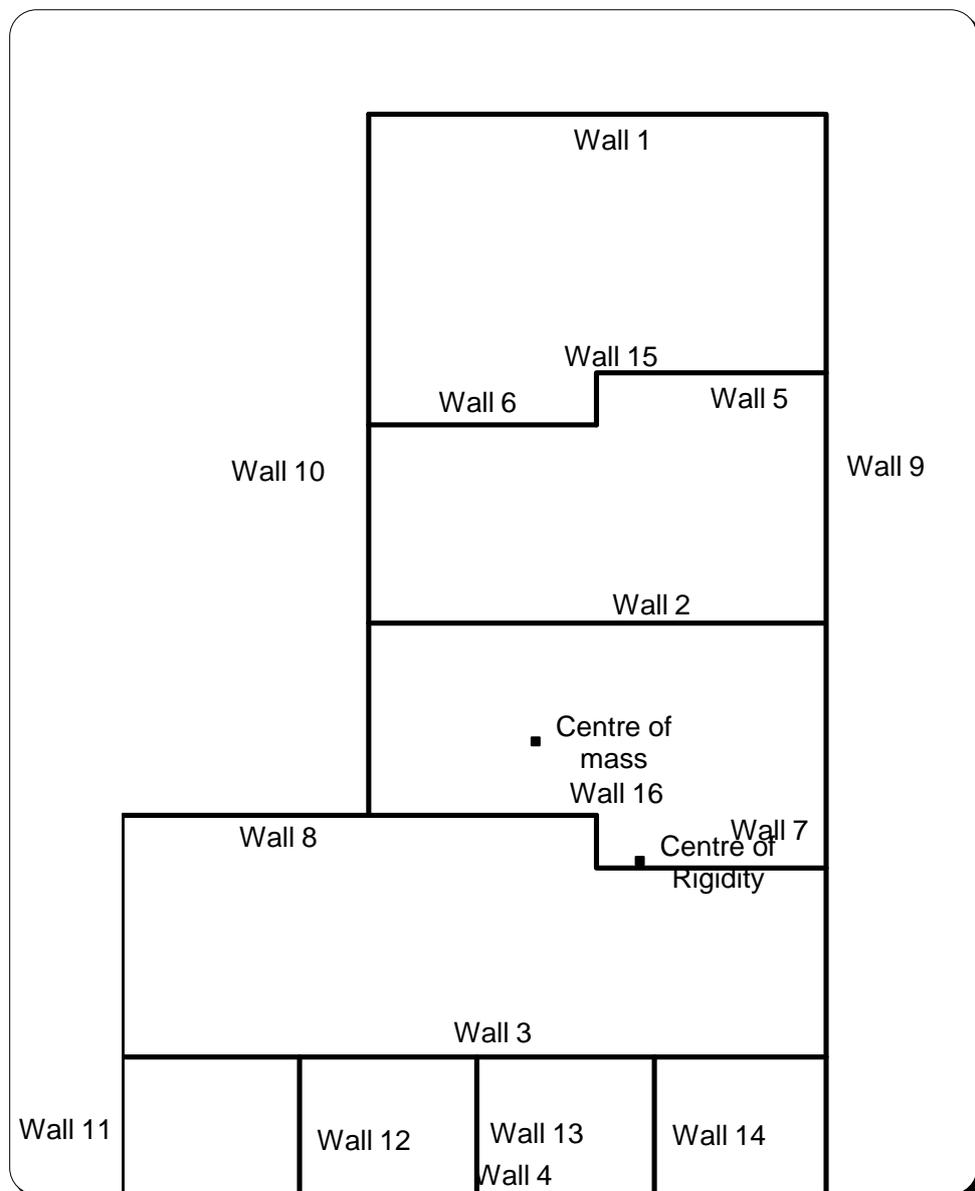
**Figure 4 Plan Centres of Mass and Rigidity and Wall Locations**

The position of each wall is indicated on Figure four below and each wall is numbered accordingly.

Following a detailed assessment, the toilet/pavilion block has been assessed as achieving 19 %NBS for the unreinforced masonry walls. Under the New Zealand Society for Earthquake Engineering (NZSEE) guidelines Hoon Hay Park Toilet/Pavilion is considered to be Earthquake Prone. Although masonry walls are unreinforced, there are no other critical structural weakness or potential collapse hazards identified in the building.

The recent seismic activity in Christchurch has not caused any visible damage to the building. However the building has achieved approximately 19% NBS following a Quantitative Detailed Engineering Evaluation. Further assessment is not required. GHD recommends significant wall strengthening or wall replacement options be explored and implemented to bring the %NBS of the building up to a minimum of 67% NBS in accordance the NZSEE guidelines.

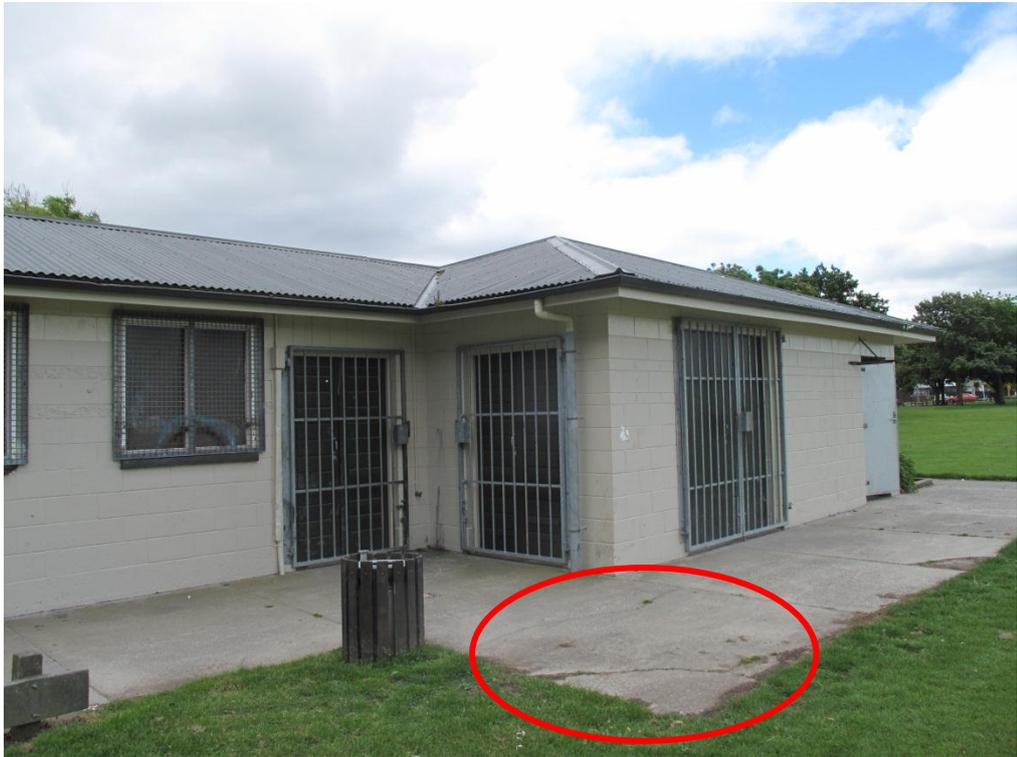
Minor cracks and movement was visible in the external concrete paved areas, but this damage does not appear to be significant (See photograph 5 & 6).

**Photograph 5 Cracks in paved area.**

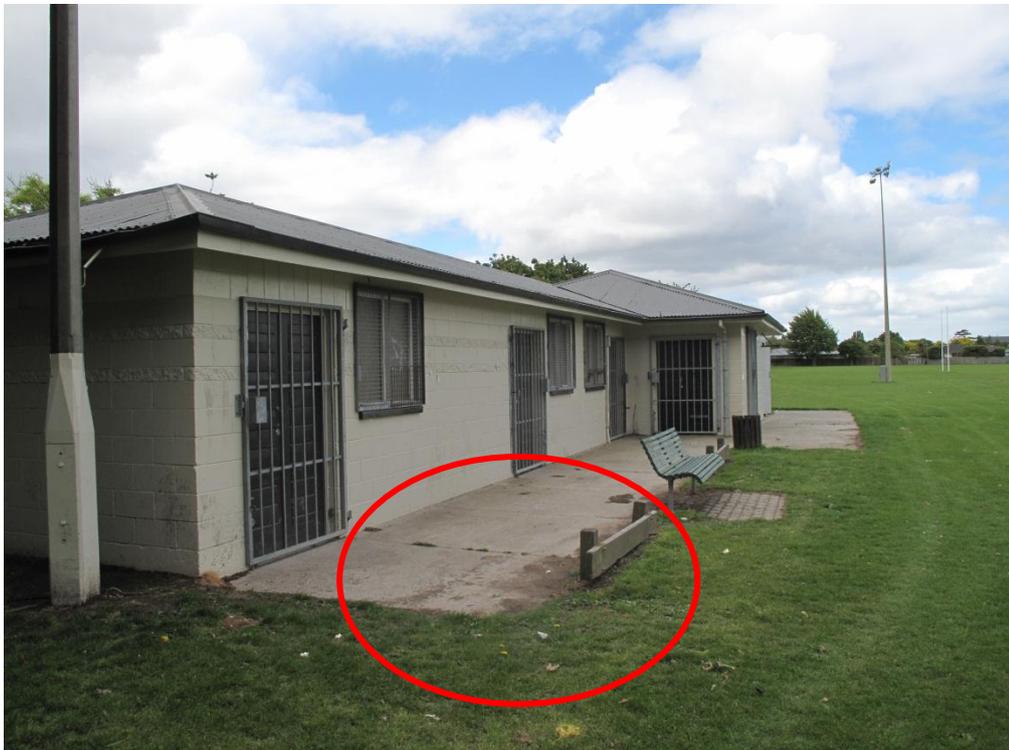
**Photograph 6 Settlement at Southeast corner of paved area.**

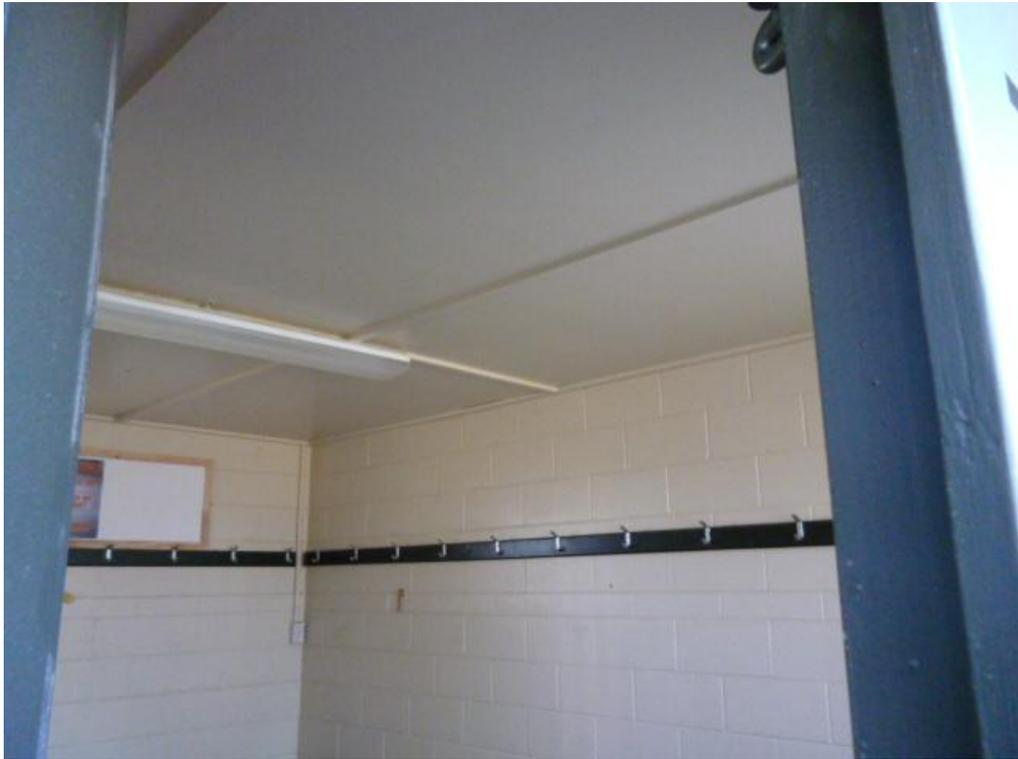
The interior of the roof inside the western (longer) section of the building was unable to be viewed because of the presence of the fully clad ceilings. It is likely that this roof section is also supported by timber trusses.

**Photograph 7 Fully lined ceiling in Pavilion areas of structure.**

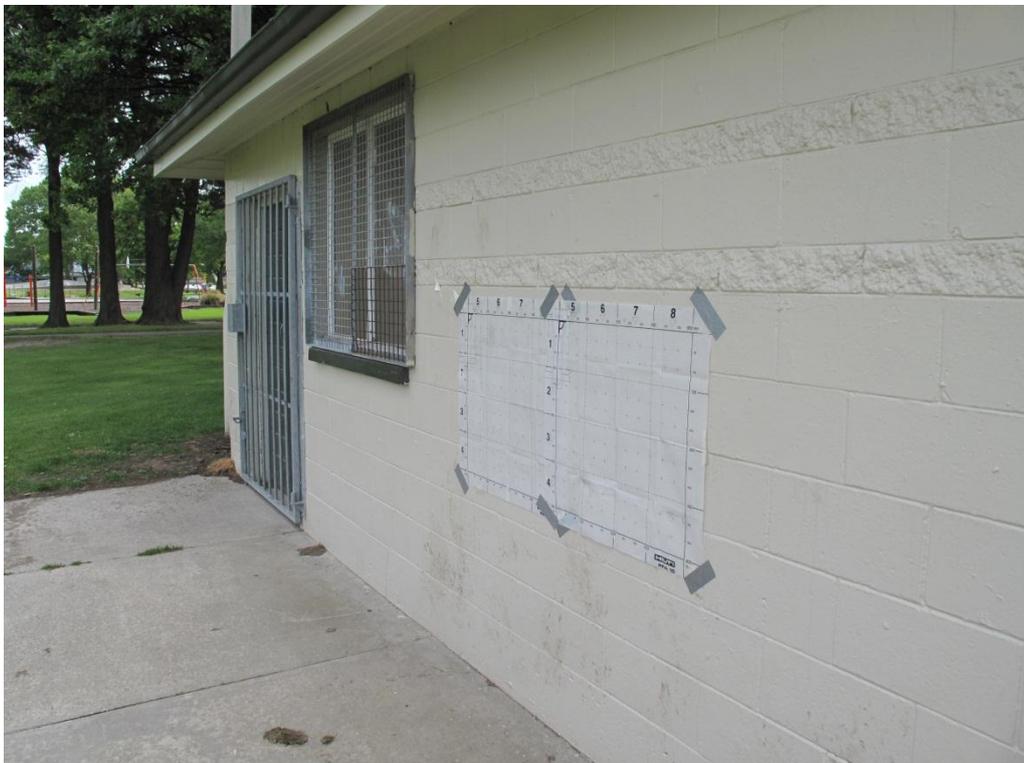
Electromagnetic scans have been carried out on site to locate any reinforcement in the walls.

**Photograph 8 One area of the Eastern wall that was scanned for reinforcement.**
