Hornby Courts Block B PRO 1580-002 Detailed Engineering Evaluation Quantitative Report FINAL Version (1.0)

2 Goulding Avenue, Hornby

Christchurch City Council

Date 31st May 2013

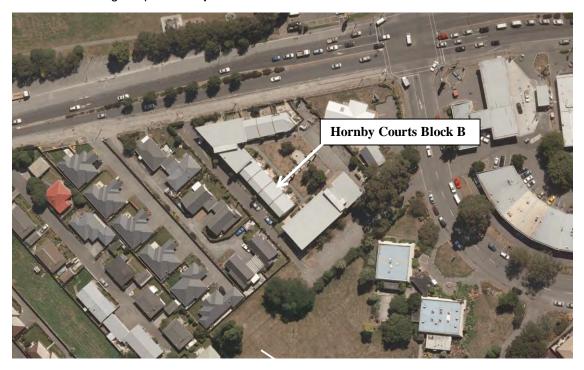
Figure 12. Post February 2011 Earthquake Aerial Photography

Aerial photography taken following the 22 February 2011 earthquake shows no signs of liquefaction outside the building footprint or adjacent to the site.

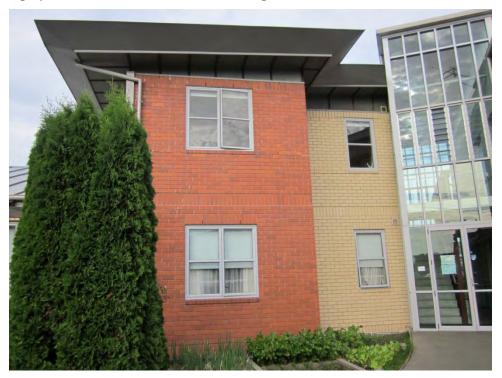
Photograph 2 View of the portions where are staircases

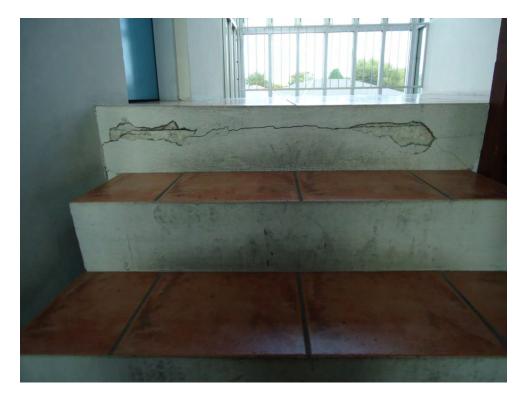
Minor spalling and cracking to the construction joint between landing slab and stairecase. These damages can be found in Photographs 2 and 6 in Appendix A.

Photograph 4 Minor Spalling and Cracking at the Construction Joint between Landing Slab and Staircase

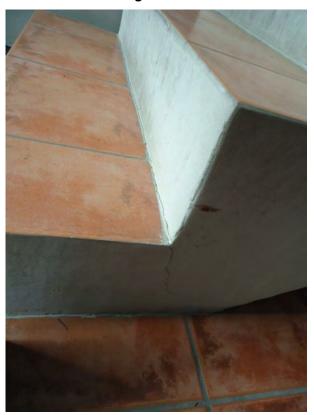
Photograph 5 Hairline Cracking at the Bottom of the Staircases

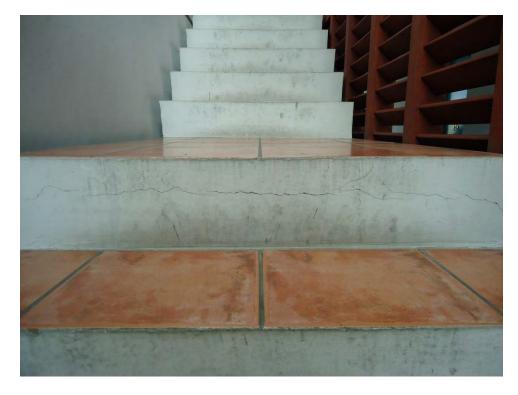
Photograph 6 Minor Spalling and Cracking at the Construction Joint between Landing Slab and Staircase
