**Hornby Domain
Toilets
PRK 1575 BLDG 001 EQ2**

**Detailed Engineering Evaluation
Quantitative Assessment Report**

Date: March 2013
Reference: 6-QUCC1.80
Status: Final

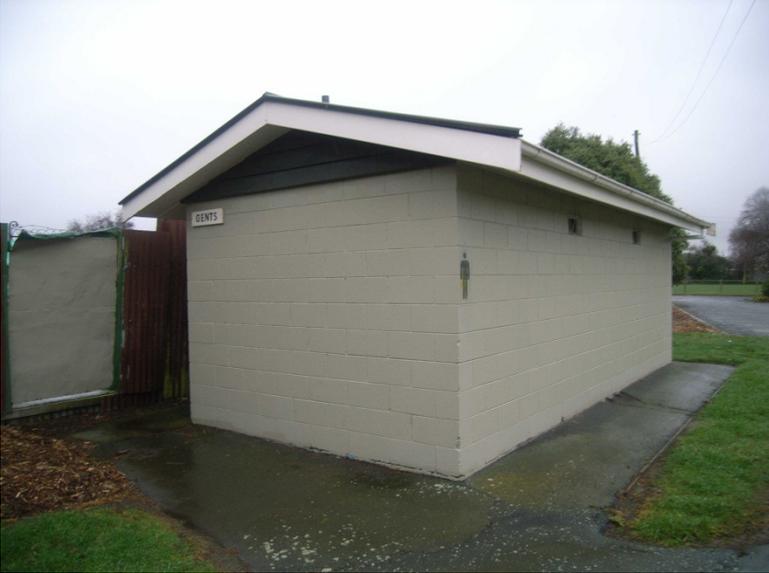
No.	Item description	Photo
General		
1.	South-east view of building

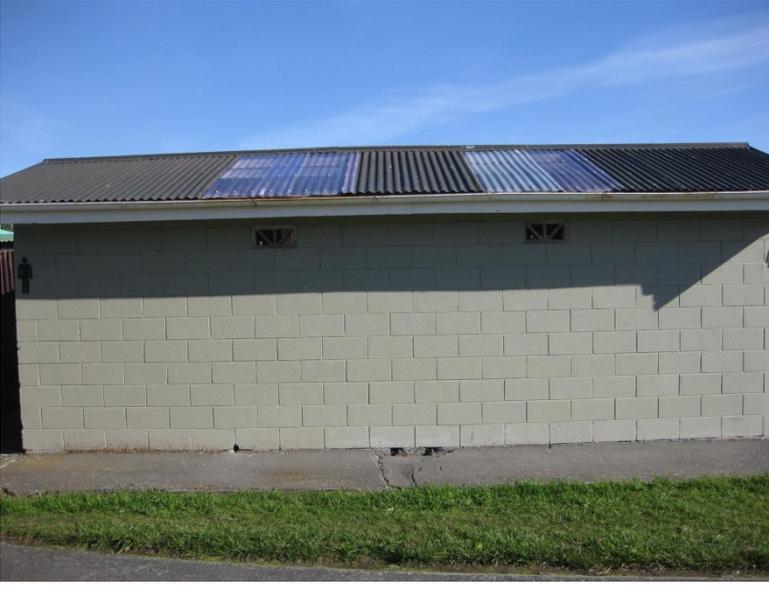
2.	Rear view of building

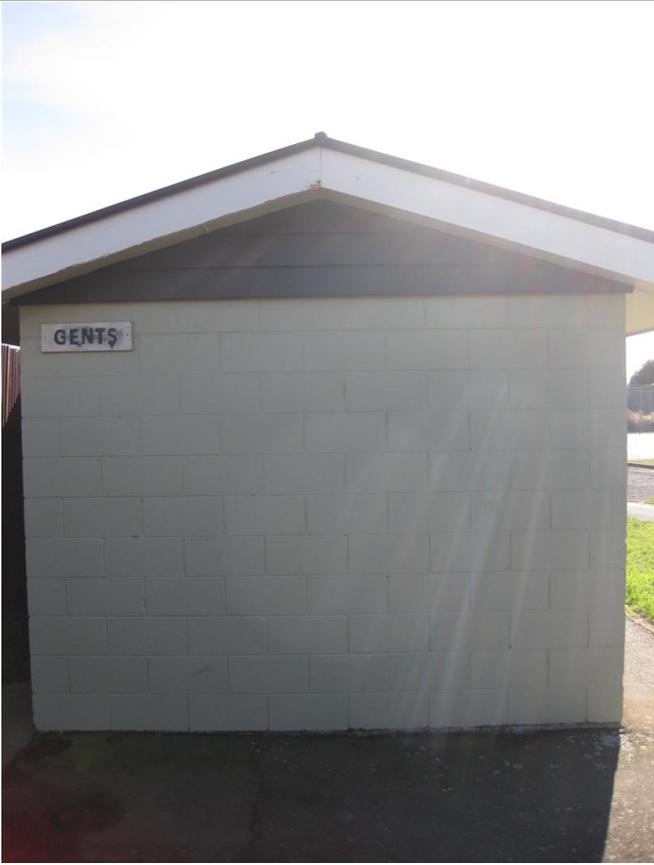
<p>3.</p>	<p>Southern view of building</p>

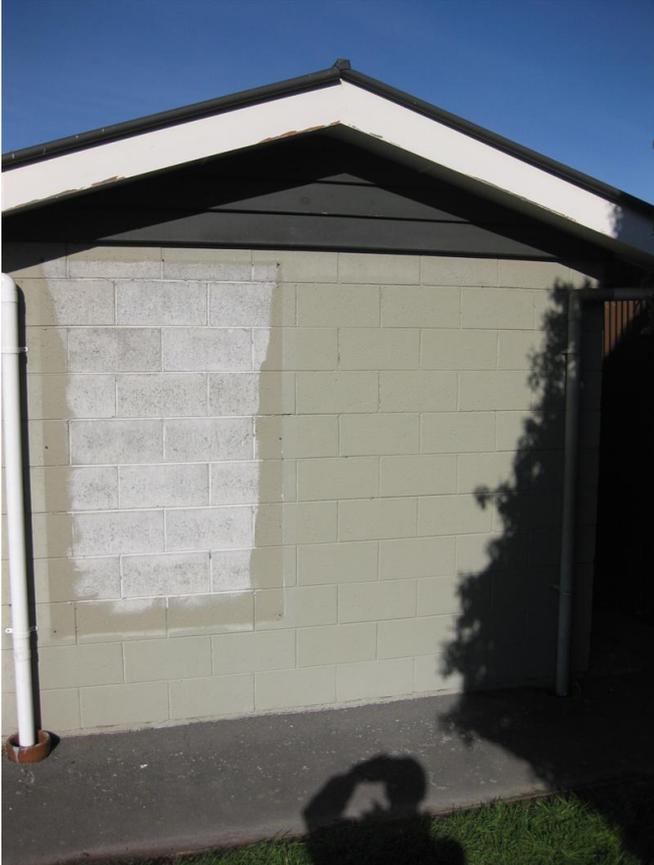
A photograph showing the southern view of a small, rectangular building with a gabled roof. The building's exterior is finished with light-colored, rectangular panels. A small sign on the left side of the wall reads "GENTS". The roof is dark, and the sky is clear and blue.
<p>4.</p>	<p>Northern view of building</p>

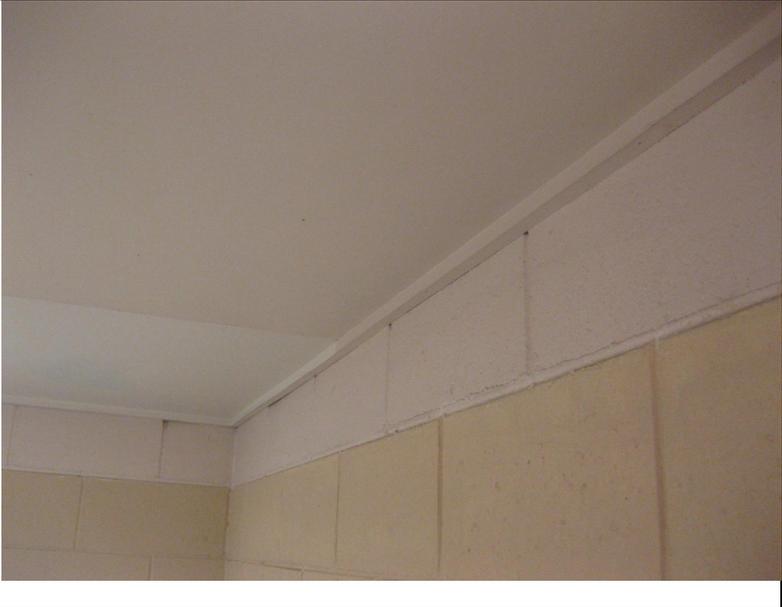
5.	Ceiling lining

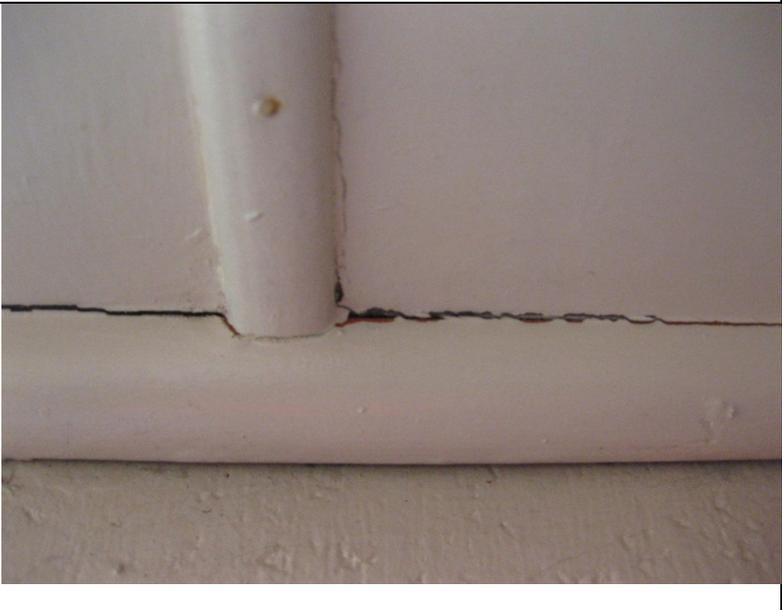
The building structure appears to have only suffered minor damage as a result of the recent earthquake events. Separation cracks in the ceiling and opening of the block separation wall joint were observed. However, intrusive investigations and level surveys have not been undertaken.

6.	Opening crack in ceiling adjacent block wall

- a) Strengthening of the building should be undertaken to increase the overall building capacity to at least 67% NBS.
- b) Remedial repair work to ceiling cracks and opened wall joints should be undertaken.
- c) Investigations should be undertaken to determine the adequacy of the ceiling diaphragm connection to the block walls.
- d) The external separation block wall should be demolished and rebuilt with reinforced masonry.

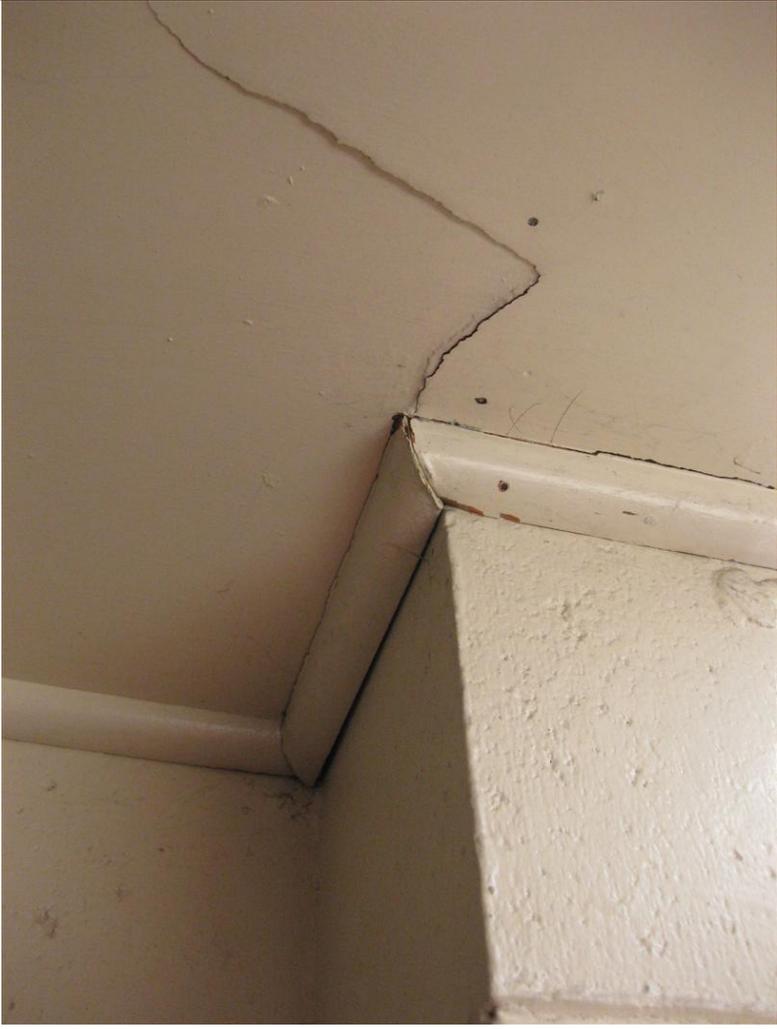
<p>7.</p>	<p>Crack in ceiling lining</p>

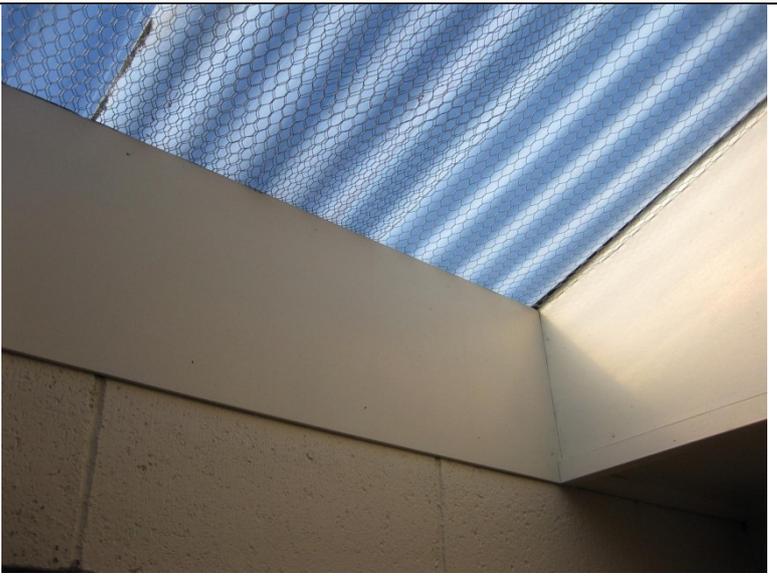
<p>8.</p>	<p>Skylight</p>

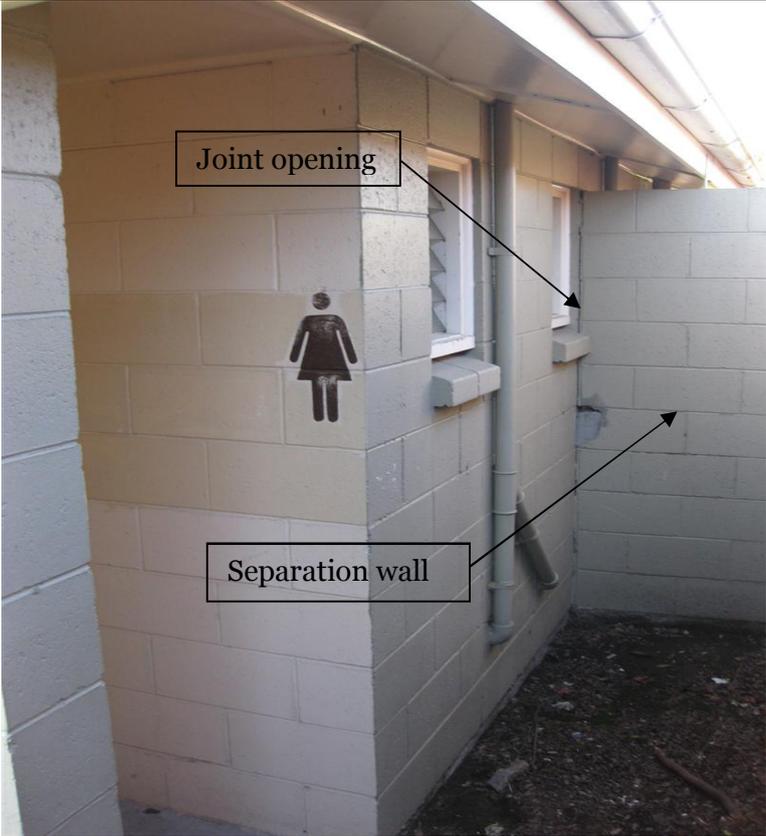
The building had no earthquake rapid assessment placard in place. No lateral displacement of the building was evident except for the joint between the building and an external block separation wall (refer Appendix 1, photos 9 & 10).

We note that the external separation block wall, although not connected to the building, has performed well under seismic conditions, with only some minor opening up of the joint against the buildings external block wall. The out-of-plane capacity of this separation wall is 42% NBS, as limited by the out-of-plane response of unreinforced masonry. It is considered to be a critical structural weakness as it is essentially unfilled and unreinforced.

<p>9.</p>	<p>External separation wall between male and female entries – showing opening of joint</p>

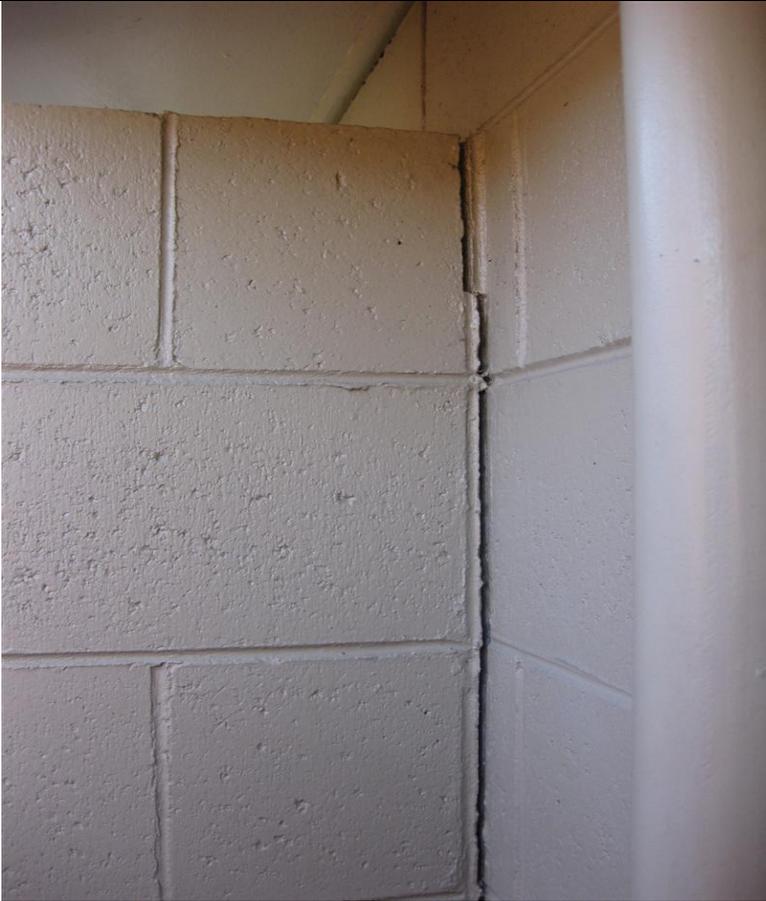
<p>The photograph shows an external corner of a building with a white brick wall. A female sign is mounted on the wall. A label 'Joint opening' with an arrow points to a gap in the brickwork above a window. Another label 'Separation wall' with an arrow points to the vertical joint between the main building wall and an adjacent wall.</p>
<p>10.</p>	<p>Opening of joint between the external separation wall and building</p>
