Hornby Library
PRO 1583-002
Detailed Engineering Evaluation
Qualitative Report
Version FINAL

8 Goulding Avenue, Hornby

Christchurch City Council

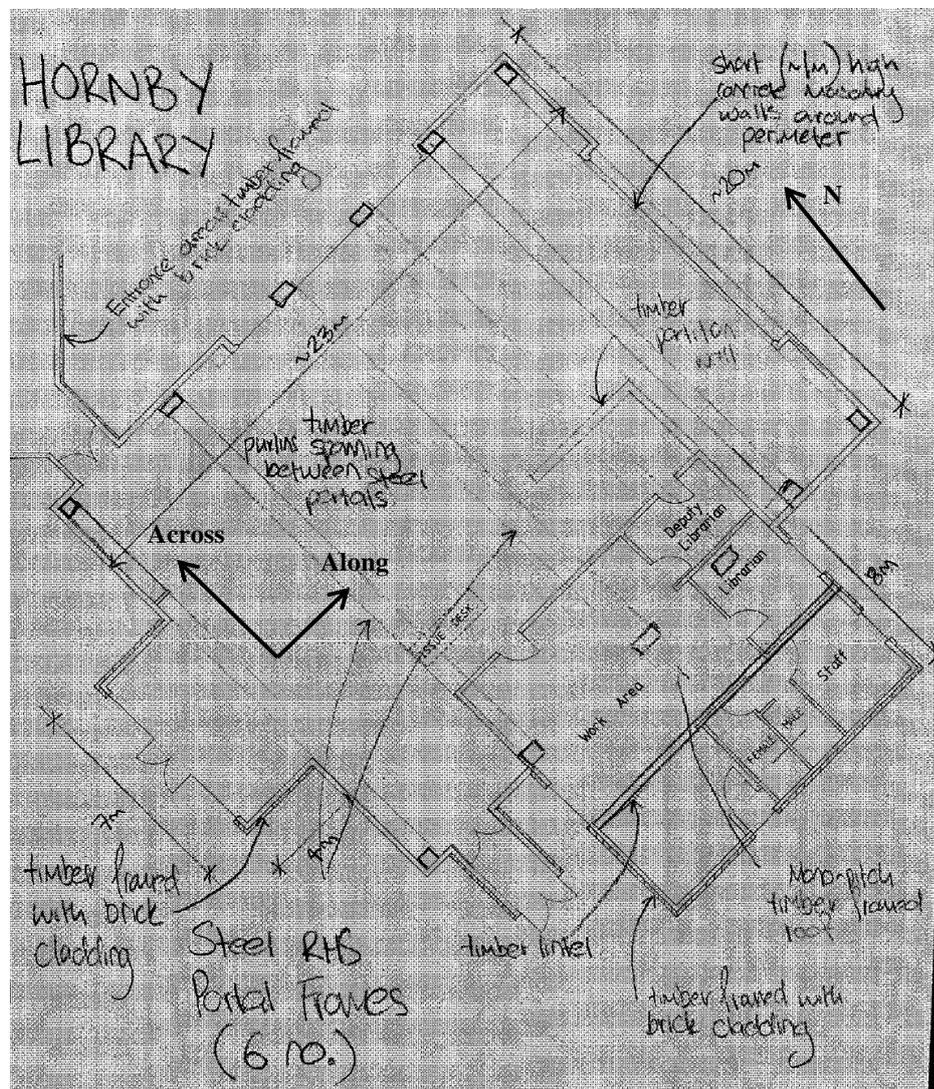
Figure 2 Plan sketch showing key structural elements

Lateral loads acting on the structure across the building are resisted by welded steel SHS portal frames. There are 6 total steel portal frames across the building. Cross bracing between steel portal frames transfers lateral forces along the building to the foundations during an earthquake.

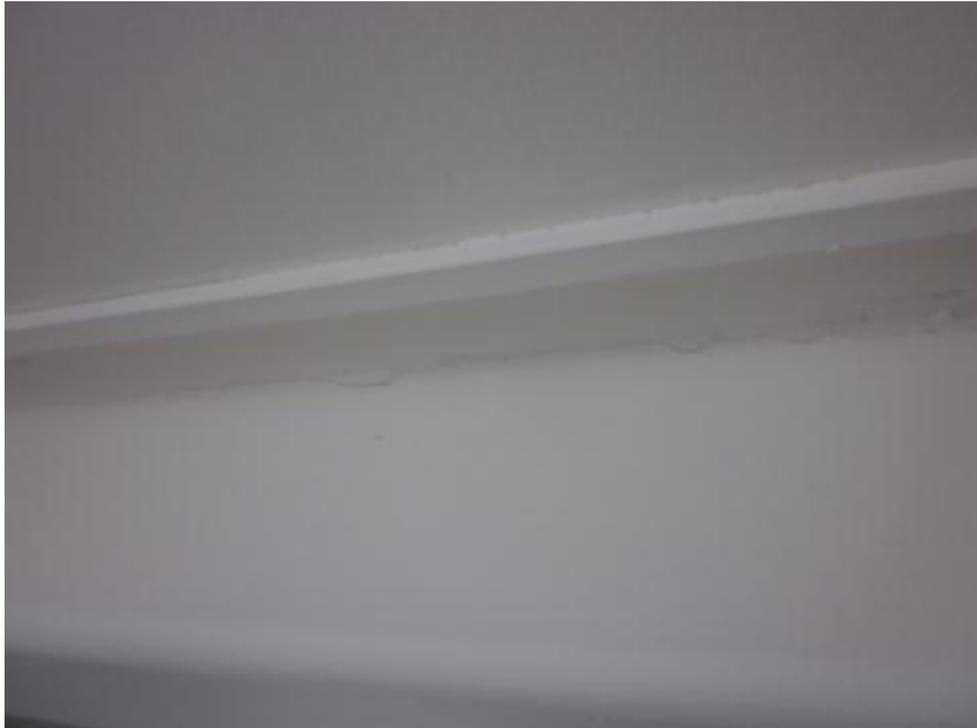
Photograph 5 Minor cracking to internal plasterboard lining.

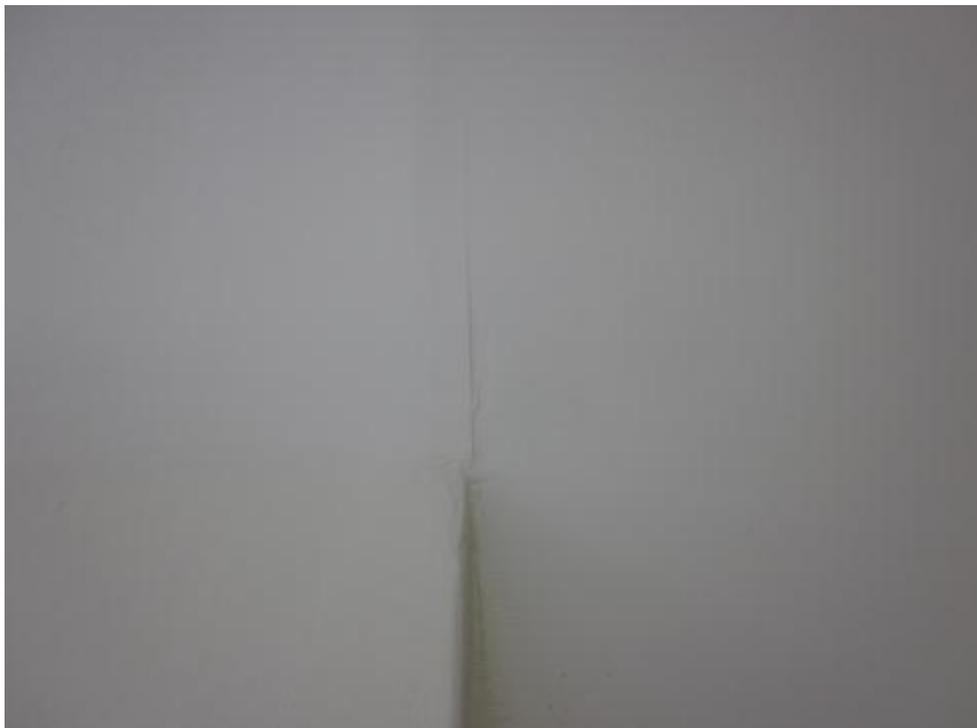
Minor cracking to the internal plasterboard lining was observed in several locations throughout the building. This is shown in Photographs 6 to 10. The damage to the plasterboard lining is due to movement of the steel portal frame structure during an earthquake. The relatively ductile steel portal frame is able to accommodate movement during an earthquake; however the plasterboard lining has behaved in a more brittle manner and has cracked as a result of the movement.

Photograph 6 Minor cracking to internal plasterboard lining.

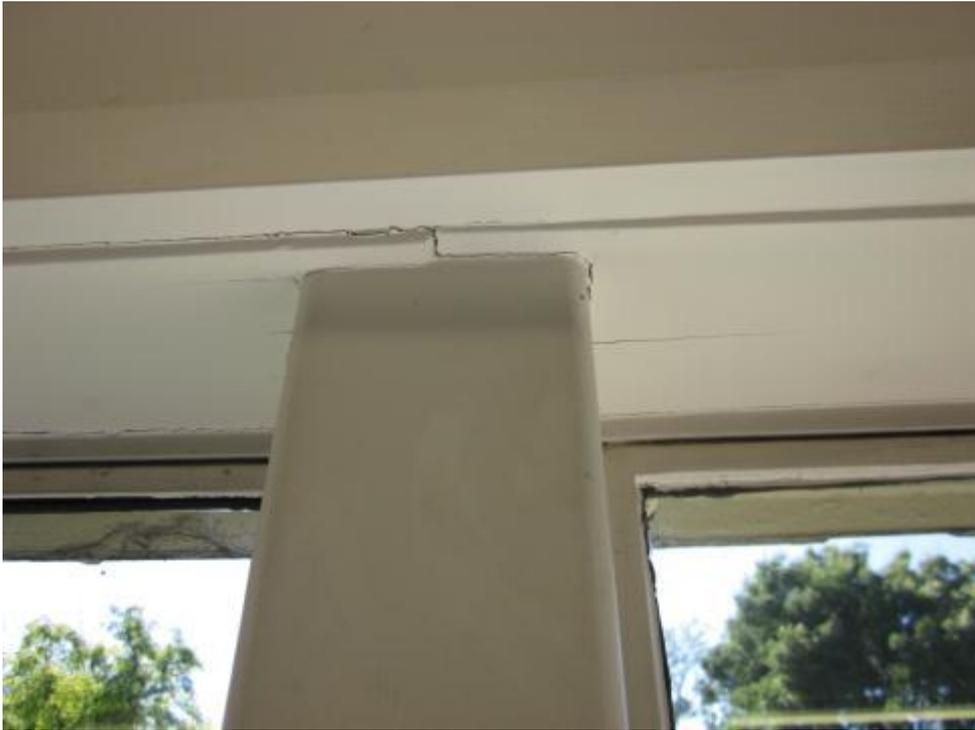
Photograph 7 Minor cracking to internal plasterboard lining around steel portal frame.

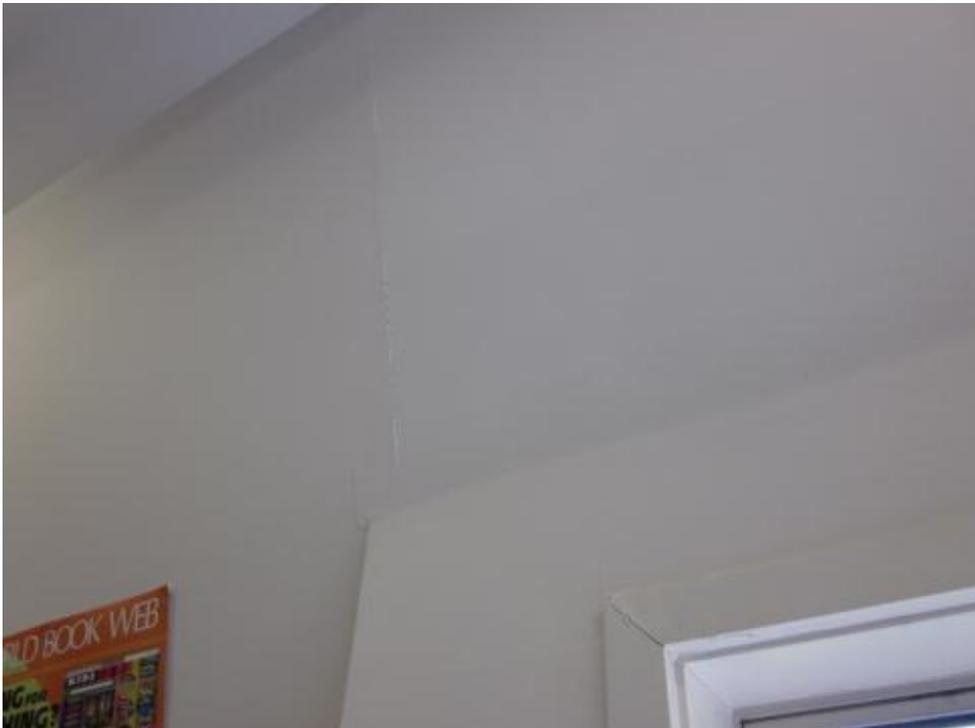
Photograph 8 Minor cracking to internal plasterboard lining.

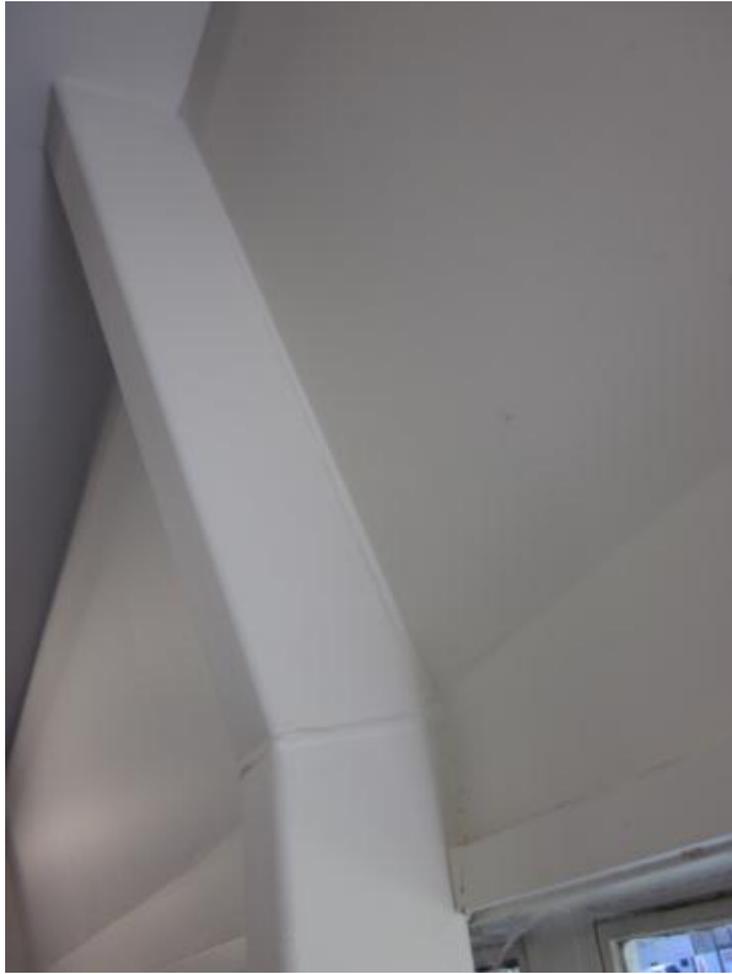
Gravity loads in the steel portal frame section of the building are transferred from the roof through the timber purlins which are supported by steel SHS portal frame. A section of the steel SHS portal frame is shown in Photograph 9. The loads are then transferred through the portal frames and into the foundations of the building.

Photograph 9 View of steel portal frame.

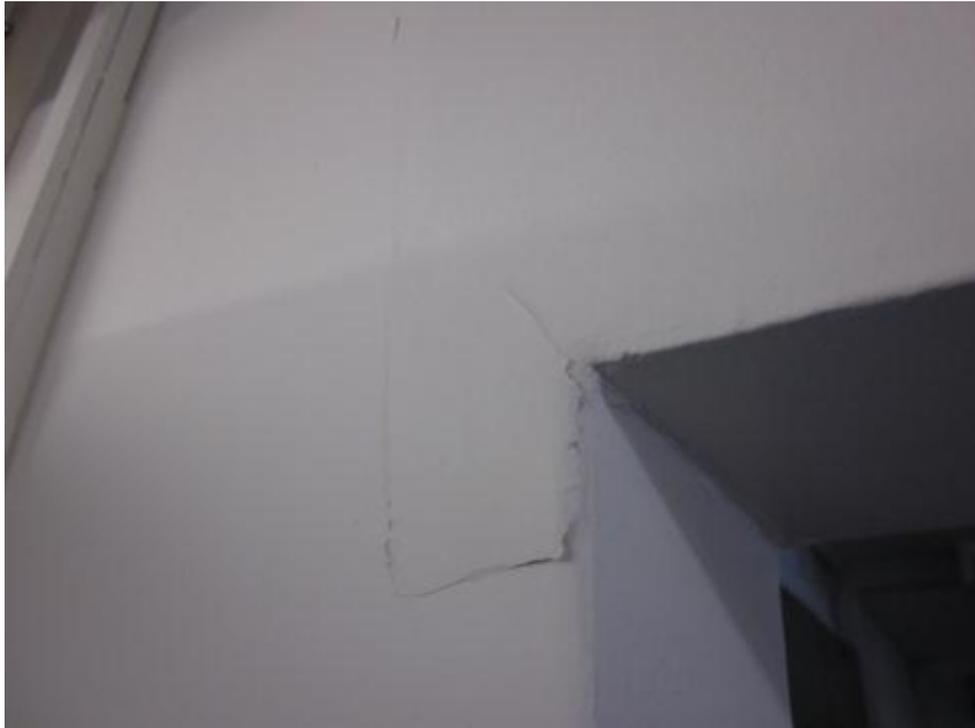
Photograph 10 Minor cracking to internal plasterboard lining.
