**CHRISTCHURCH CITY COUNCIL**  
PRK\_0966\_BLDG\_001 EQ2  
Huntsbury Community Building  
30F & G Huntsbury Ave

QUALITATIVE ASSESSMENT REPORT

- Rev B
- 14 February 2013

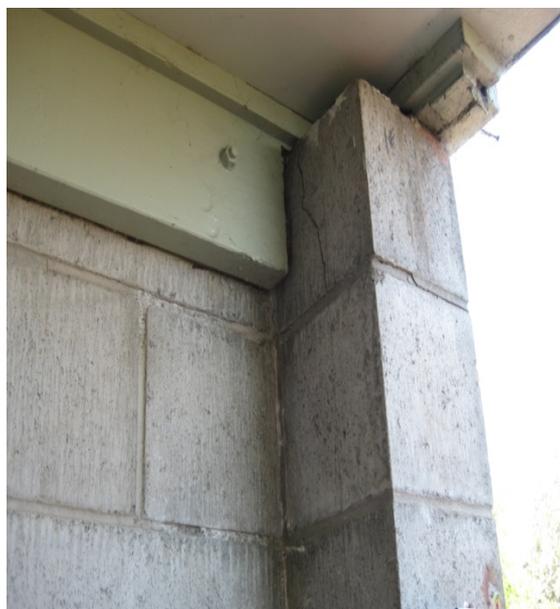
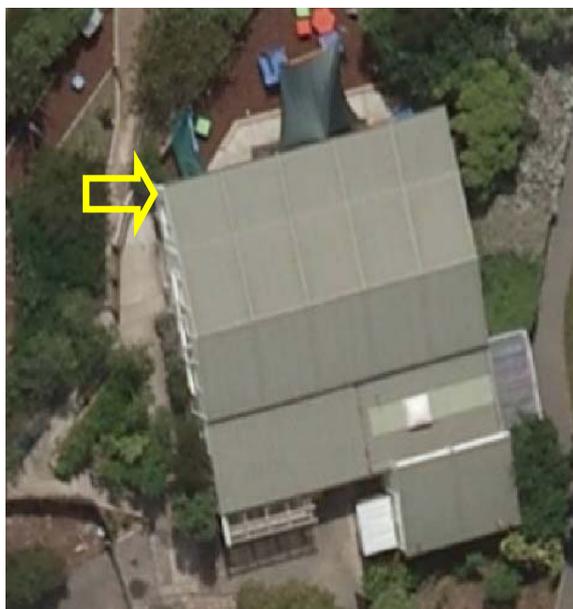
- 1) Crack at concrete masonry pilaster column on the North West corner of the basement wall (Photos 3-4).
- 2) About 12mm gap between the floor and wall base along the east side of the corridor towards the south access door (photos 9-10). No apparent movement or damage was observed on the wall. This indicates that a small amount of settlement has occurred, although it could not be determined from visual inspection whether this is earthquake related or not. Extent of damage and scope of repairs to be confirmed after level survey.

Photo 3: Photo showing cracks on the masonry column on the north west side corner of the retaining wall.

Photo 4: Aerial photo showing location of cracks in Photo 3.

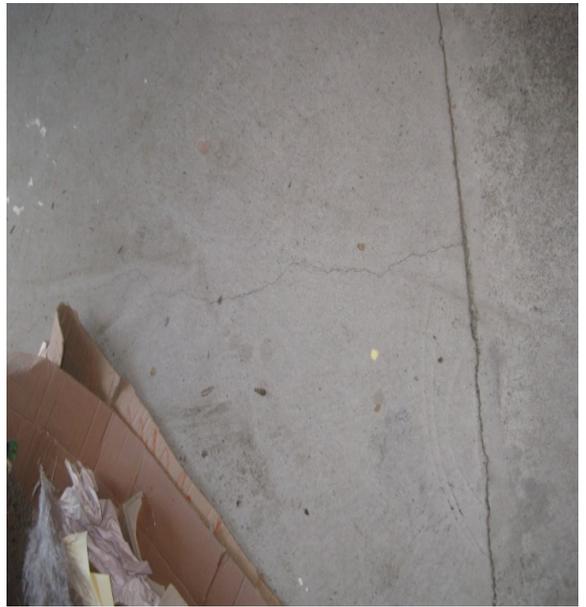
- 4) Hairline cracks on some walls of all three toilets on the southeast side of the building (photos 11-18)
- 5) Opening of construction joints (about 0.8mm) at the basement floor (photo 6). It is not clear whether this is earthquake related, and could well be the result of drying shrinkage. No repairs are recommended for this item.

Photo 6: Construction joint on the basement floor opening slightly by about 0.8mm.

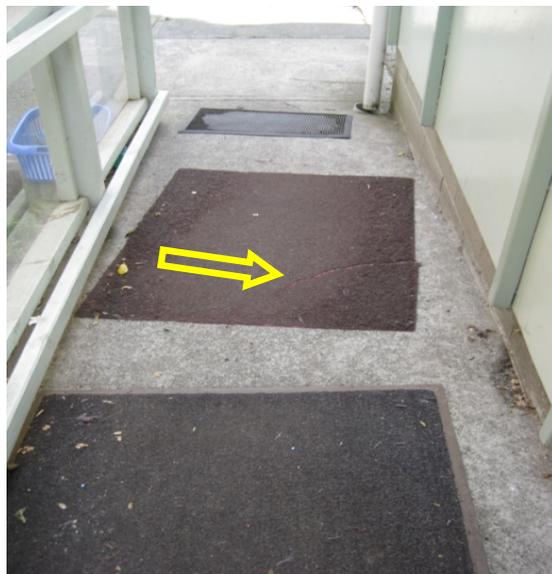
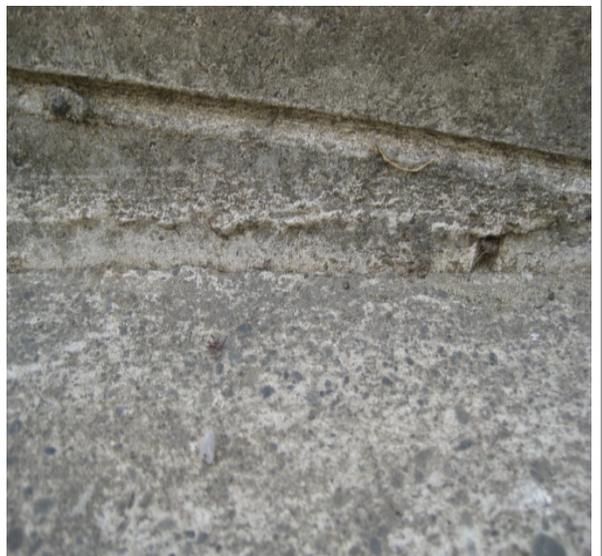
- 3) Apparent settlement of the concrete ramp on the building access on the south side (photos 7-8). It is not clear from visual inspection whether this is earthquake related. Extent of damage and scope of repairs to be confirmed after level survey.

Photo 7: Photo of the building access on the south side of building.

Photo 8: View as pointed by the arrow in photo 7 showing the concrete ramp and masonry wall interface where apparent settlement is observed.

Due to the visible settlement of the floor around the south entrance we recommend that a verticality and level survey be conducted on the entire building.

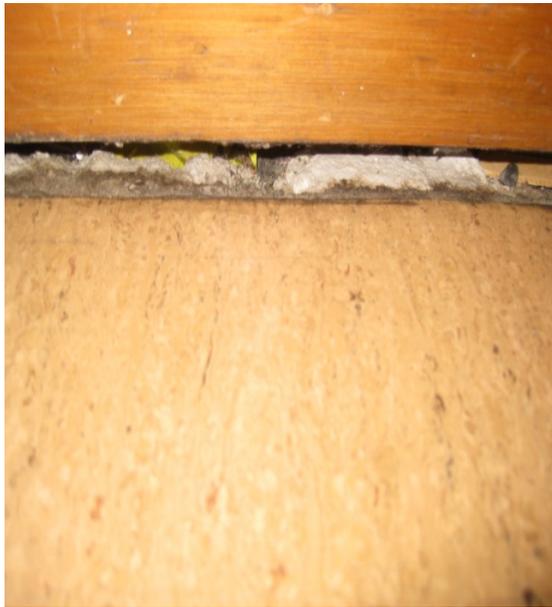
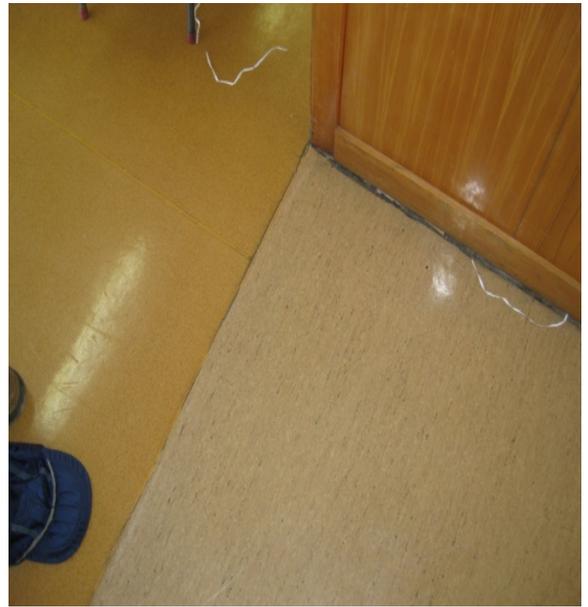
Photo 9: Photo showing increased gap between floor and wall base on the along the corridor of the building access on its south.

Photo 10: Zoomed out view where the cracks along the corridor shown in Photo 9 were found.

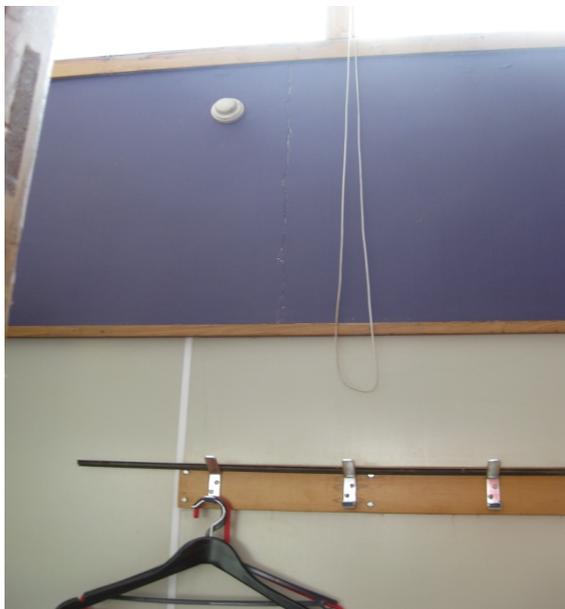
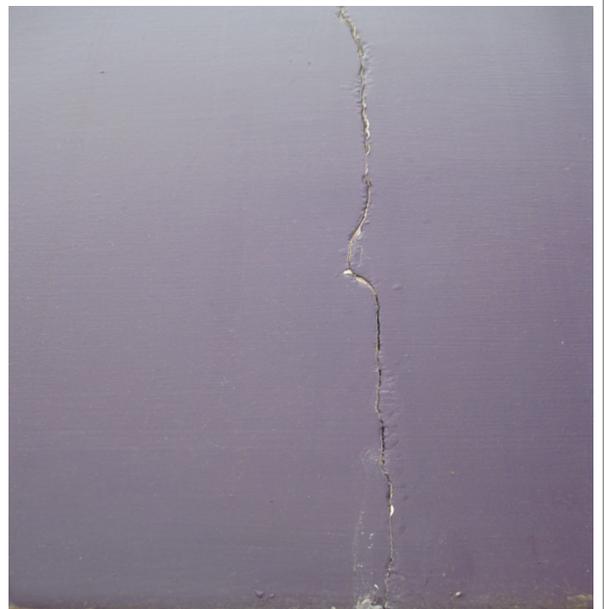
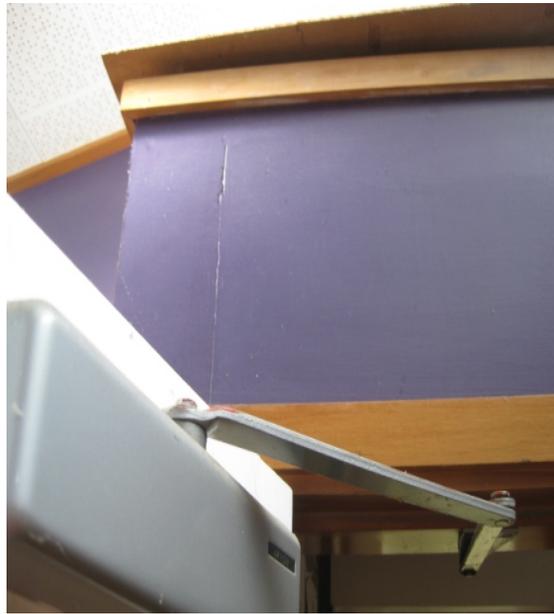
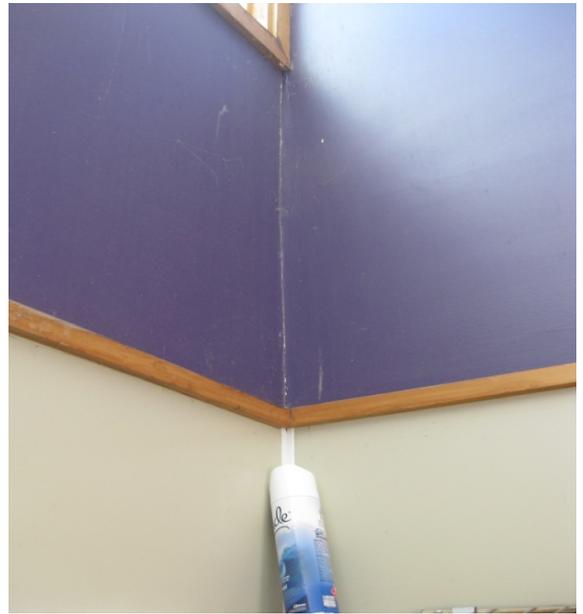
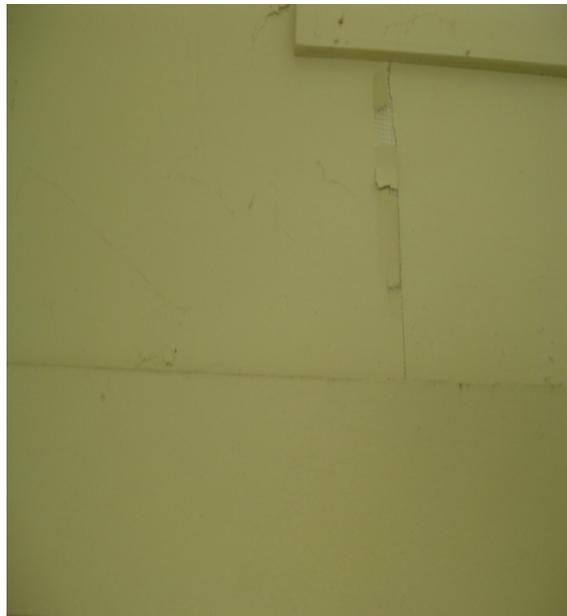
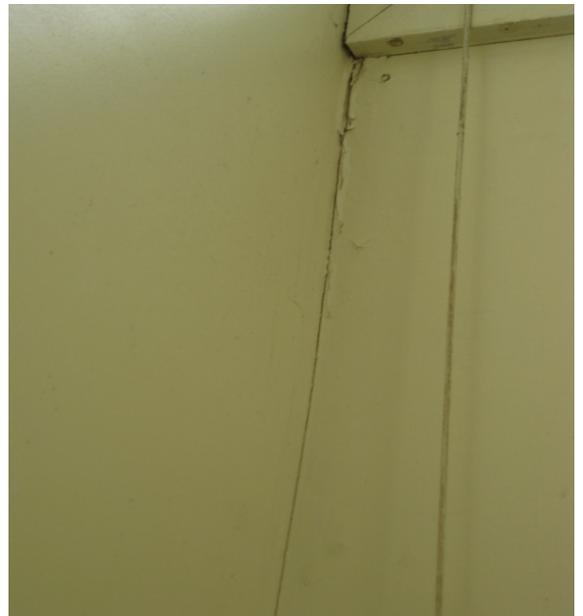
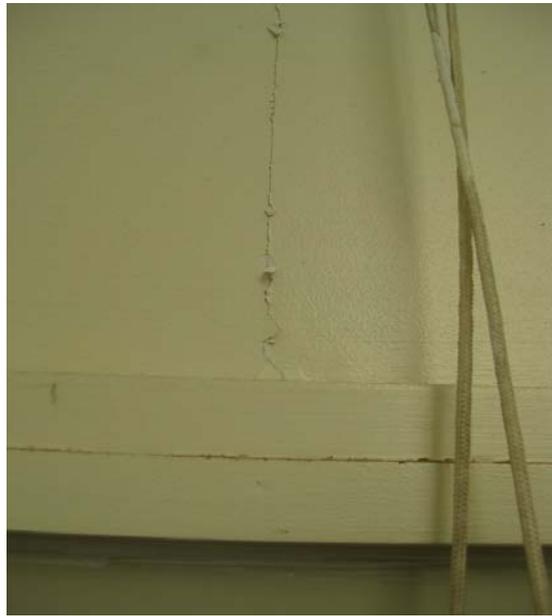
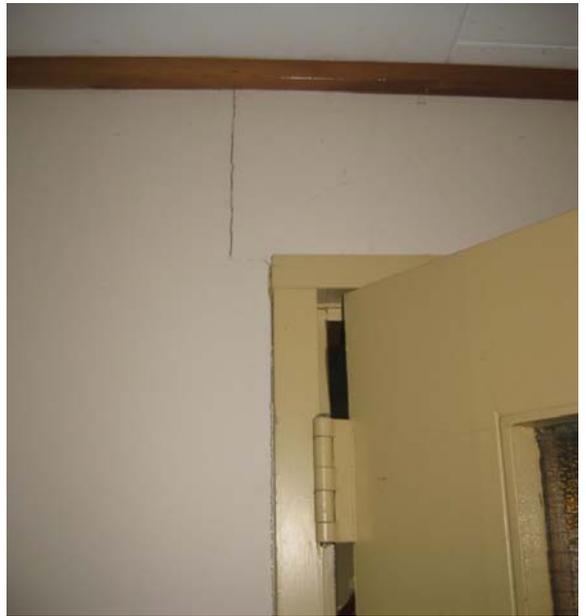
Photo 11: Plaster board cracks found on toilet walls.

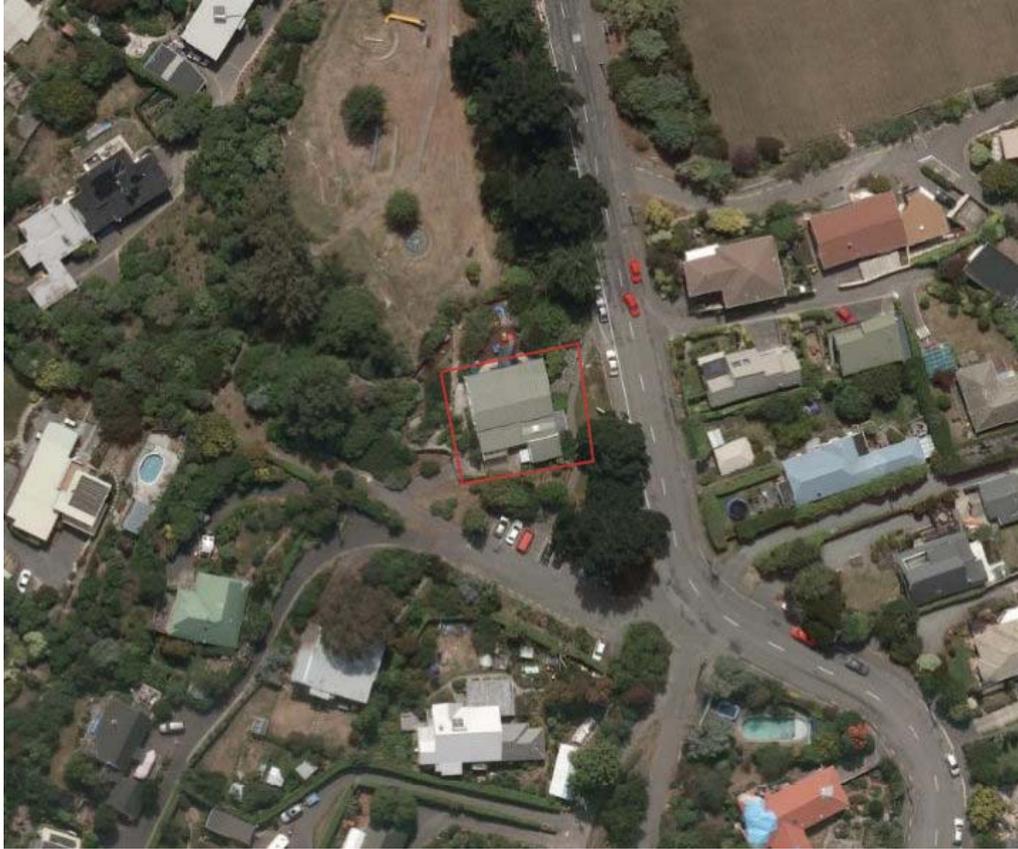
- **Figure 4 – Aerial photography from 24 Feb 2011 (<http://viewers.geospatial.govt.nz/>)**

There is no evidence of land damage noted from the aerial photography on the site or neighbouring properties.

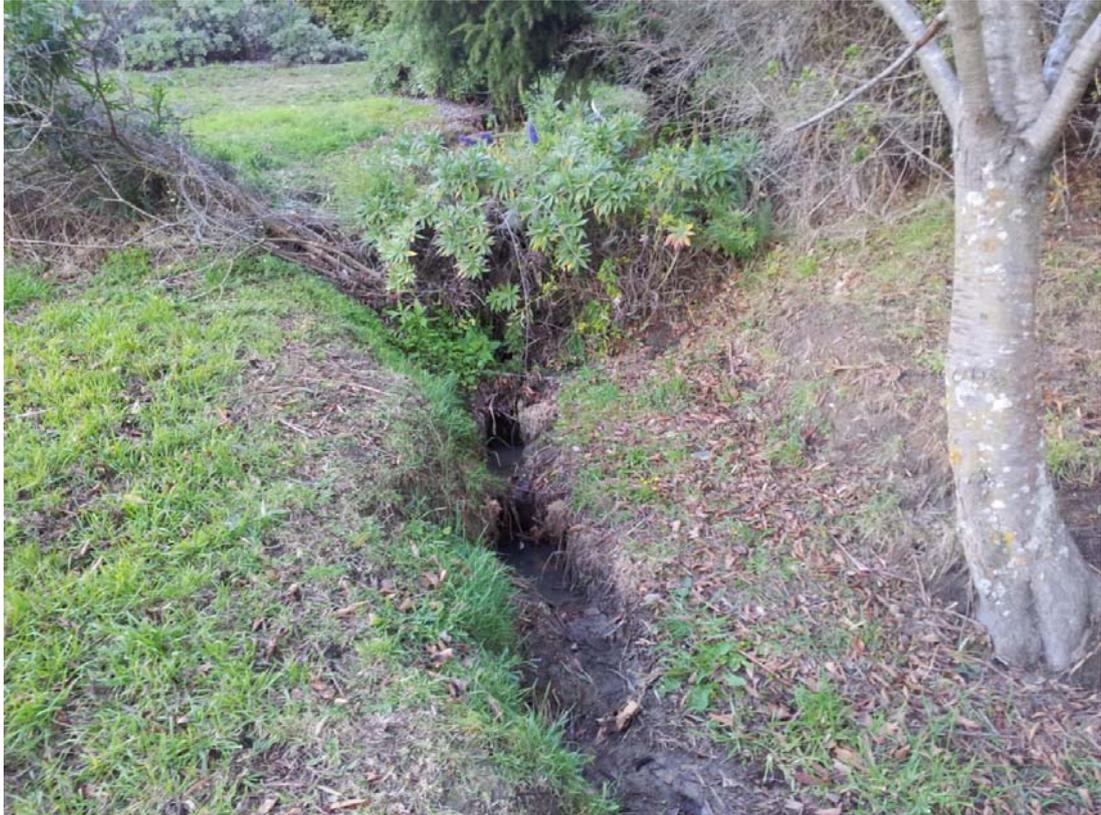
There was evidence of tunnel-gully erosion, but this is not believed to be as a result of earthquake damage. No visual evidence of tension cracks was noted within the site; however, a minor gap was observed between the concrete ramp and wall base to the south side of the building, likely as a result of settlement.

■ **Figure 7 Observed tunnel gully**
