Innes Courts PRO 0643

**Detailed Engineering Evaluation
Quantitative Assessment Report**

**403 & 407 Innes Road, Mairehau,
Christchurch**

Date: June 2013
Reference: 6-QUCC2.16
Status: Final

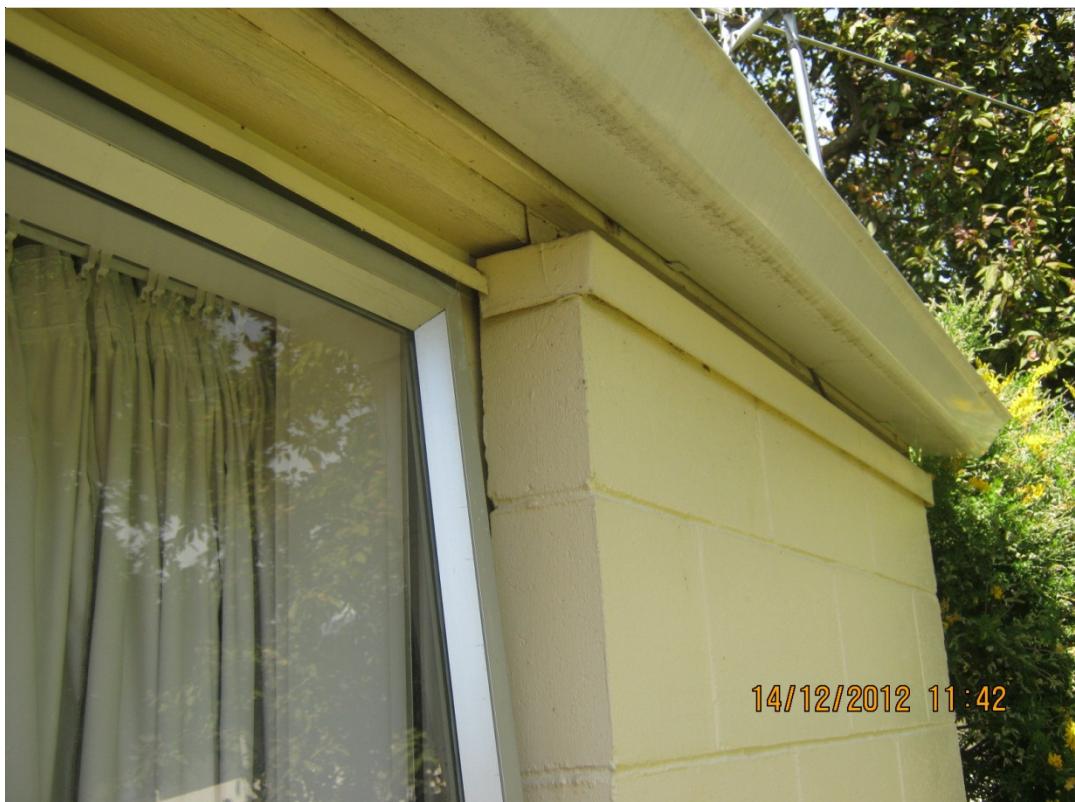
Photo 3: Connection of the block veneer to the roof structure

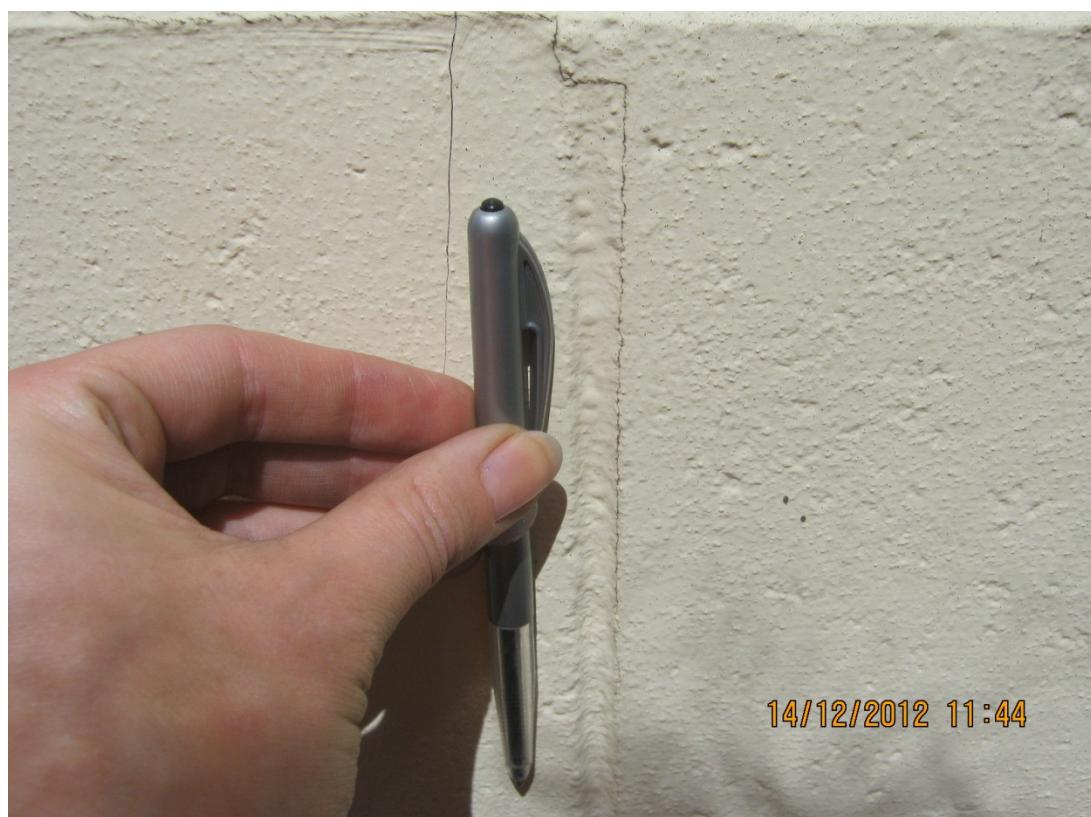
Photo 4: Cracking of the block veneer

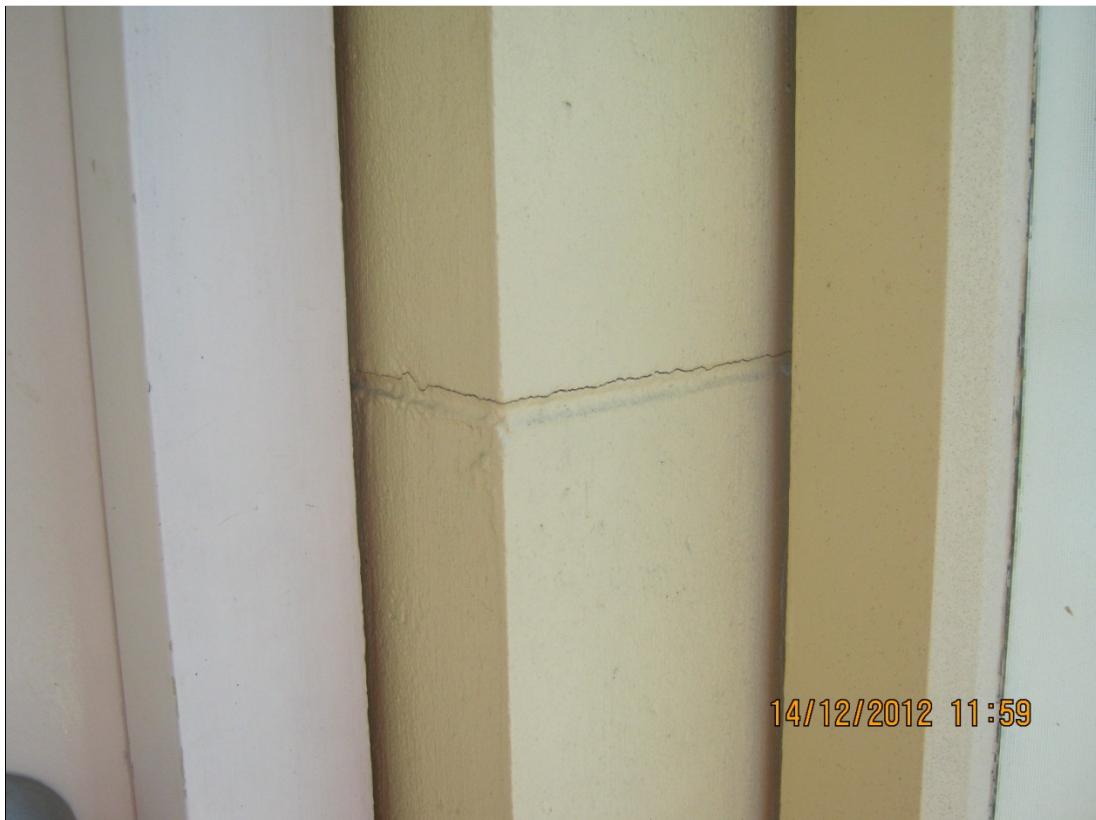
Photo 5: Cracking of the block veneer

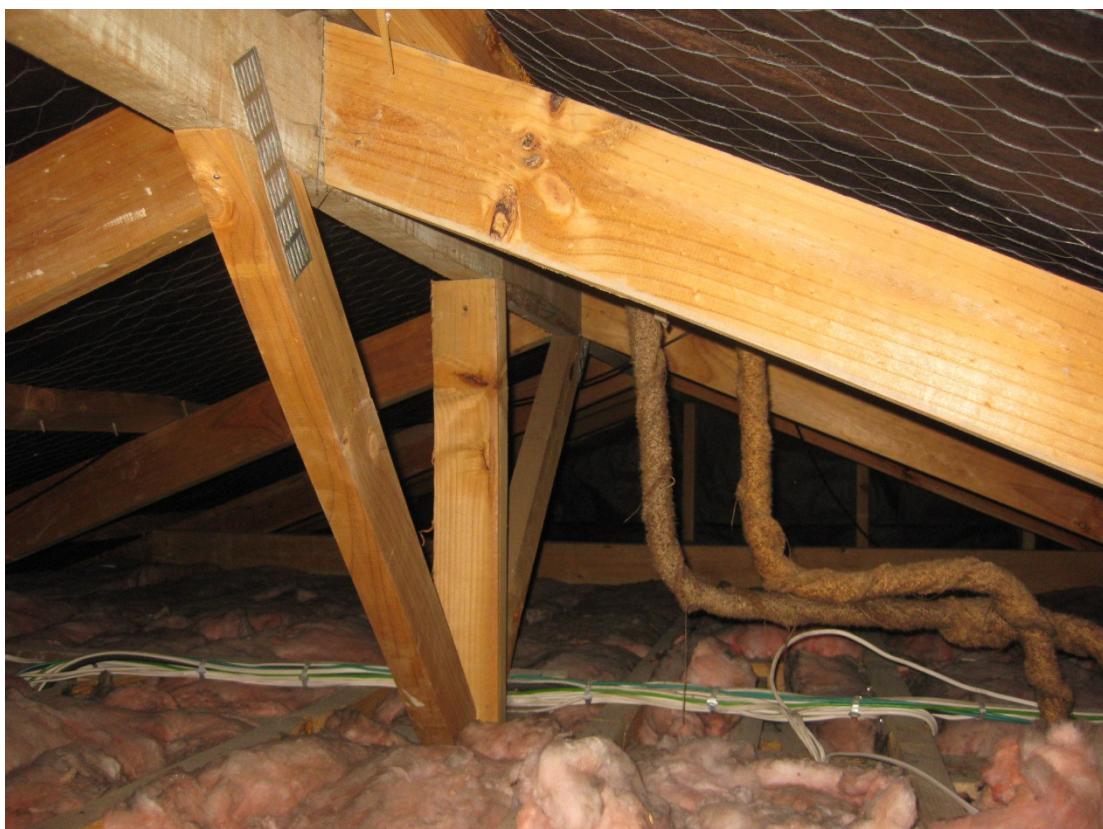
Photo 6: Roof structure without bracings

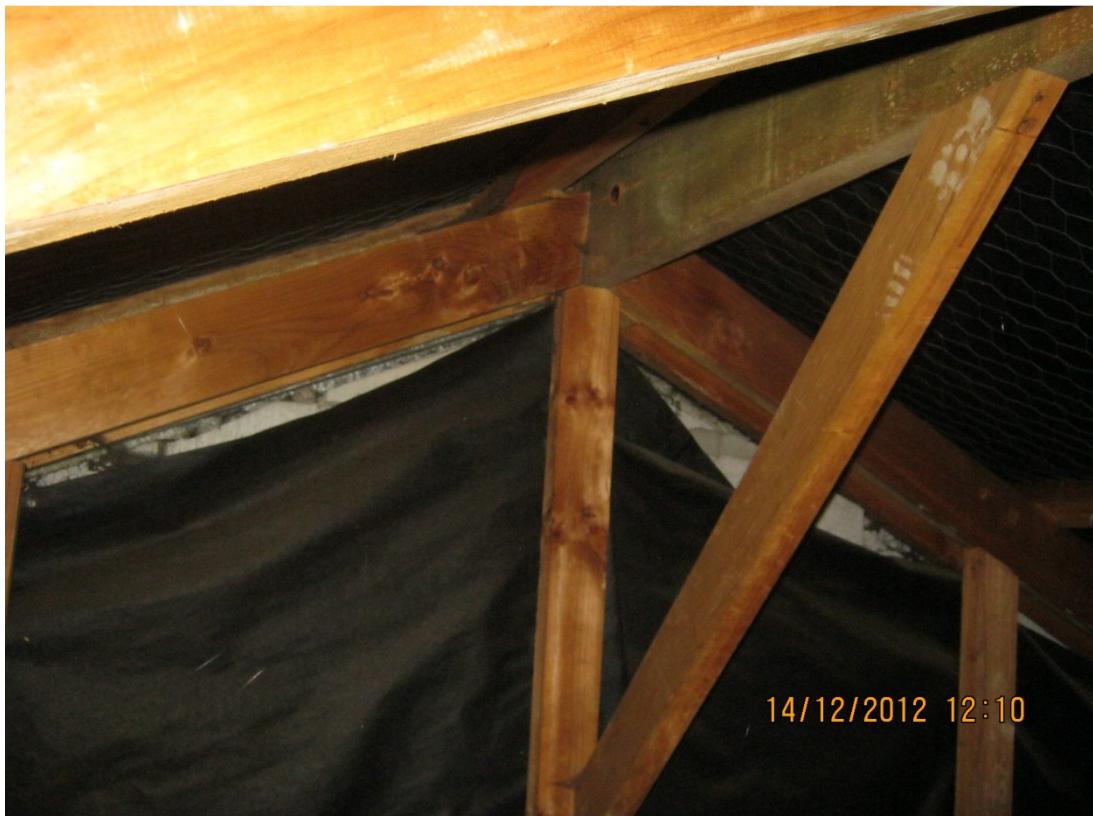
Photo 7: Roof structure without bracings

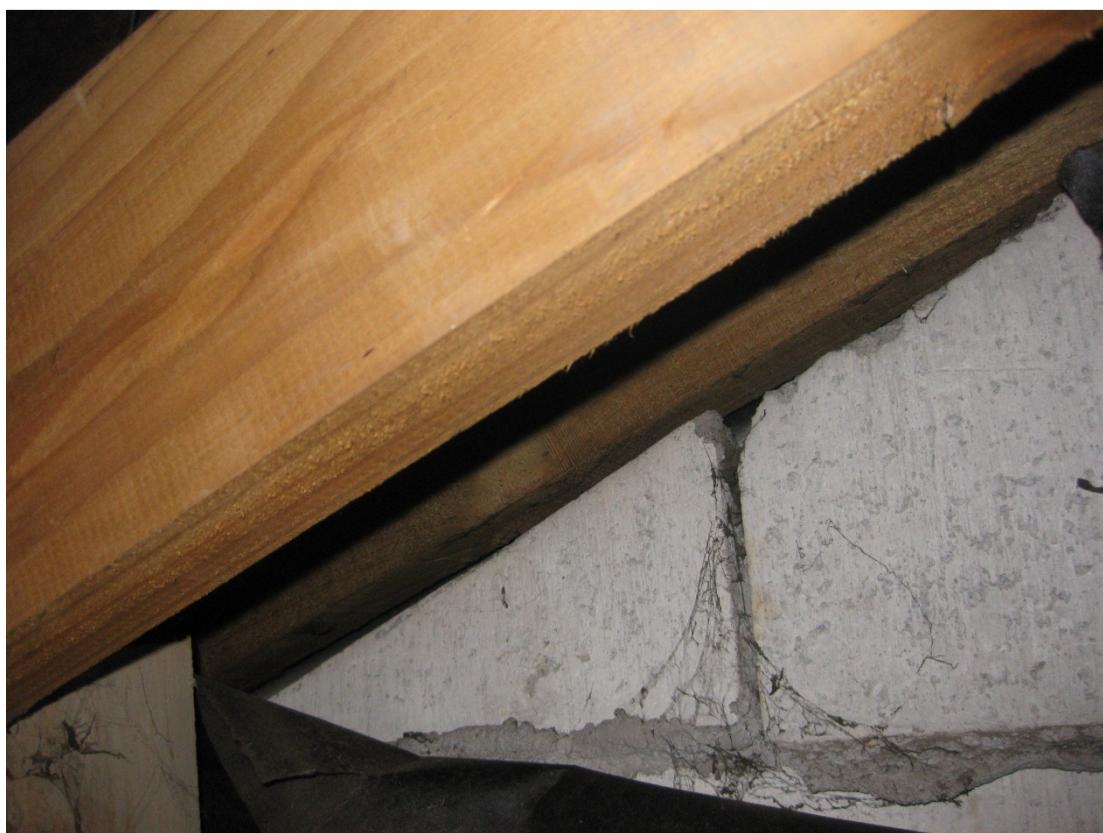
Photo 8: Roof structure without bracings

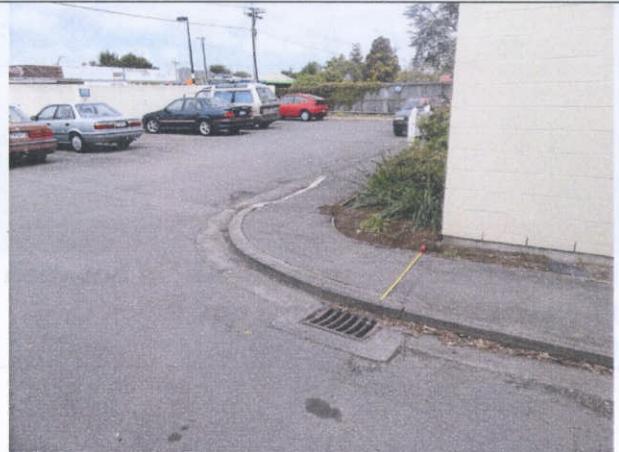
Figure 3 Cracks in footpath, same location as figure 3

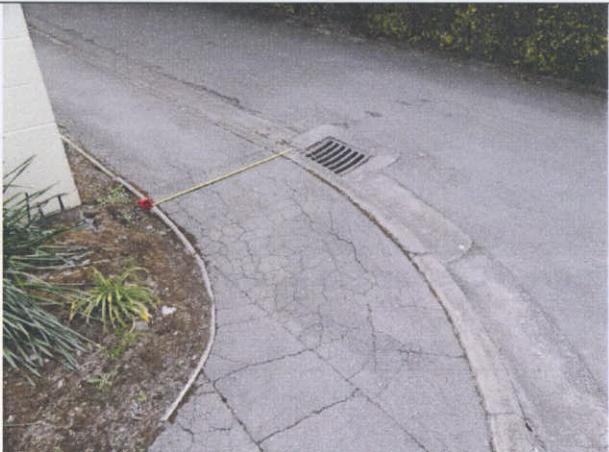
Figure 4 Detail of various cracks and settlement near gully pot, same location as (figure 3)

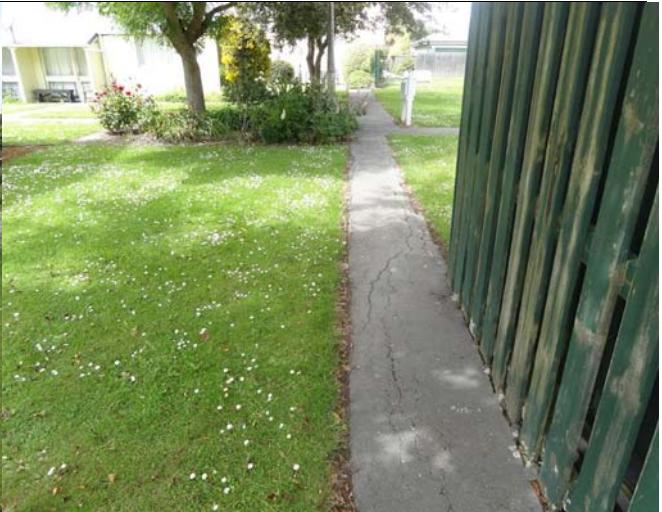
Figure 6 Cracking in footpath next to block E.

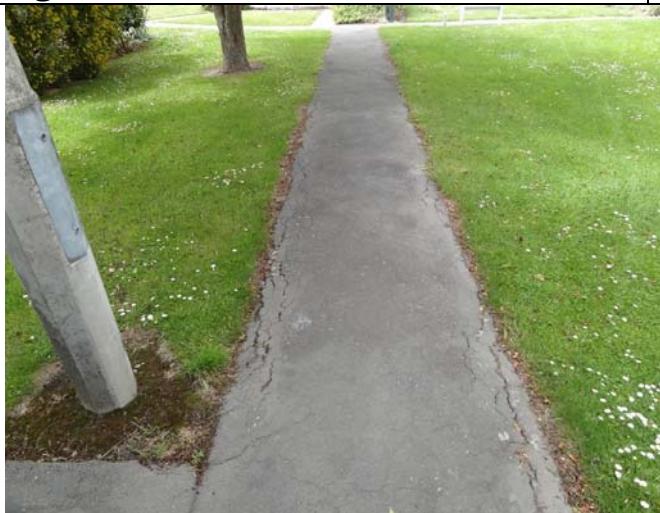
Figure 7 Cracking in footpath through the lawn

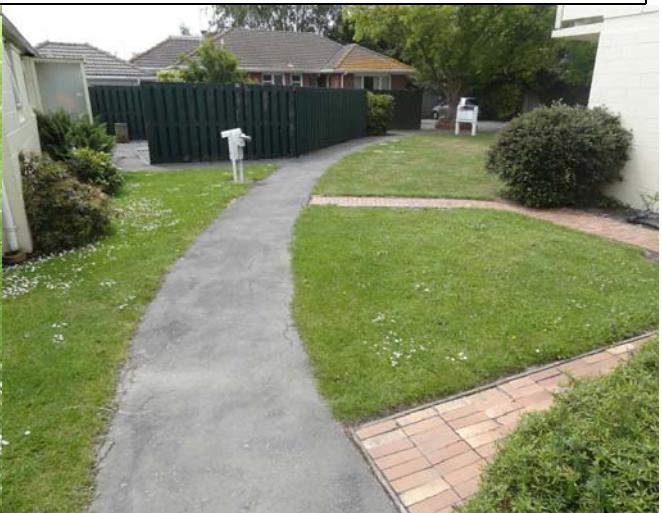
Figure 8 Cracking in footpath, in between block B unit 11/12 (right) and block C, unit 13/14 (left)

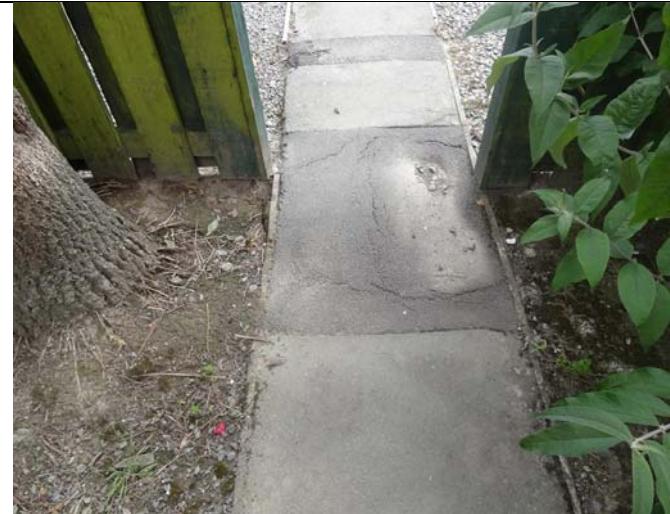
Figure 9 Local depression in footpath

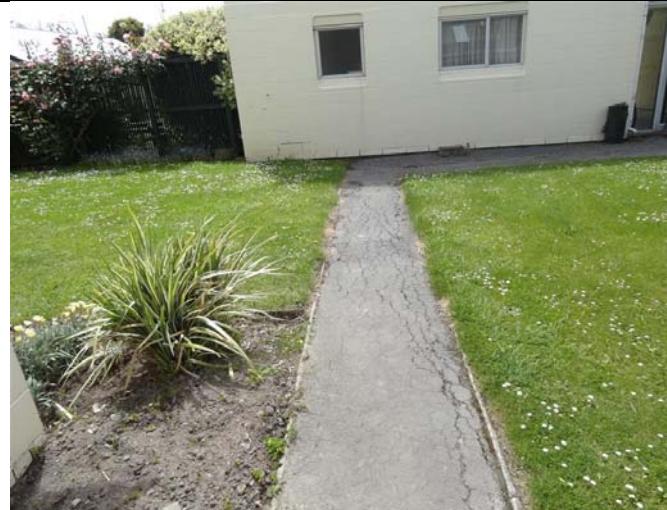
Figure 11 Typical cracking in footpaths

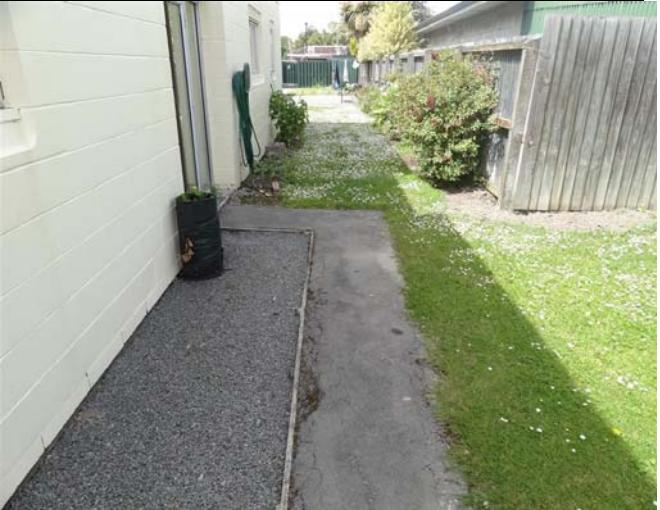
Figure 12 General ground level depression visible

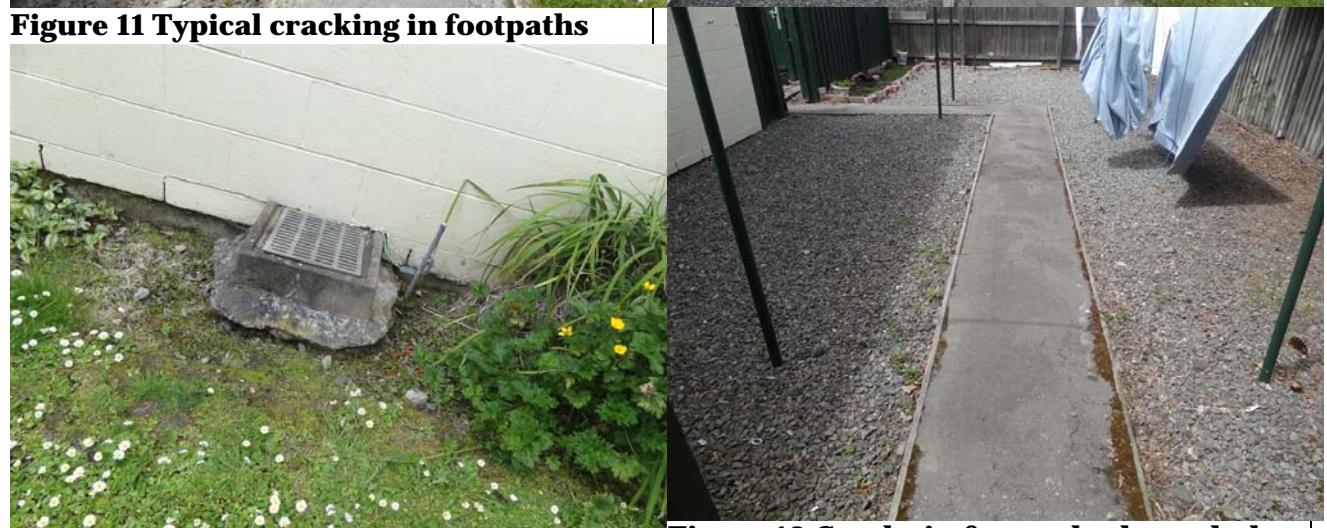
Figure 13 Cracks in footpath, through the drying area, next to unit 23/30 block E

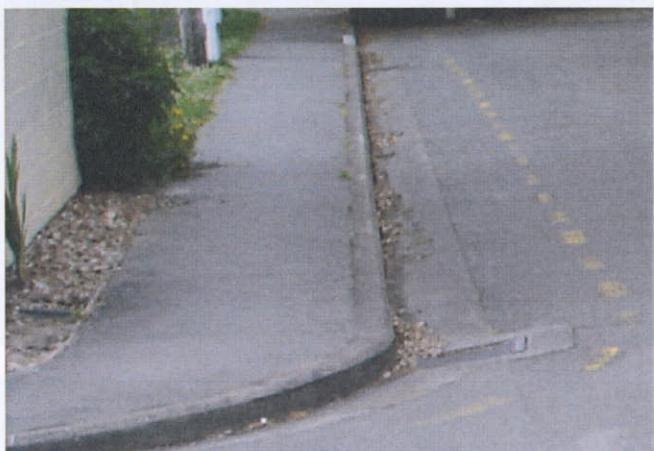
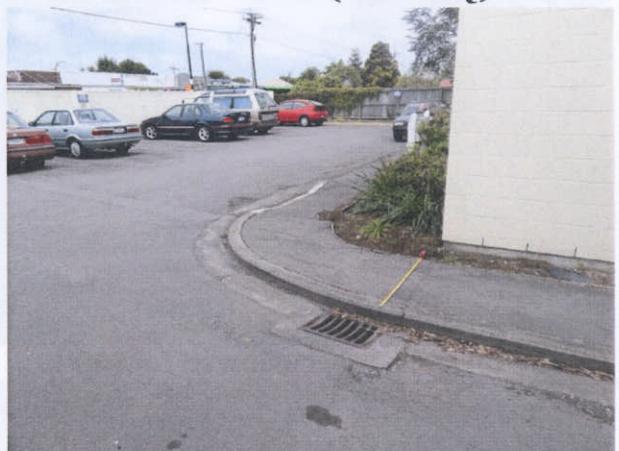
Cracks in footpath pavement

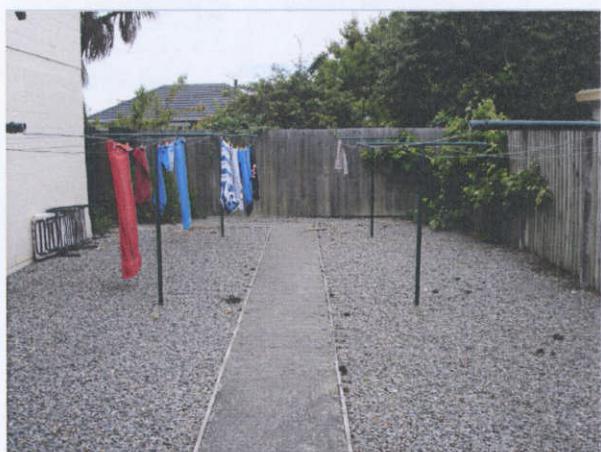
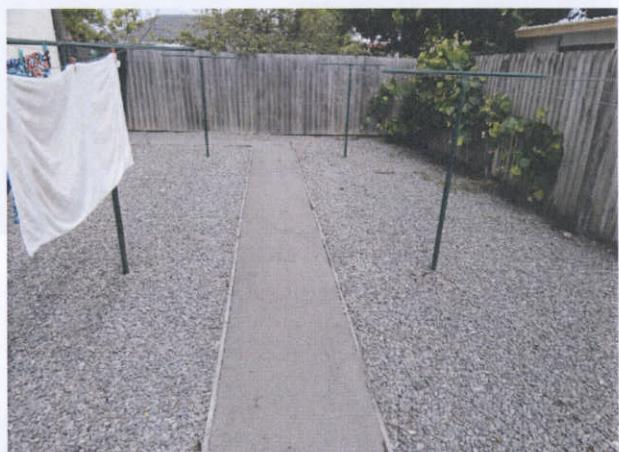
Cracks in washing area
